# **Assessment of Dam Safety of Coal Combustion Surface Impoundments**

**Indianapolis Power & Light Company**

**Petersburg Generating Station**

**June 8, 2010**

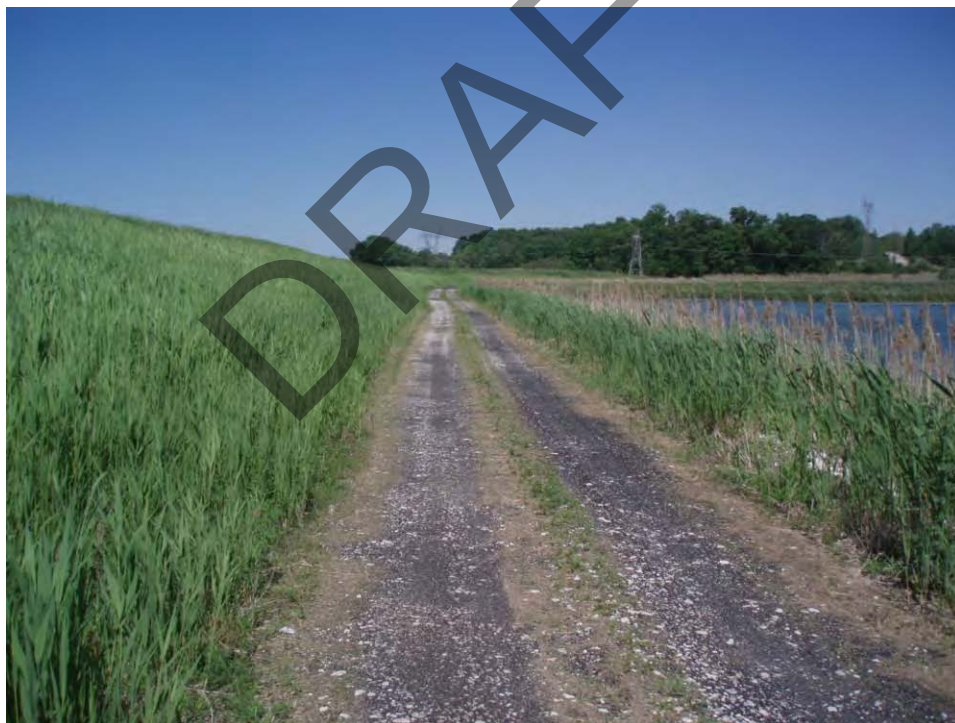
64. Pond A - Discharge north embankment crest and Pond B south embankment toe, looking northeast.

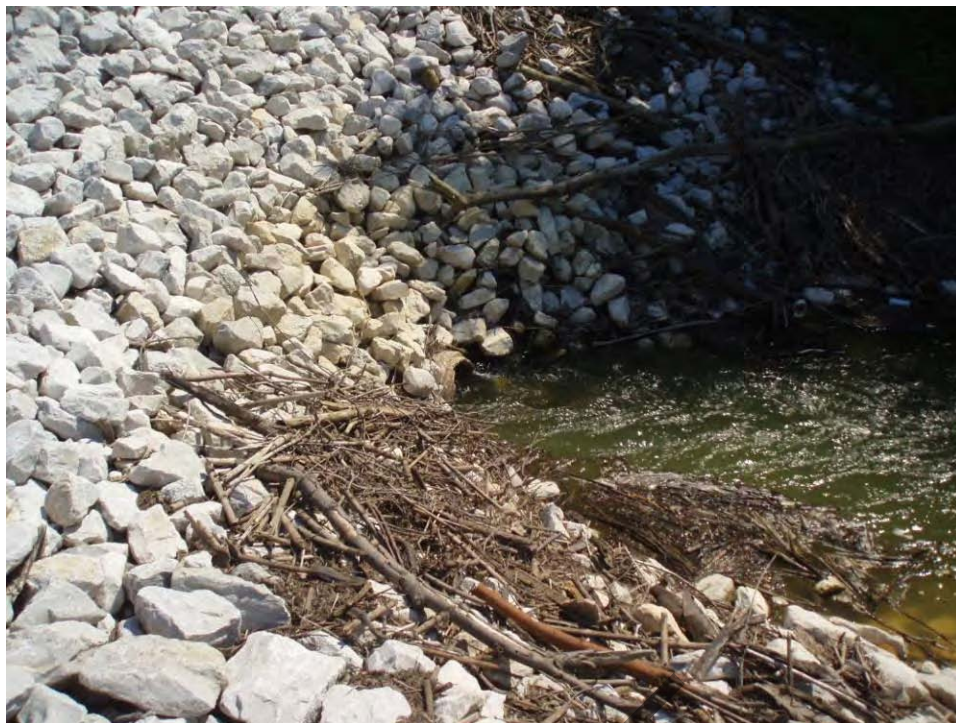
69. Pond A - Discharge, looking south at 24-inch-diameter RCP outlet pipe.

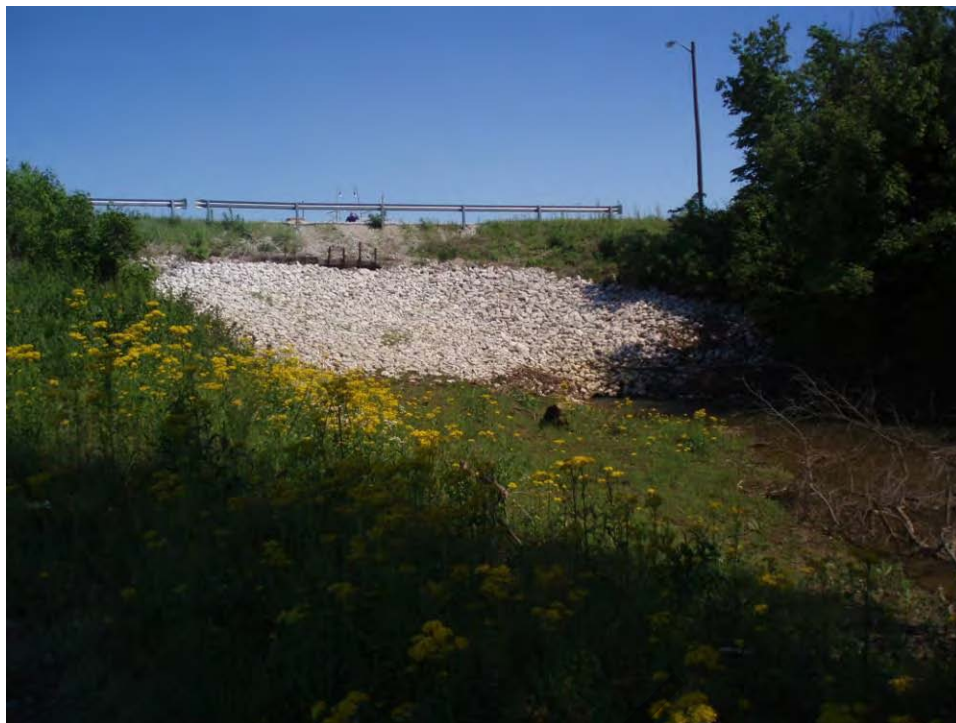
71. Pond A - Discharge, overview of downstream area from outfall.

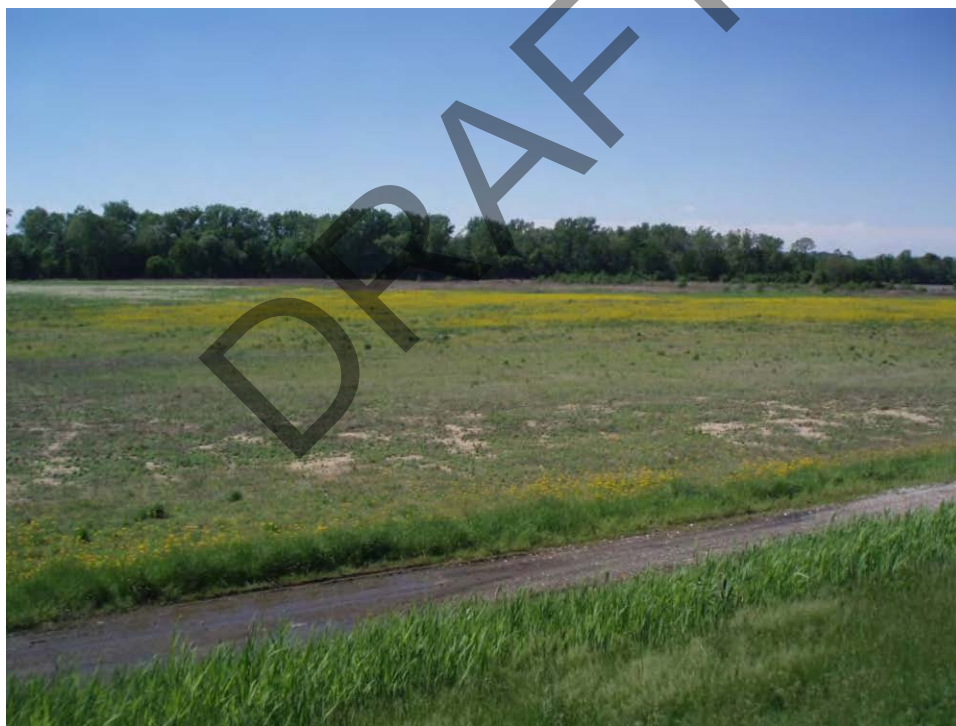
78. Overview of Pond B - West embankment, downstream area, looking west.

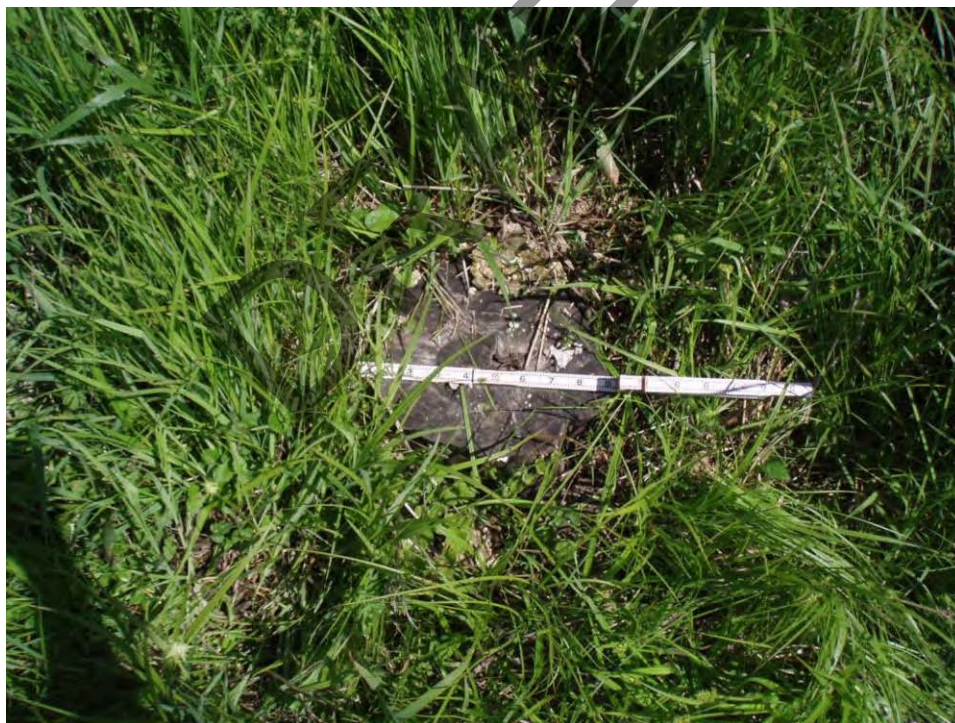
80. Pond B - West embankment lower exterior slope, looking at 0.9-foot-diameter tree stump at toe.

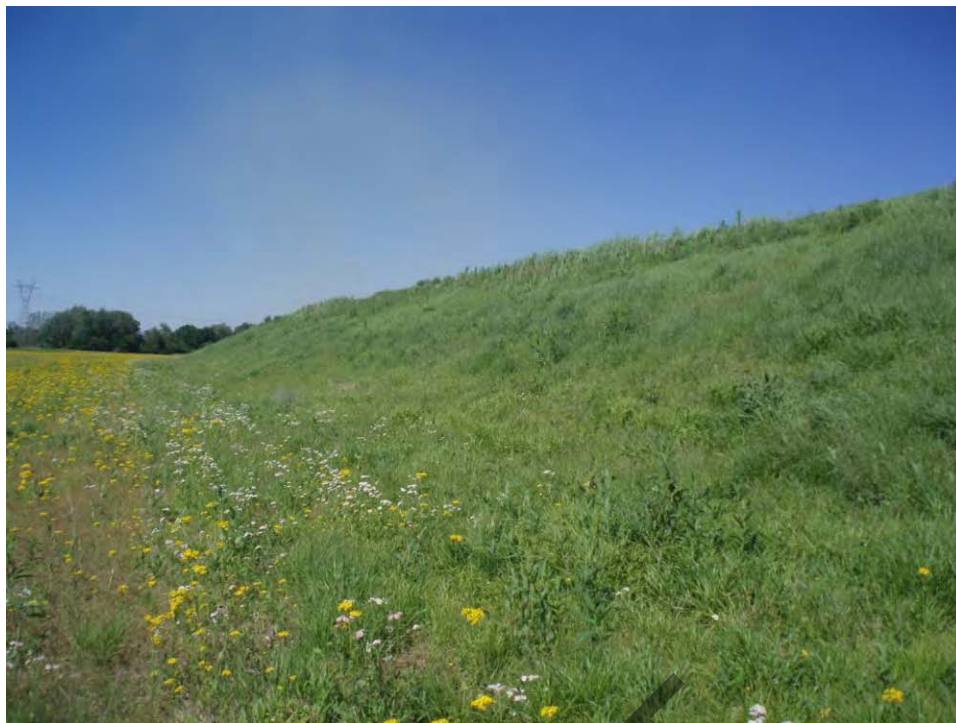
81. Pond B - West embankment lower exterior slope, looking north.

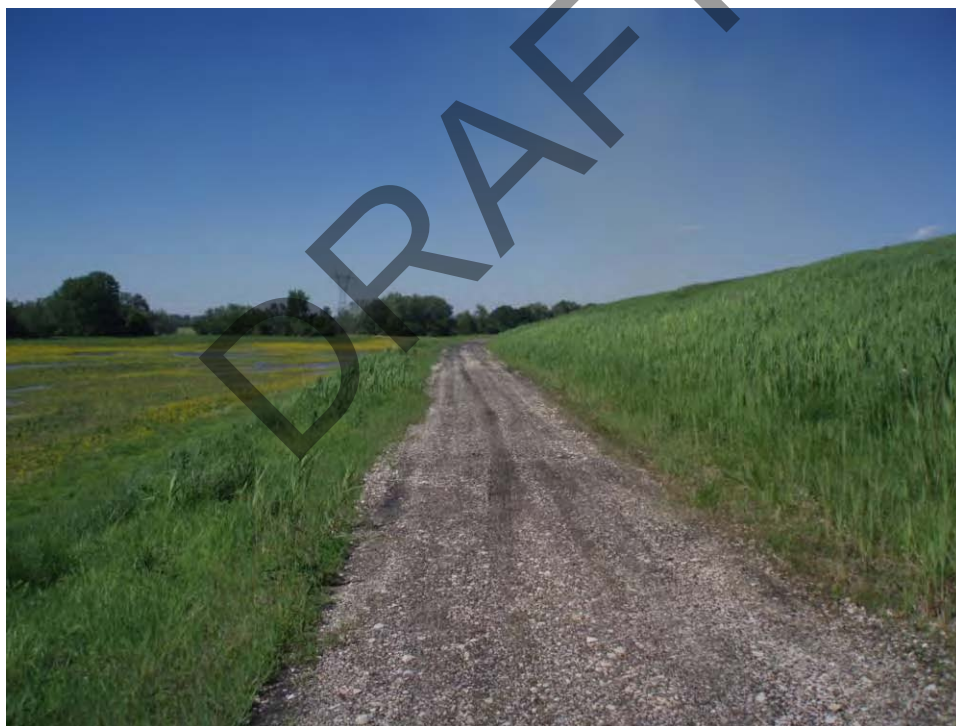
82. Pond B - West embankment bench, looking north.

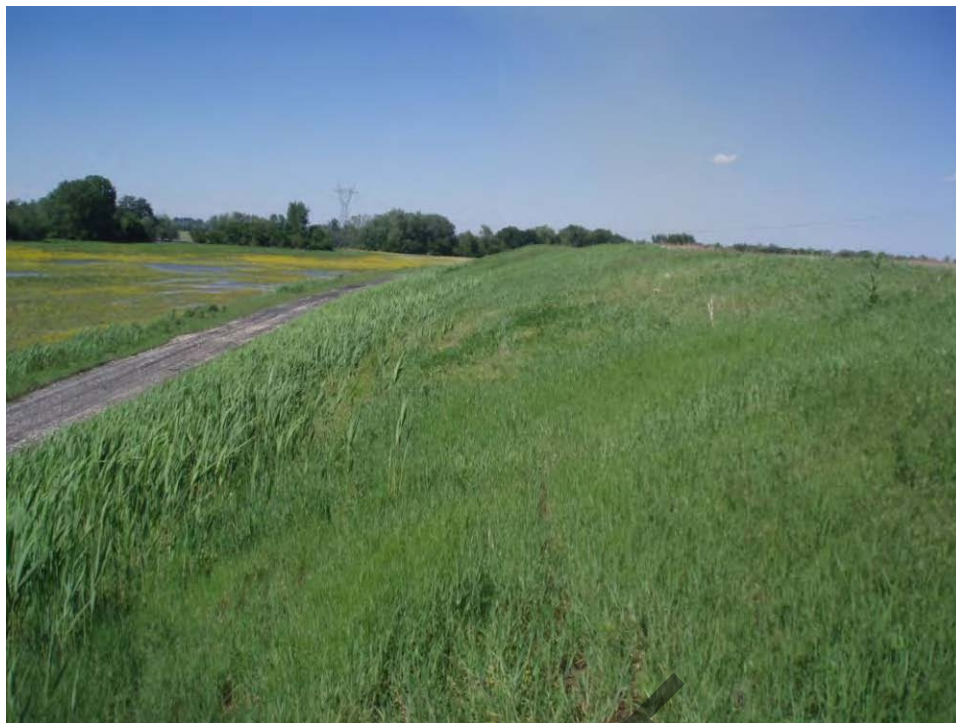
83. Pond B - West embankment upper exterior slope, looking north.

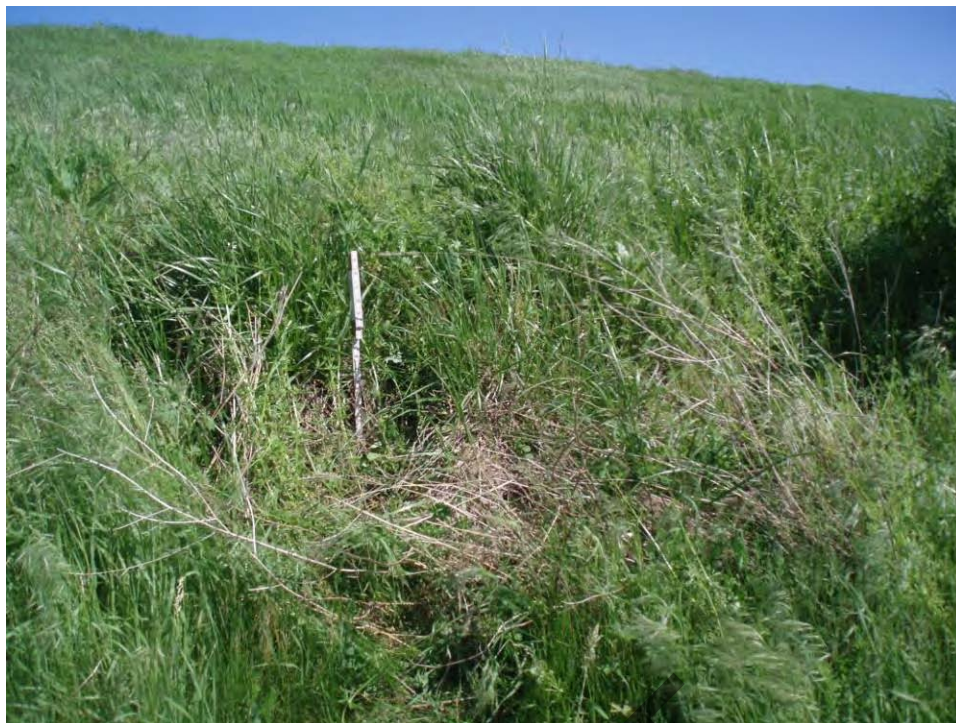
85. Pond B - West embankment lower exterior slope, looking at over-steep area and surficial erosion at bench.

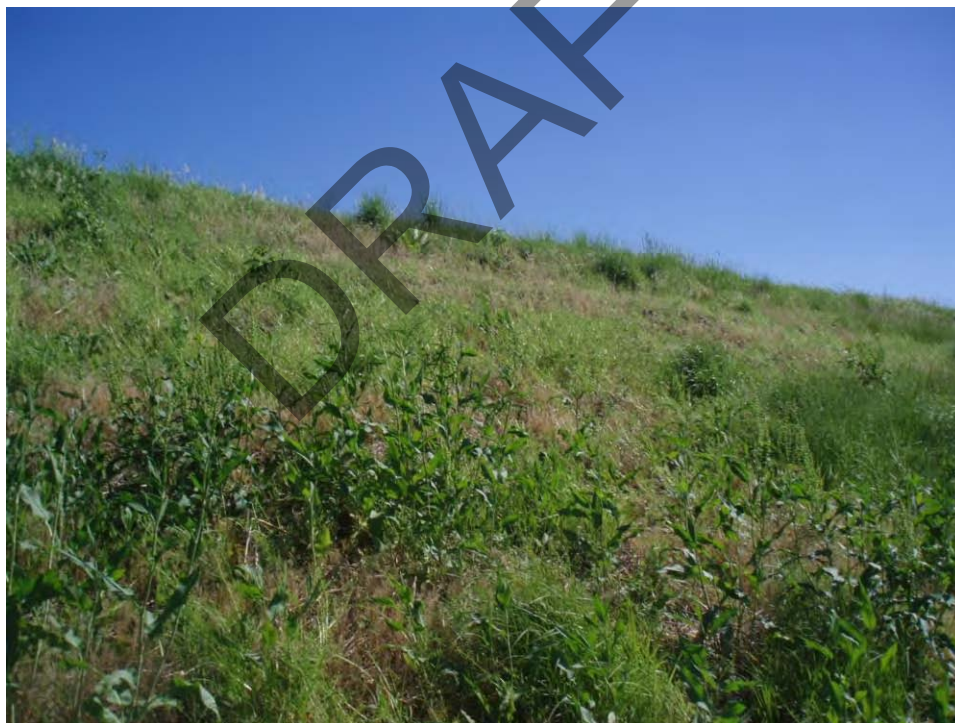
88. Pond B - West embankment lower exterior slope, looking southwest.

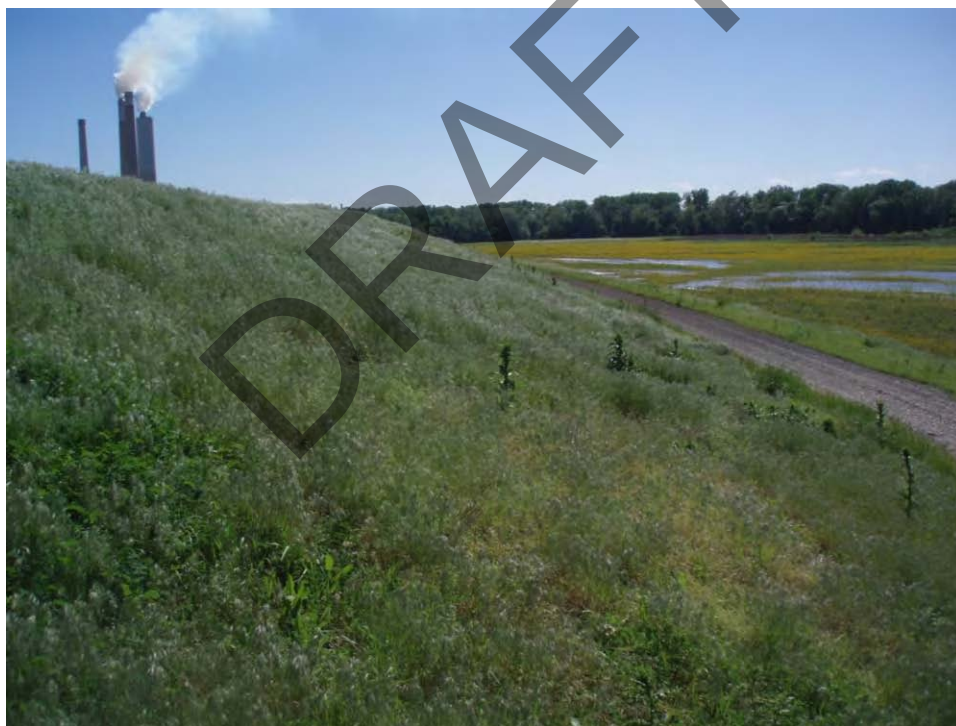
90. Pond B - West embankment upper exterior slope, looking southwest.

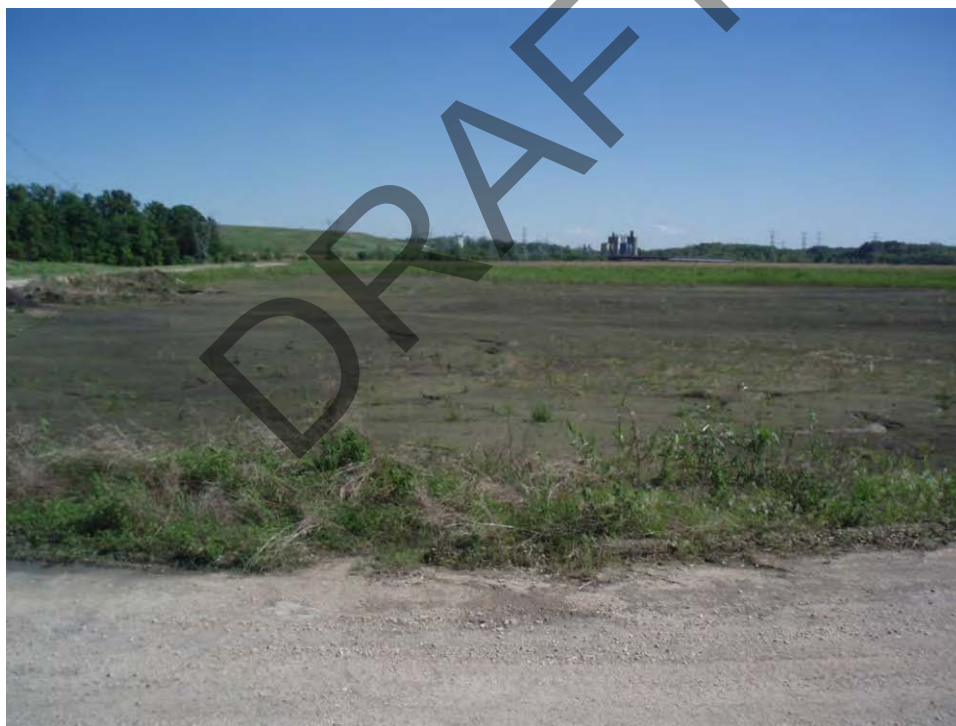
92. Overview of Pond B from northwest corner, looking southeast.

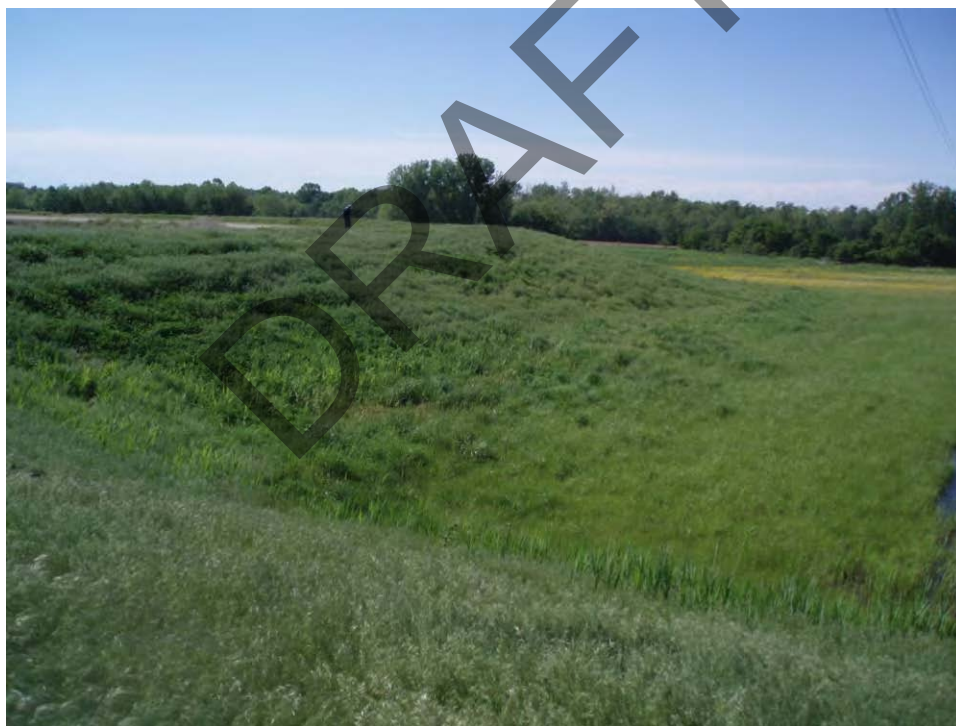
94. Pond B - North embankment exterior slope, looking northwest.

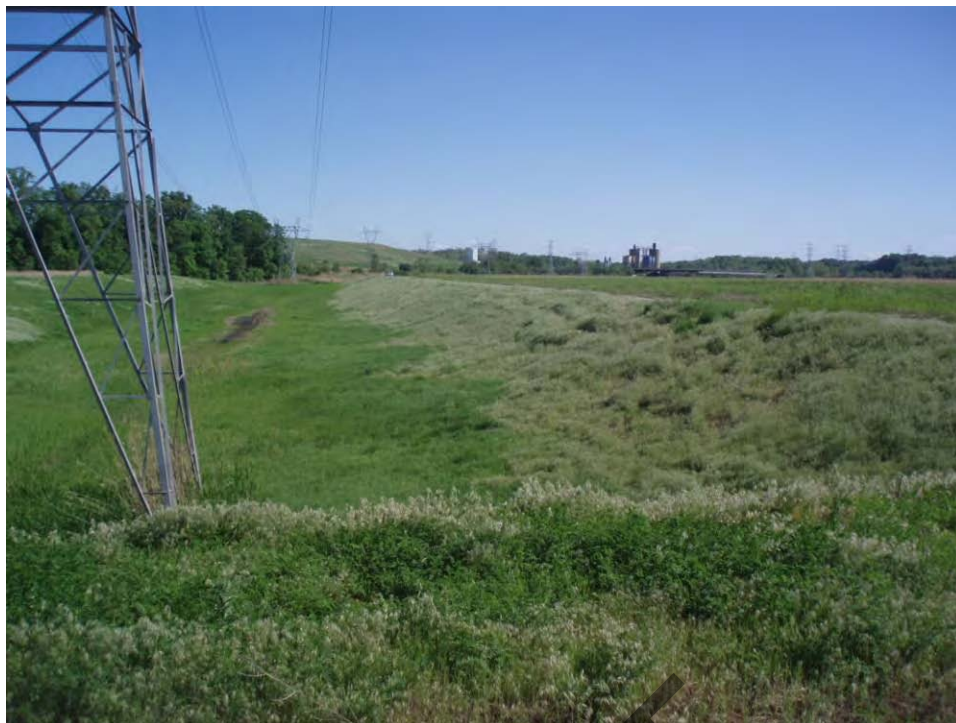
95. Pond B – North embankment exterior slope, looking southeast.

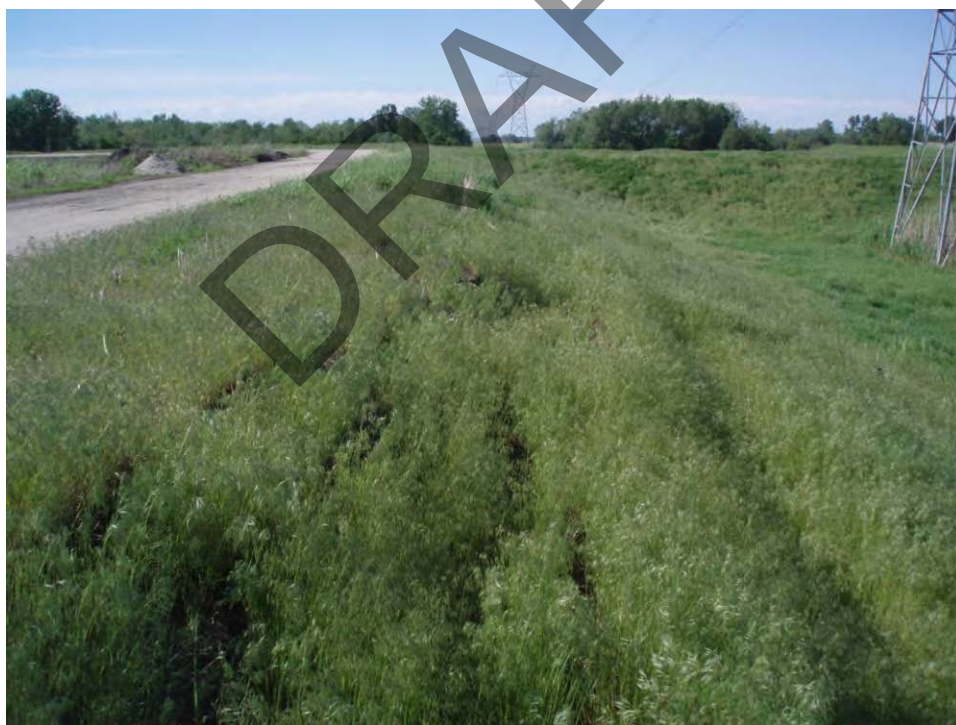
96. Pond B – North embankment exterior slope looking northwest at tractor ruts, bare spots, very soft stabilized FGD.

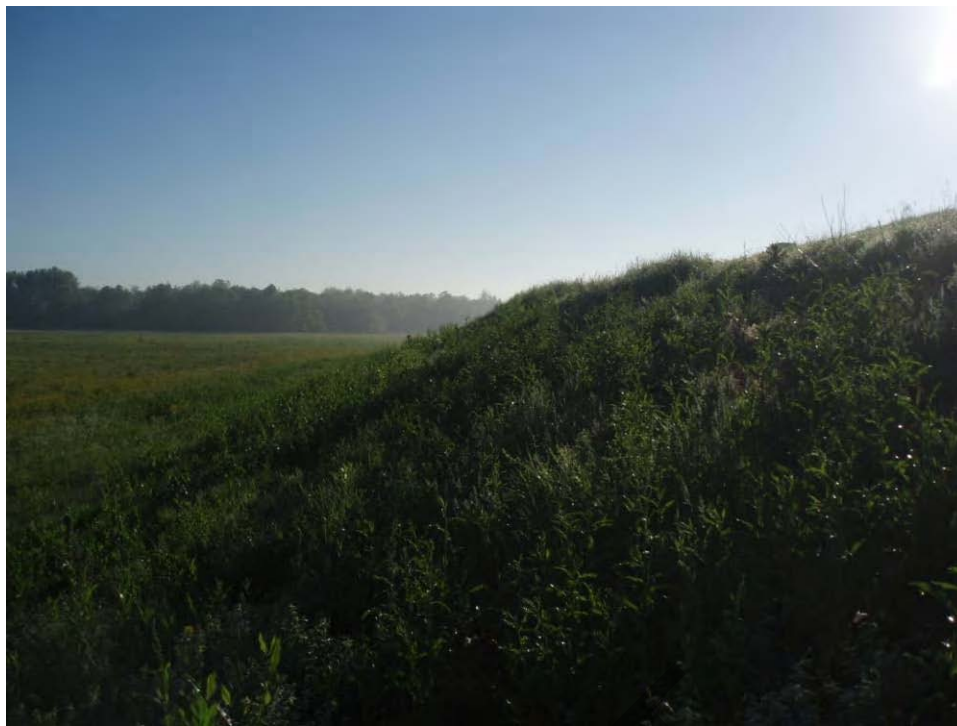
103. Pond C - West embankment lower exterior slope, looking northeast.

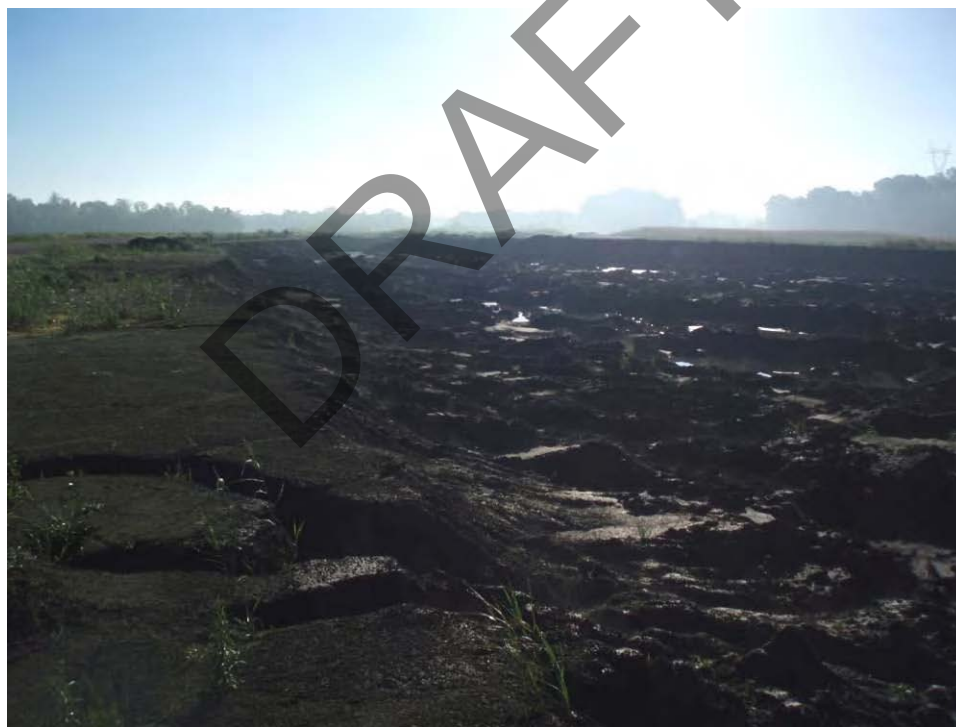
104. Overview of Pond C from northeast corner, looking east.

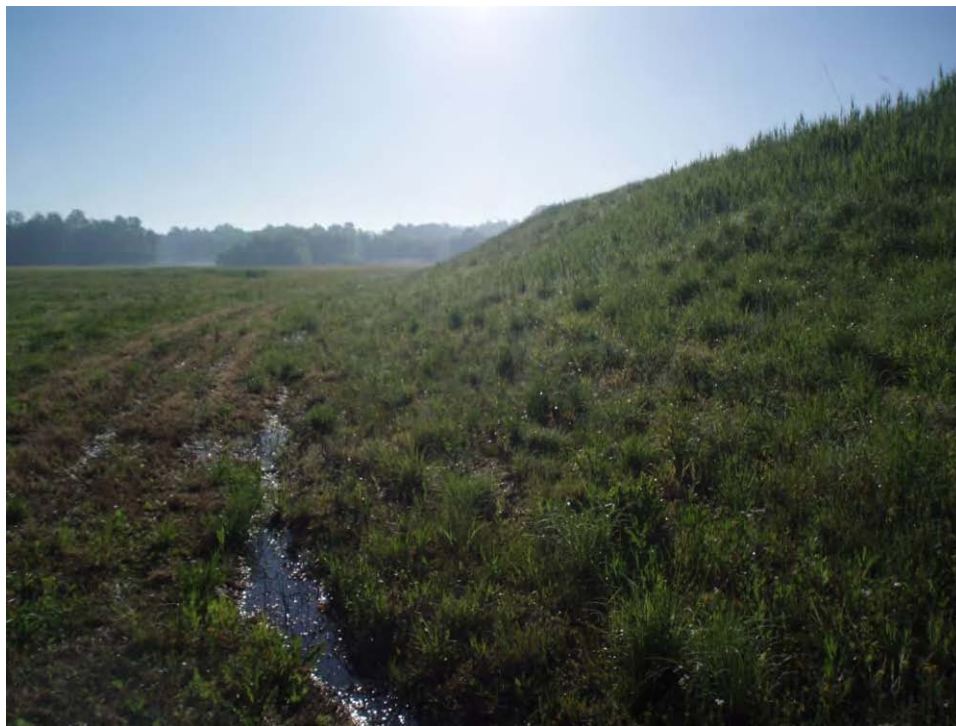
105. Pond C - West embankment lower exterior slope, looking northeast.

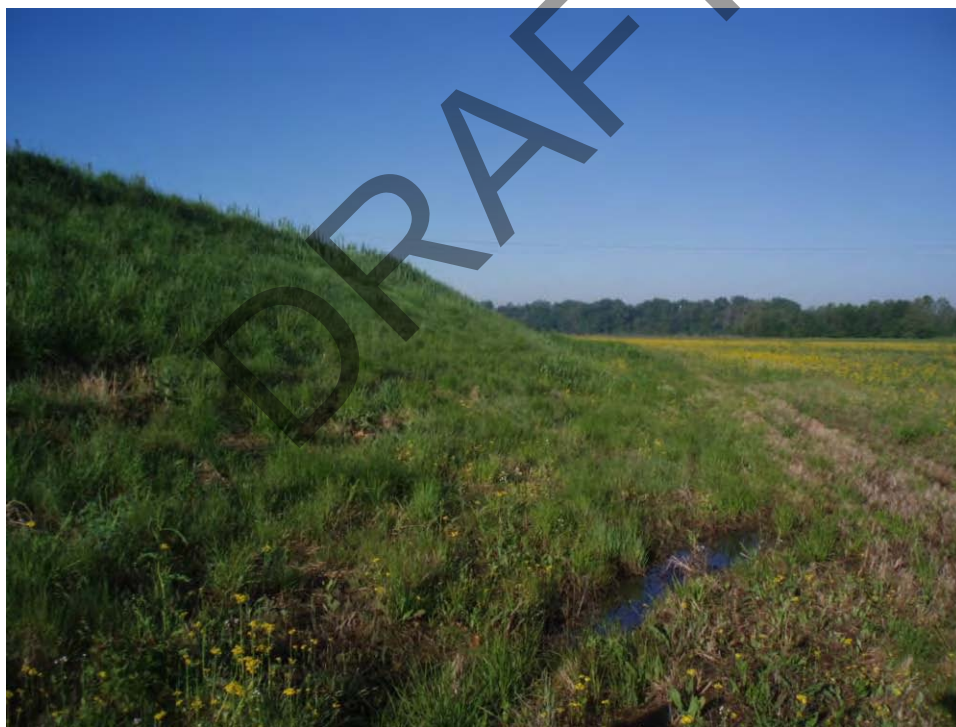
106. Pond C - West Embankment lower exterior slope, looking southwest.

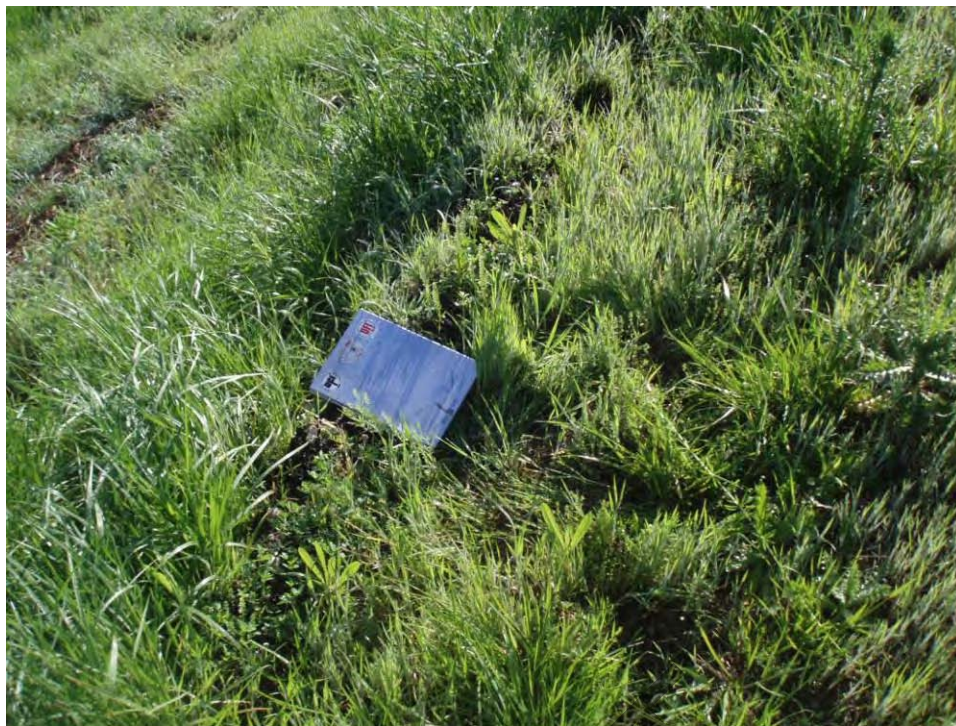
115. Pond C - West embankment lower exterior slope, looking at over-steepened area and tractor rutting at bench.

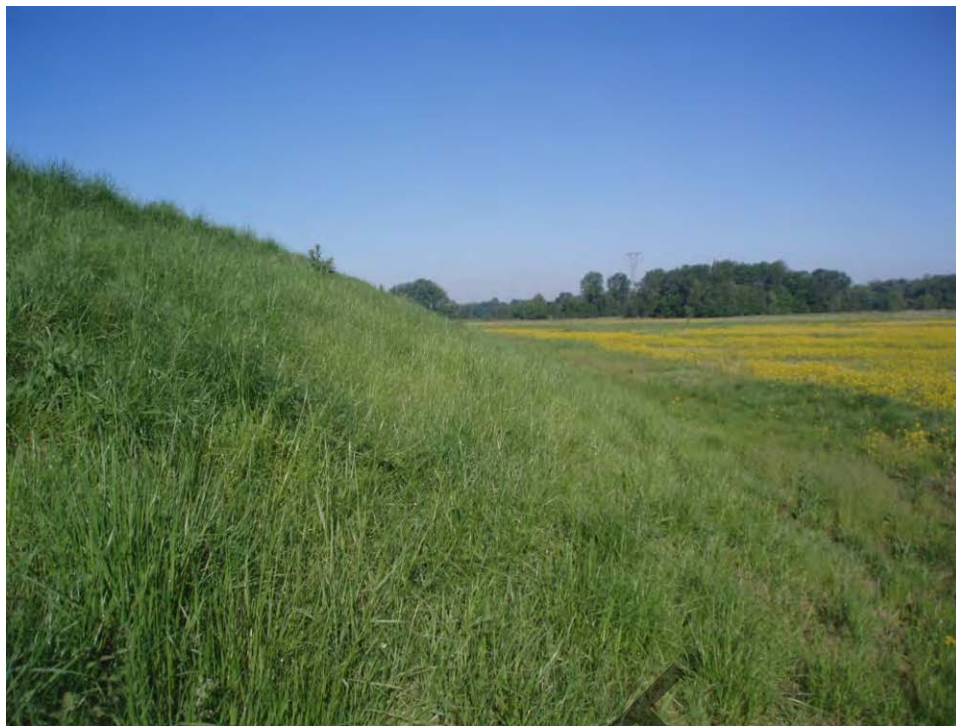
117. Pond C - West embankment lower exterior slope, looking west.

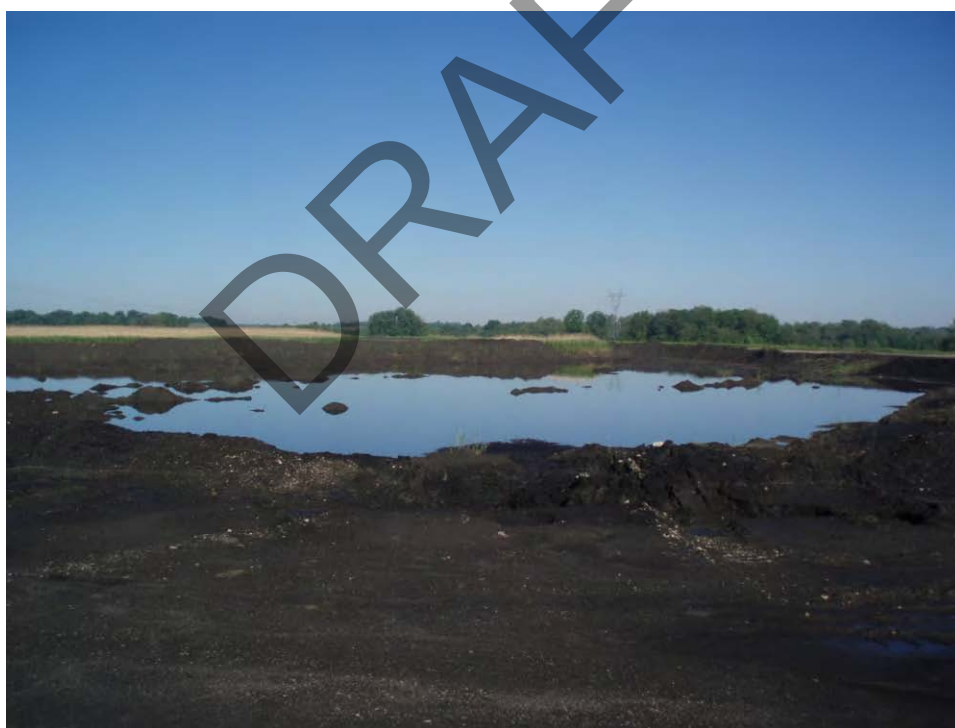
126. Overview of Pond C from northeast corner, looking northwest.

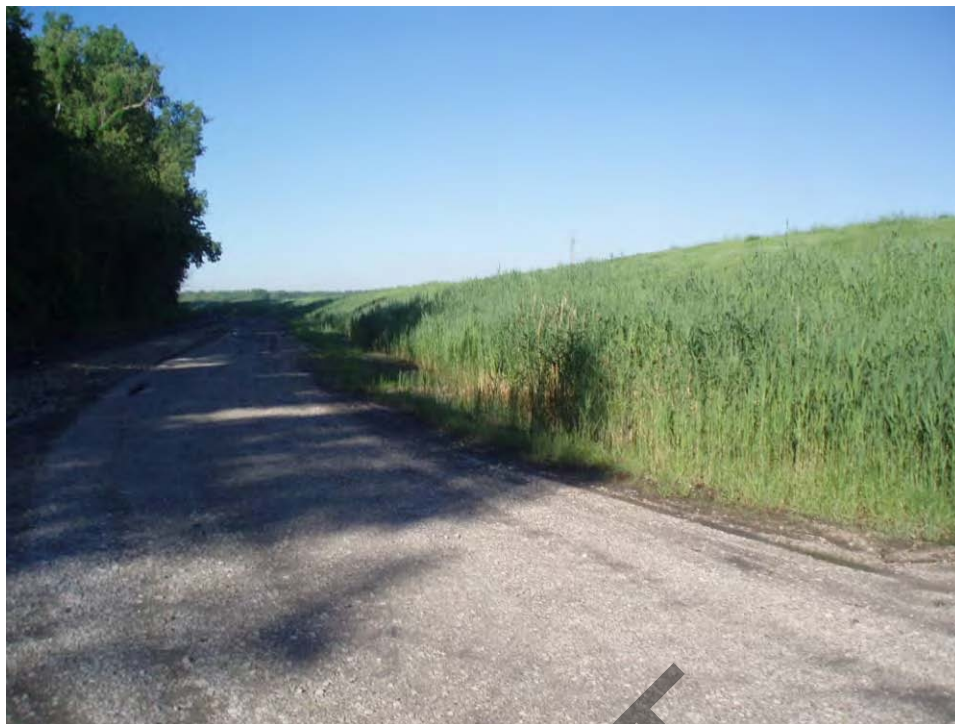
127. Pond C - East embankment exterior slope and drainage ditch, looking southwest. Note water level in drainage ditch approximately 1.5' below roadway and 5'-8' tall vegetation on lower portion of the slope extending from northern corner to access ramp. Slope at drainage ditch is over-steepened.

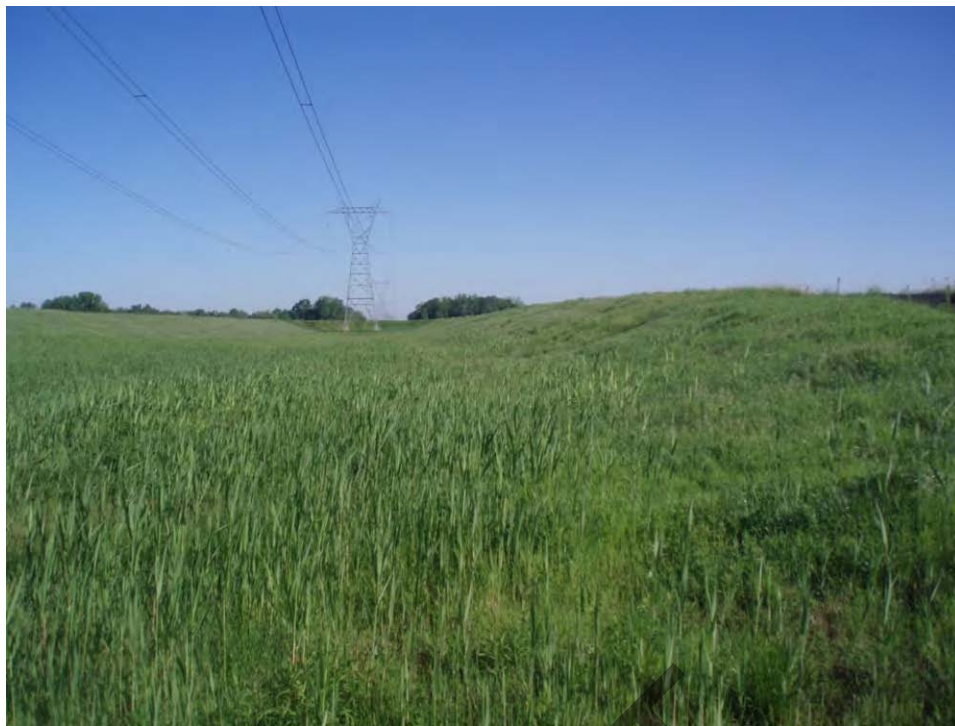
131. Overview of area between Pond B and Pond C, looking northwest. Note area between embankments is the top of the original impoundment.

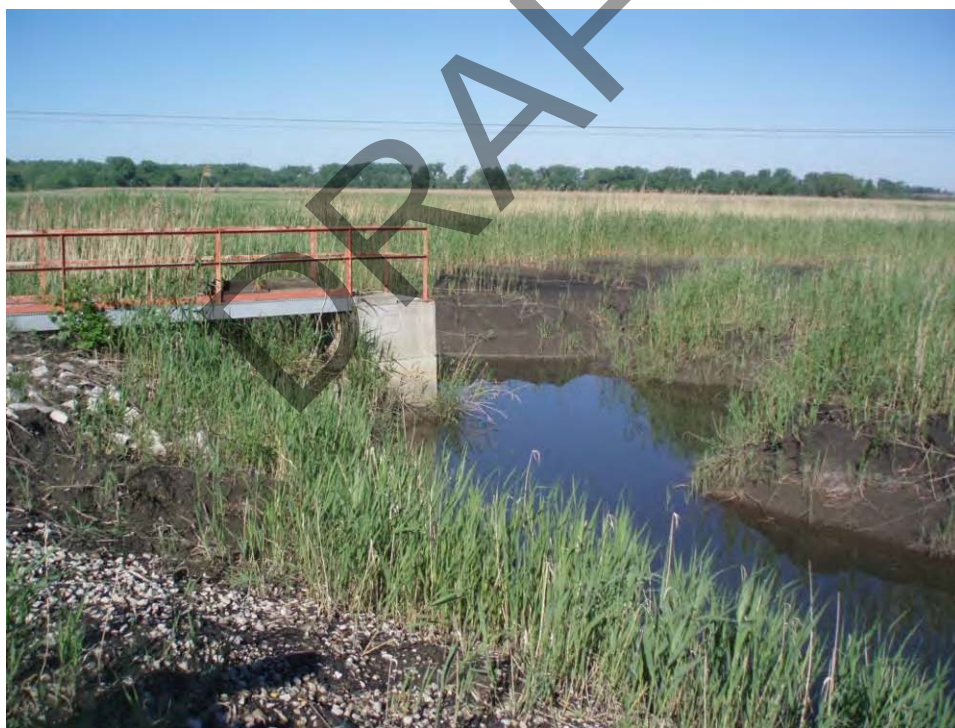
132. Pond C - Outlet structure with stoplogs, looking southwest. Note water level 6.6' below crest at outlet.

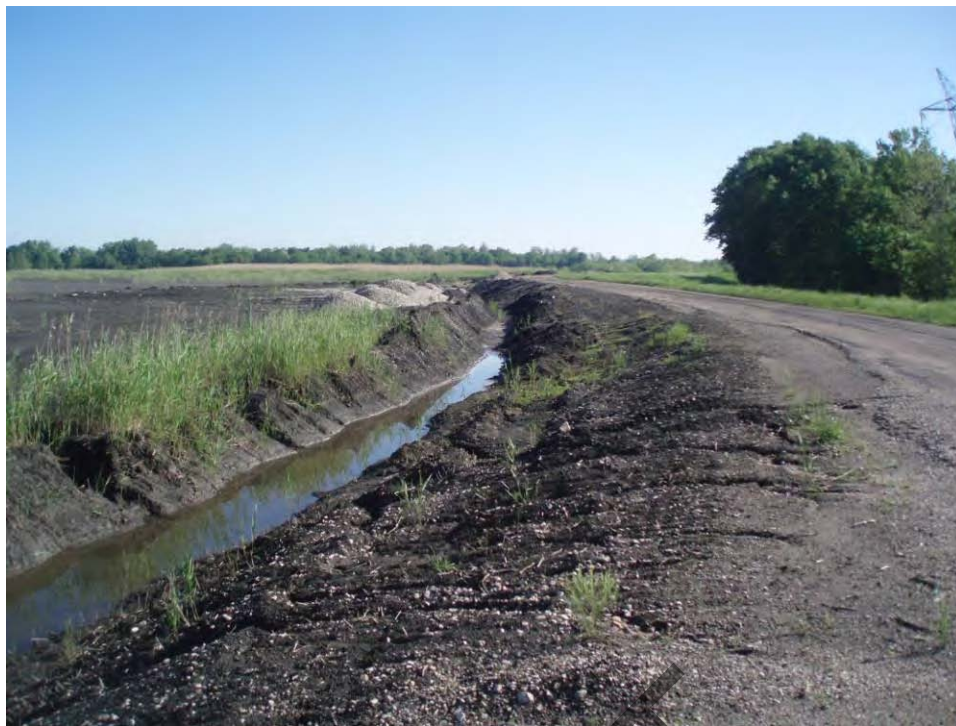
133. Pond C - East embankment interior slope, looking north at rim ditch to outlet structure.

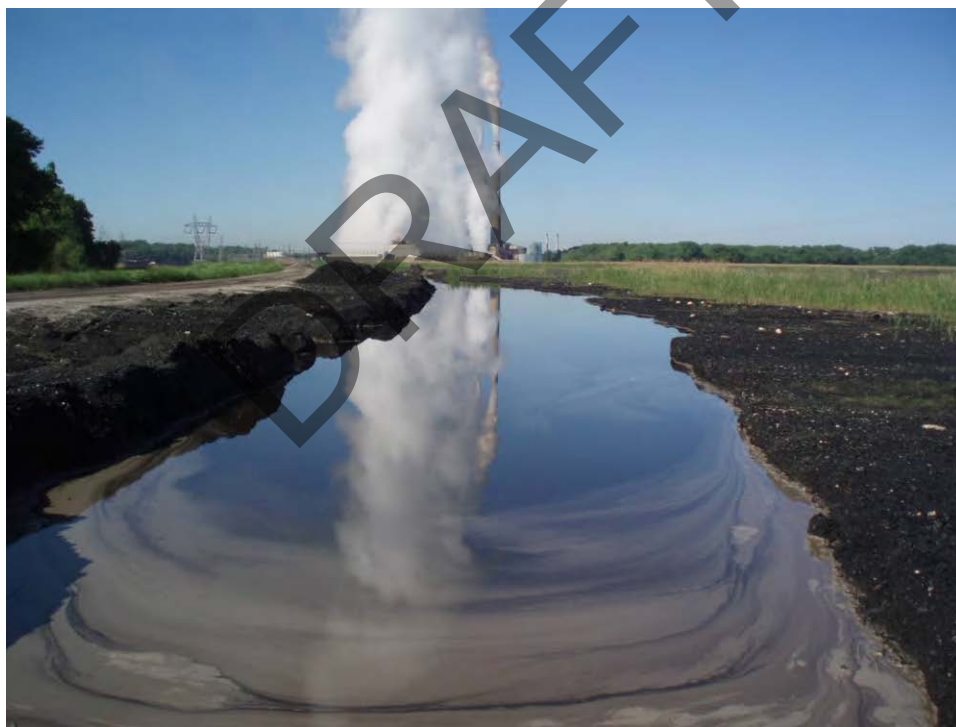
134. Pond C - East embankment interior slope, looking southwest at rim ditch to outlet structure. Note water level 3' below crest.

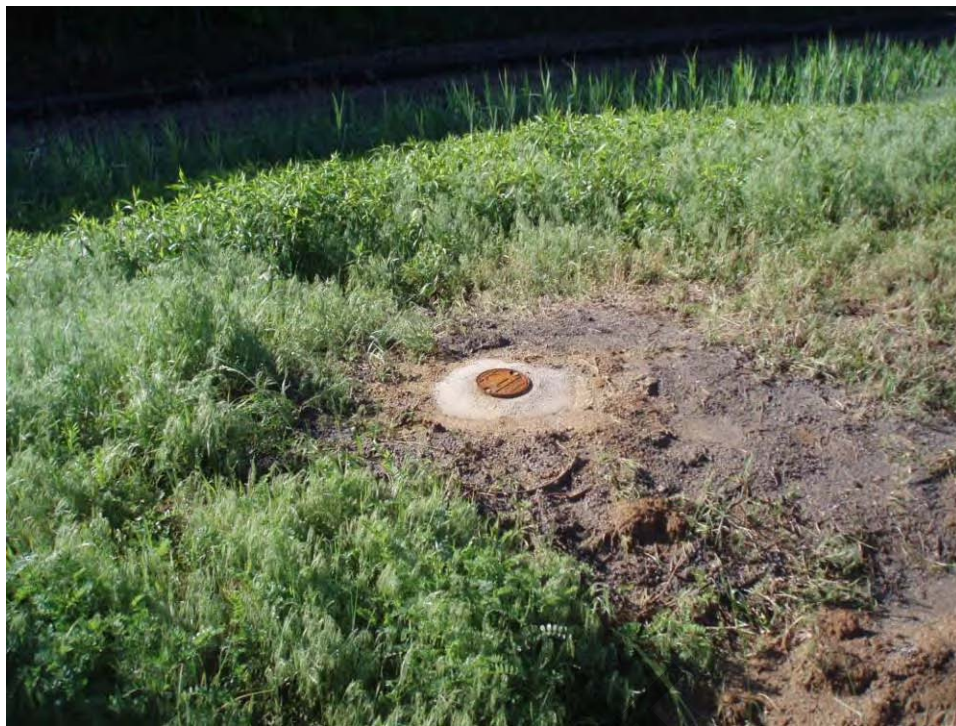
135. Pond C - East crest, looking at monitoring well installed by BT<sup>2</sup> on 4/23/10.

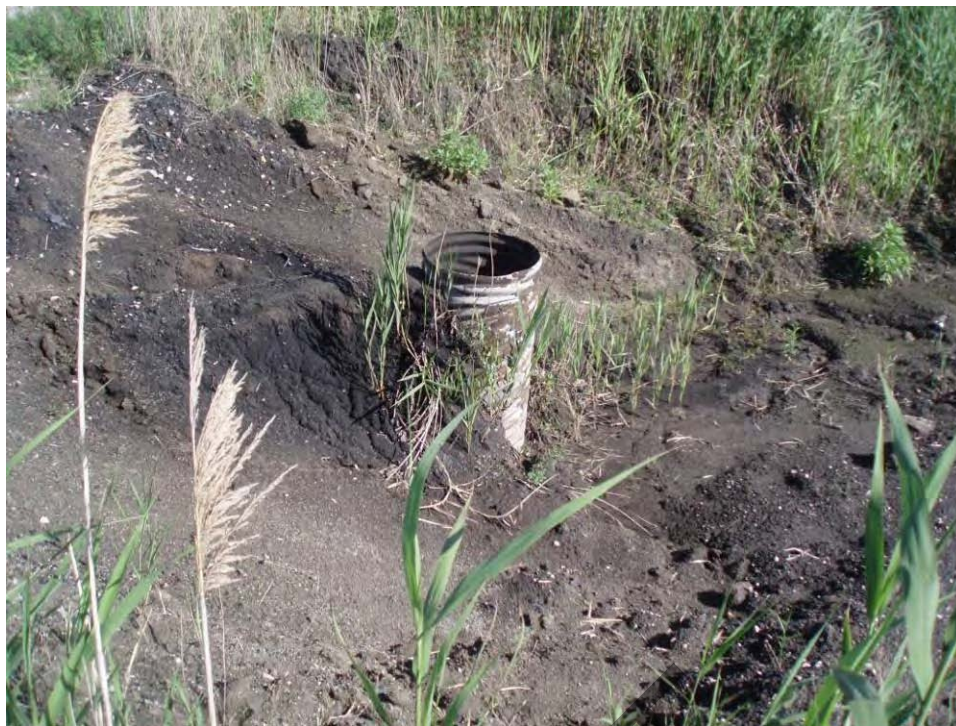
141. 24-inch-diameter CMP equalizer pipe from Pond C to Pond B. Note inlet has a T connection on the end of the pipe.

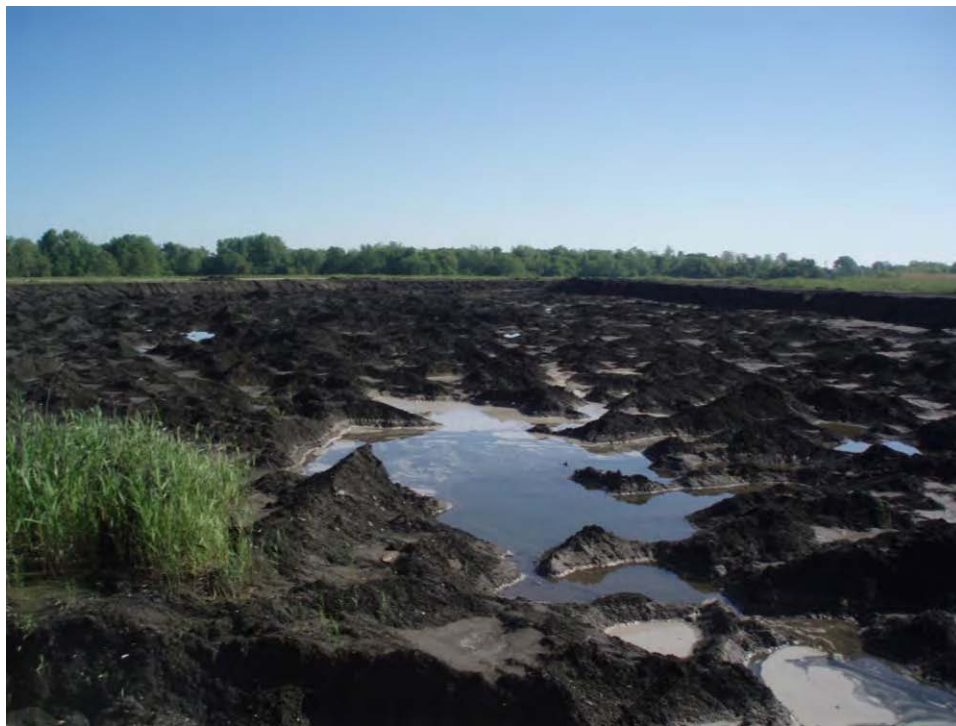
143. Overview of Pond C, looking northeast.

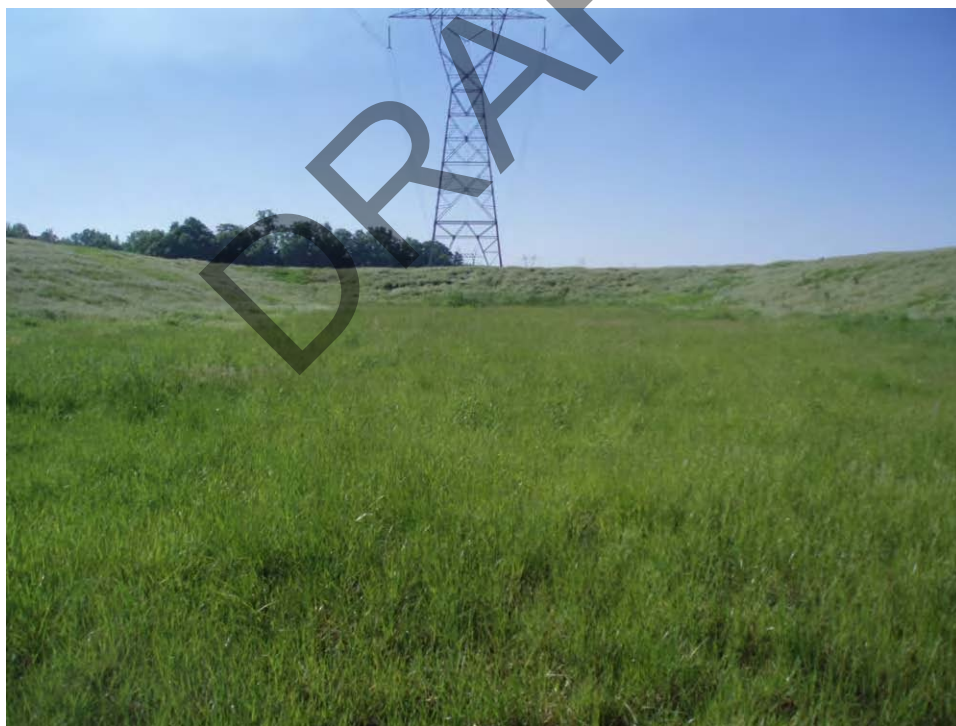
144. Low area between Pond B and Pond C, looking north at embankment between two impoundments. Note the equalizer pipe runs through the embankment.

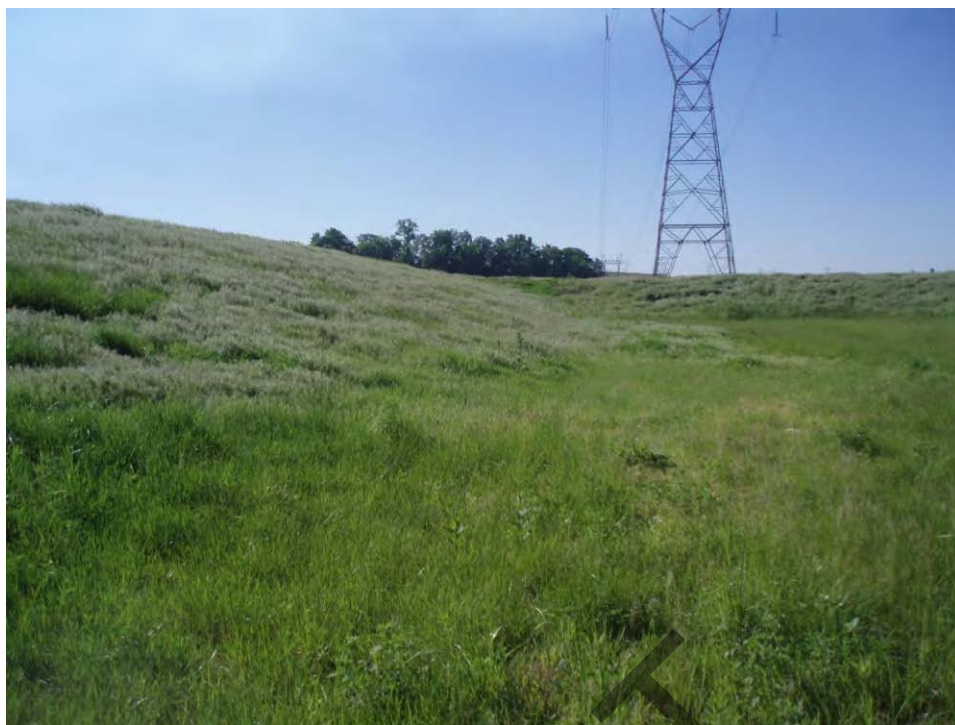
145. Pond C - South embankment exterior slope, looking southeast.
