Comments on Draft Report on Kentucky Utilities – Green River Station

**Re: Kentucky Utilities' Comments on  
*DRAFT Report of Geotechnical Investigation Dam Safety Assessment of Coal Combustion Surface  
Impoundments Kentucky Utilities, a Subsidiary of E.ON U.S. Green River Station, Central City, Kentucky***

***Report of Geotechnical Exploration and Slope Stability Analyses  
Kentucky Utilities (KU) Green River Power Station  
No. 2 Pond/Coal Pile Runoff Pond and Scrubber Pond  
South Carrollton, Muhlenberg County, Kentucky***

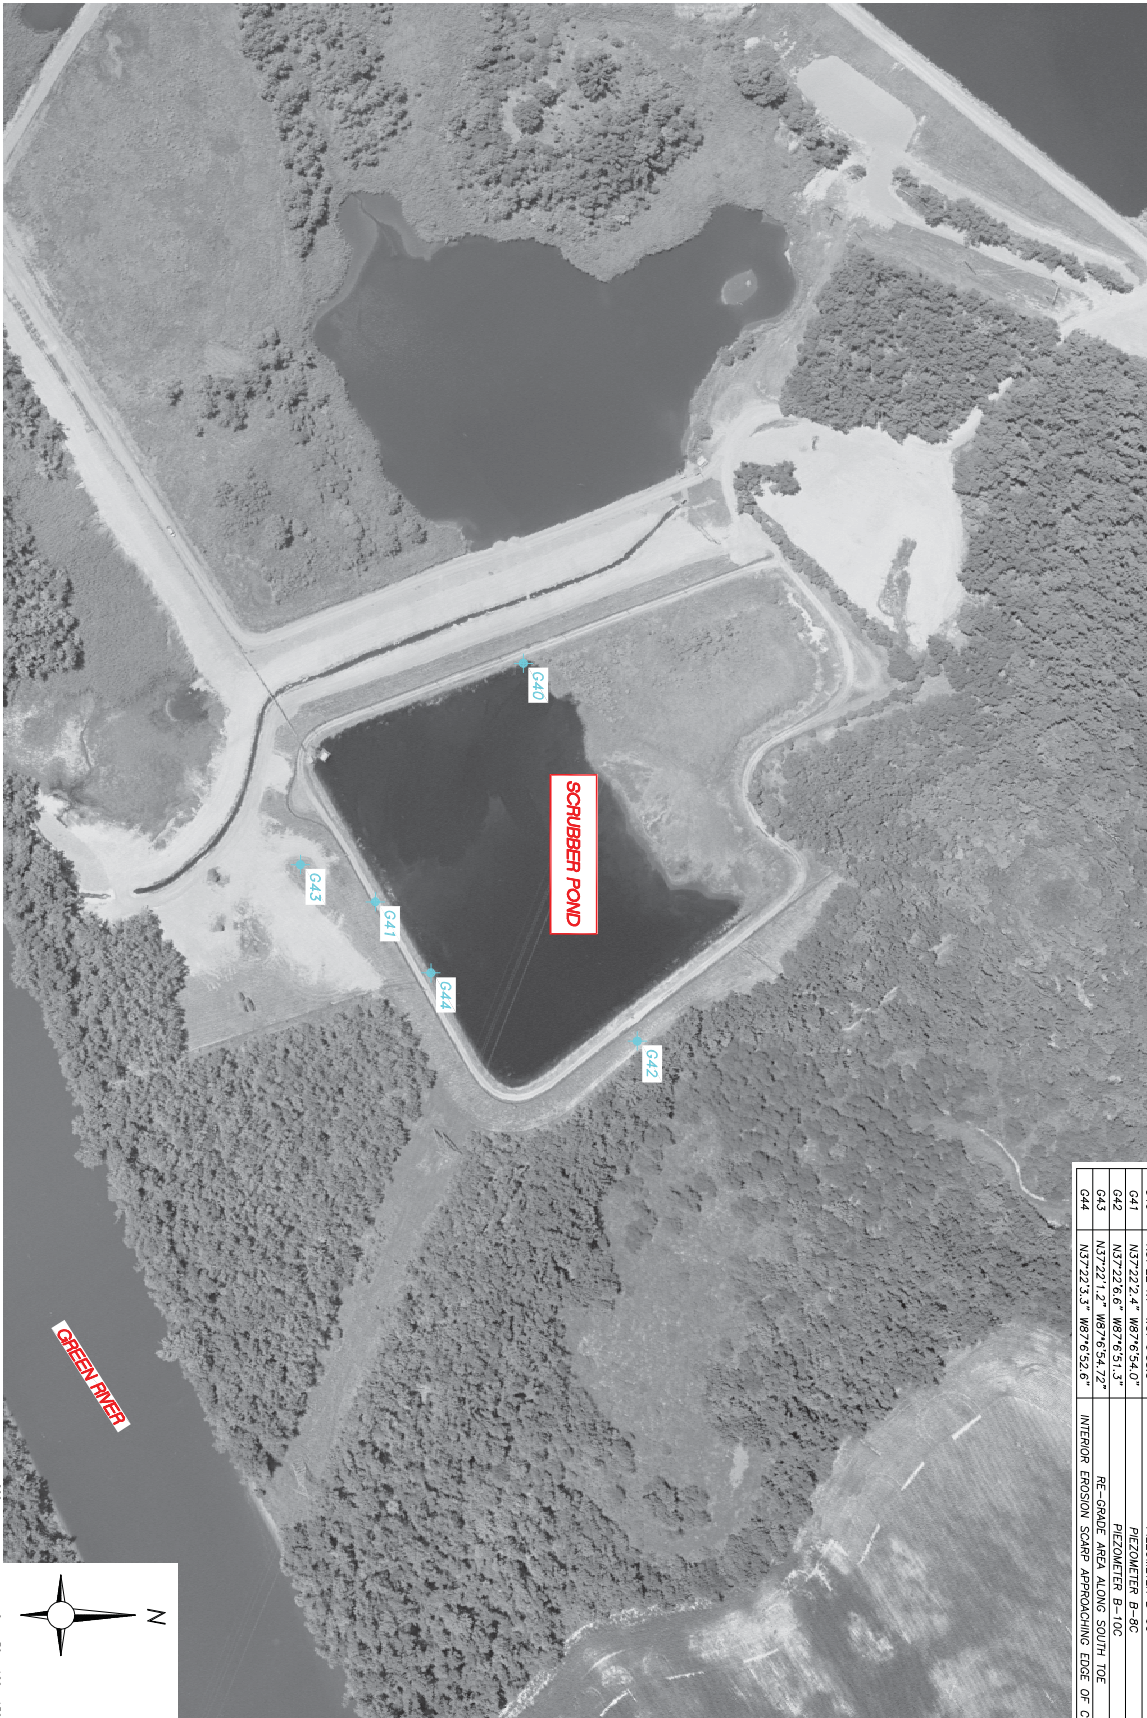
GPS PT.	COORDINATES	DESCRIPTION
G40	N37°22'4.7" W87°6'58.8"	PIEZOMETER B-8C
G41	N37°22'2.4" W87°6'54.0"	PIEZOMETER B-8C
G42	N37°22'6.6" W87°6'51.3"	PIEZOMETER B-10C
G43	N37°22'1.2" W87°6'54.72"	RE-GRADE AREA ALONG SOUTH TOE
G44	N37°22'5.3" W87°6'52.6"	INTERIOR EROSION SCARP APPROACHING EDGE OF CREST

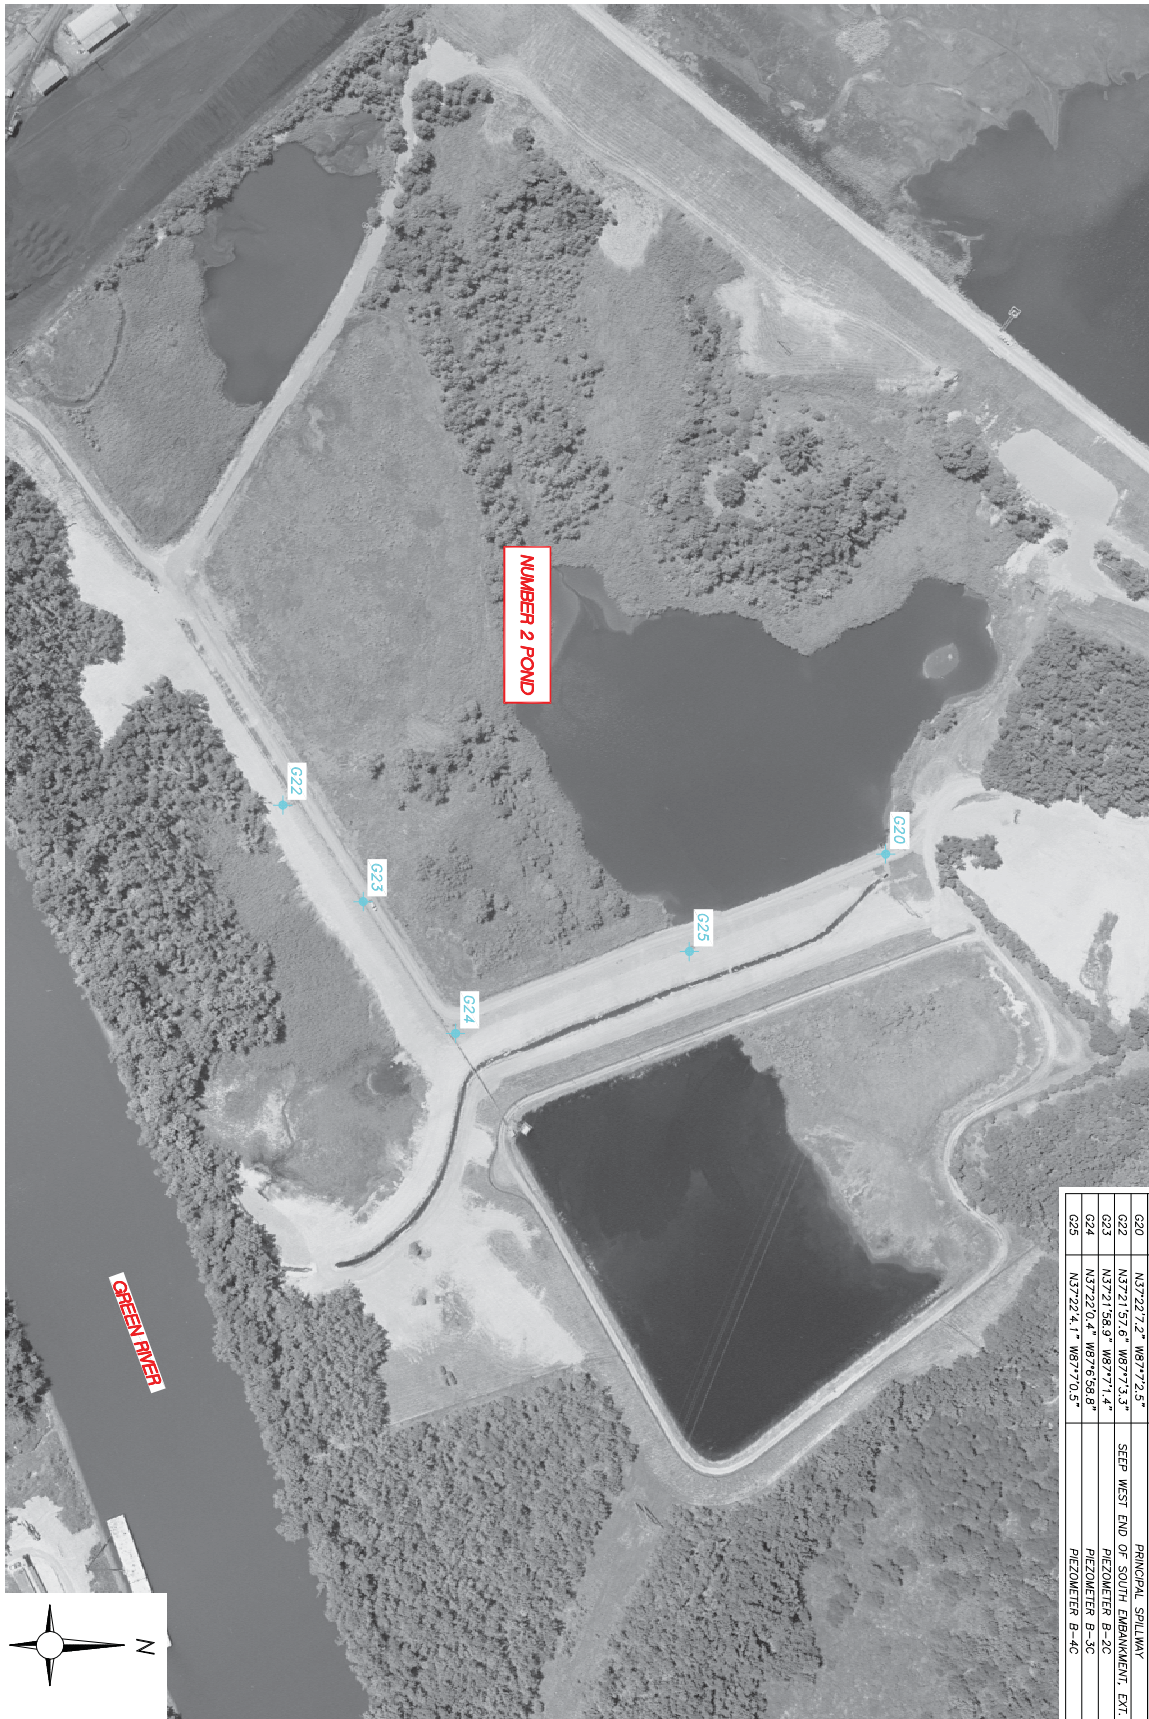
GPS PT.	COORDINATES	DESCRIPTION
G20	N37227.2° W8772.5°	PRINCIPAL SPILLWAY
G22	N372157.6° W87773.3°	SEEP WEST END OF SOUTH EMBANKMENT, EXT. SLOPE
G23	N372158.9° W87771.4°	PIEZOMETER B-3C
G24	N37220.4° W87558.8°	PIEZOMETER B-3C
G25	N37224.1° W87770.5°	PIEZOMETER B-4C
