Report of Dam Safety Assessment of Coal
Combustion Surface Impoundments
NRG Energy
Huntley Generating Station
Tonawanda, NY

AMEC Project No. 3-2106-0194

March 2013

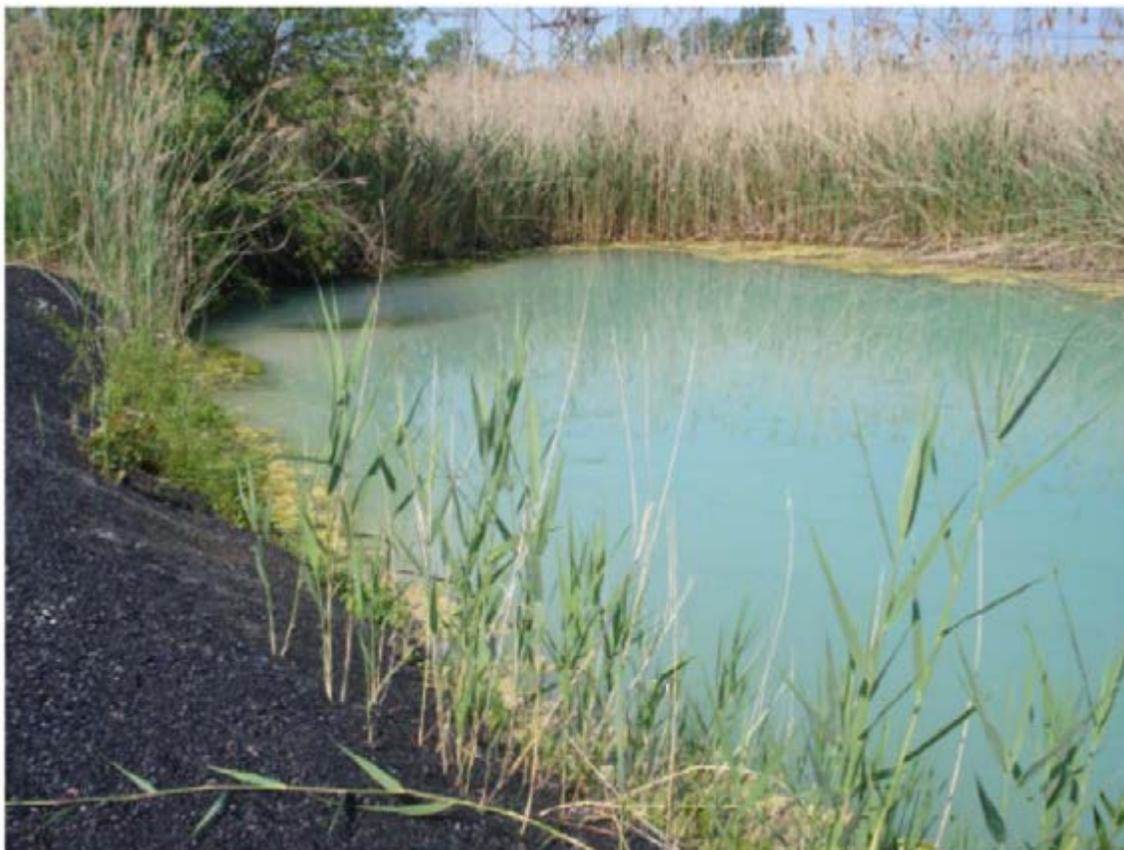
Pond 1 is located in the ash management area at the north end of the plant (North Ponds). The pond is situated in the southwest corner of this area. Pond 1 is bordered by a section of Pond 3 and a field to the east, Pond 2 to the north, a substation to the west and the plant grounds to the south. Pipes from the plant for wastewaters (and formerly CCW) enter Pond 1 from pipes on its southwest corner. Dense, tall grass and trees prevented a good view of the area (Photos 1-1 and 1-4). See the following photo presented as 1-1 in Appendix B.

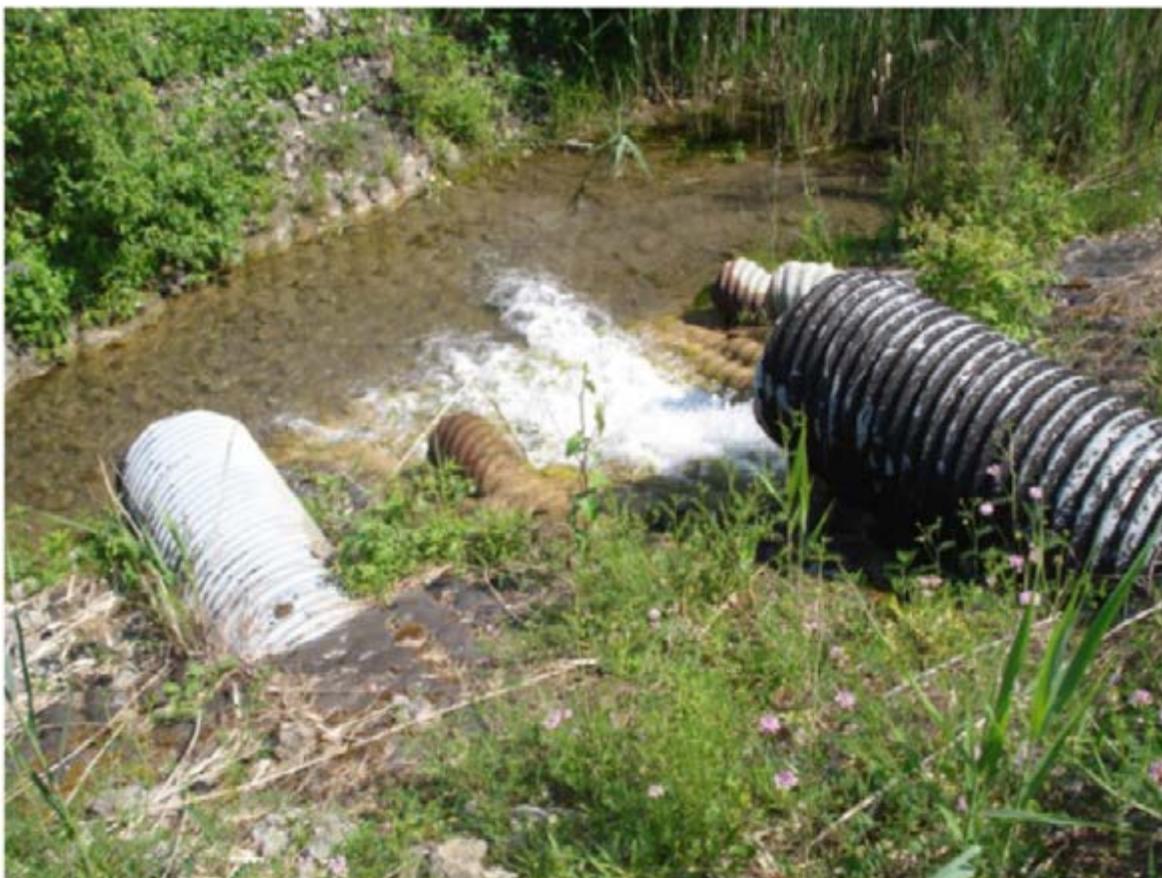
Pond 2 discharges flow by gravity through a 24-inch diameter gated culvert pipe located on the north dike (Photo 2-3). The flow discharges to a ditch that slopes from east to west along the north boundary of the property and then west to the Niagara River. "Fabriform" slope protection is present upstream and downstream in the outfall area. See the following photo of the outfall

area presented as 2-4 in Appendix B. Three other 15-inch diameter gated pipes are present at the outlet and are reported to include an emergency overflow, a bottom drain and unknown drain. The inlet and outlet elevations of the 24-inch pipe are 576.3 and 569.0 feet, respectively.

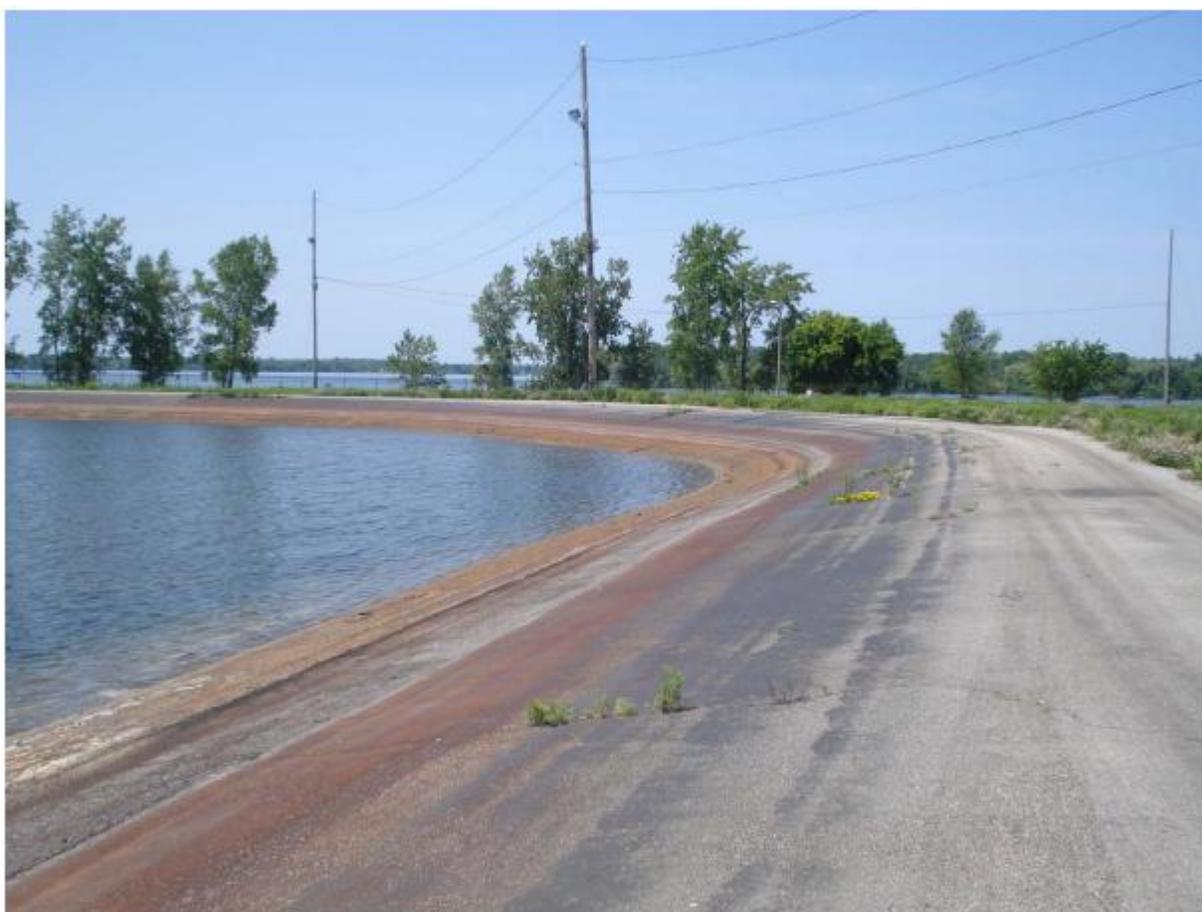
The North Equalization Basin is incised on the north embankment and diked on the east, south and west. Drawings indicate the top of berm (crest) elevation is 580.3 feet. The bottom, upstream slopes, crest and portions of the downstream slopes have an asphalt liner. The liner is shown to consist of 2-inches of binder and 2-inches of surface for a total 4-inch asphalt cover. The lined slopes and crest appeared to be in fair condition with red staining on the lower sections of the upstream slopes and areas of cracks with or without protruding vegetation in several locations (Photos NEQ-1 through NEQ-6). The downstream slopes, especially on the west dike appeared to be in poor to fair condition with more degradation of the asphalt liner as evidenced by more protruding vegetation (Photo NEQ-4 and NEQ-7). As you proceed south along the west dike, the North Basin is located approximately 185 feet to 110 feet from the edge of the bank of the Niagara River. The following photo presented as NEQ-3 in Appendix B presents a view of the crest and the upstream and downstream slopes of the basin.

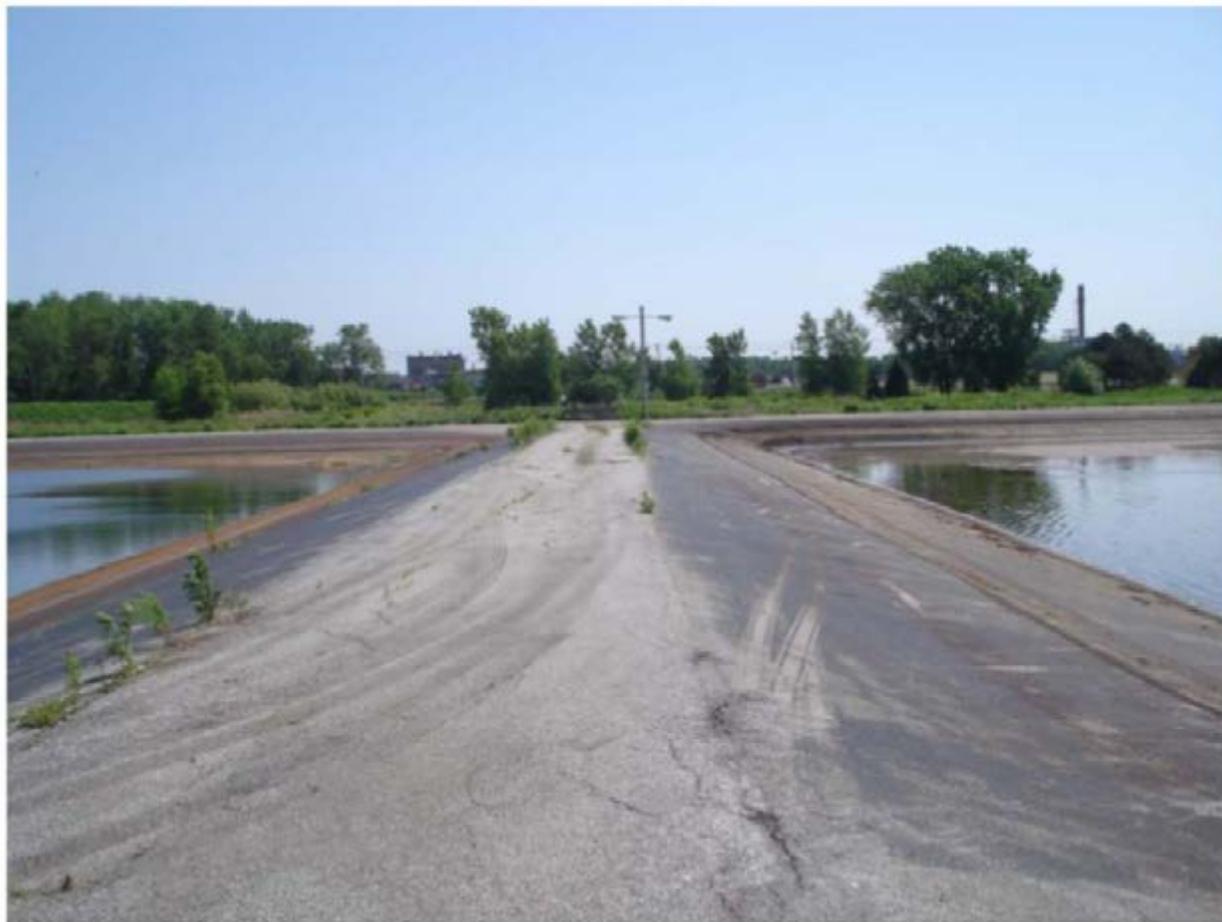
The South Equalization Basin, or Equalization Basin No. 2, is located adjacent and south of the North Equalization Basin in the ash management area at the south end of the plant (South Ponds). The South Basin is situated in the west-central section of this area. The basin is bordered by the north basin to the north, an open area and the South Pond to the east, an open area and the South Pond to the south, and an open area and/or the Niagara River to the west. A 12-inch diameter inlet pipe from the flow control structure enters the basin at the northeast corner. Plans show the width of the top of the common dike of the North and South Equalization Basins as 12 feet. See the following photo presented as NEQ-6 in Appendix B.

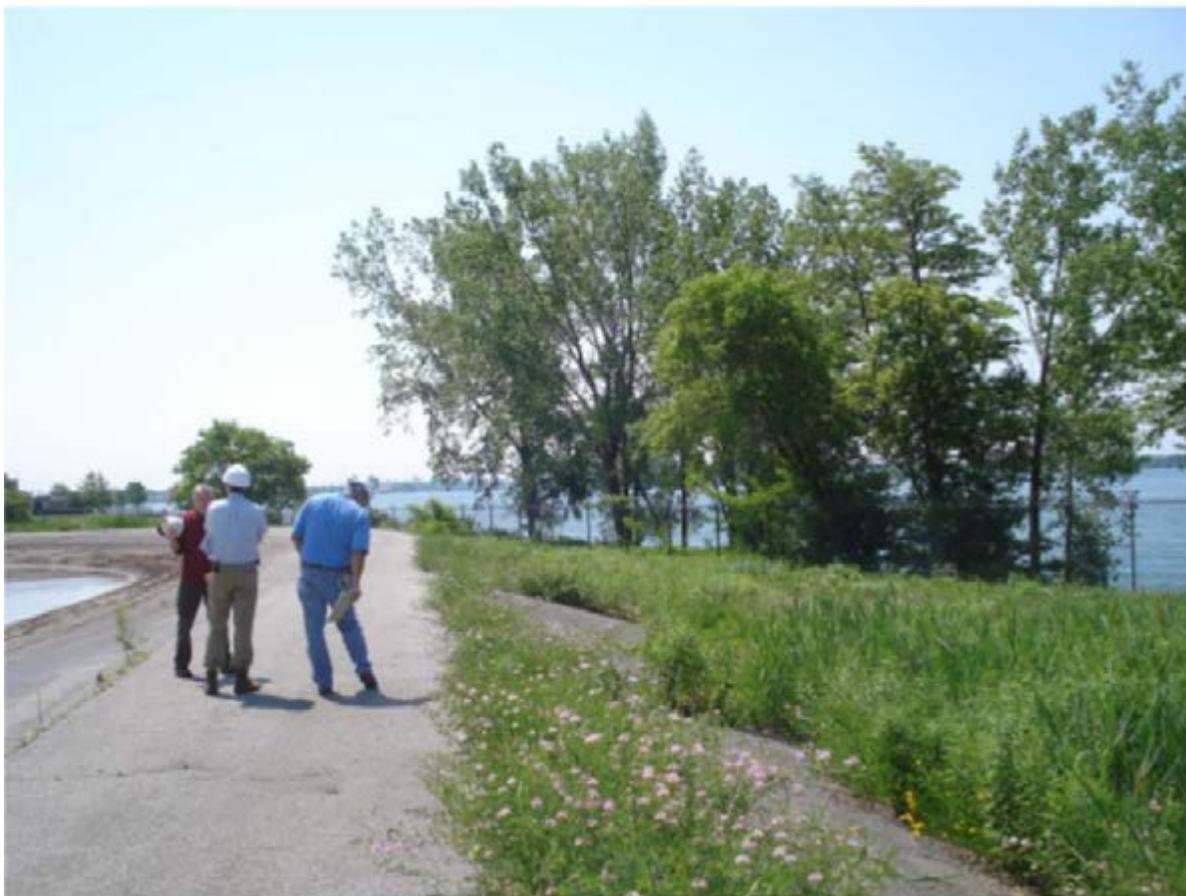
The South Equalization Basin is a diked impoundment. Drawings indicate the top of berm elevation is 580.3 feet. The bottom, upstream slopes, crest and portions of the downstream slopes have the same type and thickness of asphalt liner as the north basin. The lined slopes and crest appeared to be in fair condition with slight red staining on the lower sections of the upstream slopes and areas of cracks with or without protruding vegetation in several locations (Photos SEQ-1 through SEQ-4). The downstream slopes, especially on the west dike appeared to be in poor to fair condition with more degradation of the asphalt liner as evidenced by more protruding vegetation (Photo SEQ-3 and SEQ-4). As you proceed south along the west dike, the South Basin is located approximately 100 feet to 35 feet from the edge of the bank of the

Niagara River (Photos SEQ-3 through SEQ-5). From the southwest corner of the South Basin looking south, the outlet pipe of the South Pond can be seen (Photo SEQ-6). The following photo presented as SEQ-3 in Appendix B presents a view of the southwest corner of the basin, Niagara River in background.

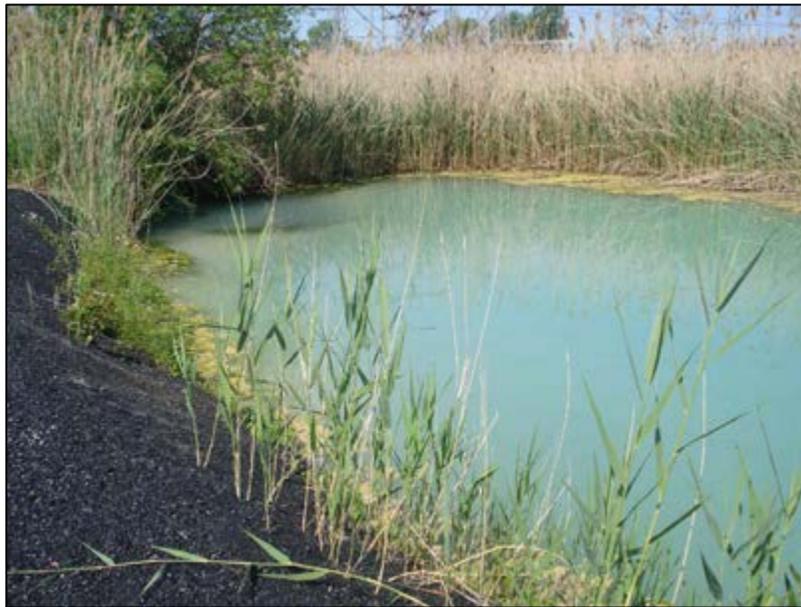
1-1

LOOKING NORTHWEST AT POND 1, HIGH VEGETATION

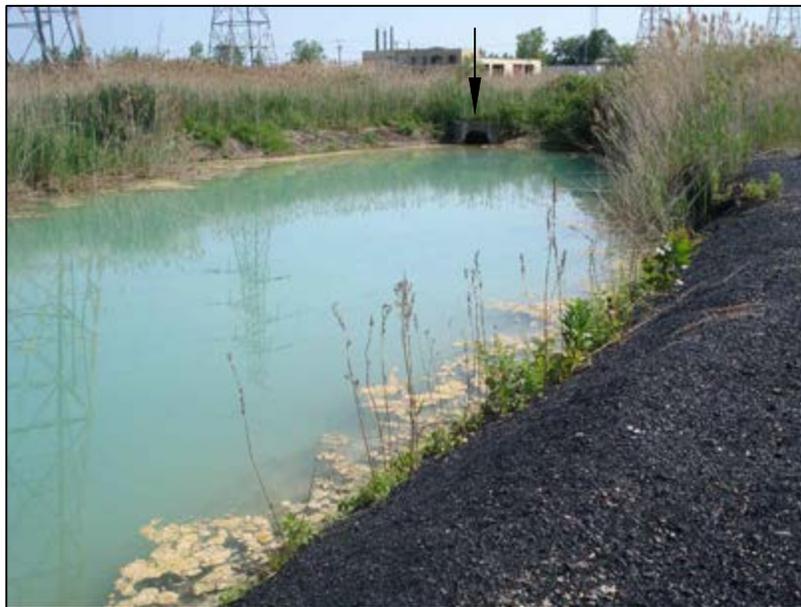
1-2

LOOKING NORTHEAST AT POND 1 AND OUTLET PIPE TO POND 3, HIGH VEGETATION

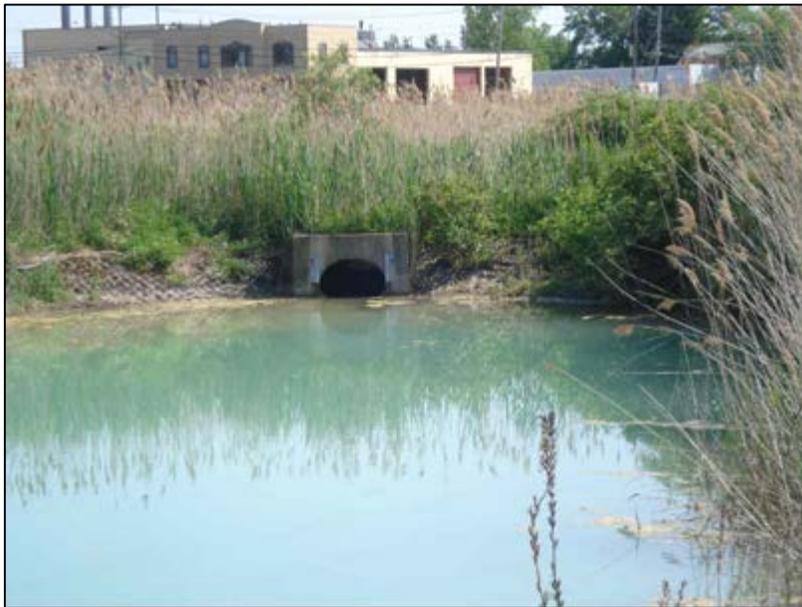
1-3

LOOKING NORTHEAST AT POND 1, CLOSEUP OF
OUTLET TO POND 3, HIGH VEGETATION

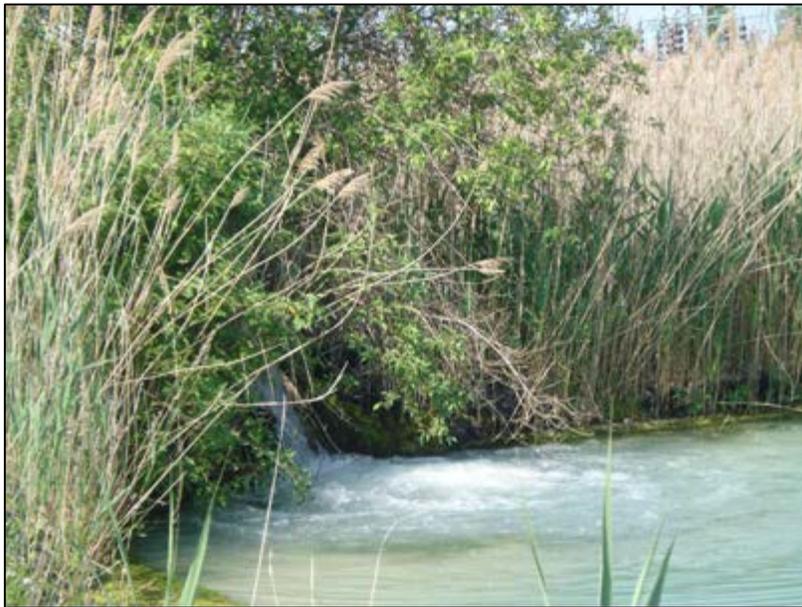
1-4

LOOKING WEST AT INLET PIPE FROM
PLANT TO POND 1, HIGH VEGETATION

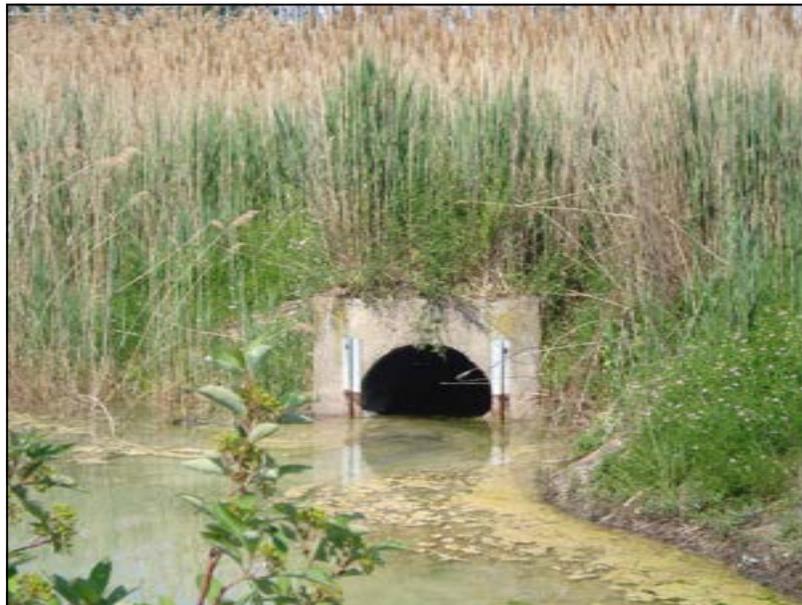
1-5

LOOKING WEST POND 1 AND OUTLET PIPE TO POND 2, HIGH VEGETATION

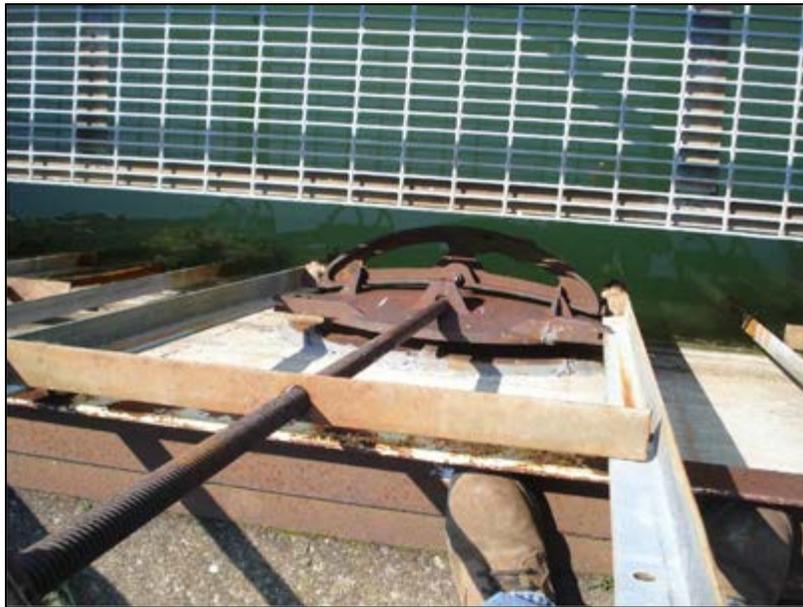
2-3

NORMAL GATED OUTLET PIPE FROM POND 2

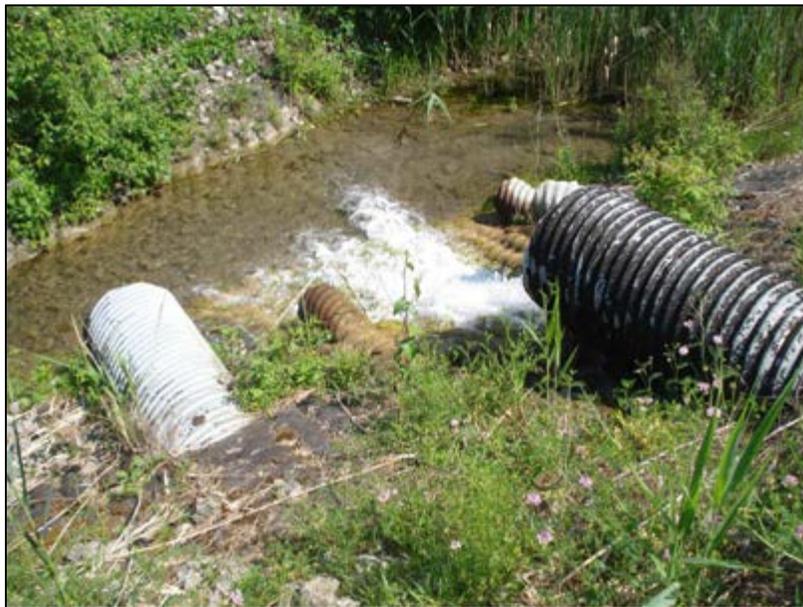
2-4

LOOKING NORTH AT OUTFALL TO DITCH FROM POND 2

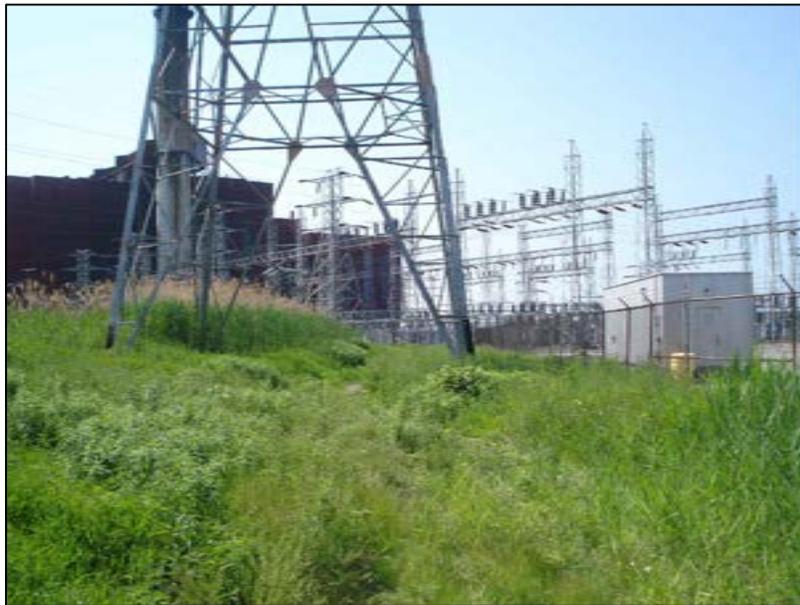
2-5

LOOKING SOUTHWEST AT NORTHWEST DOWNSTREAM EMBANKMENT OF POND 2, HIGH VEGETATION

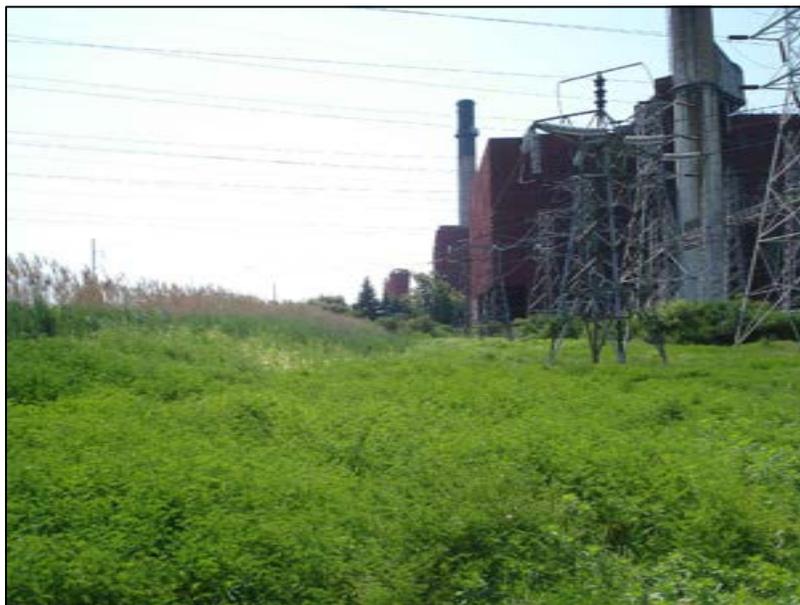
2-6

LOOKING SOUTH AT SOUTHWEST DOWNSTREAM EMBANKMENT OF POND 2, HIGH VEGETATION

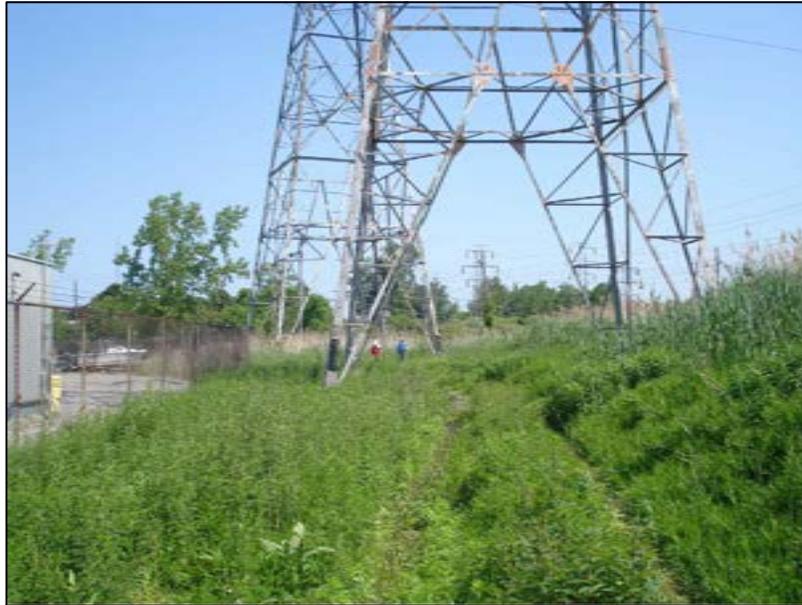
2-7

LOOKING NORTH AT NORTHWEST DOWNSTREAM EMBANKMENT OF POND 2

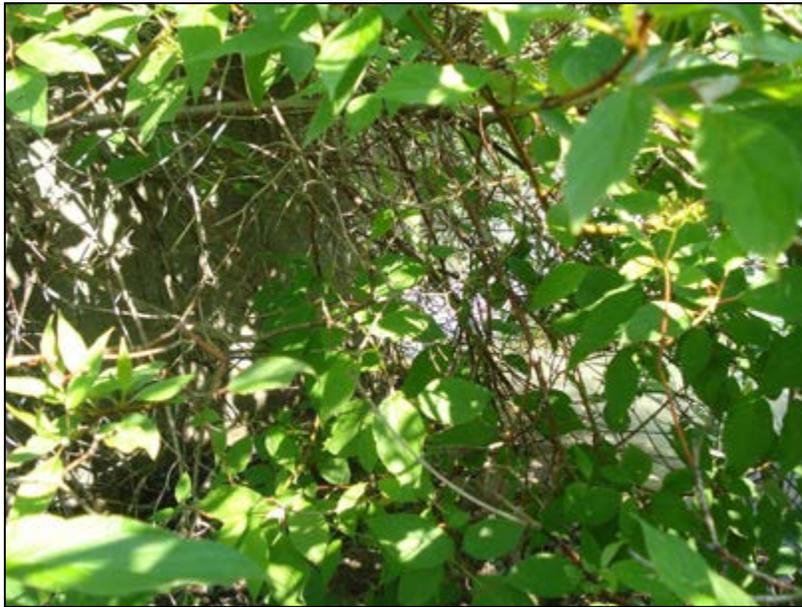
3-1

Pond 3 is located in the ash management area at the north end of the plant (North Ponds). The pond is situated in the east section of this area. Pond 3 is the original pond in this area and previously designated as the “North Slag Pond.” Pond 3 is bordered by an open field and River Road to the east; a ditch to the north; an open field with towers, Pond 2 and Pond 1 to the west; and an open field and plant grounds to the south. Pond 3 appeared to be generally below grade on the south and east side. An inlet pipe from Pond 1 enters Pond 3 at the southwest end of the pond. Plans show the width of the top of the common dike of Pond 3 with Pond 1 as 20 feet, or more. Dense, tall grass prevented a good view of the inlet area (Photo 3-1).

LOOKING NORTH AT INLET TO POND 3 FROM POND 1, HIGH VEGETATION

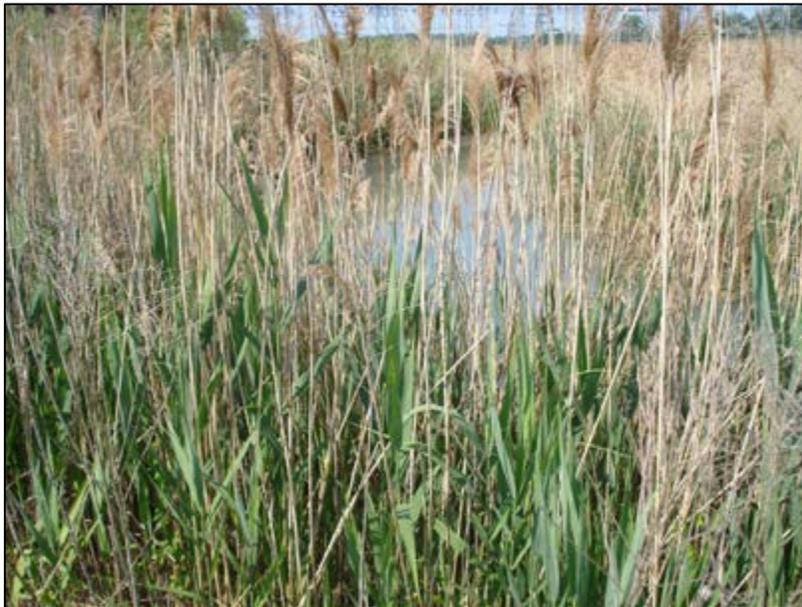
3-2

LOOKING WEST AT SOUTH END OF POND 3, HIGH VEGETATION

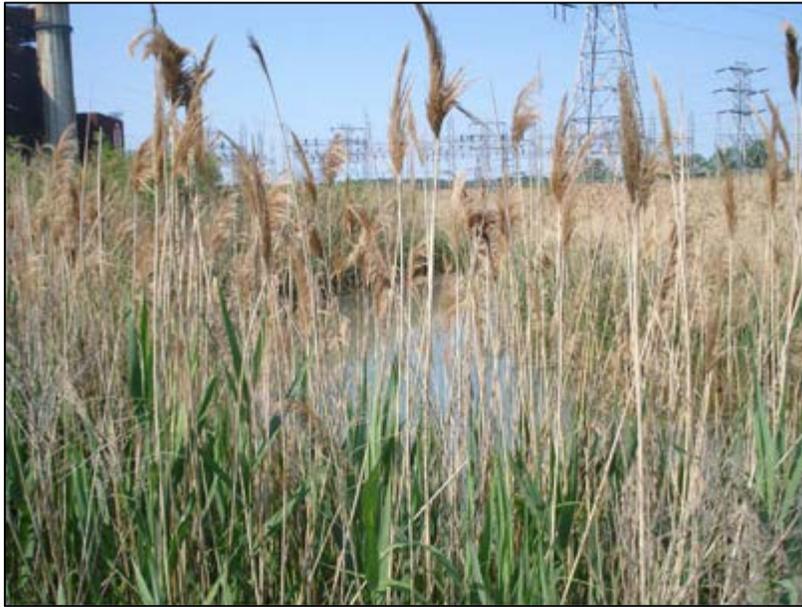
3-3

LOOKING WEST AT NORTH END OF POND 3, HIGH VEGETATION

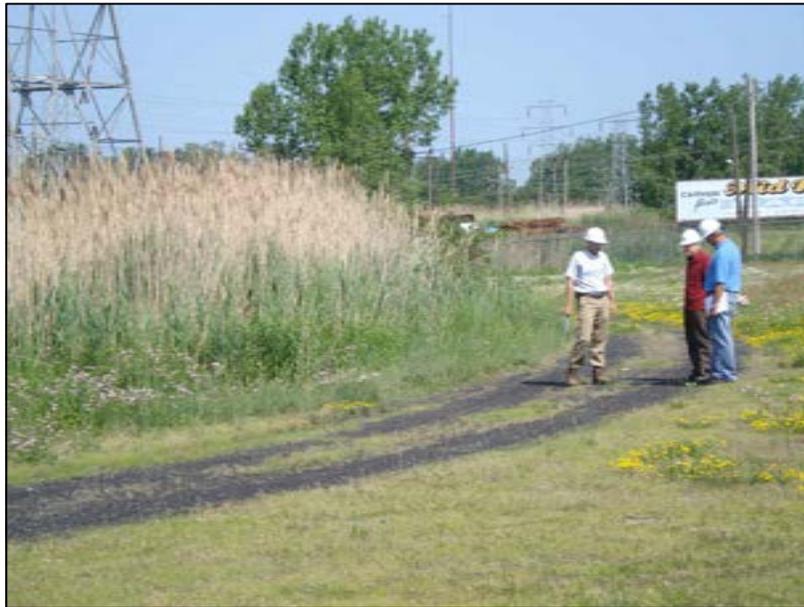
3-5

LOOKING NORTHEAST AT EAST SIDE OF POND 3, HIGH VEGETATION

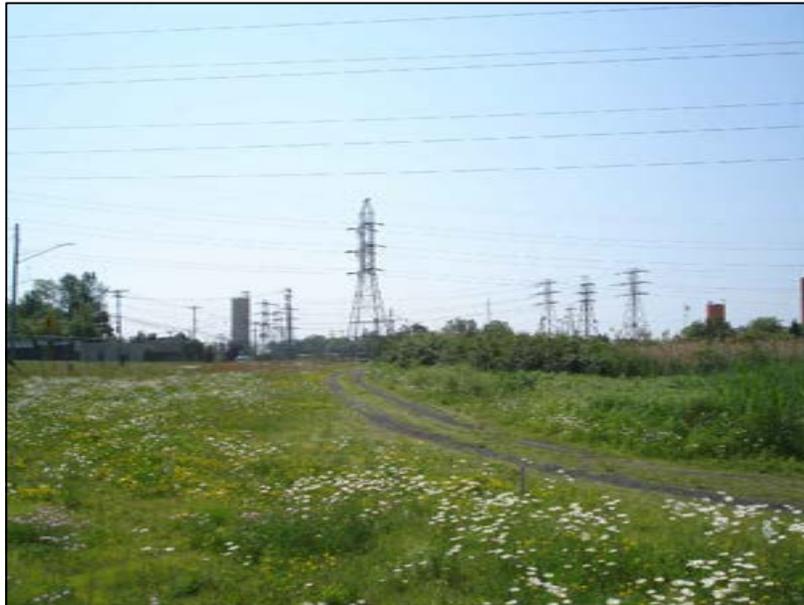
3-6

LOOKING SOUTH AT EAST SIDE OF POND 3, HIGH VEGETATION

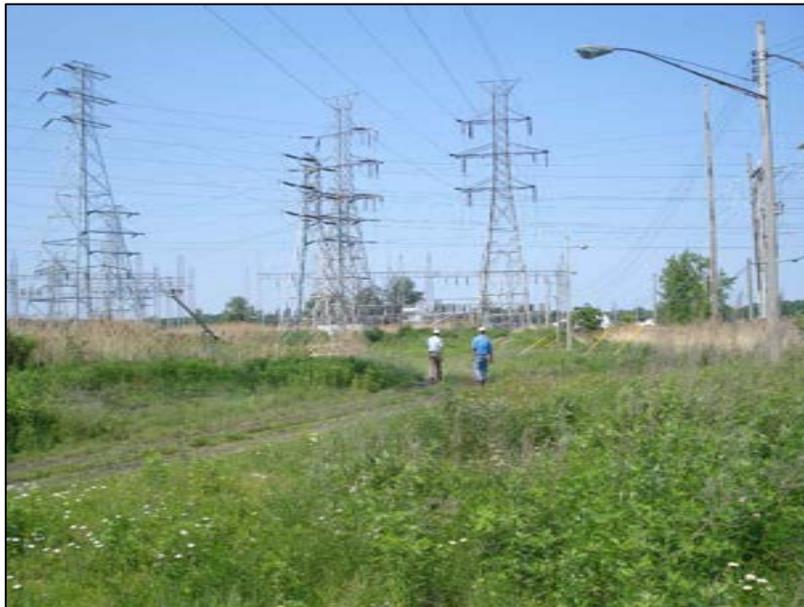
3-8

LOOKING WEST AT NORTH END OF POND 3 (FOREGROUND)
AND POND 2 (MOUND IN BACKGROUND)

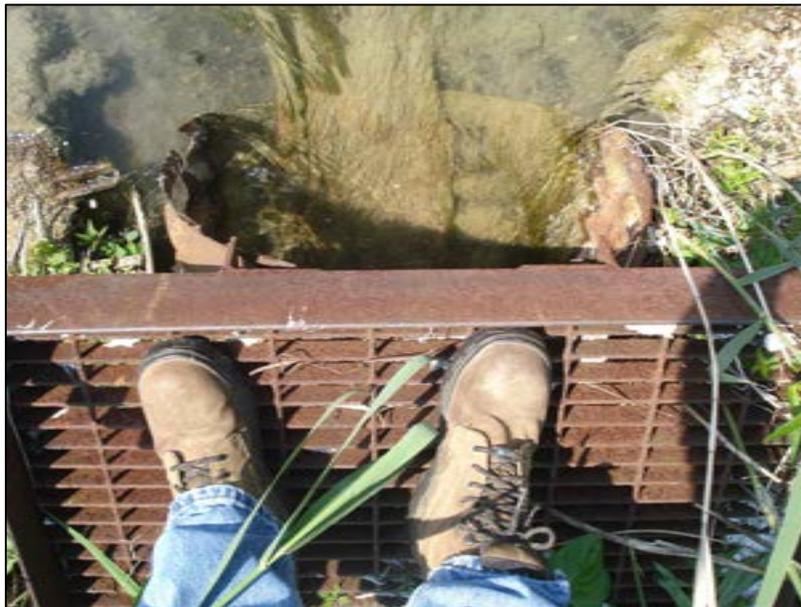
3-9

INLET OF OUTLET PIPE FROM POND 3

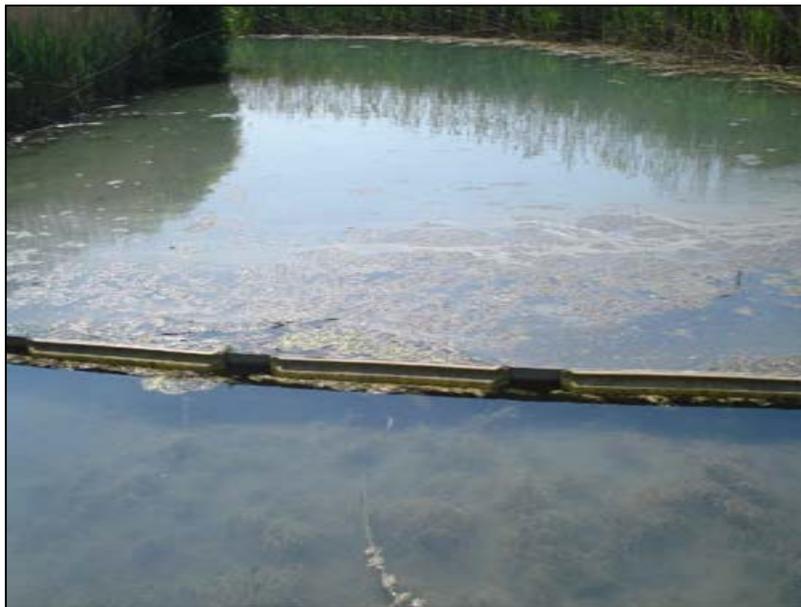
3-10

LOOKING SOUTH AT SKIMMER
ABOVE OUTLET PIPE FROM POND 3

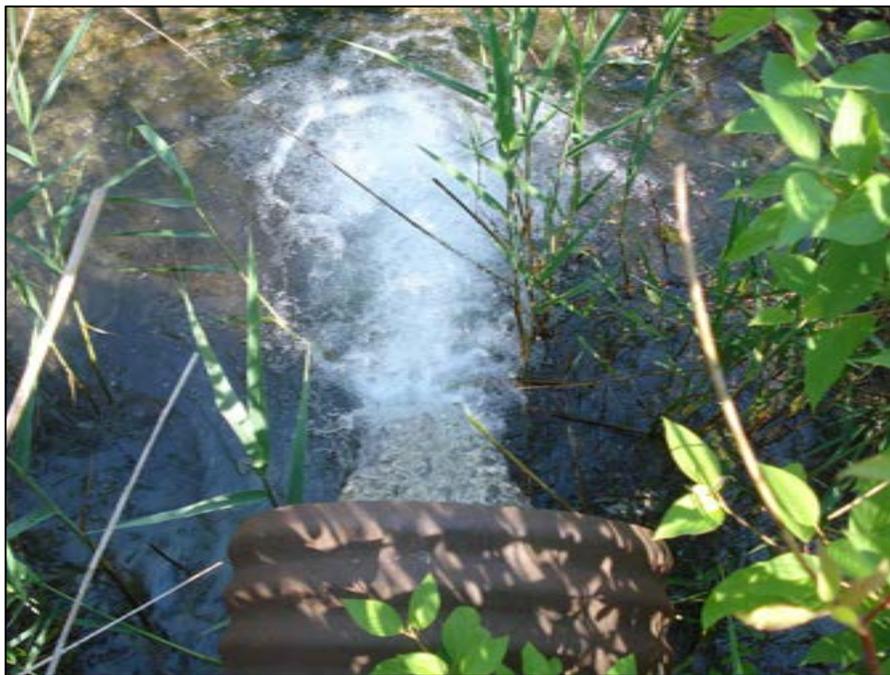
3-11

LOOKING NORTH AT OUTLET TO
DITCH FROM POND 3

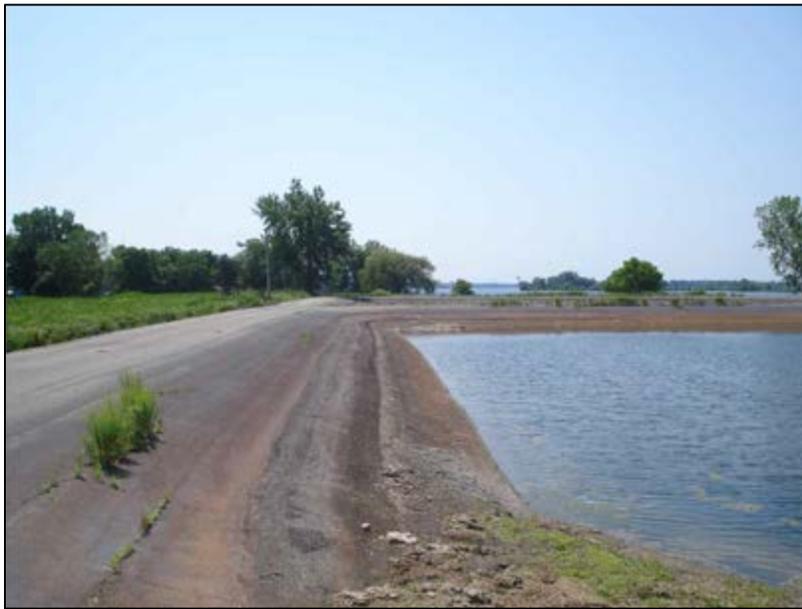
NEQ-1

LOOKING SOUTHEAST AT EAST CREST AND INTERIOR SLOPES OF NORTH AND SOUTH EQUALIZATION BASINS

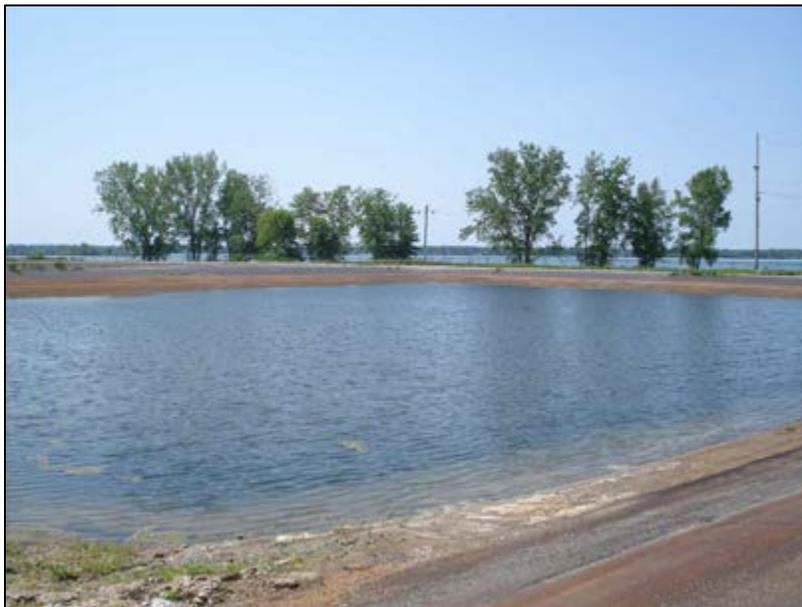
NEQ-2

LOOKING SOUTHWEST ACROSS NORTH EQUALIZATION BASIN, NIAGARA RIVER IN BACKGROUND

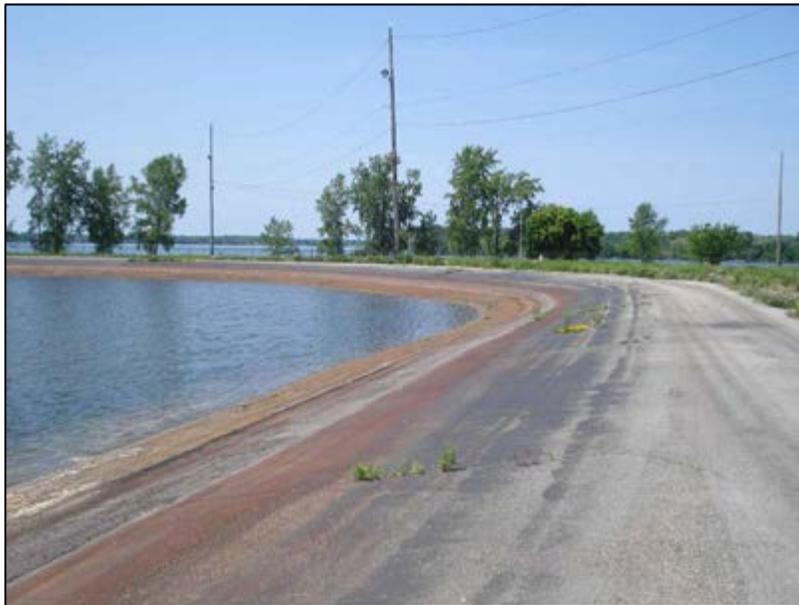
NEQ-3
 LOOKING WEST AT NORTHWEST
 CORNER OF NORTH EQUALIZATION BASIN

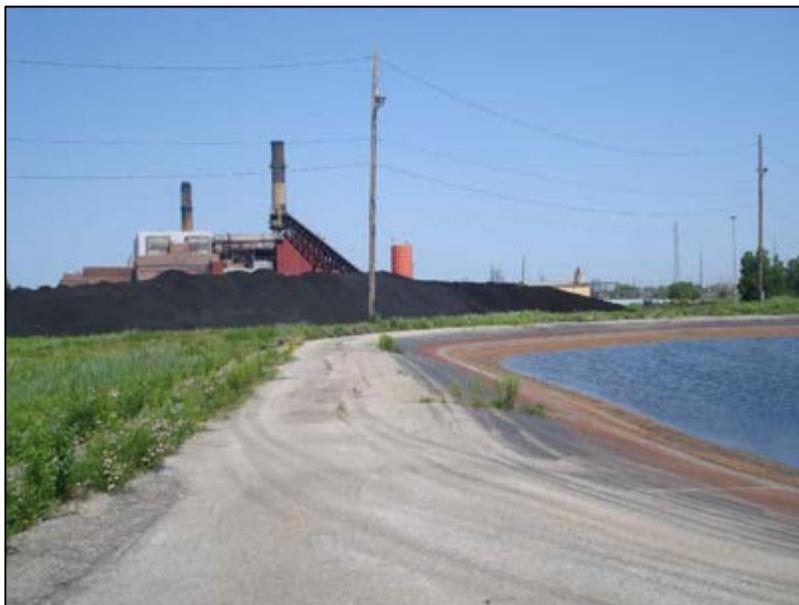
NEQ-4
 BETWEEN EQ PONDS LOOKING NORTH AT
 WEST END OF NORTH EQUALIZATION BASIN

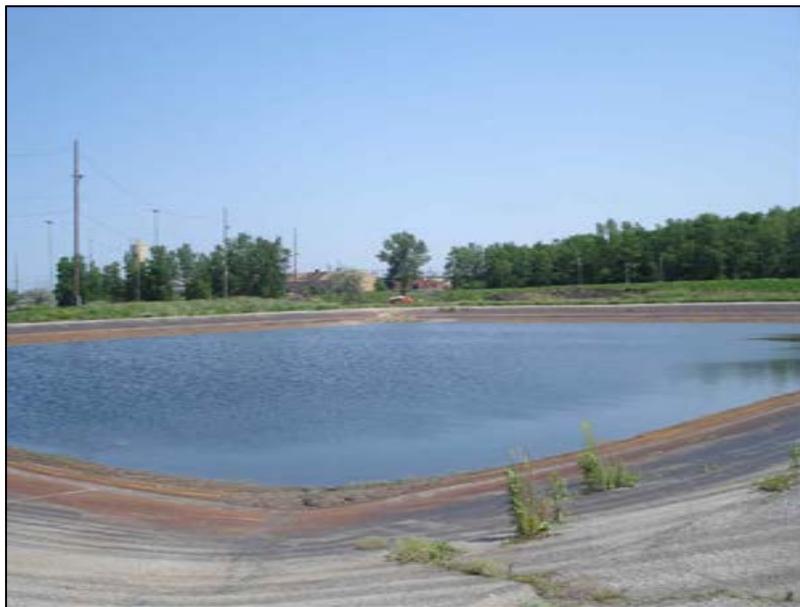
NEQ-5

BETWEEN EQ PONDS LOOKING NORTHEAST AT INTERIOR OF NORTH EQUALIZATION BASIN

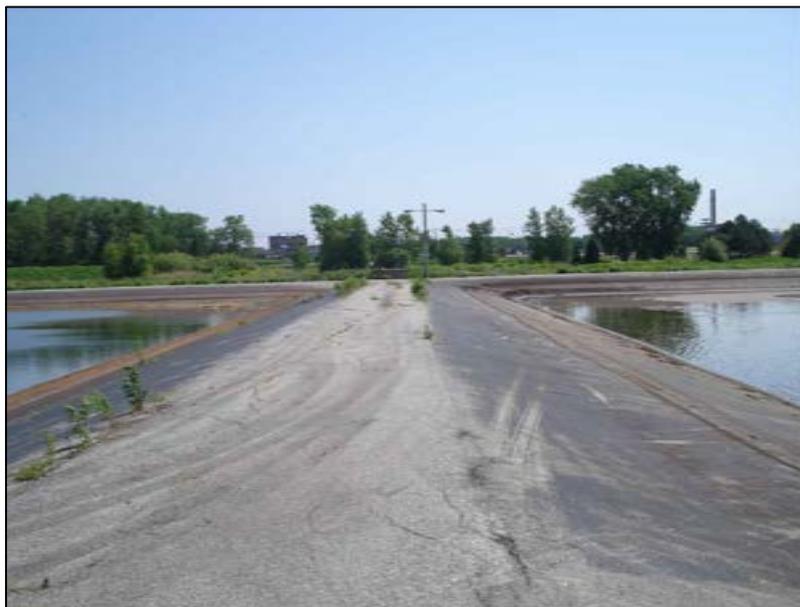
NEQ-6

BETWEEN EQ PONDS LOOKING EAST AT CREST BETWEEN NORTH AND SOUTH EQUALIZATION BASIN

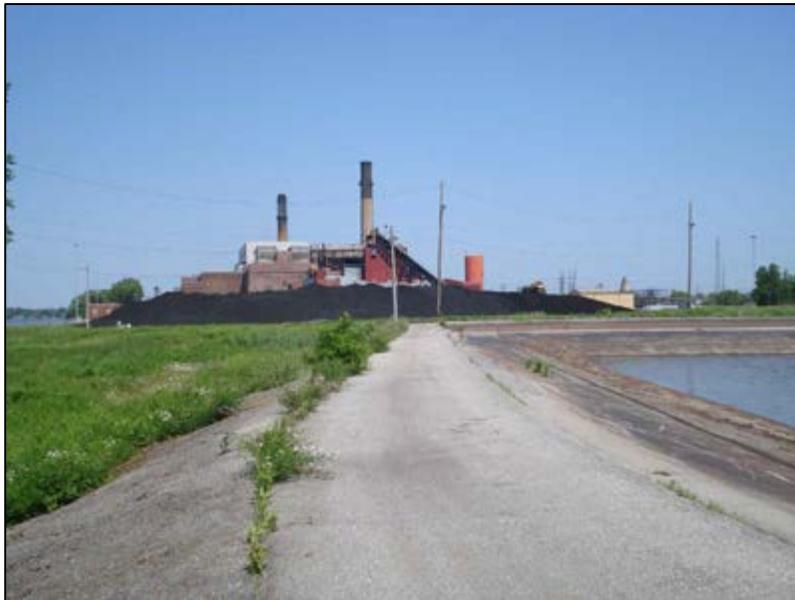
NEQ-7

SOUTHWEST CORNER OF SOUTH EQUALIZATION BASIN LOOKING NORTH AT WEST DIKE OF SOUTH EQUALIZATION BASIN (FOREGROUND) AND NORTH EQUALIZATION BASIN (BACKGROUND)

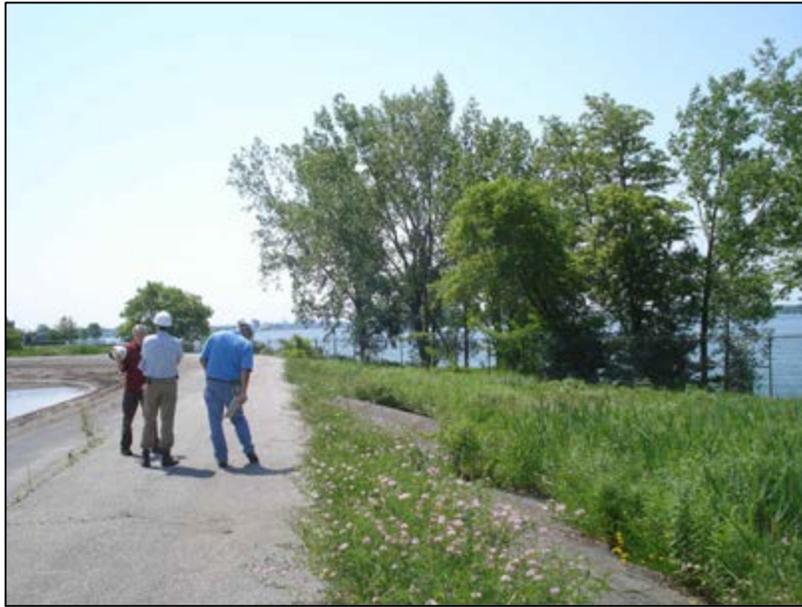
SEQ-3

SOUTH EQUALIZATION BASIN - LOOKING SOUTHWEST AT CREST AND
DOWNSTREAM SLOPE OF WEST EMBANKMENT, HIGH VEGETATION

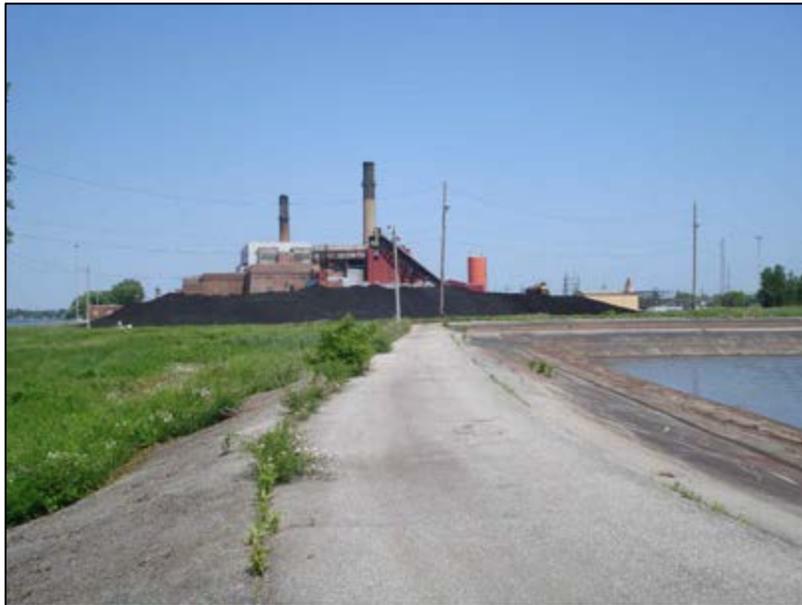
SEQ-4

SOUTHWEST CORNER OF SOUTH
EQUALIZATION BASIN LOOKING NORTH

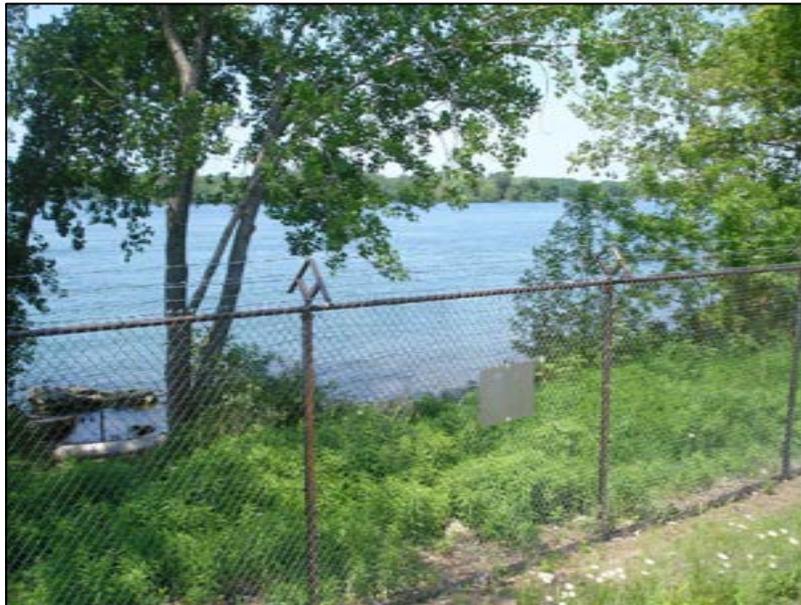
SEQ-5

SOUTHWEST CORNER OF SOUTH EQUALIZATION BASIN LOOKING WEST AT TOE OF DOWNSTREAM SLOPE/BANK OF NIAGARA RIVER

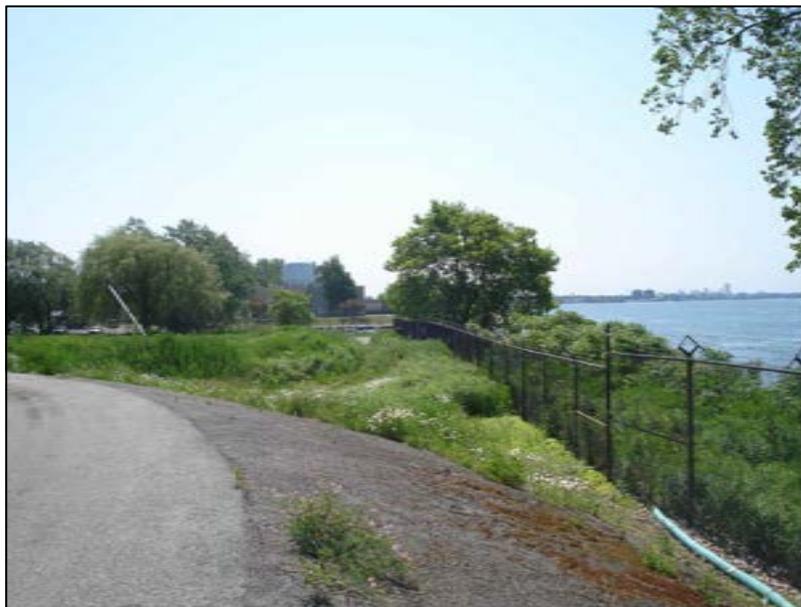
SEQ-6

SOUTHWEST CORNER OF SOUTH EQUALIZATION BASIN LOOKING SOUTH AT DOWNSTREAM SLOPE, SOUTH POND OUTLET IN BACKGROUND.

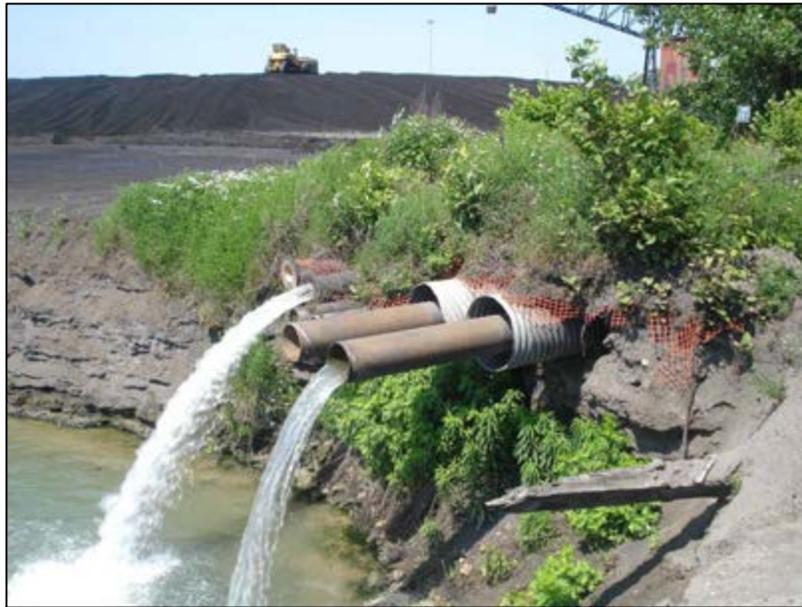
S-1

LOOKING NORTHWEST AT SLUICE PIPES INLETS AT NORTH END OF SOUTH POND

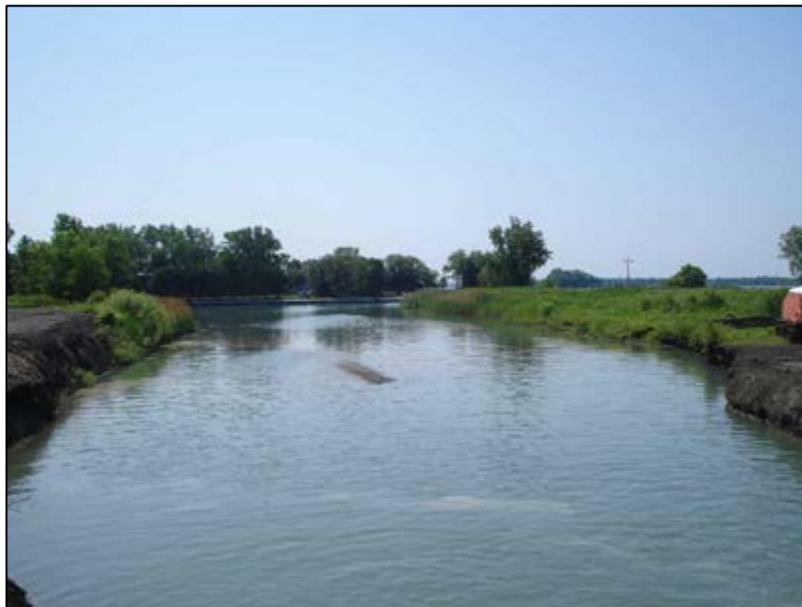
S-2

LOOKING SOUTH/SOUTHWEST INTO INTERIOR OF NORTH END OF SOUTH POND, SLOPES WITH STEEP ASH AND HIGH VEGETATION
