Report of Dam Safety Assessment of Coal
Combustion Surface Impoundments
NRG Energy
Huntley Generating Station
Tonawanda, NY

AMEC Project No. 3-2106-0194

March 2013

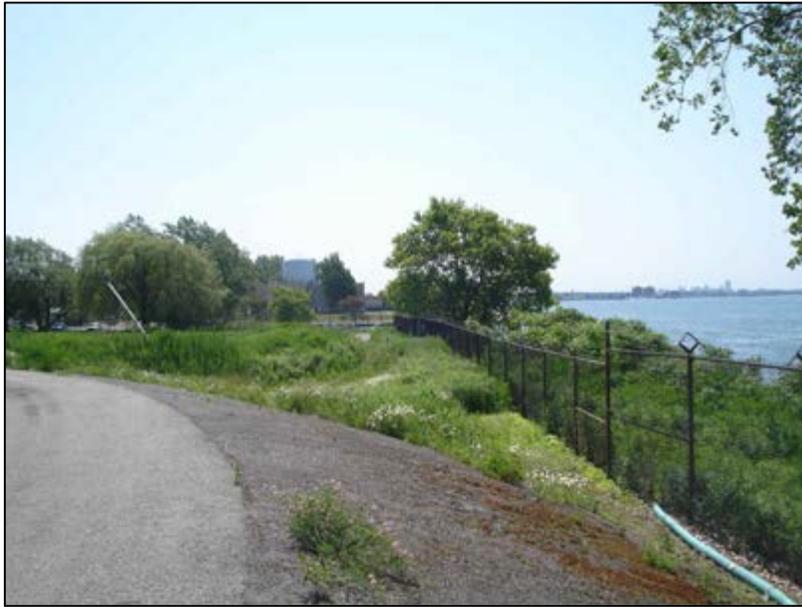
S-3

LOOKING SOUTH TOWARD AREA AT SOUTHWEST END OF SOUTH POND AND OUTLET, SOUTH POND OUTLET PIPE EXPOSED IN BACKGROUND

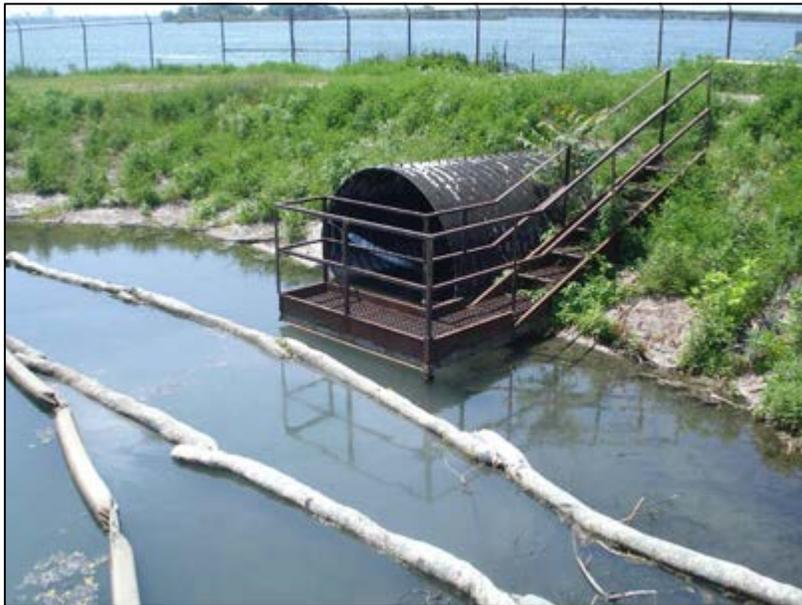
S-4

INLET OF OUTLET PIPE AT SOUTH POND, SKIMMER BOOMS UPSTREAM FROM OUTLET.

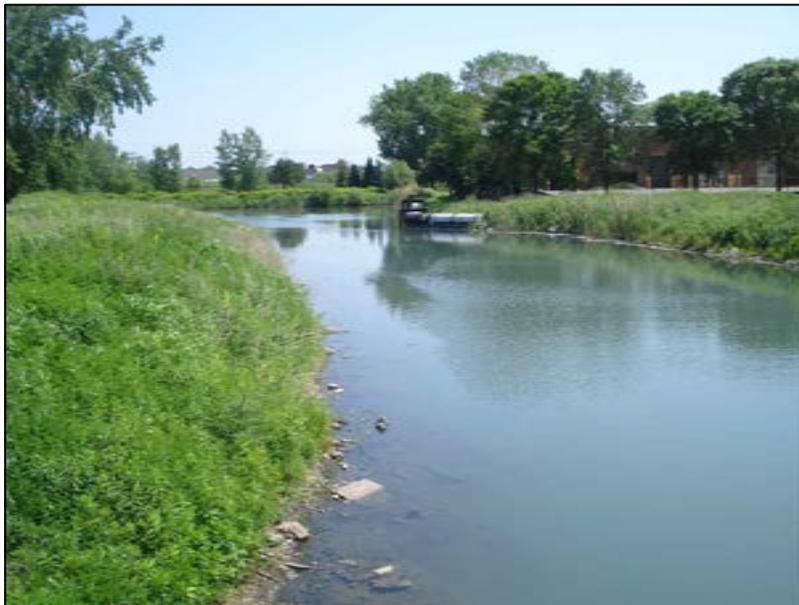
S-5

NEAR SOUTH POND OUTLET LOOKING EAST
AT INTERIOR OF POND, HIGH VEGETATION

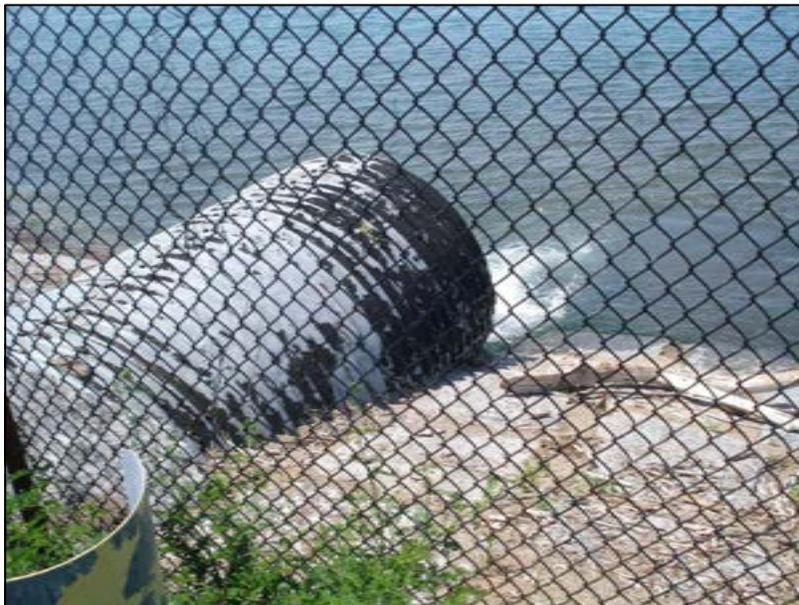
S-6

OUTLET OF SOUTH POND TO NIAGARA RIVER

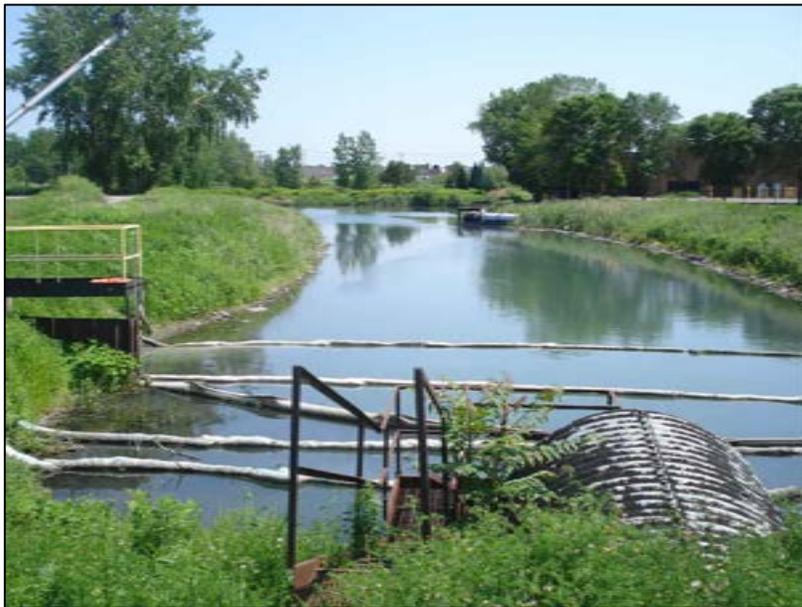
S-7

AT SOUTH POND OUTLET LOOKING EAST AT INTERIOR OF SOUTH END OF POND, HIGH VEGETATION

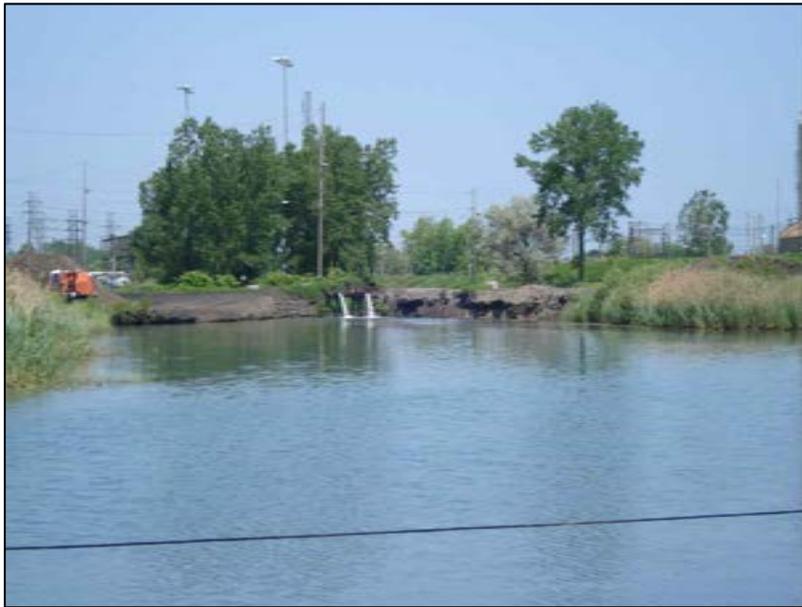
S-8

FROM SOUTH DIKE LOOKING NORTH AT POND INTERIOR AND SLURRY INLET PIPES, NOTE ADJACENT BARE AREAS

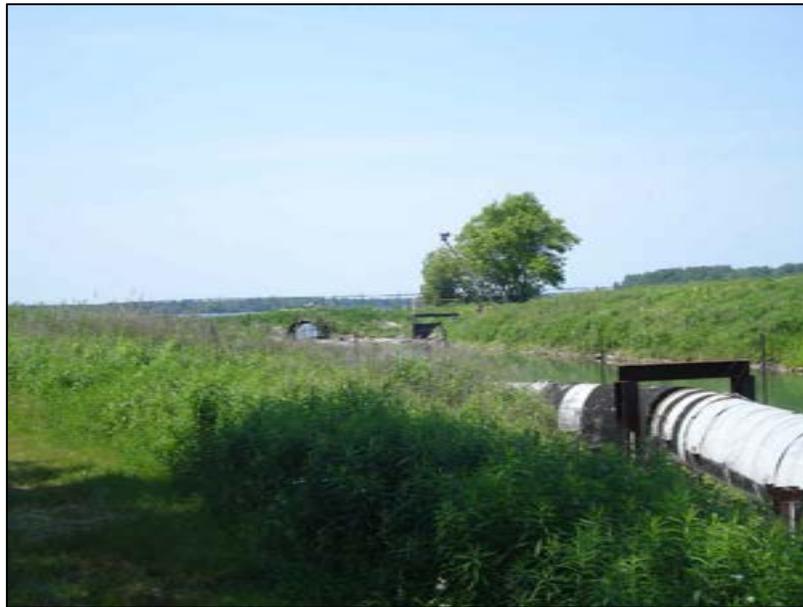
S-9

FROM SOUTH DIKE LOOKING WEST AT POND INTERIOR AND OUTLET TO NIAGARA RIVER, HIGH VEGETATION

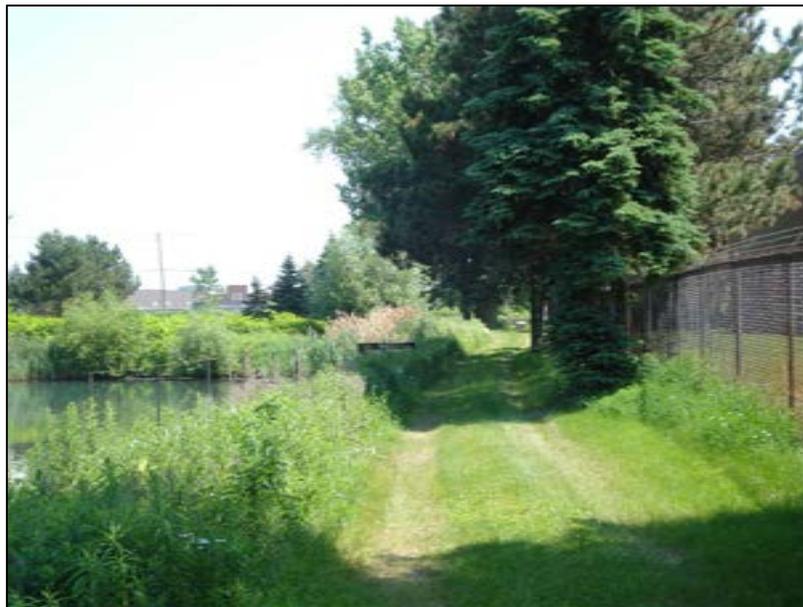
S-10

FROM SOUTH DIKE LOOKING EAST AT SOUTHEAST CORNER OF POND, SOUTH US SLOPES AND CREST, HIGH VEGETATION
