# Assessment of Dam Safety

## Coal Combustion Surface Impoundments (Task 3)

Northern States  
Power Company –  
Minnesota

Sherburne County  
Power Station

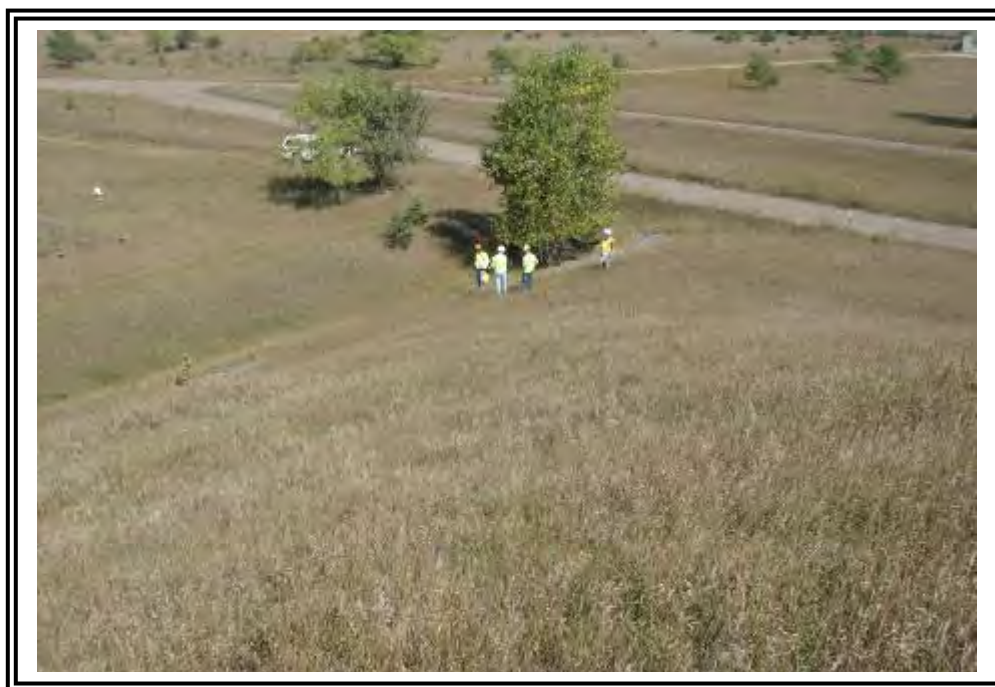
1

Intersection of downstream embankment slopes of North and East Dams, looking northwest.

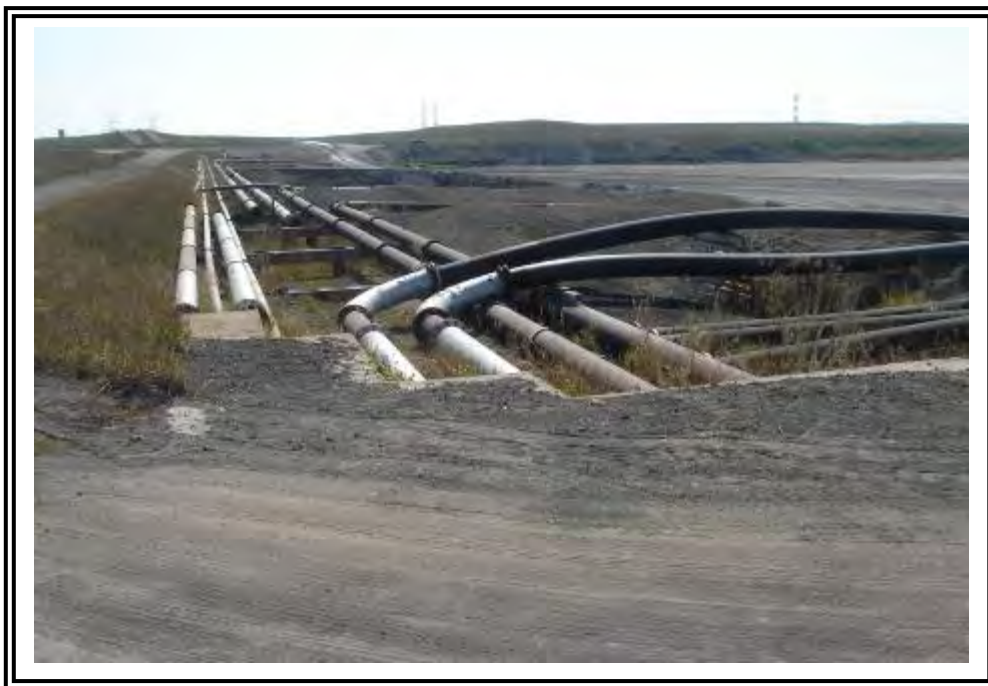
3

Upstream embankment slope of East Dam, looking south.

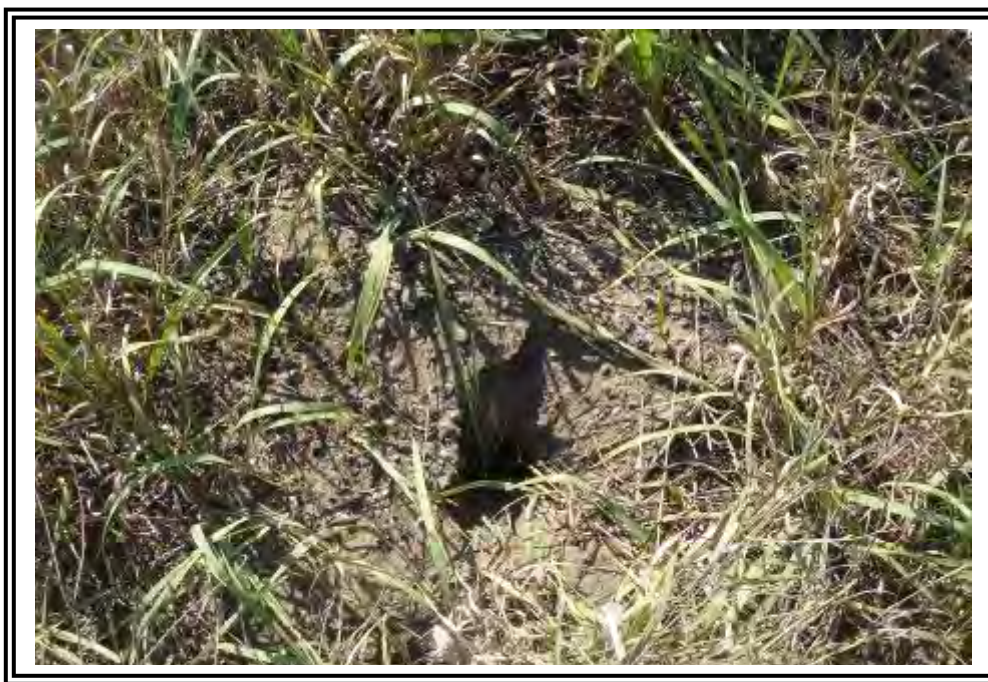
4

Animal burrows were observed along the faces and groins of the North and East Dams (Photo 4). One burrow was measured to be 24 inches deep at the groin of the East Dam (Photo 8).

Animal burrow in East Dam.

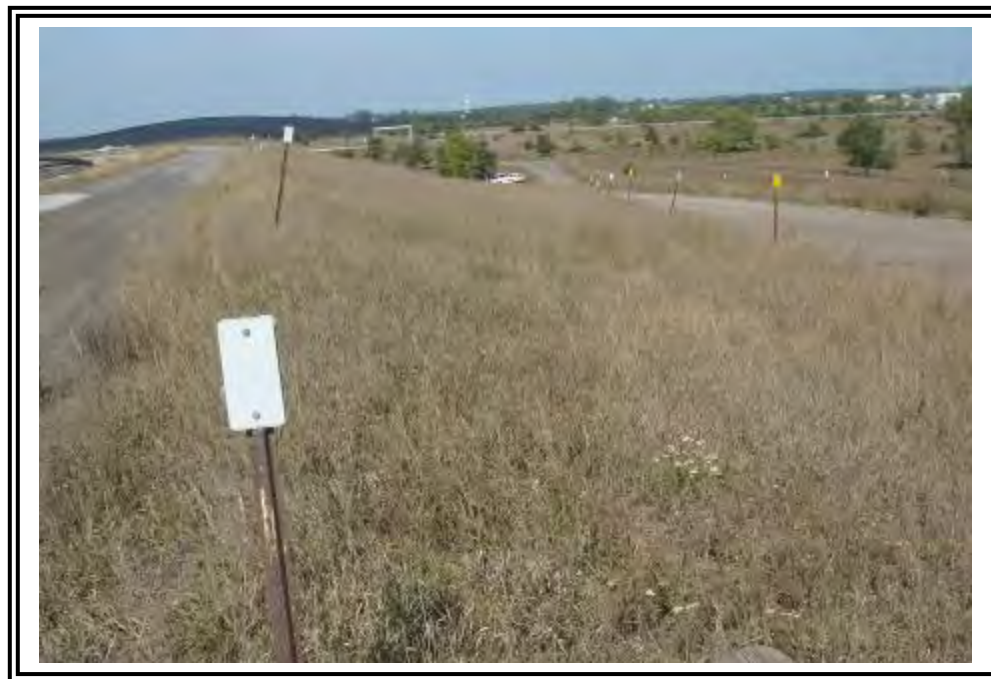
6

Downstream embankment slope of East Dam, facing north.

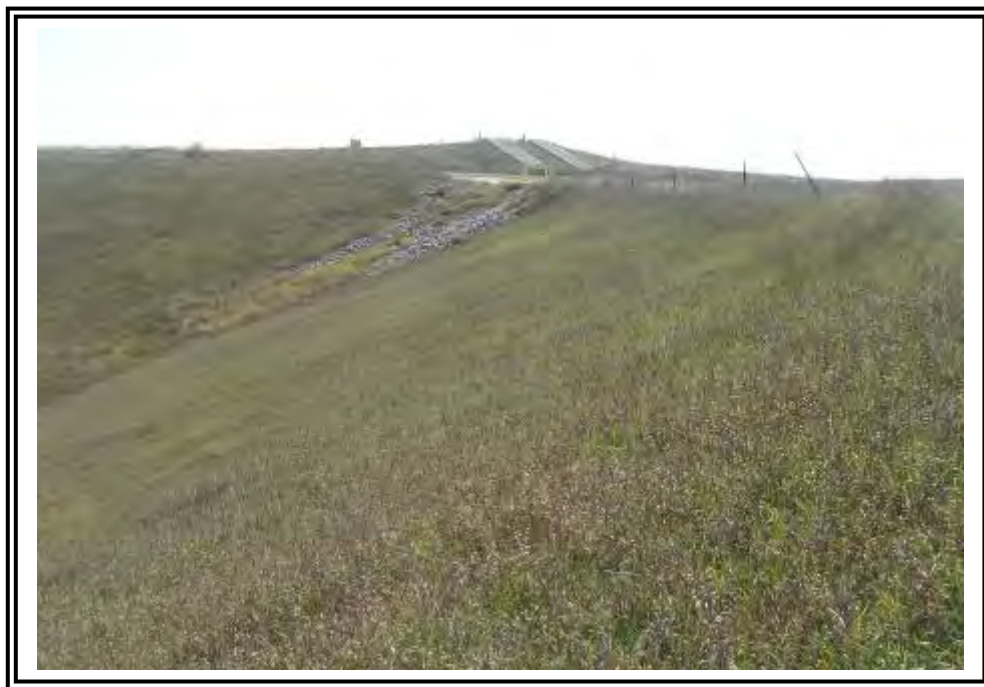
7

Downstream embankment slope of East Dam at south end of slope (groin), looking southeast.

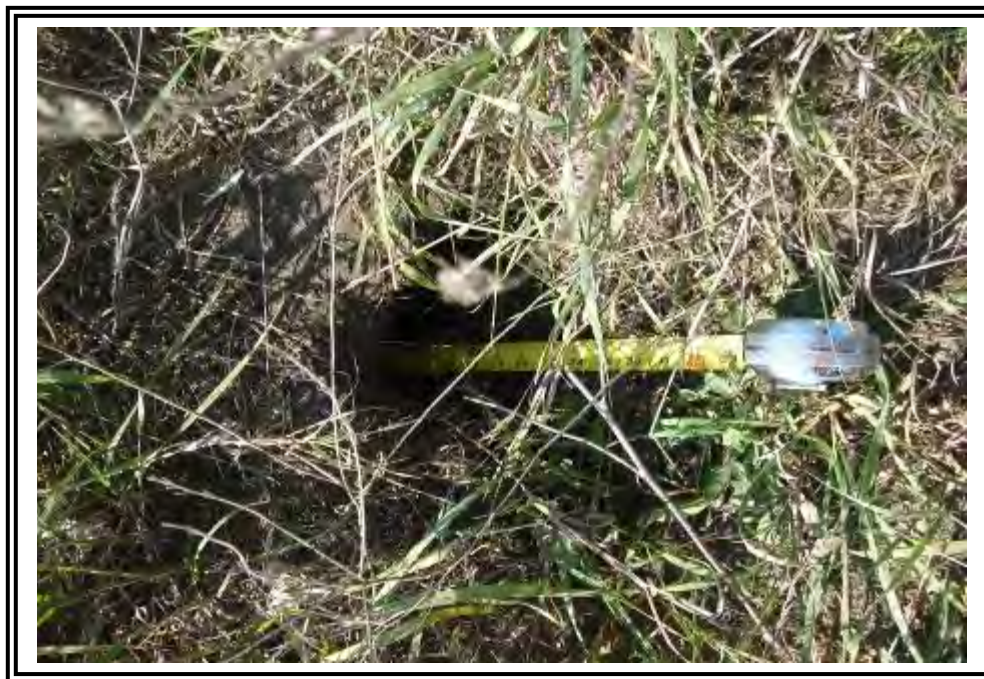
8

Animal burrow in East Dam near groin. Burrow was measured to be approximately 2'-4" deep from the ground surface.

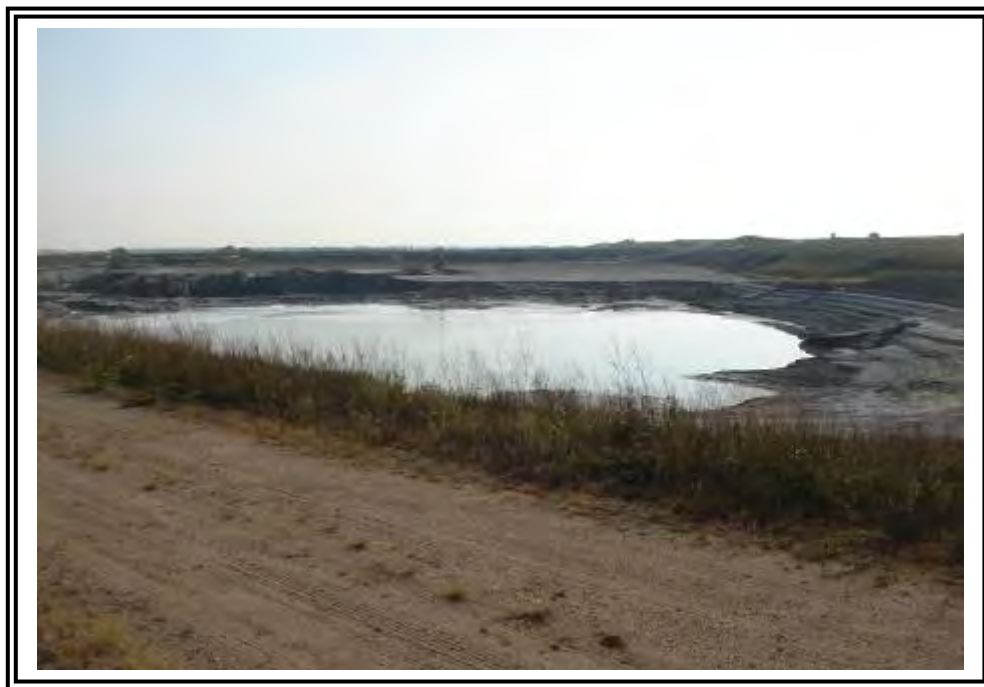
9

Looking across Bottom Ash Pond from the West Dam.

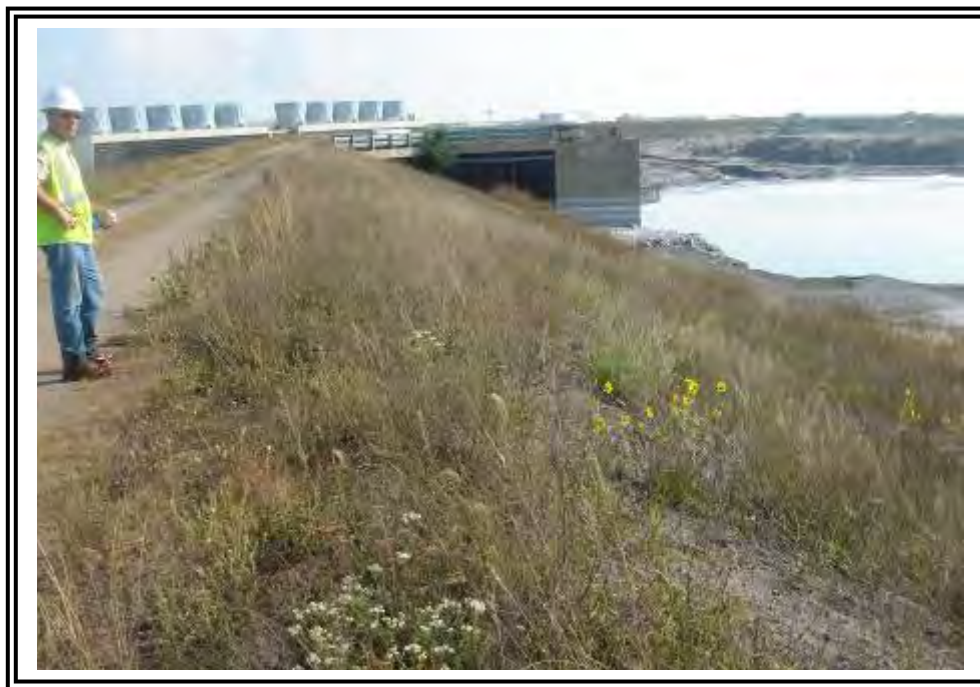
11

Upstream embankment slope of West Dam, facing northeast.

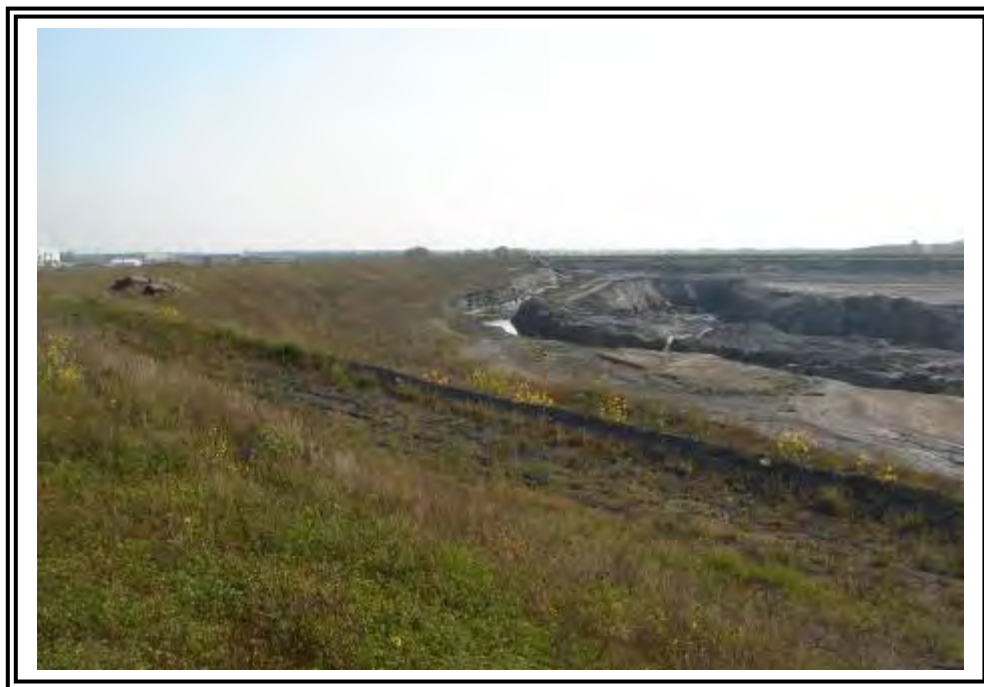
13

Upstream embankment slope of North Dam, facing east at corner of West and North Dams.

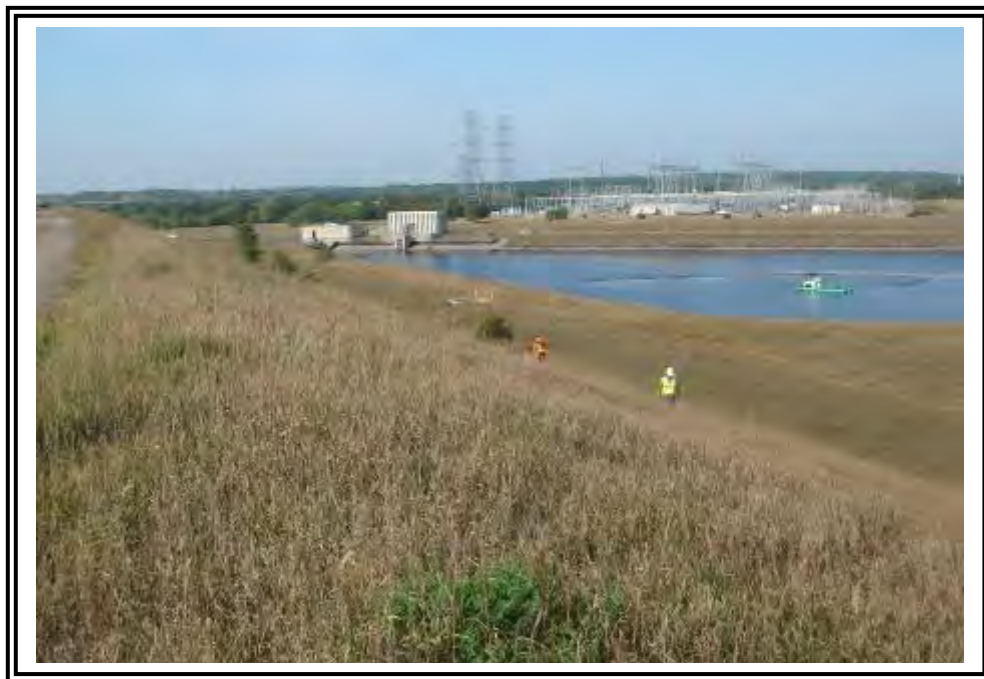
16

Downstream embankment slope of West Dam, facing northwest.

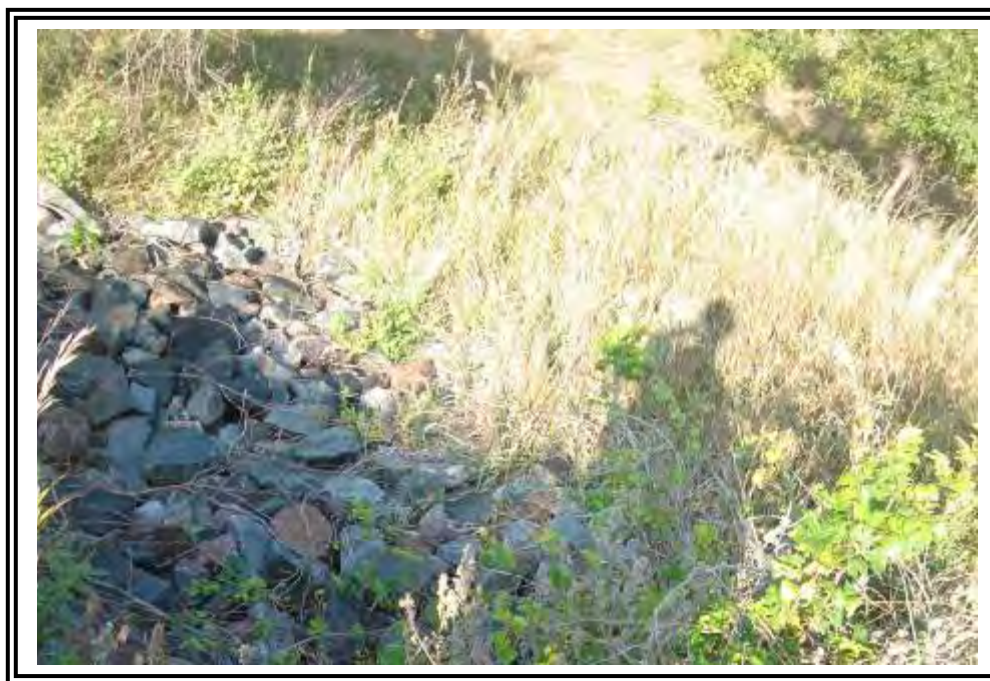
25

Drainage along downstream embankment slope of South Dam.

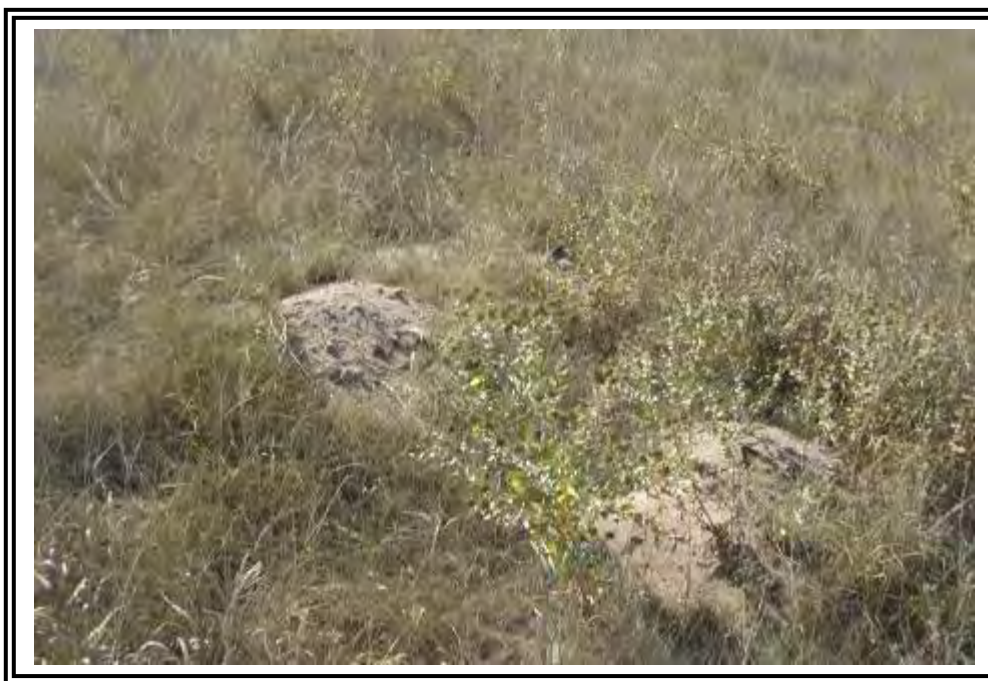
42

Animal burrows on downstream embankment of North Dam.

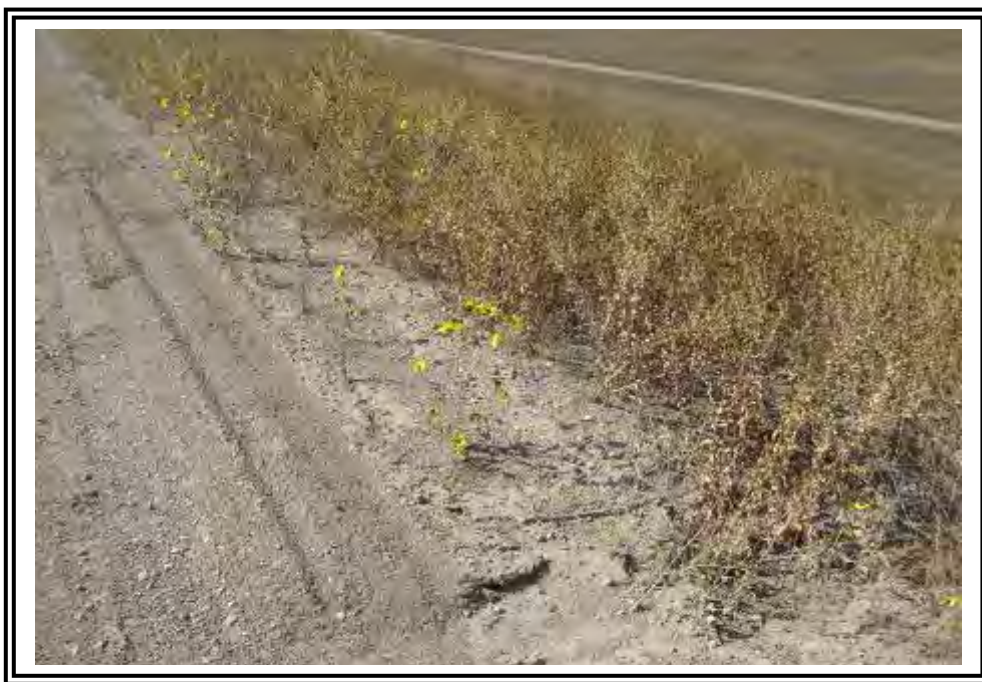
50

Minor erosion at top of downstream embankment of North Dam, facing northwest.

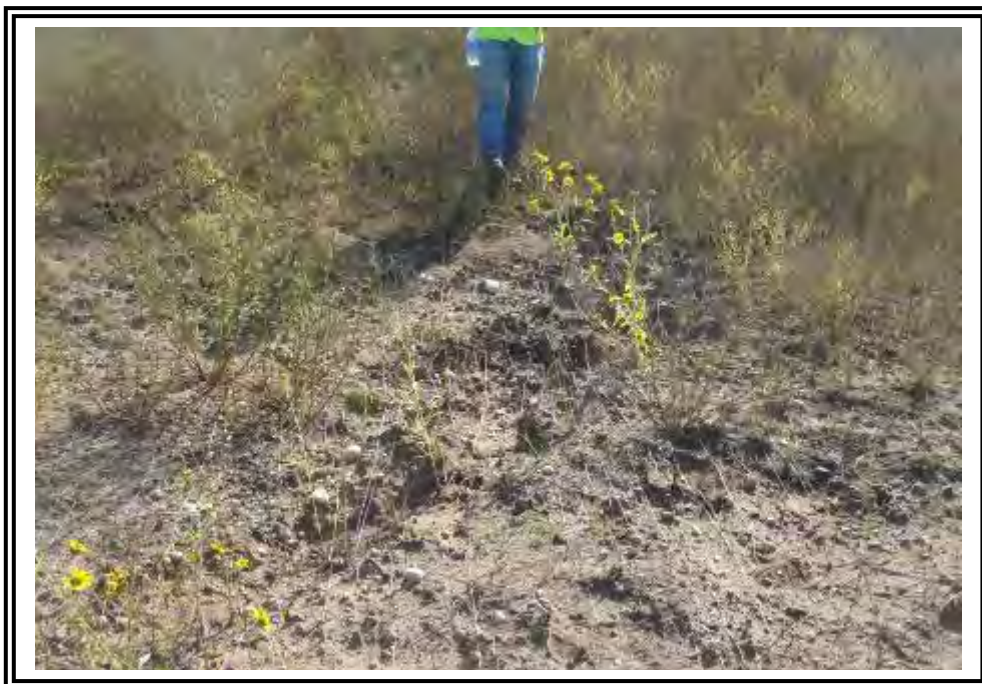
51

Minor erosion on downstream embankment slope of North Dam.

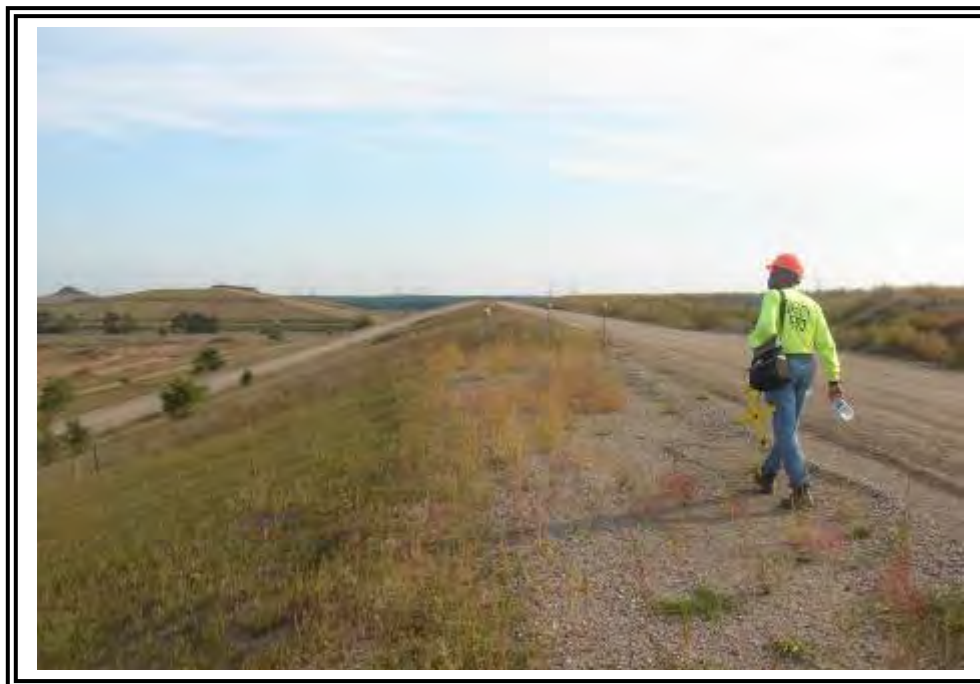
53

Trees were observed on the East Dam slope in area of future Pond 3S. The trees are to be removed as part of Pond No. 3S construction planned in 2010.

Downstream embankment slope and crest of East Dam adjacent to Pond 3S, facing south.

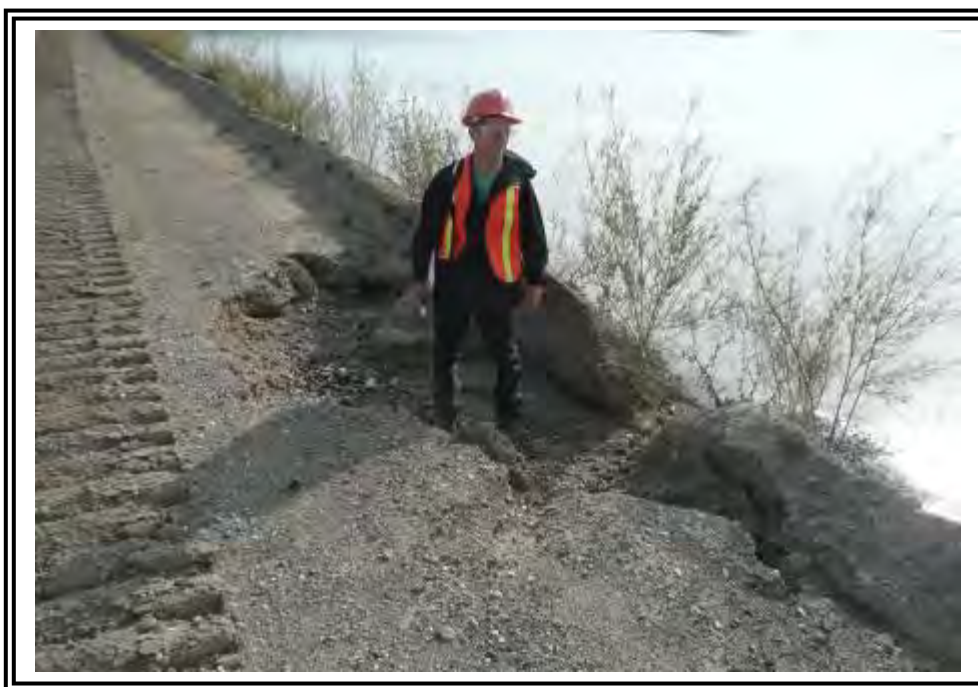
54A

Pond No. 2 contains a temporary interior dam which was measured to be approximately 17 feet wide. The freeboard measured approximately 1.5 feet. Erosion was observed along the interior dam slope.

Erosion of Pond No. 2 upstream embankment, facing south west.

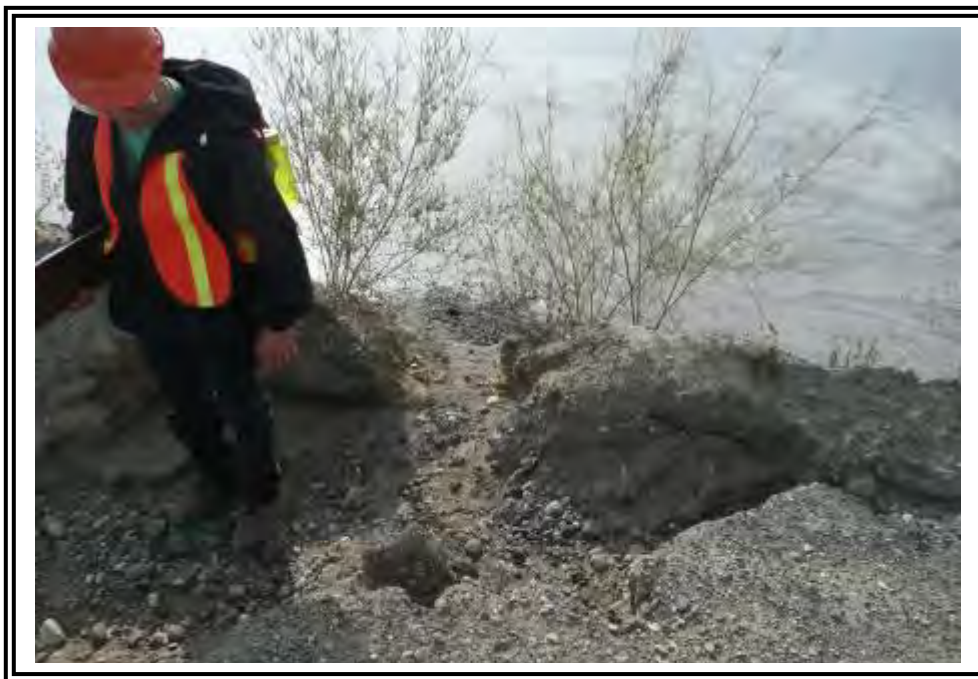
54B

Erosion of Pond No. 2 upstream embankment, facing west.

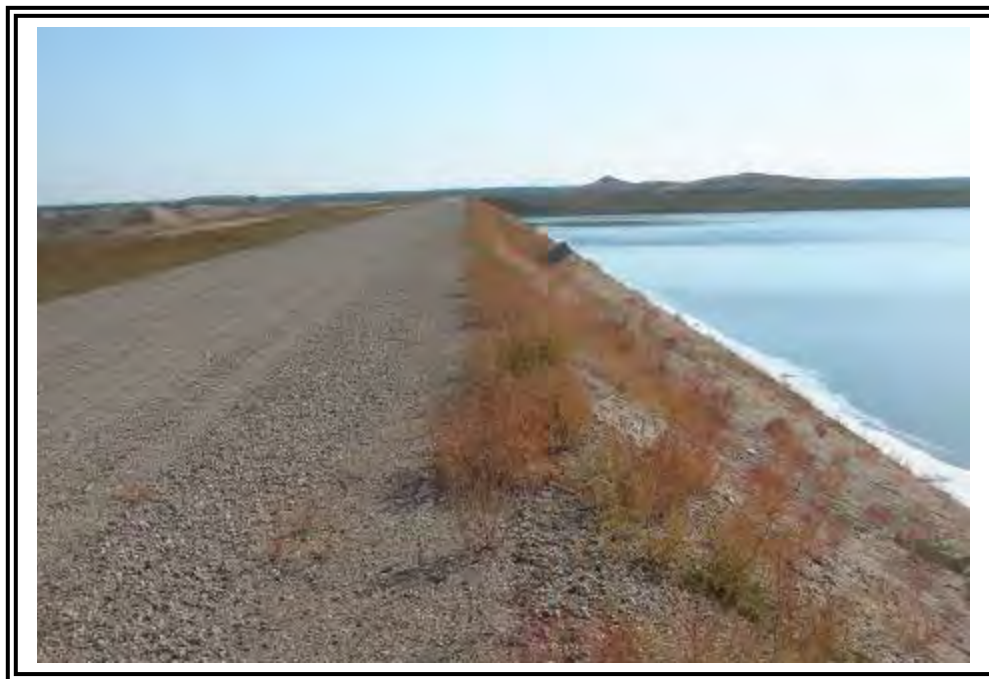
62

Crest and upstream slope of East Embankment, facing south.

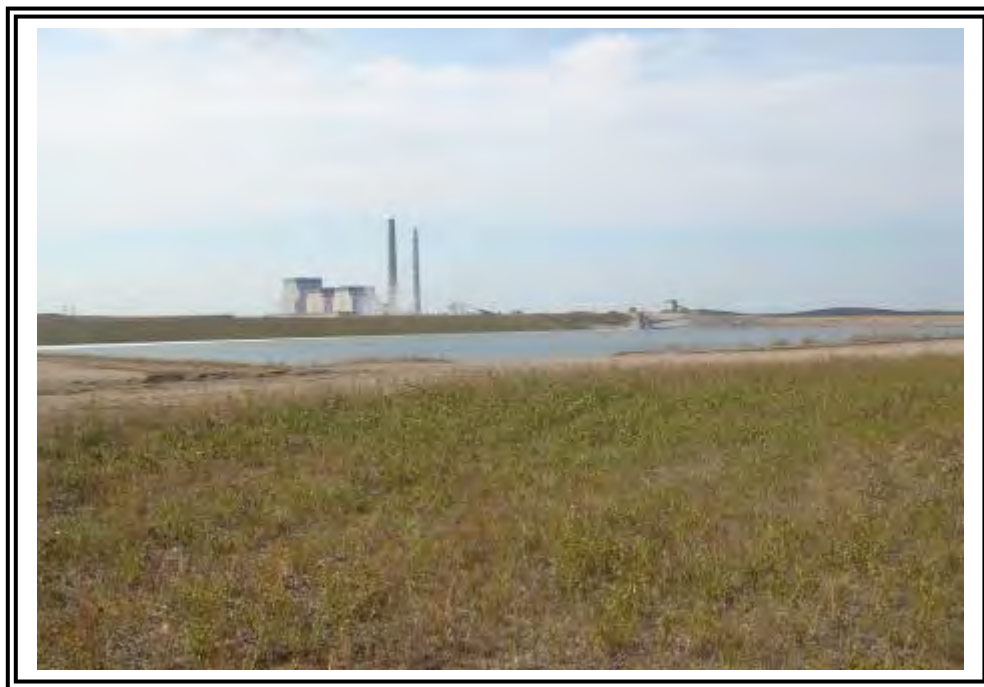
63

Looking across Pond 3N at West Side Slope, facing northwest.

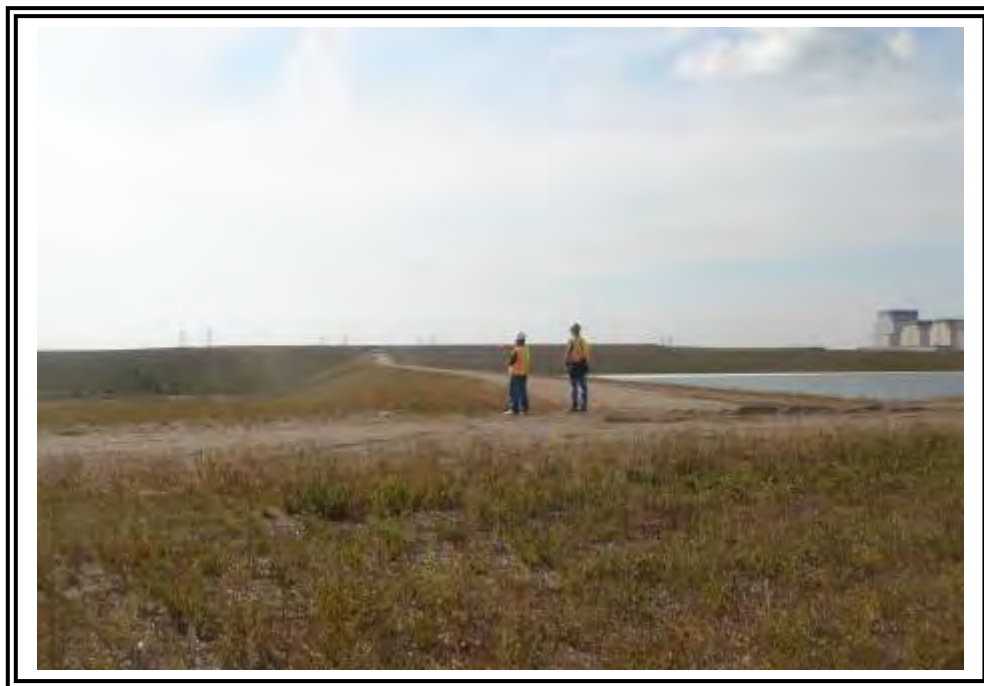
65

South Embankment of Pond 3N which separated Pond 3N and 3S.

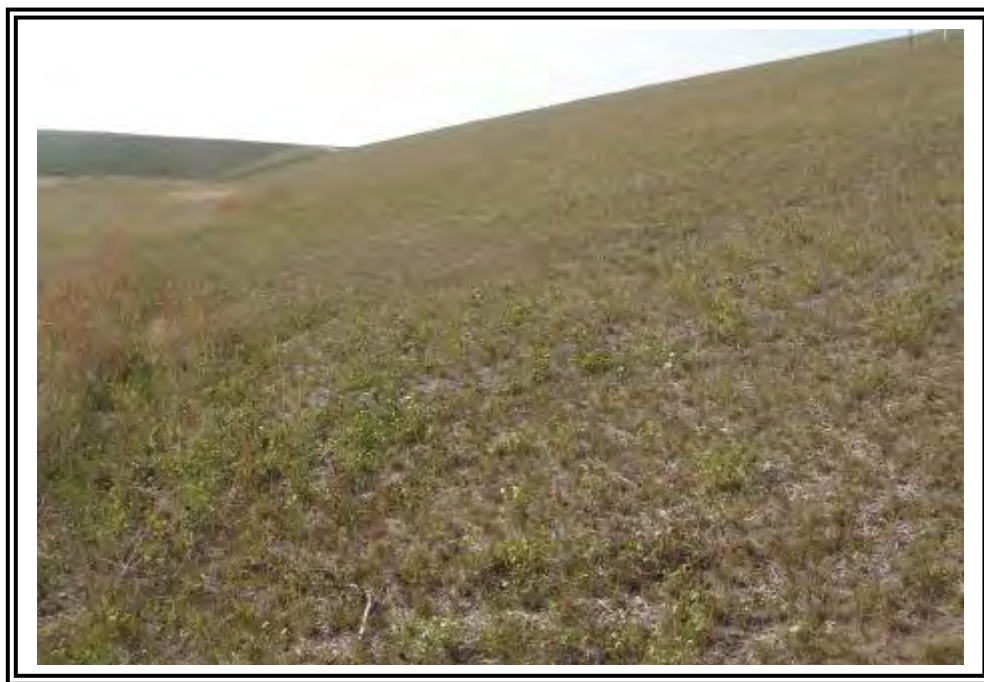
66

Downstream embankment slope of Dam between Pond 3N to Pond 3S, facing west.

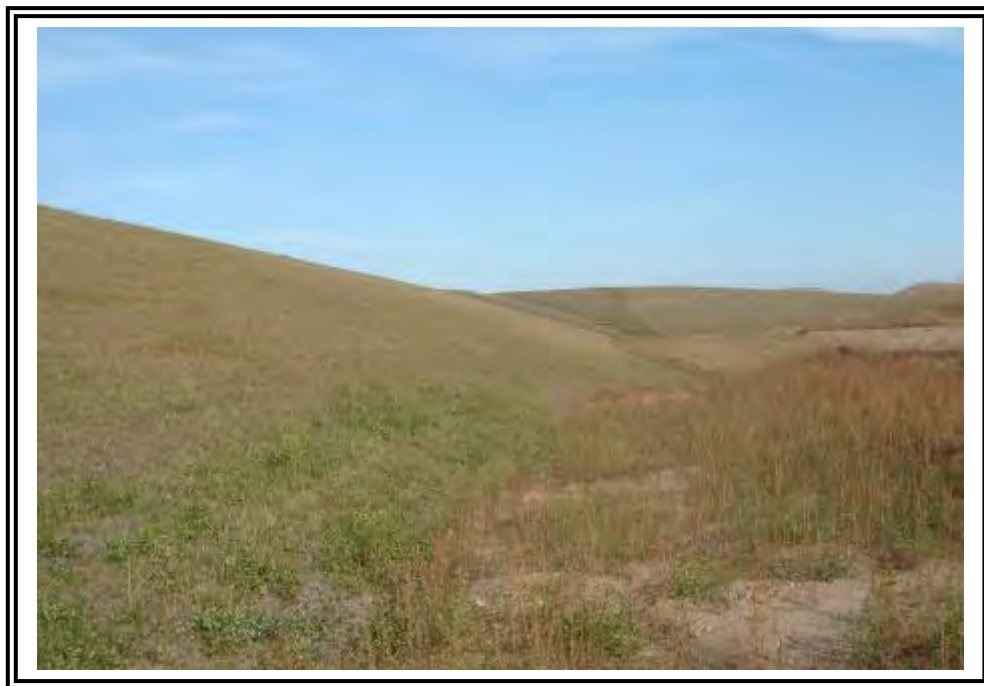
67

Downstream slope of Embankment between Pond 3N to Pond 3S, facing east.

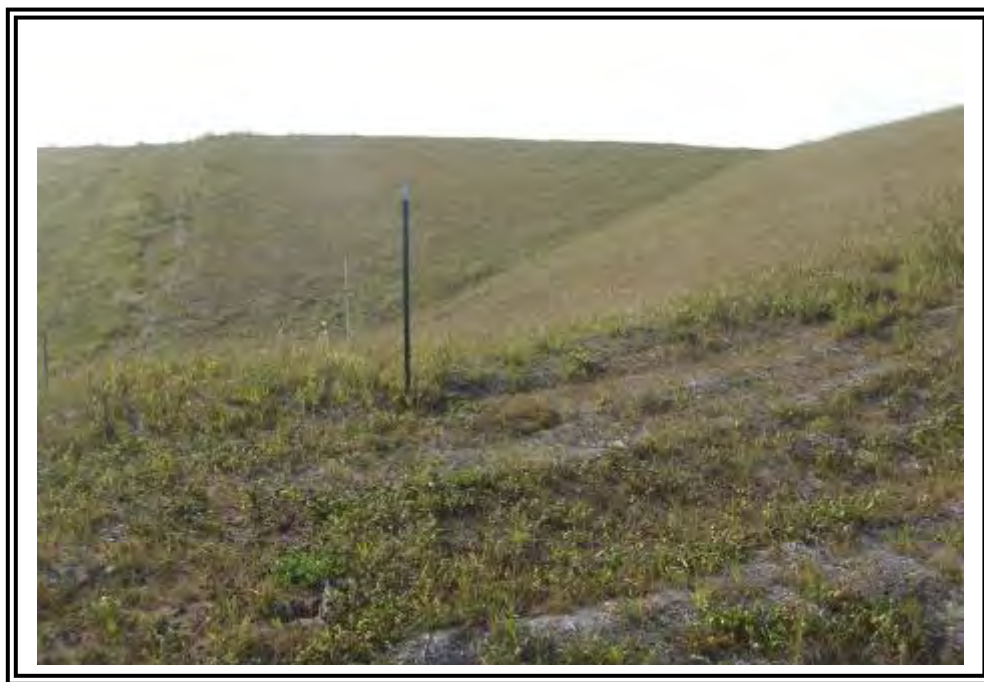
68

Groin at Ponds 3S and Pond 2, facing west.

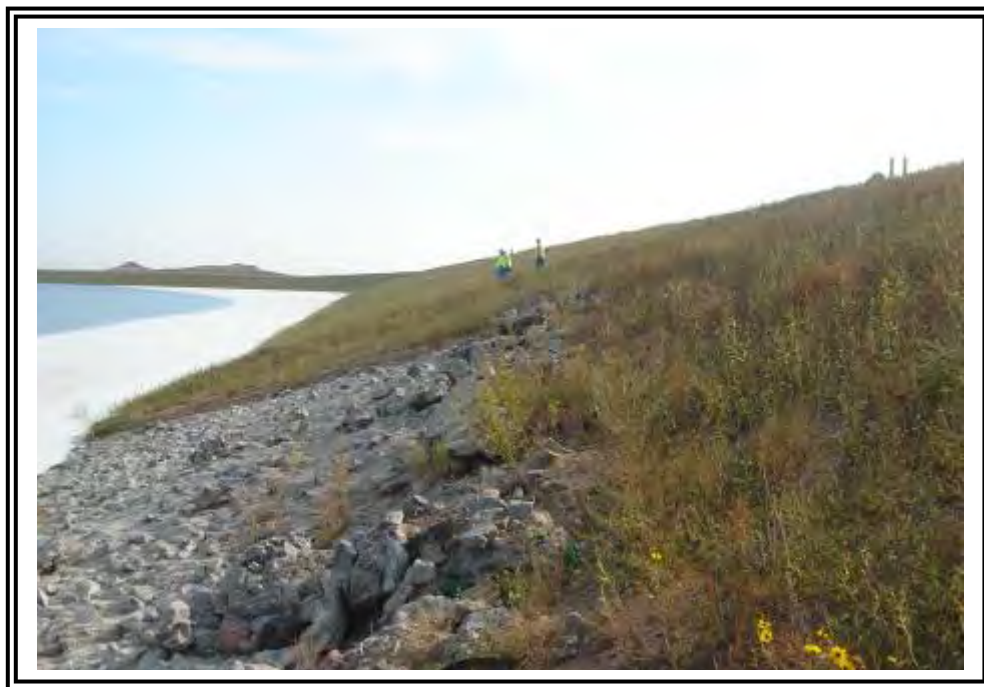
69

Upstream slope of Embankment between Pond 3N to Pond 2, facing south.
