DRAFT
Specific Site Assessment for
Coal Combustion Waste
Impoundments at Reid
Gardner Generating Station

NV Energy
Moapa, Nevada

April 2011
Project 092885

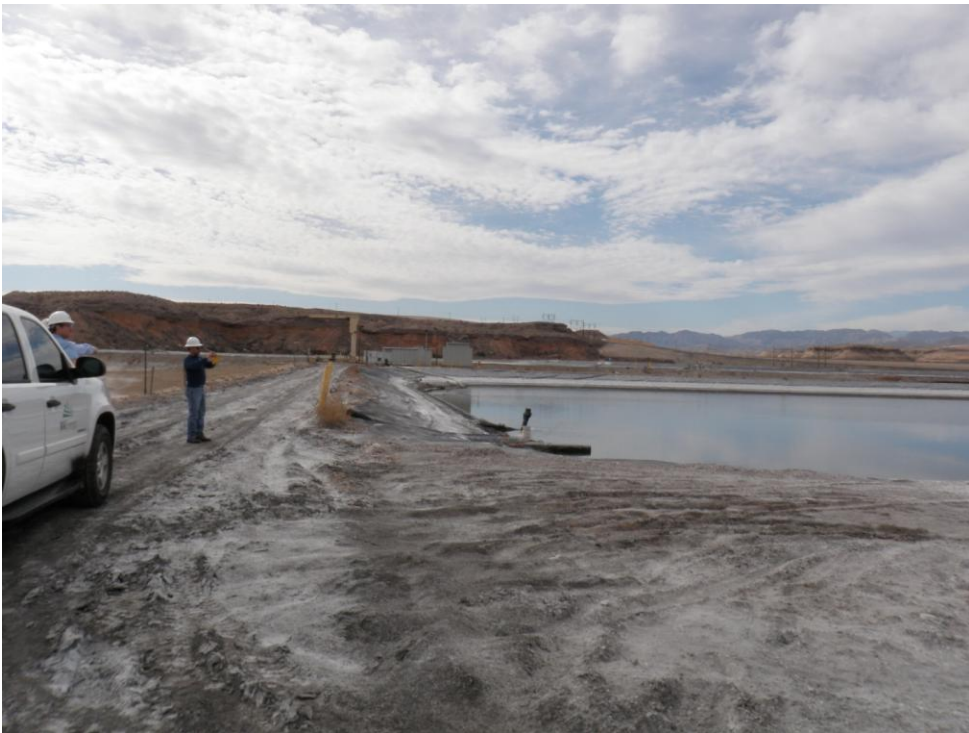
Photo 6: Looking southwest. Pond F on right. Former Pond G on left.

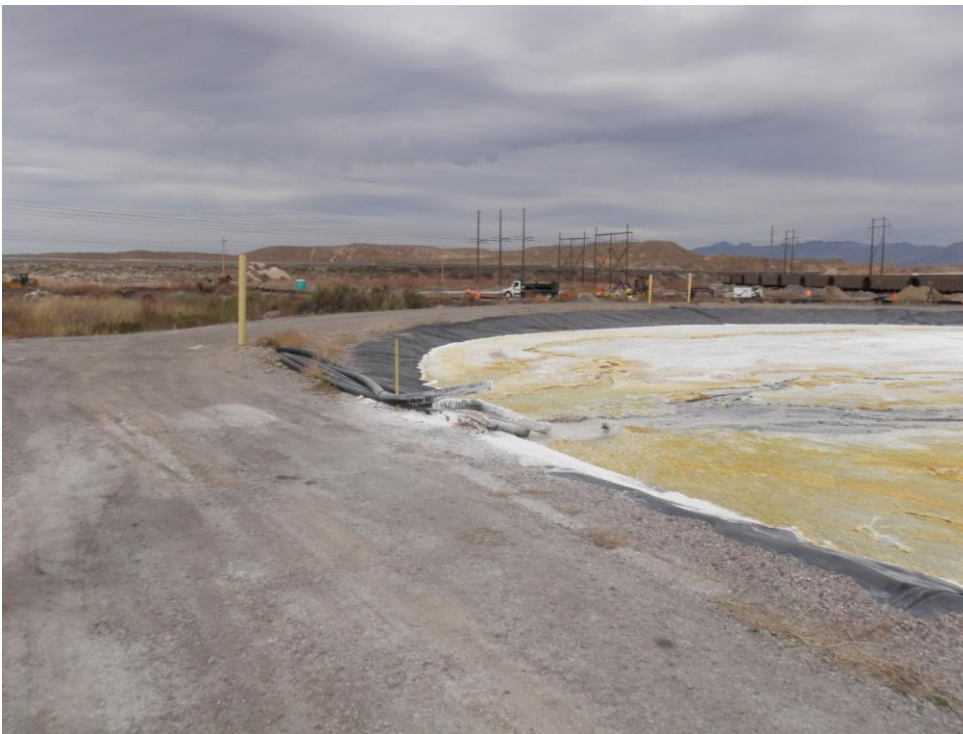
Photo 12: Looking north. Western end of Pond F.

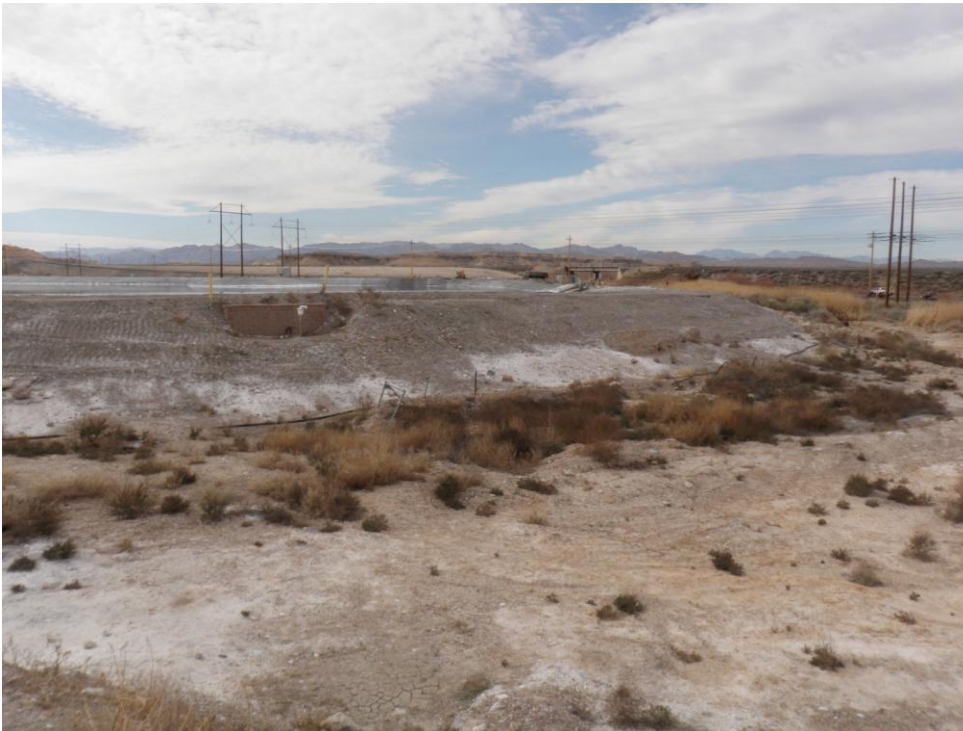
Photo 18: Looking west. Northeast corner of Pond E2.

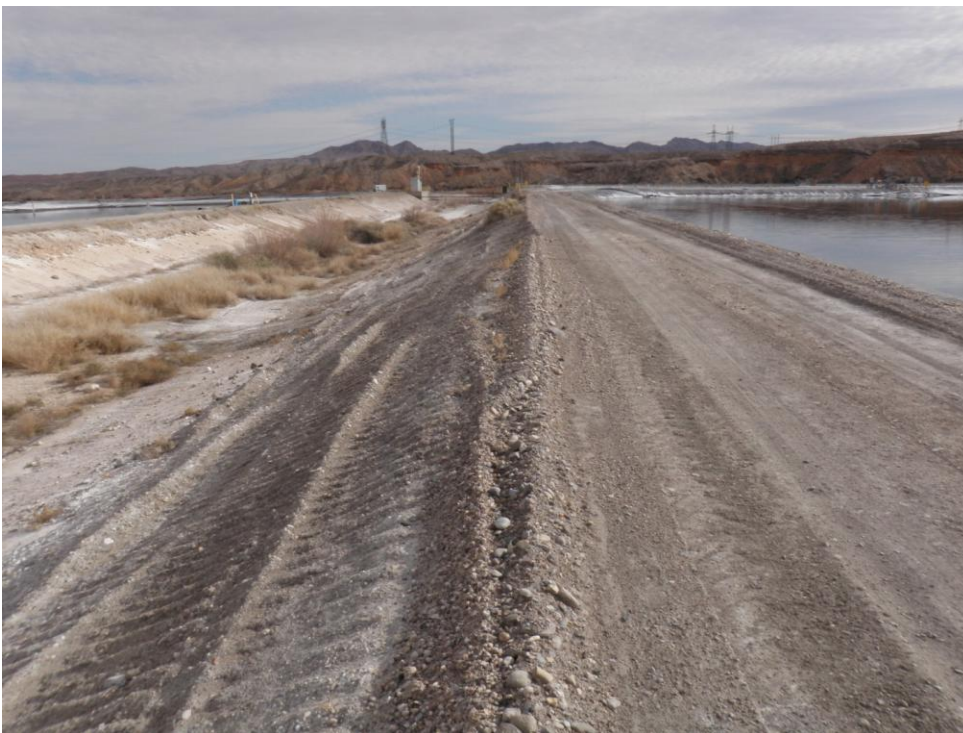
Photo 26: Looking southeast. Pond E2 east dike. Pond F on left.
