Specific Site Assessment for Coal Combustion Waste Impoundments at Reid Gardner Generating Station

**NV Energy
Moapa, Nevada**

September 2011
Project 092885

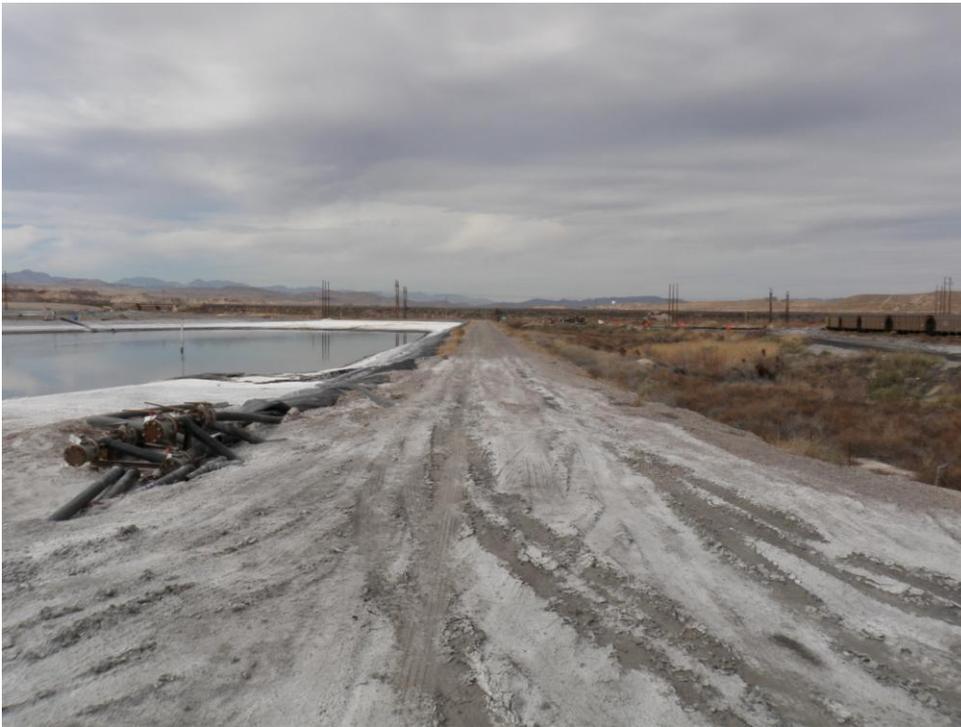
Photo 5: Looking northwest. North dike of Pond F. Muddy River drainage at right.

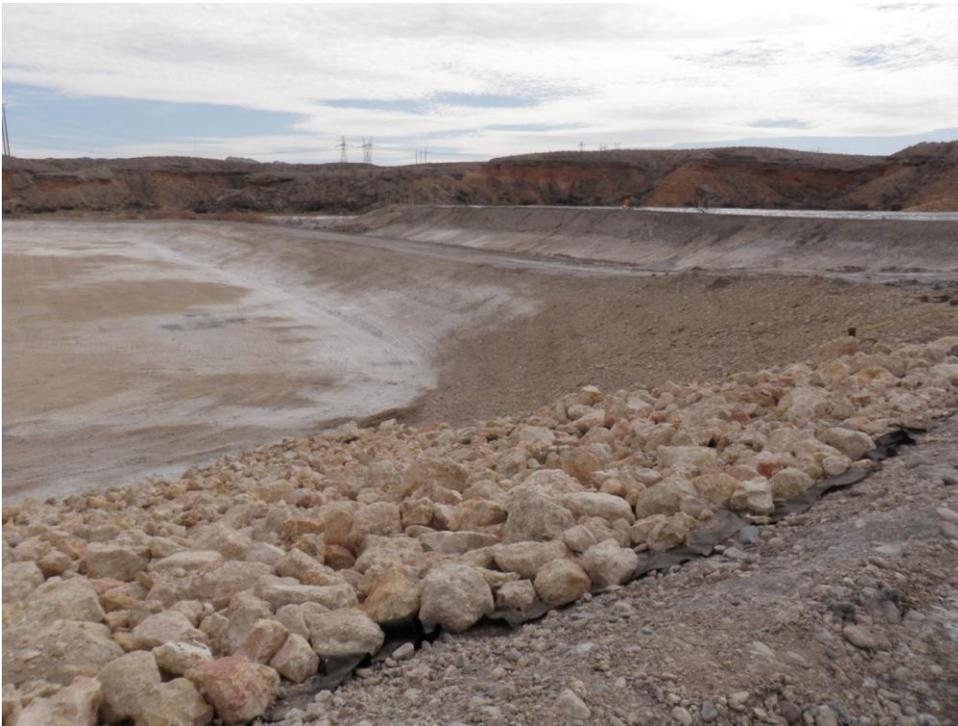
Photo 10: Looking south. Former Pond G. Riprap slope protection and partially removed dike. North dike of Pond E1 at right.

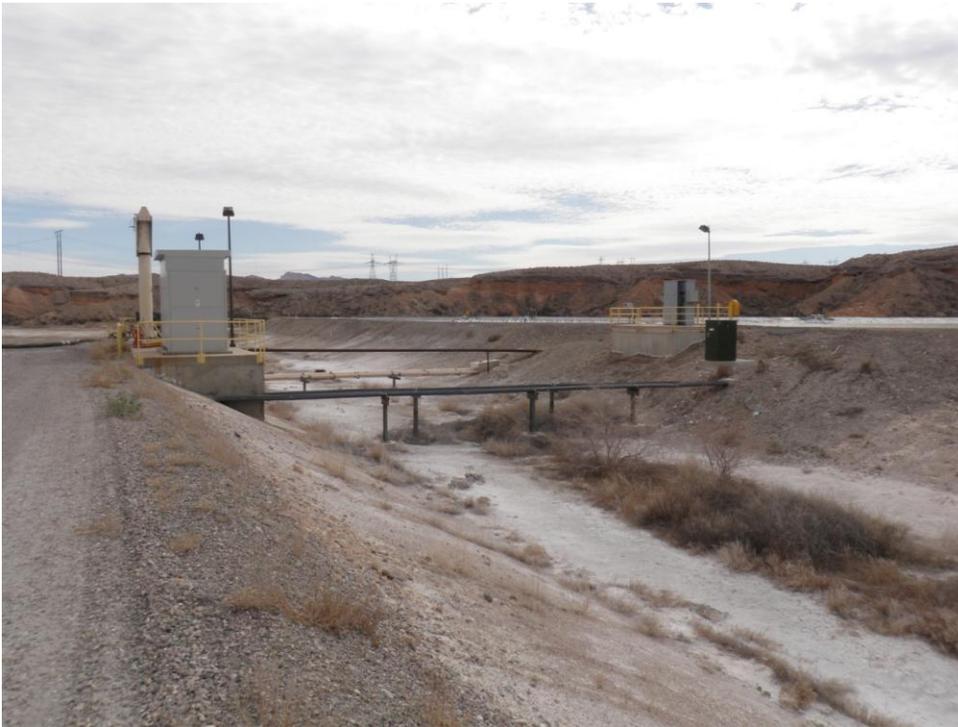
Photo 11: Looking east. From south dike of Pond F. Pumphouse at left and pipes to Ponds E1 and E2. The only pipes in service are the cream colored set in the background near the ground.

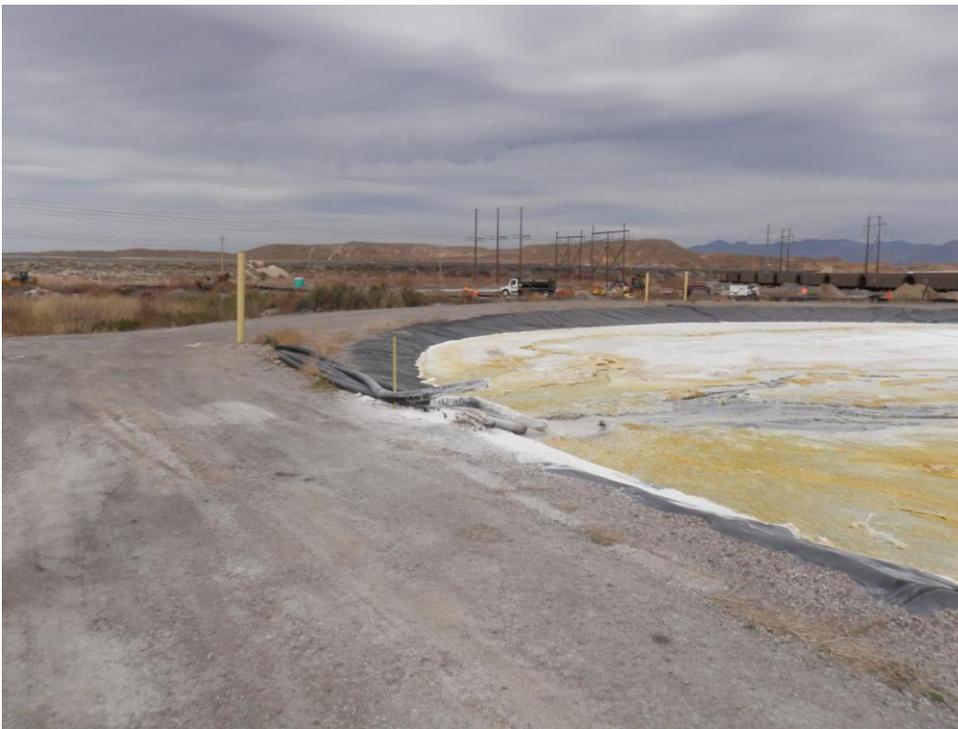
Photo 12: Looking north. Western end of Pond F.

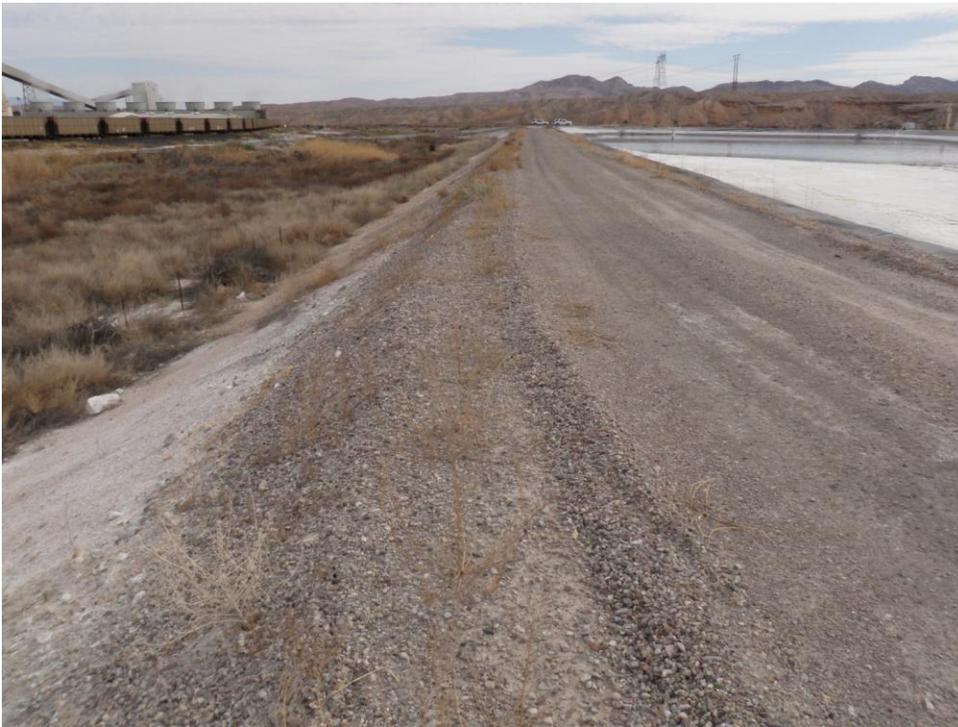
Photo 13: Looking southeast. North dike of Pond F. Typical soil cement slope protection. Muddy River located at left.

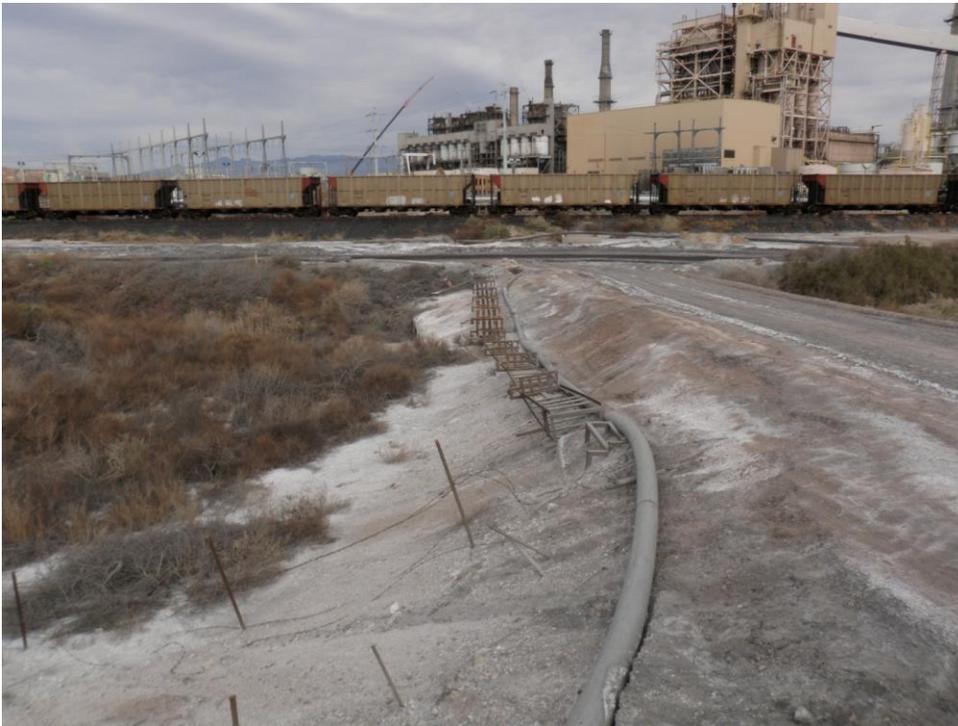
Photo 16: Looking northeast. Piping from Reid Gardner Station to Pond F.

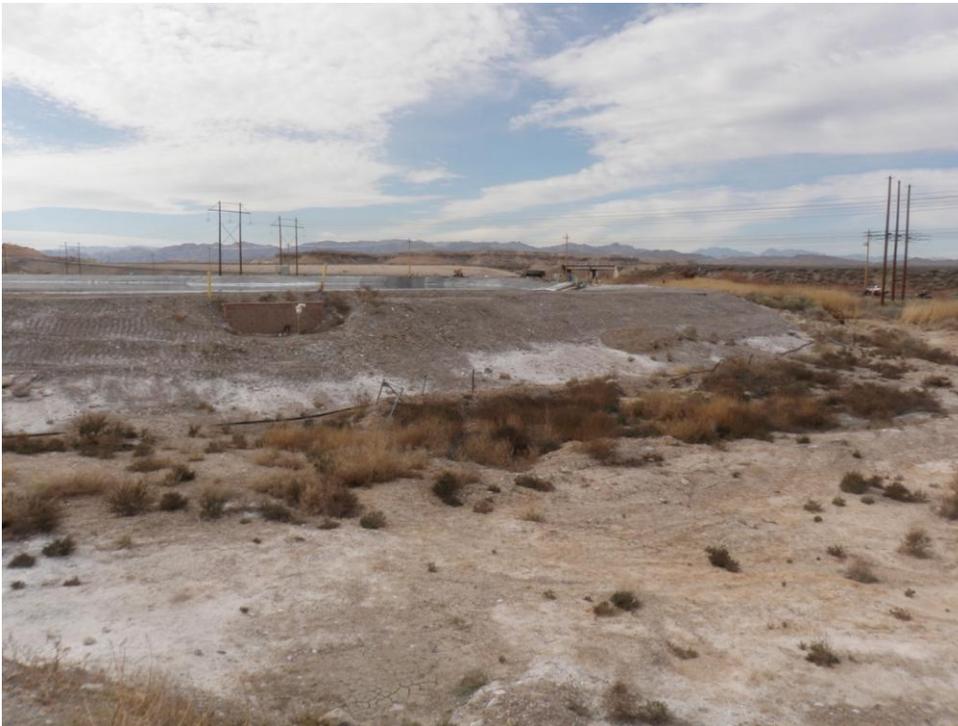
Photo 18: Looking west. Northeast corner of Pond E2.

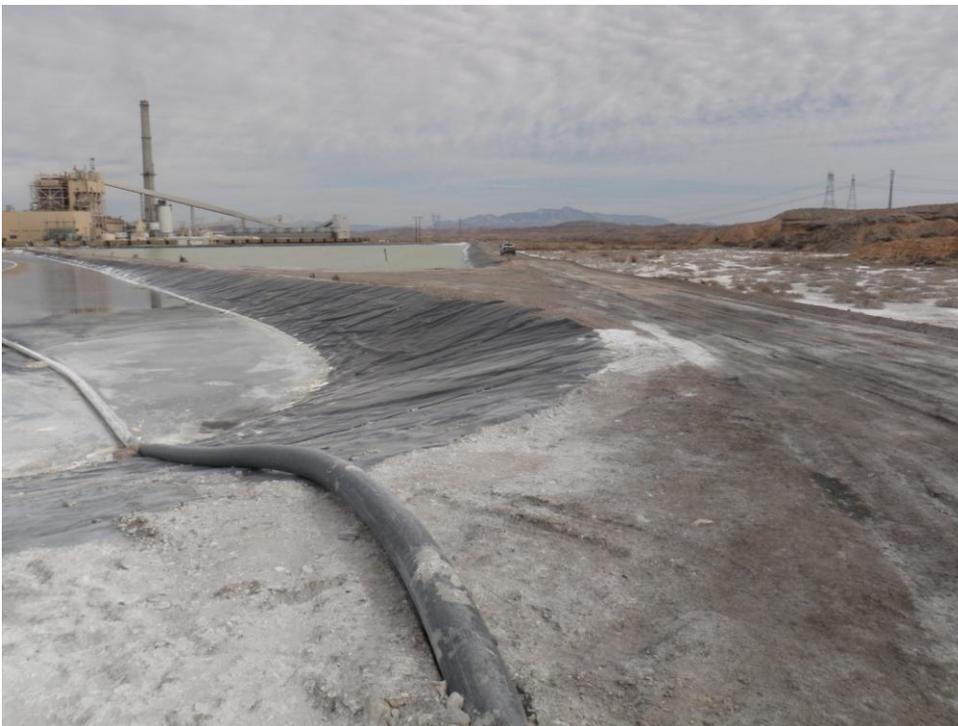
Photo 20: Looking east. Pond E1 in background. Pond E2 with outlet pipe in foreground.

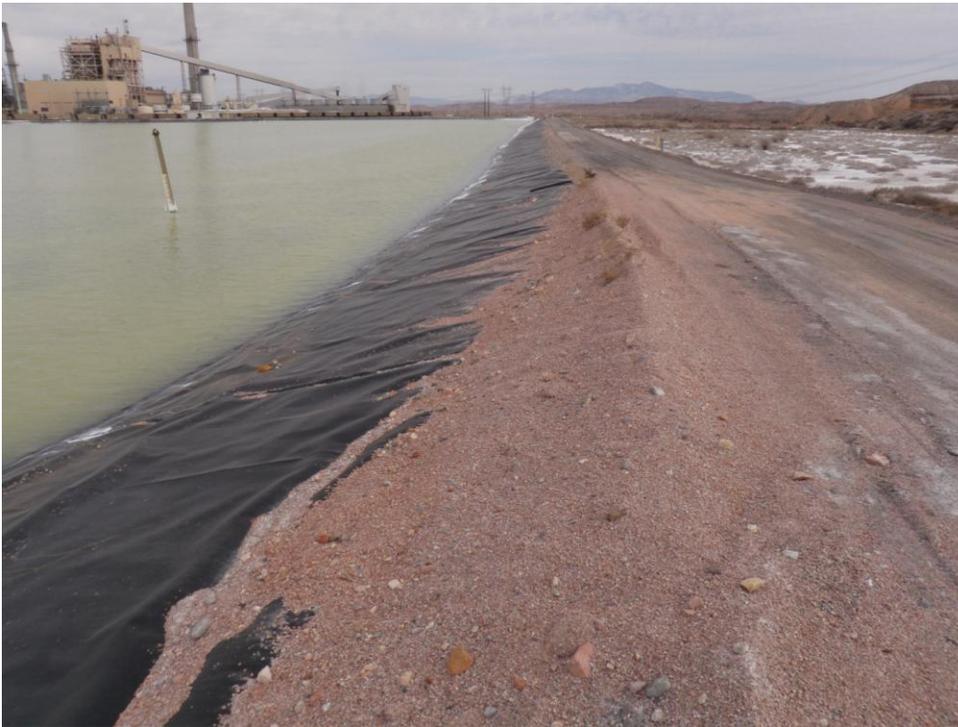
Photo 21: Looking east. Pond E1 south dike - HDPE liner and staff gage.

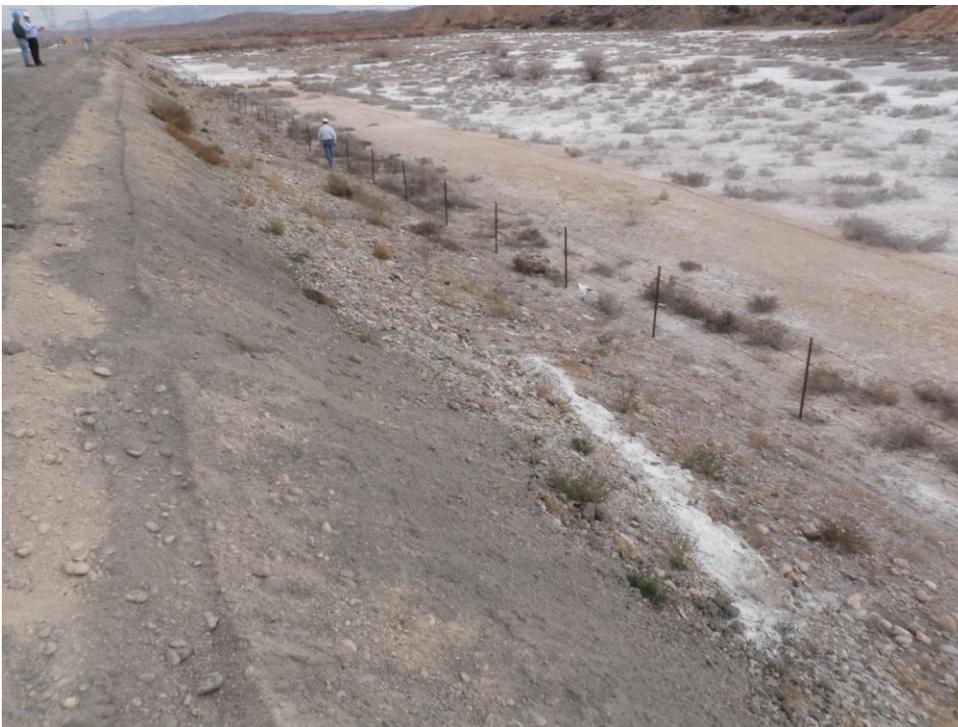
Photo 22: Looking east. Pond E1 south dike.

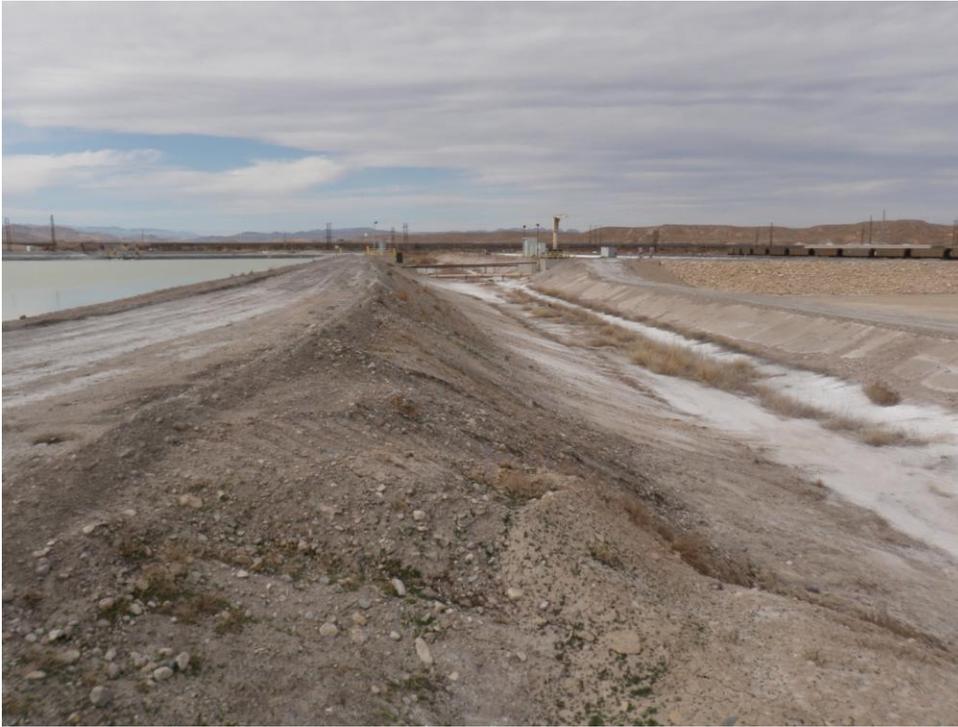
Photo 23: Looking northwest. Pond E1 east dike. Former Pond G on right with partially removed dike and rip rap slope protection on former divider dike with Pond F. Pipes connecting Pond F with Pond E1 in the center-background.

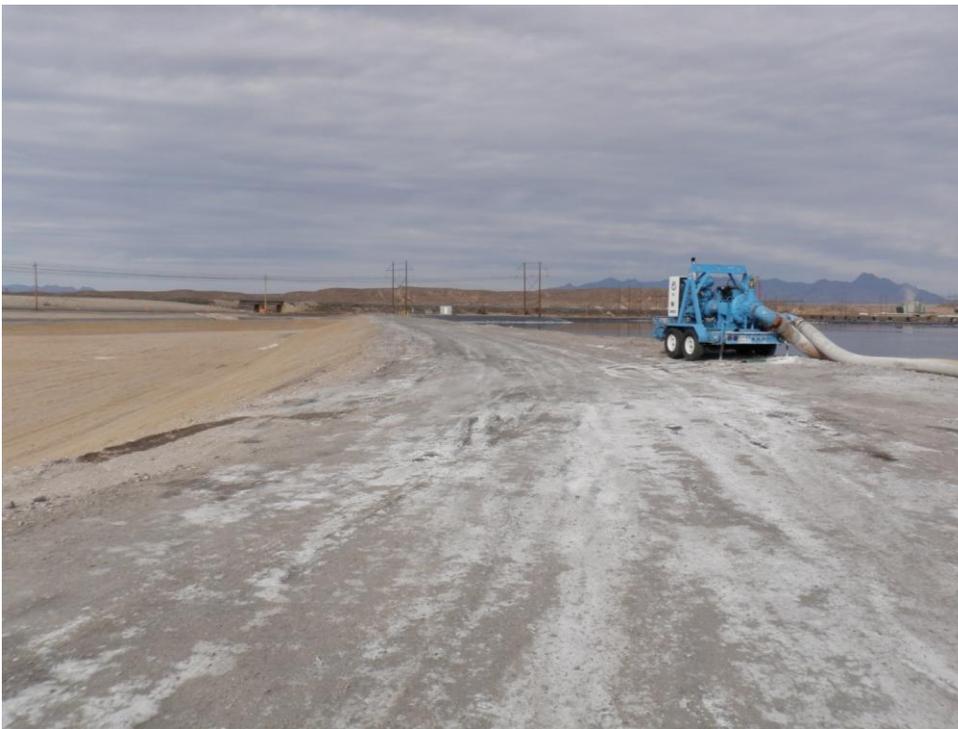
Photo 24: Looking north. Pond E2 west dike. Pond E2 on right. Former Pond D on left.

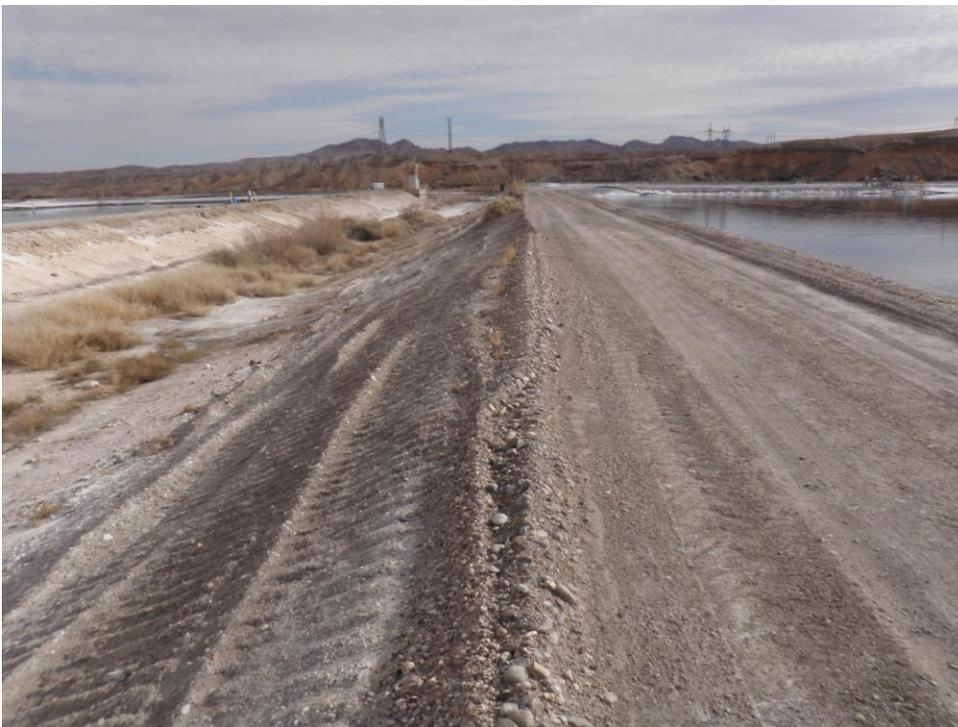
Photo 26: Looking southeast. Pond E2 east dike. Pond F on left.

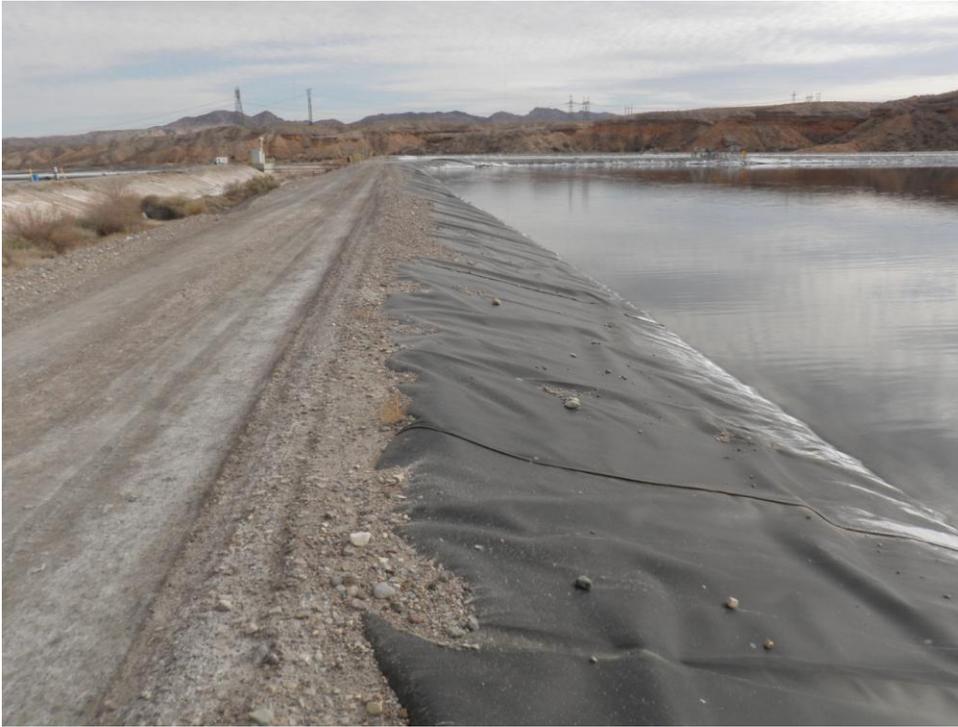
Photo 27: Looking southeast. Pond E2 east dike.

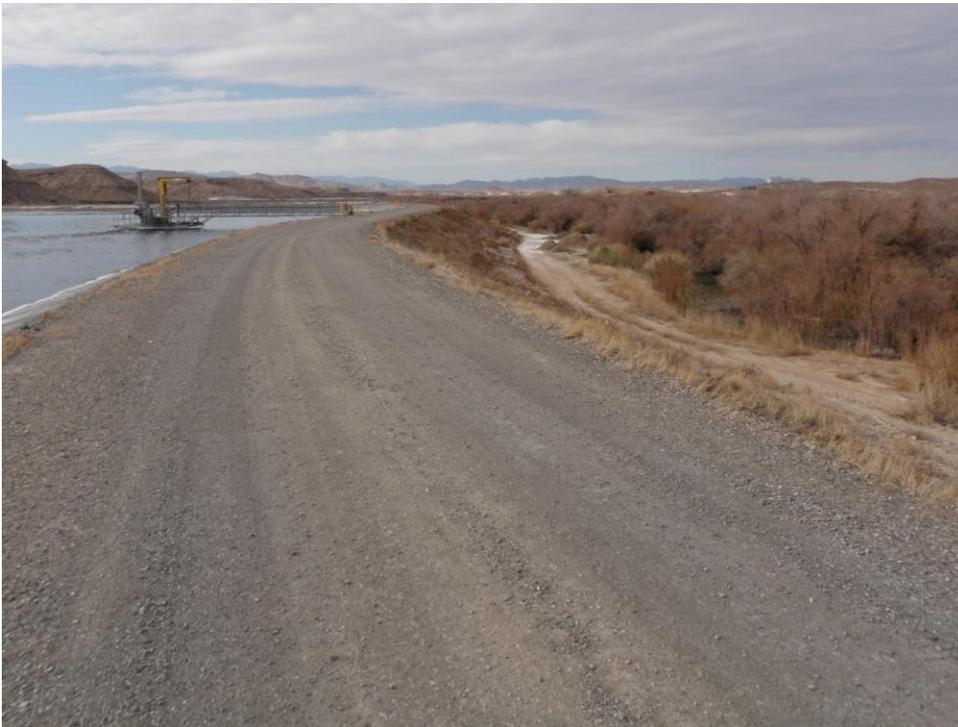
Photo 28: Looking northwest. Pond B1 north dike. Muddy River at right.

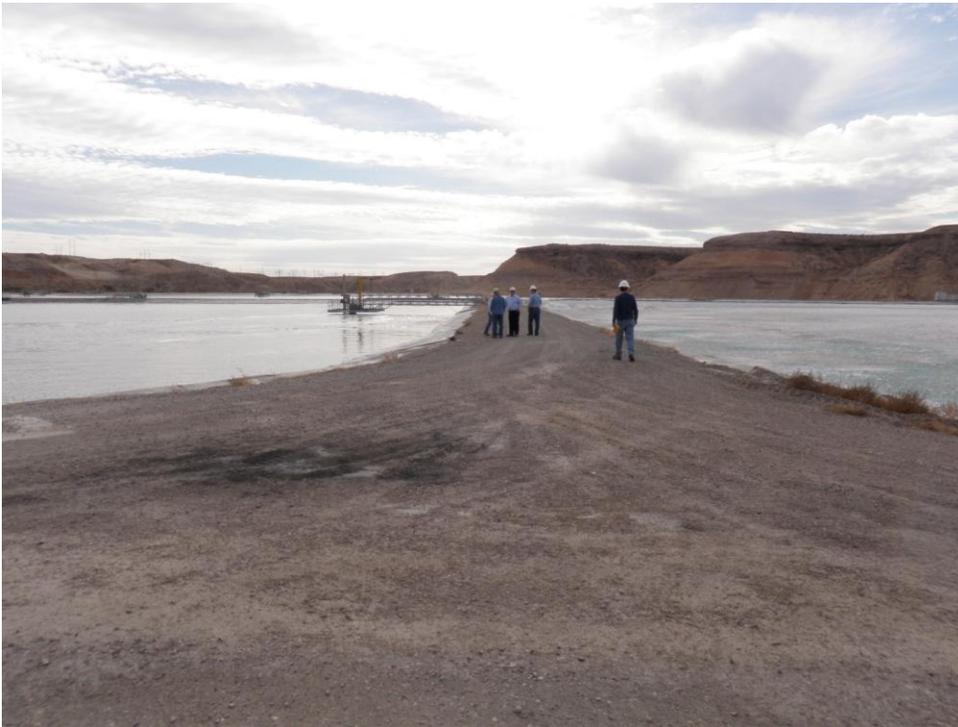
Photo 29: Looking southwest. Divider dike. Pond B1 on left. Pond C1 on right.

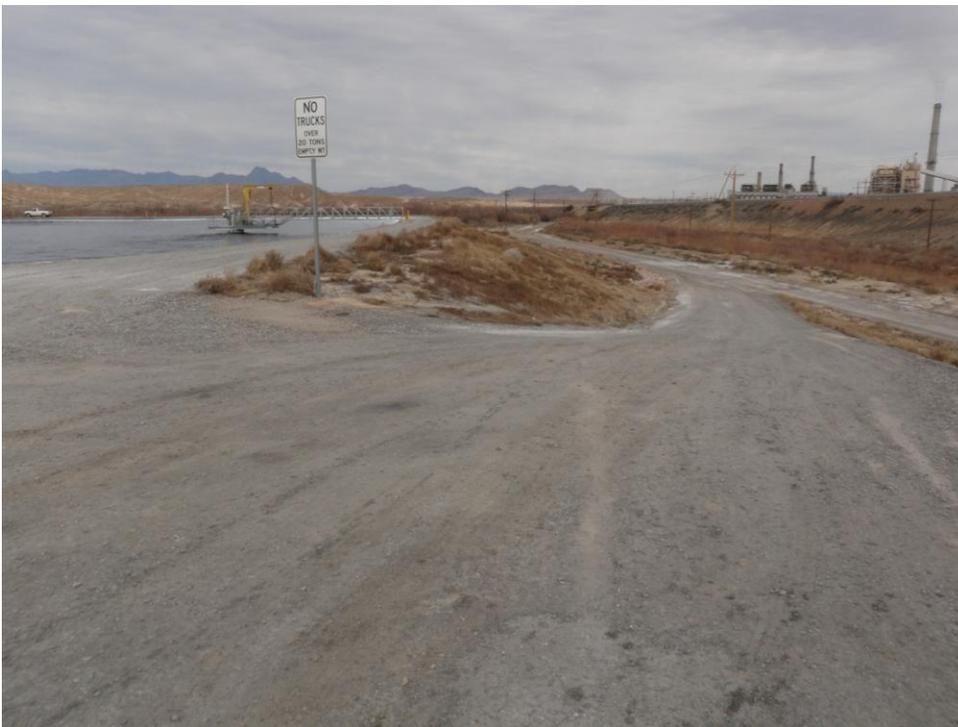
Photo 30: Looking northeast. Pond B1 east dike.

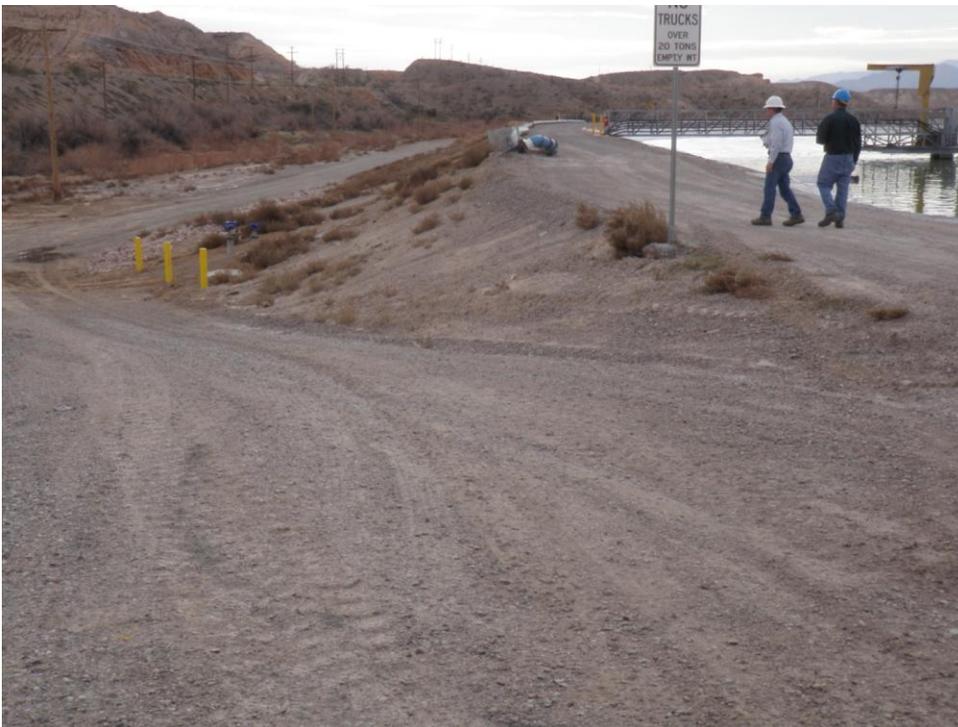
Photo 32: Looking southwest. Pond B2 east dike. Riprap at toe.

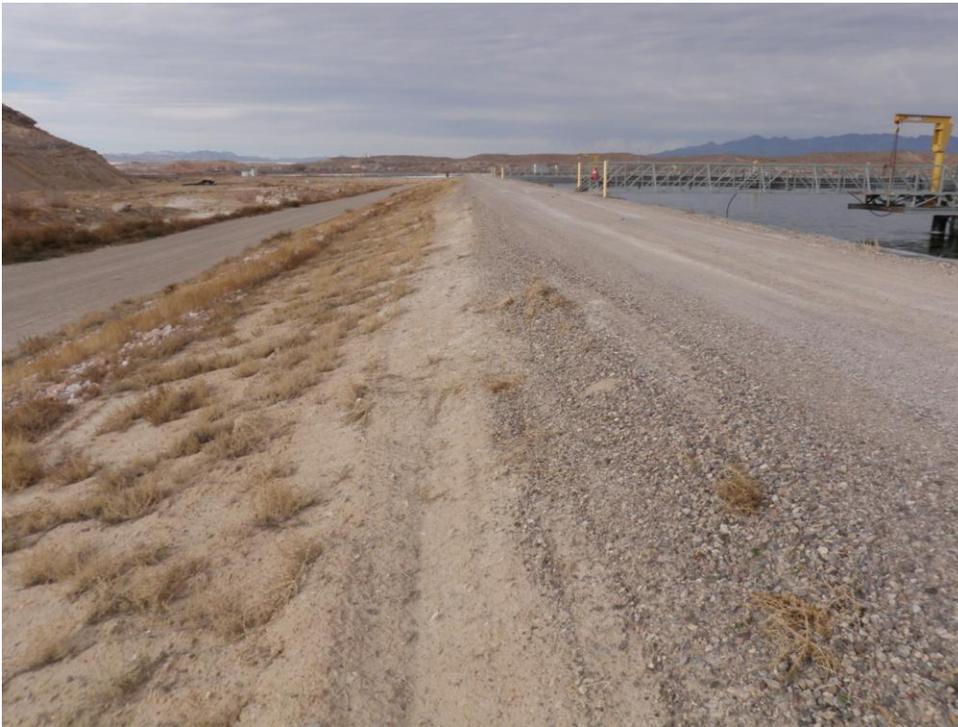
Photo 33: Looking north. Pond B3 west dike.

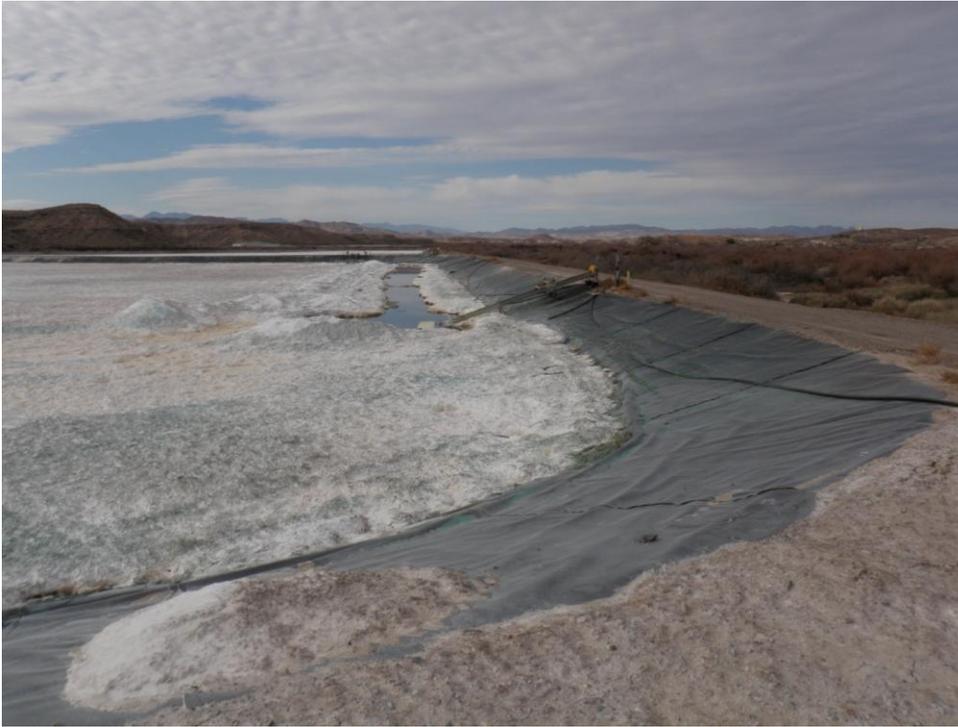
Photo 35: Looking northwest. Pond C1 HDPE liner north dike. Pond C2 in background. Muddy River at right.

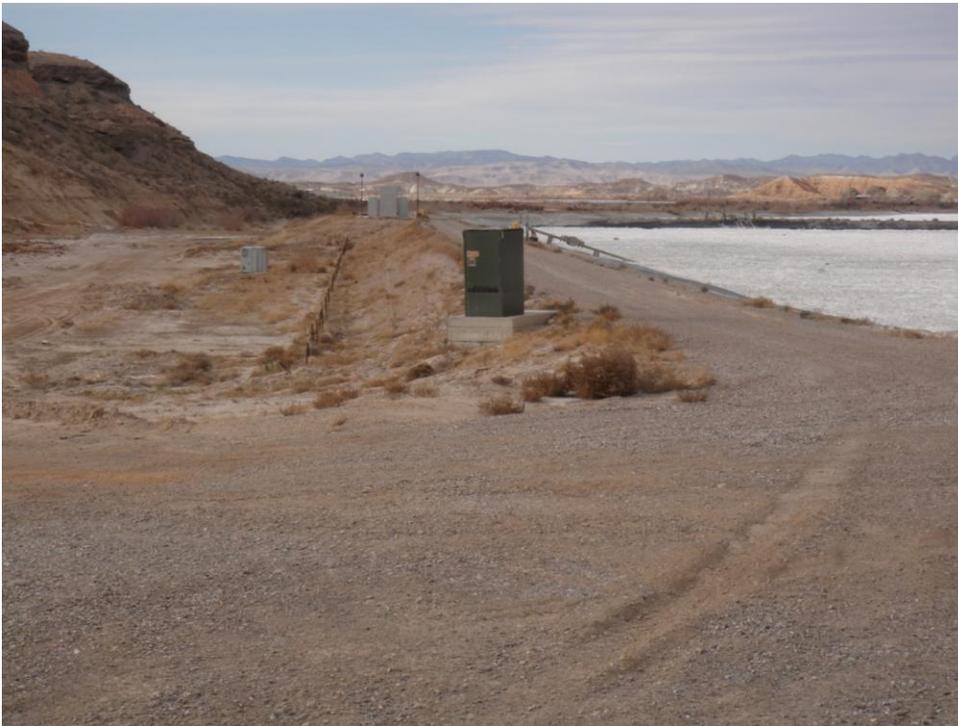
Photo 36: Looking northwest. Pond C1 south dike. Pond C2 in background at the right.

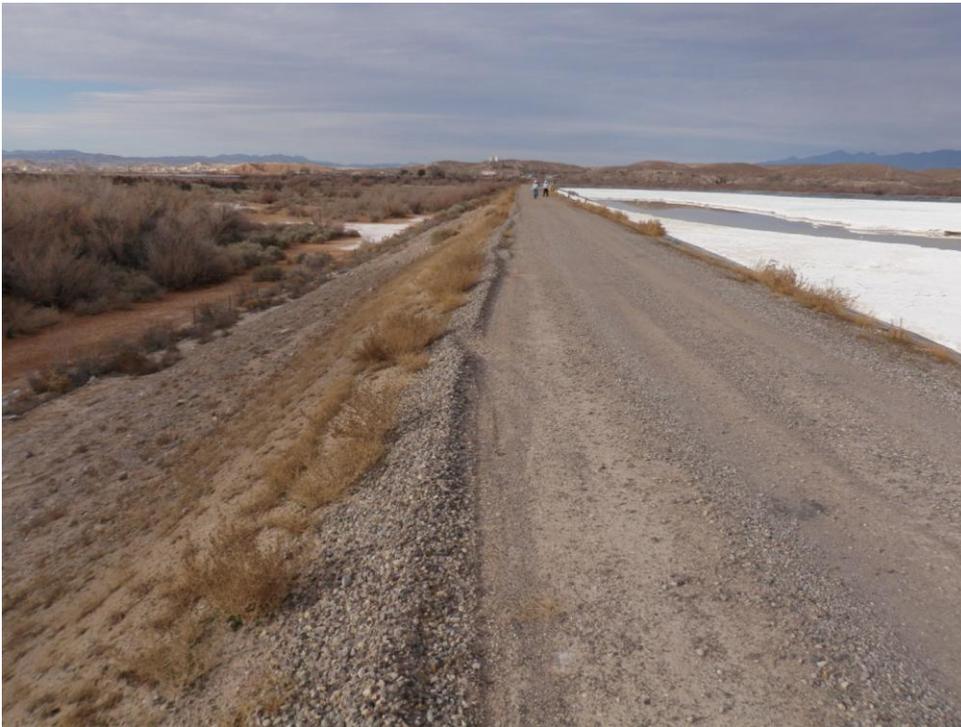
Photo 37: Looking north. Pond C2 west dike. Muddy River at left.

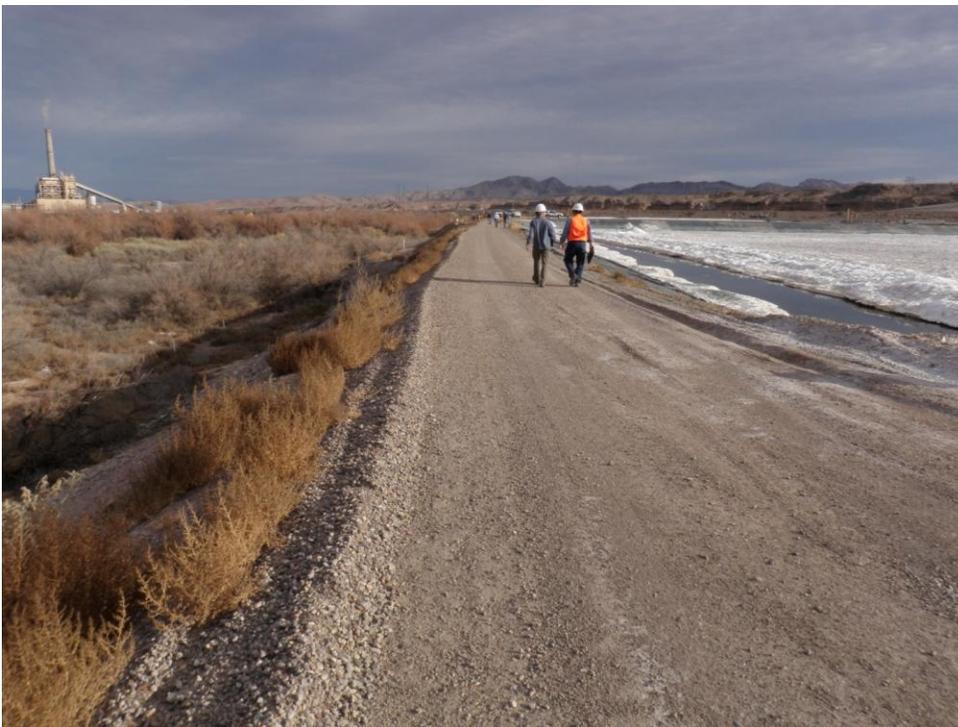
Photo 40: Looking southeast. Pond C1 north dike.

GEI: *"Slightly oversteepened downstream slopes were observed on the north berm of Pond C1 and on the north end of the west berm of C2."*

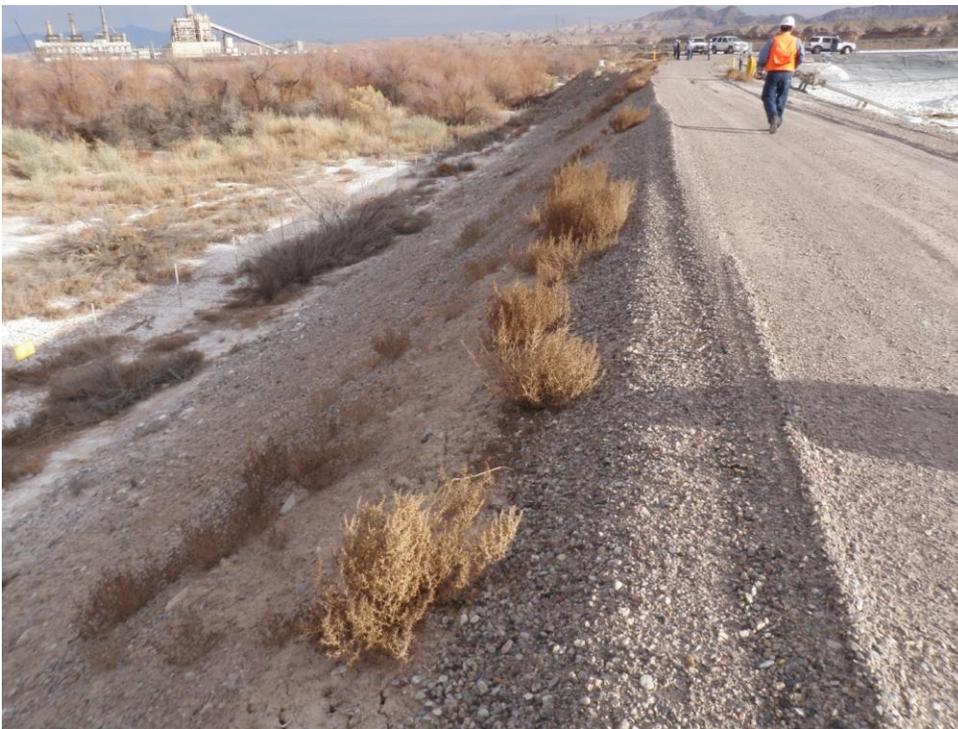
Photo 42: Looking southeast. Pond C1 north dike.
