COAL ASH IMPOUNDMENT  
SITE ASSESSMENT DRAFT REPORT

Coy Station  
Ottawa Oil Power Company  
Beulah, North Dakota

KLEINFELDER PROJECT NUMBER 118953-3

June 26, 2011

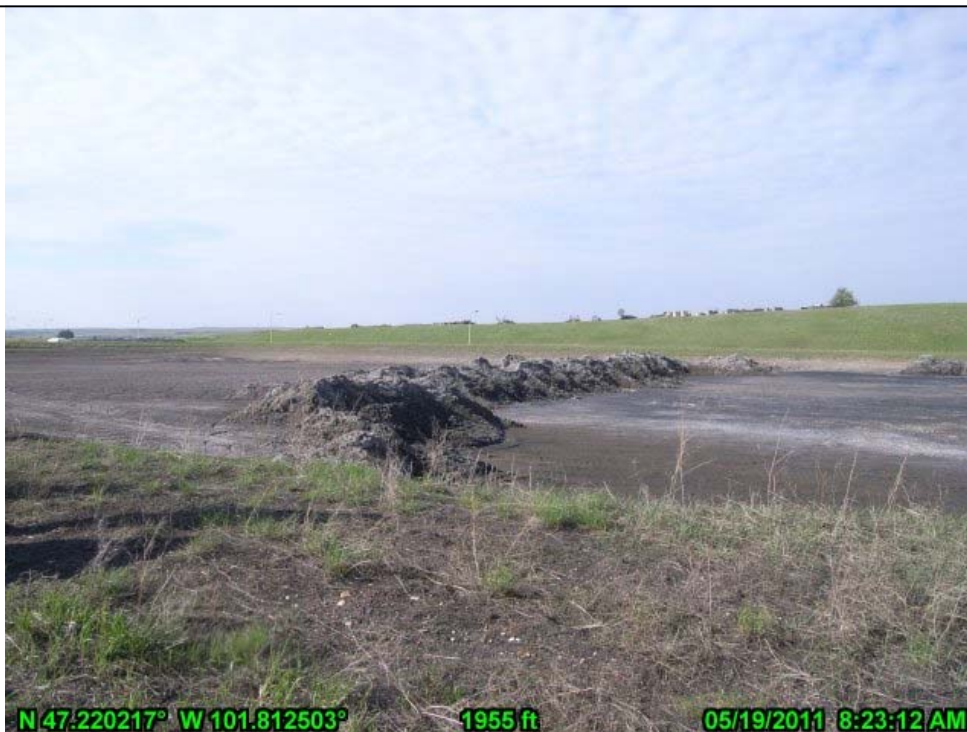
3-Nelson Pond Dredging Activity (looking SW)

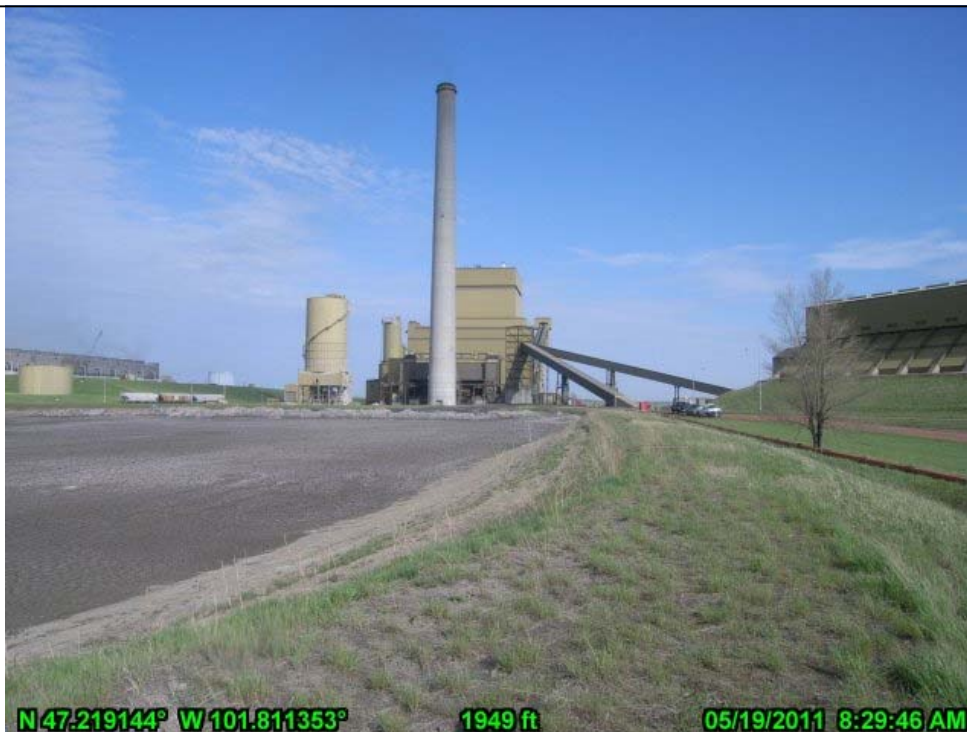
Overall, the upstream slope of the impoundment was in Satisfactory condition. Photos 1, 3, 7, 15, 21, and 22 show the conditions of the upstream slope. Specific observations include:

Overall, the crest of the impoundment was in Satisfactory condition. Photos 1, 2, 7, 15, 19, 21, and 22 show the condition of the crest. Specific observations include:

7-Nelson Pond Northeast Waterside Embankment (looking NW)

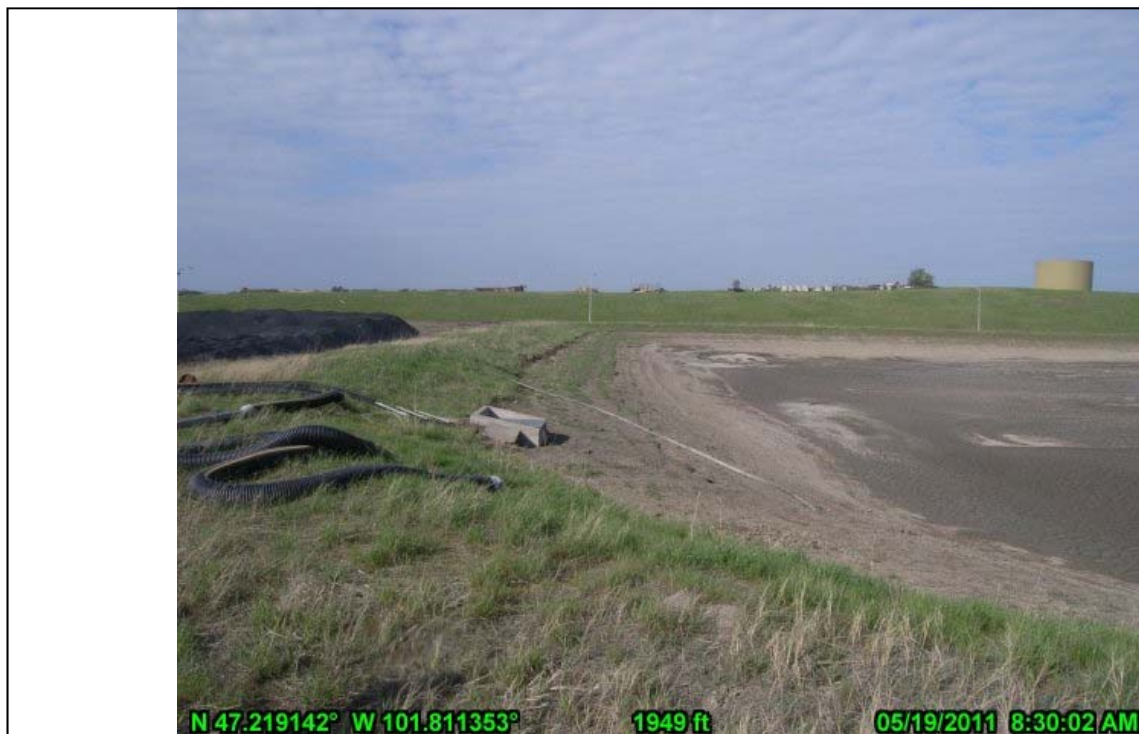
15-Nelson Pond South Waterside Embankment with Overflow Inlet Structure (looking SW)

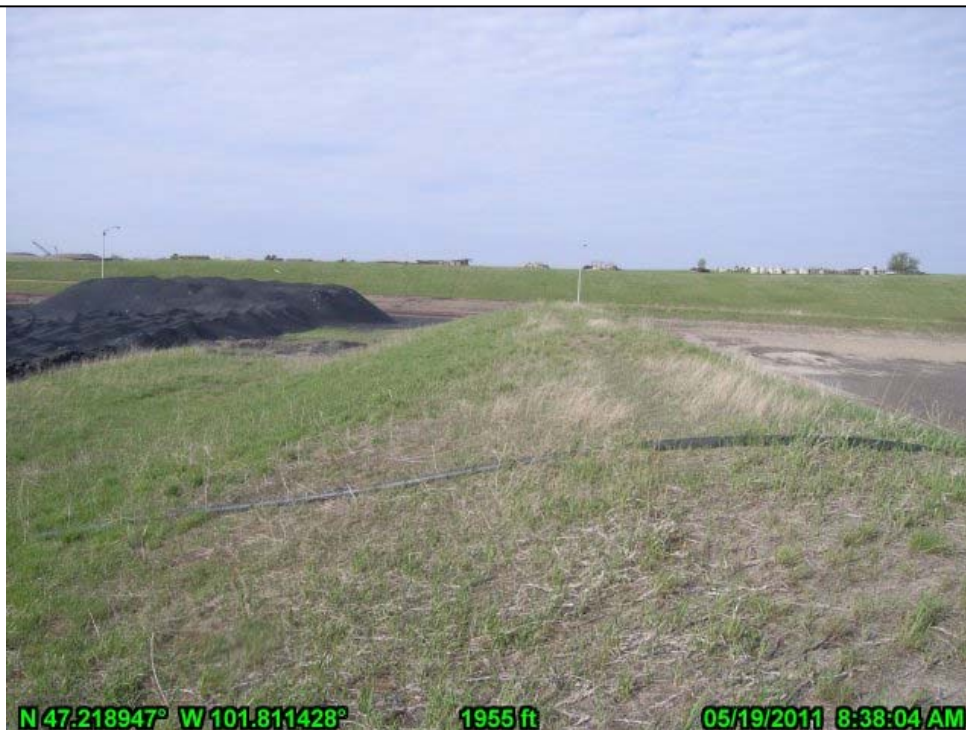
Overall, the downstream slope was in Satisfactory condition. Photos 5, 8, 19, 22, 23, and 25 show the condition of the downstream slope. Specific observations include:

The toe areas of the embankment were in Satisfactory condition. See photos 5, 8, 19, 23, 24, and 25 for the condition of these areas. Key features and observations of these areas include:

19-Nelson Pond Southeast Landside Embankment (looking SW)

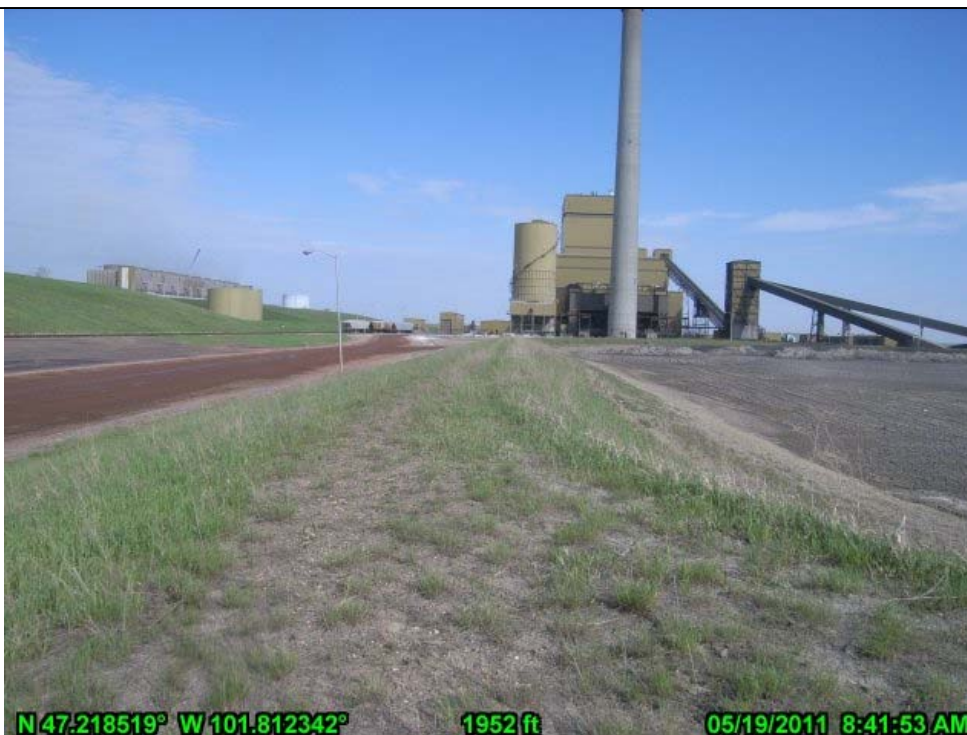
22-Nelson Pond Southwest Embankment Crest (looking NW)

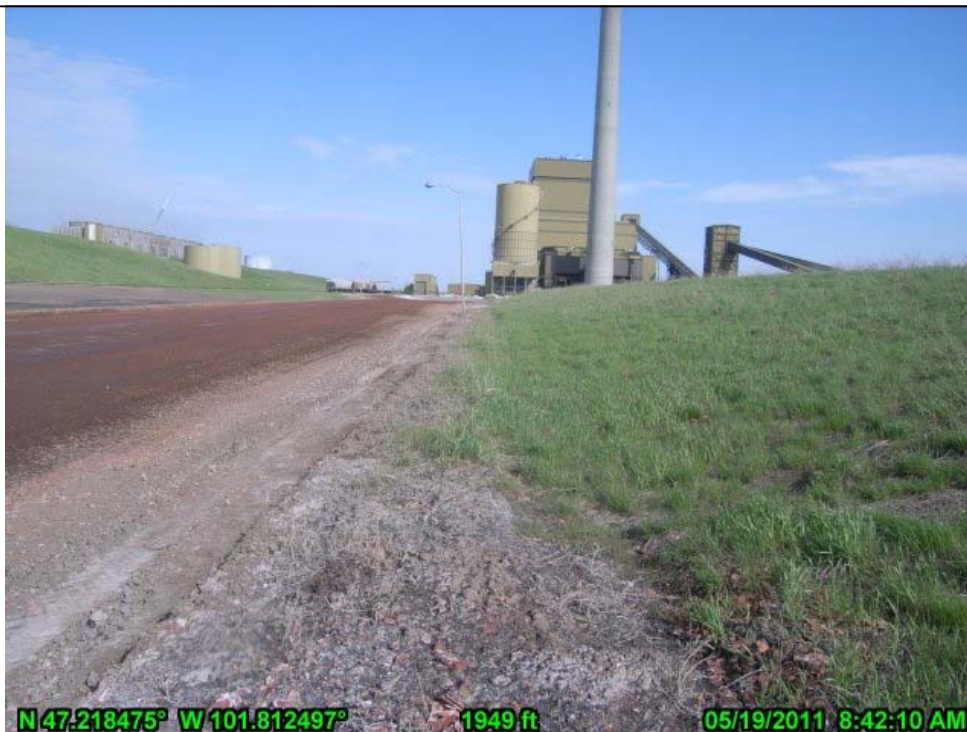
23-Nelson Pond Southwest Landside Embankment (looking NW)

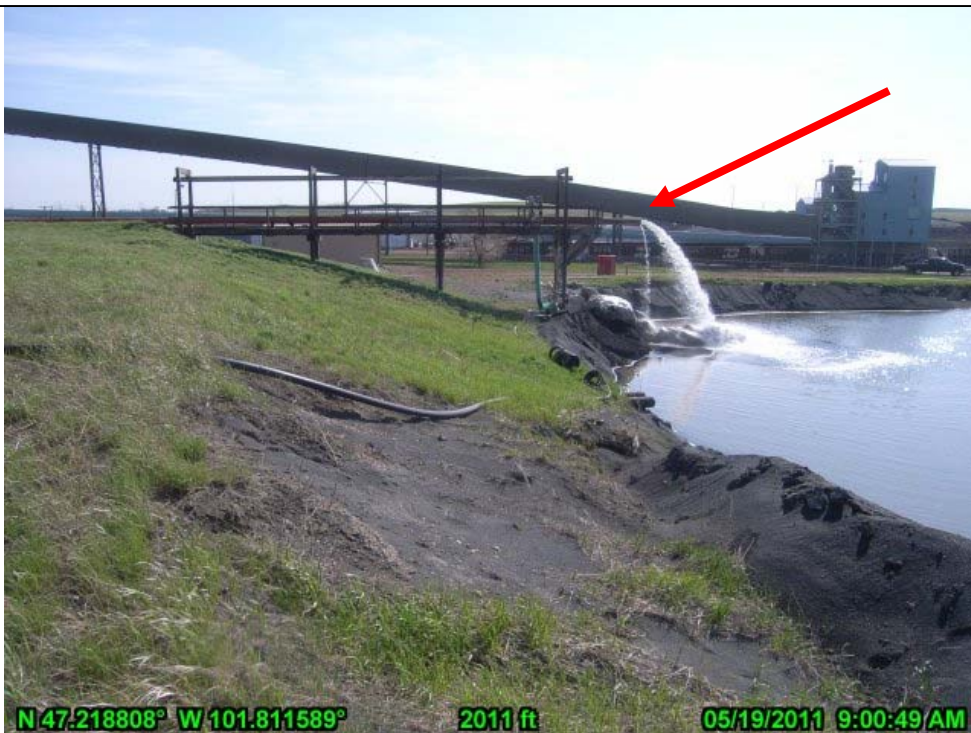
Overall, the upstream slopes of the incised pond were in Fair condition. Photos 28 through 34 show the condition of the upstream slope within the pond. The eastern side of the pond is also an access road for mining trucks, and because the pond is constructed on sloping land, the east side is primarily incised with roadway embankment. Specific observations include:

Overall, the crest of the pond perimeter was in Fair condition. Photos 28 through 34 also show the condition of the perimeter crest. Specific observations include:

- Much of the perimeter crest also serves as an access road.
- No major depressions, erosion, or rutting was noted on the pond crest.
- A trestle structure supports the sluice pipe entering the west side of the pond, as shown in photos 28 and 32.

28-Sluice Pond Inlet and Northwest Waterside Embankment (looking NE)

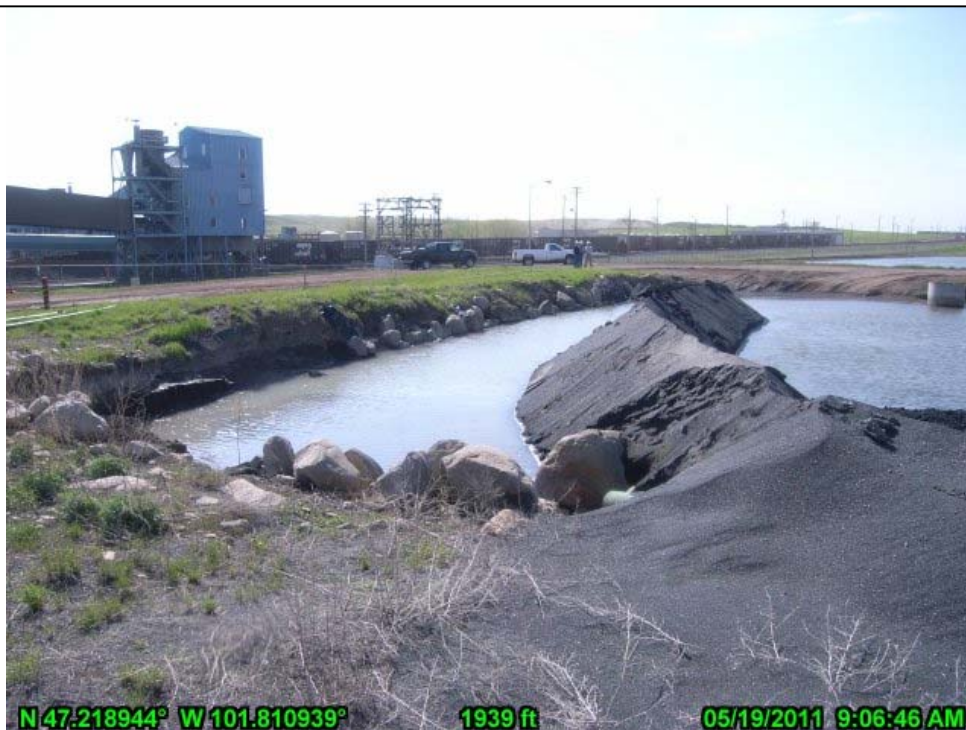
31-Sluice Pond Economizer Inlet Channel (looking SE)

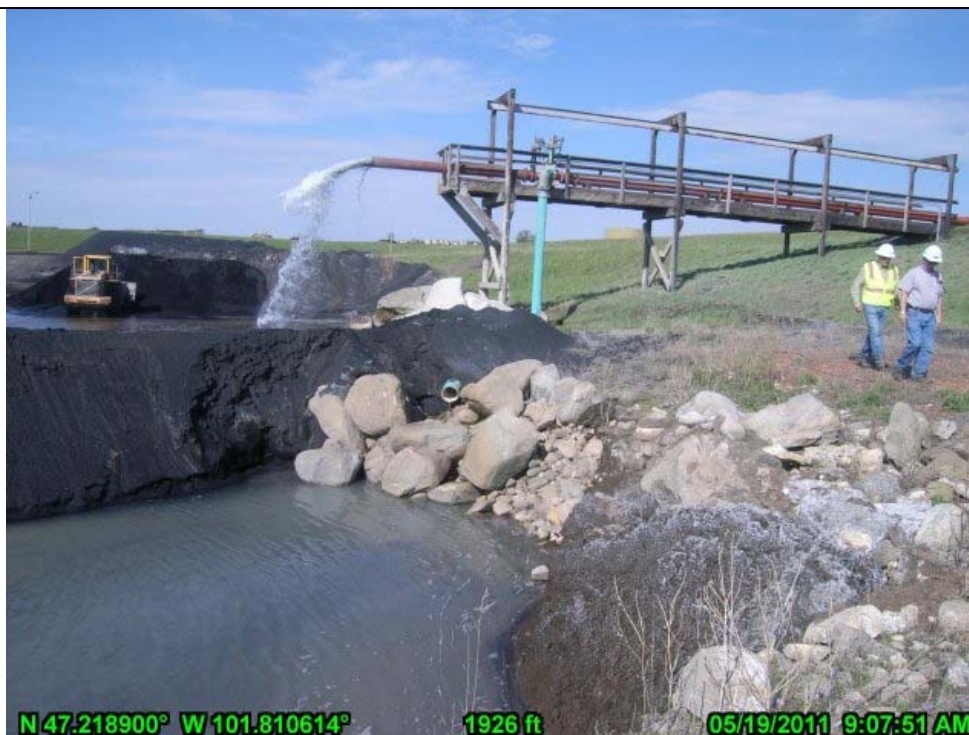
32-Sluice Pond Slag Inlet (red pipe) and Economizer Inlet (green pipe)

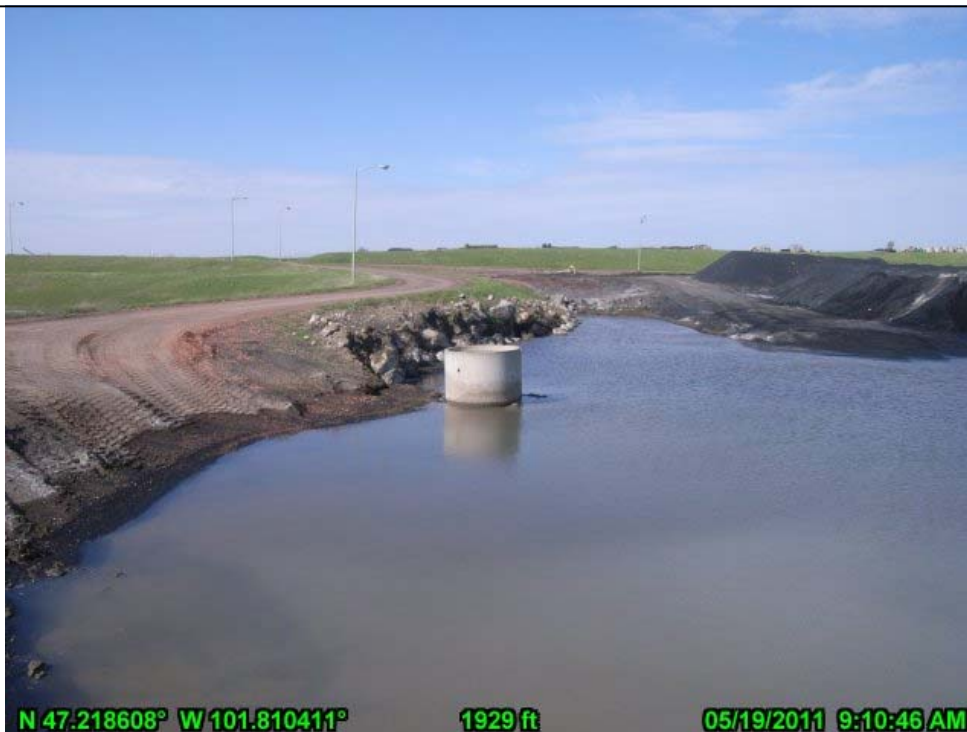
33-Sluice Pond and Original Outlet Intake (looking SW)

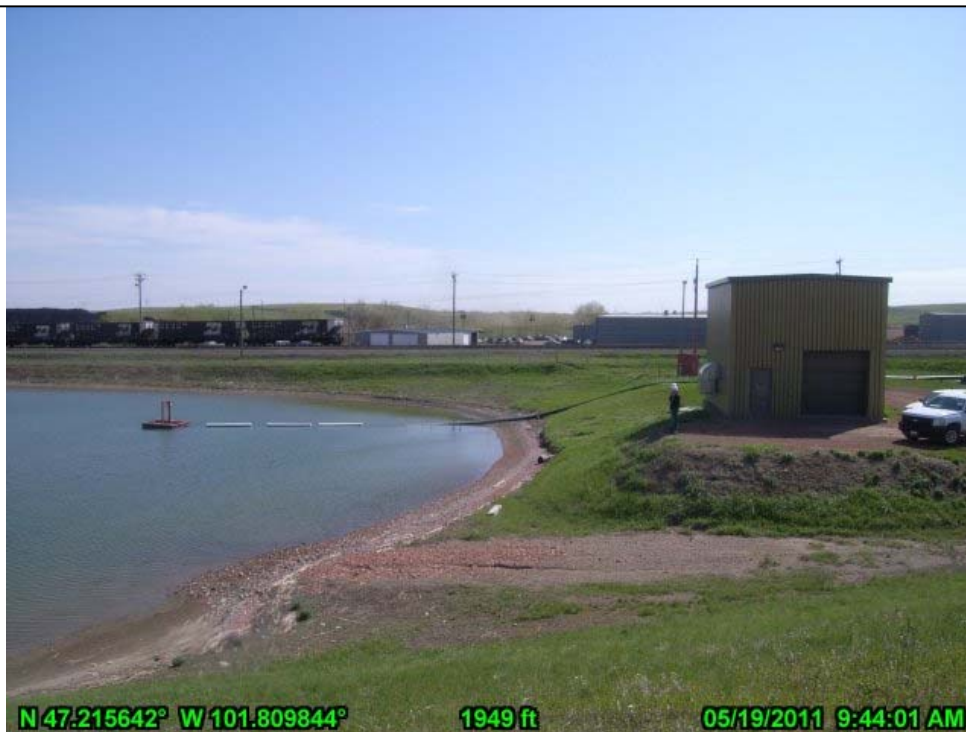
The Ash Pond is almost completely incised. Overall, the upstream slope of the pond is in fair condition. Photos 39, 40, and 42 through 46 show the conditions of the upstream slope. Specific observations include:

43-Ash Pond South Waterside Embankment and Pump Station (looking E)

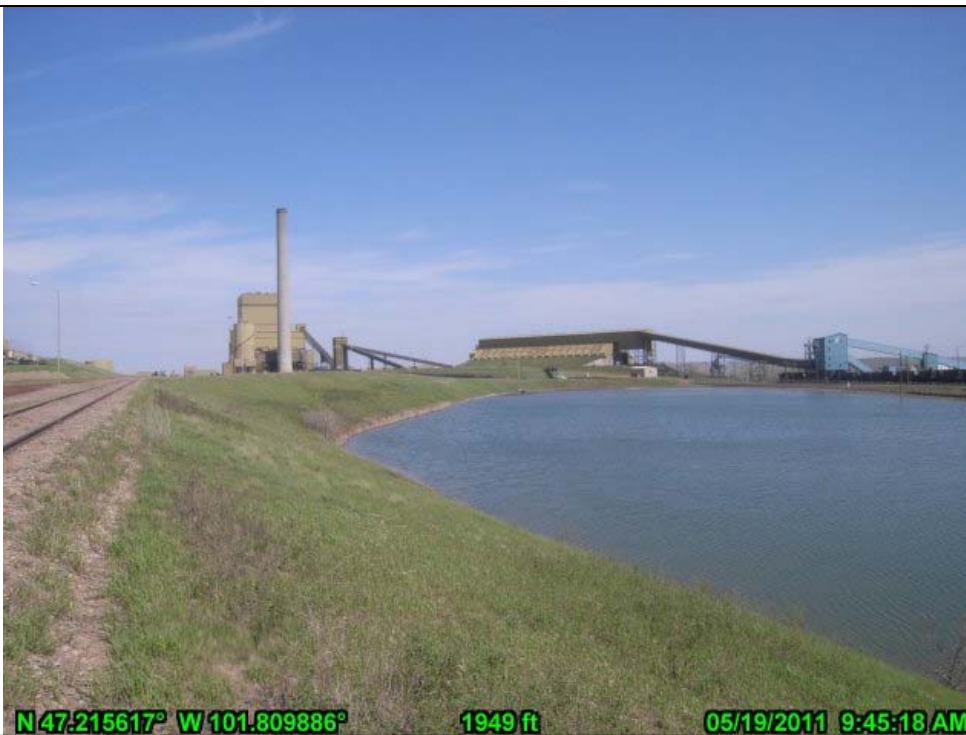
44-Ash Pond West Waterside Incised Embankment (looking N)

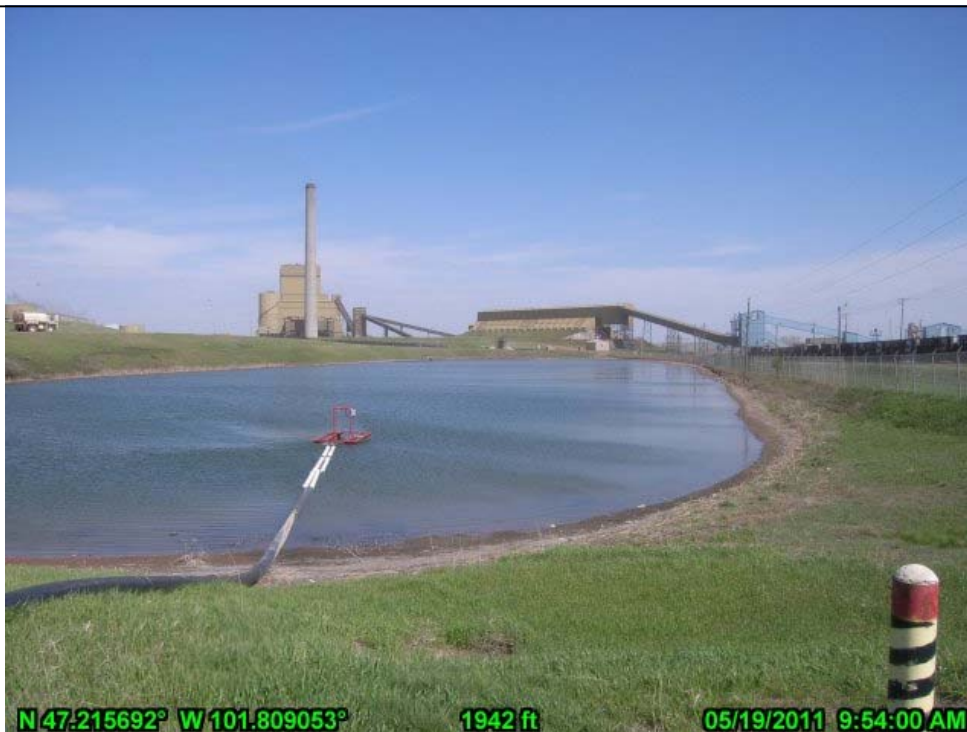
45-Ash Pond East Waterside Incised Embankment (looking N)

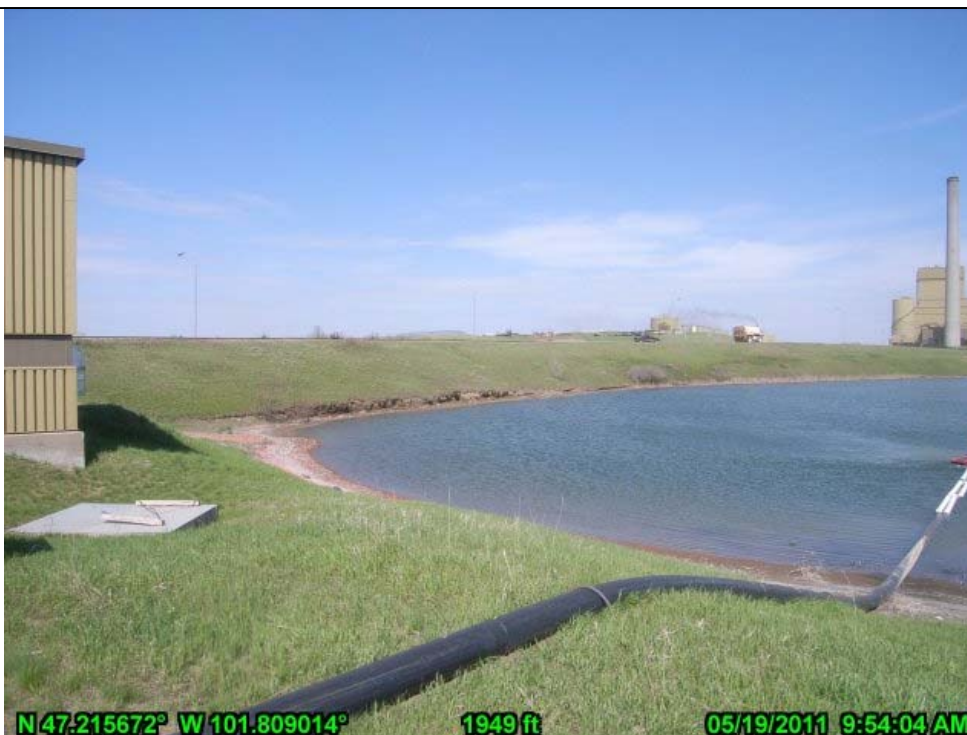
46-Ash Pond West Waterside Incised Embankment (looking NW)
