**COAL ASH IMPOUNDMENT
SITE ASSESSMENT FINAL REPORT**

**Coyote Station
Otter Tail Power Company, Montana-
Dakota Utilities, Co., Northern
Municipal Power Agency, and
NorthWestern Energy**

KLEINFELDER PROJECT NUMBER 118953-3

February 28, 2013

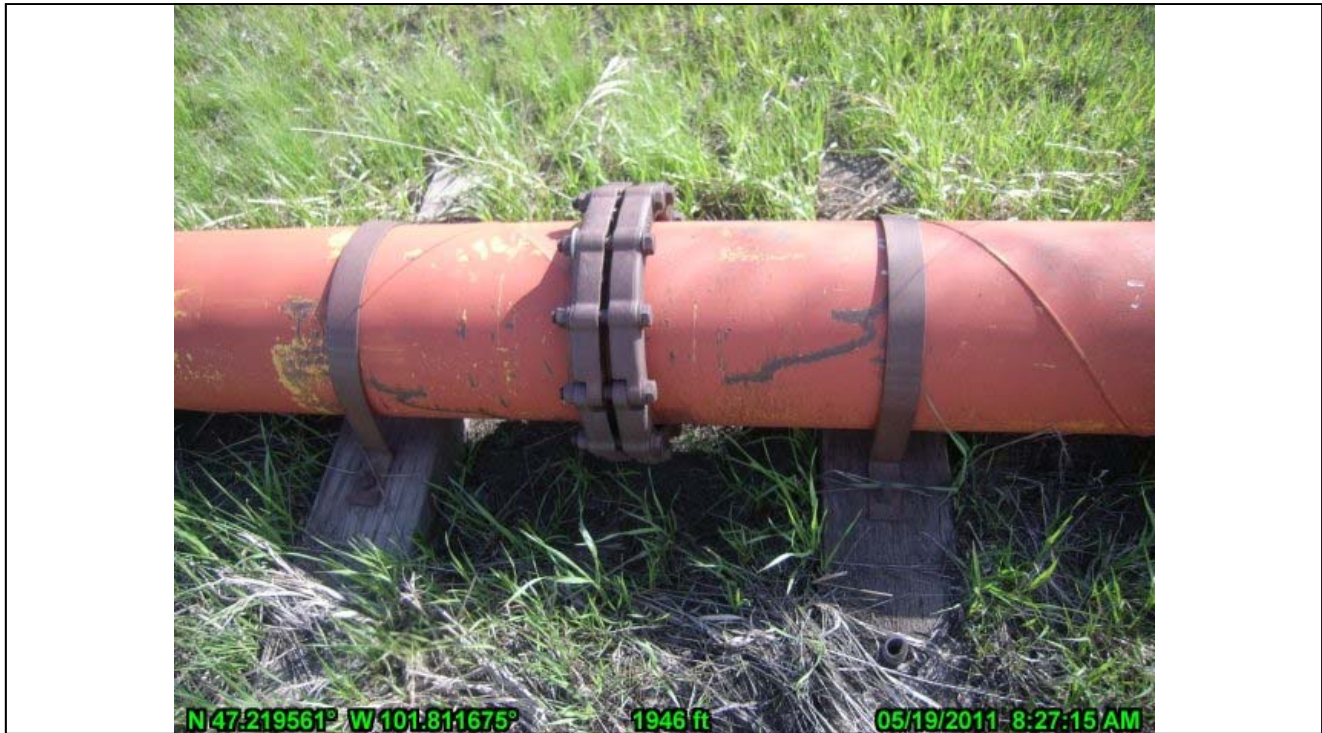
5-Nelsen Pond Northeast Landside Embankment and Sluice Pipe (looking SE)

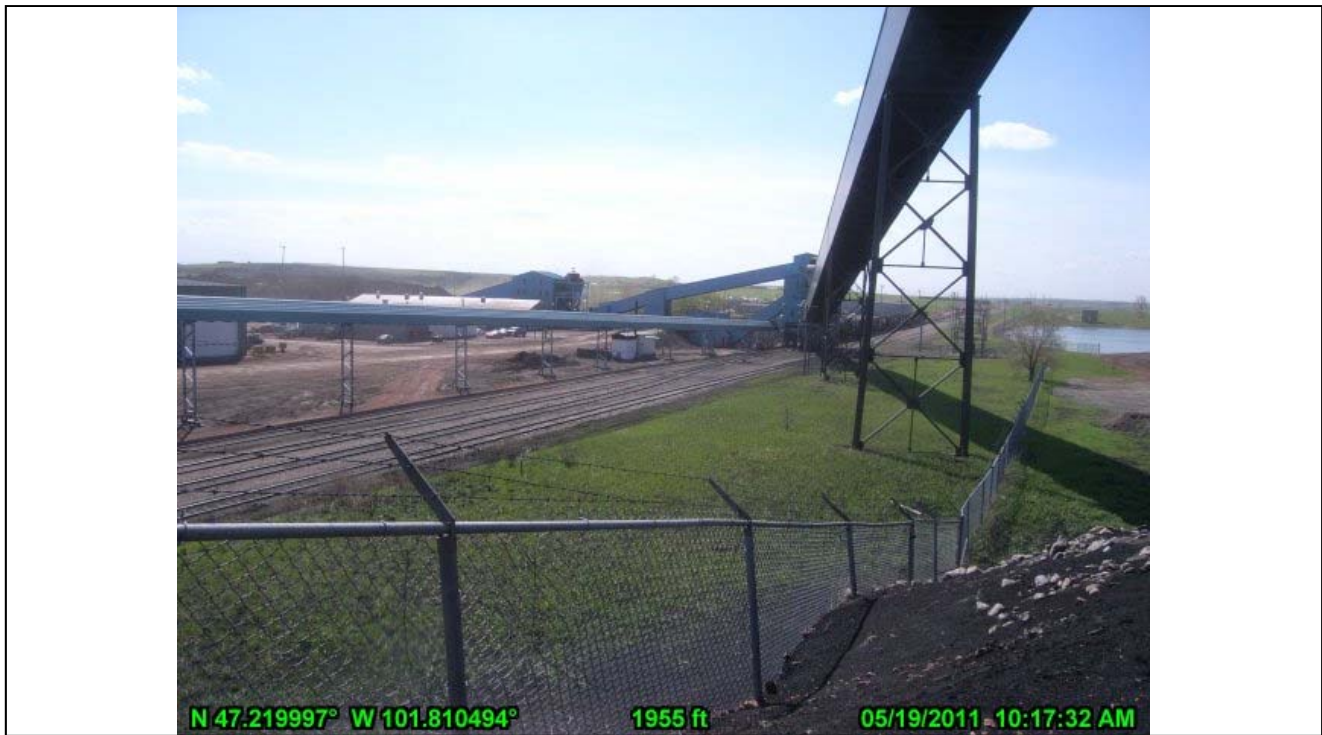
12-Continued Down Gradient Railroad Adjacent to the Nelsen Pond (looking S)

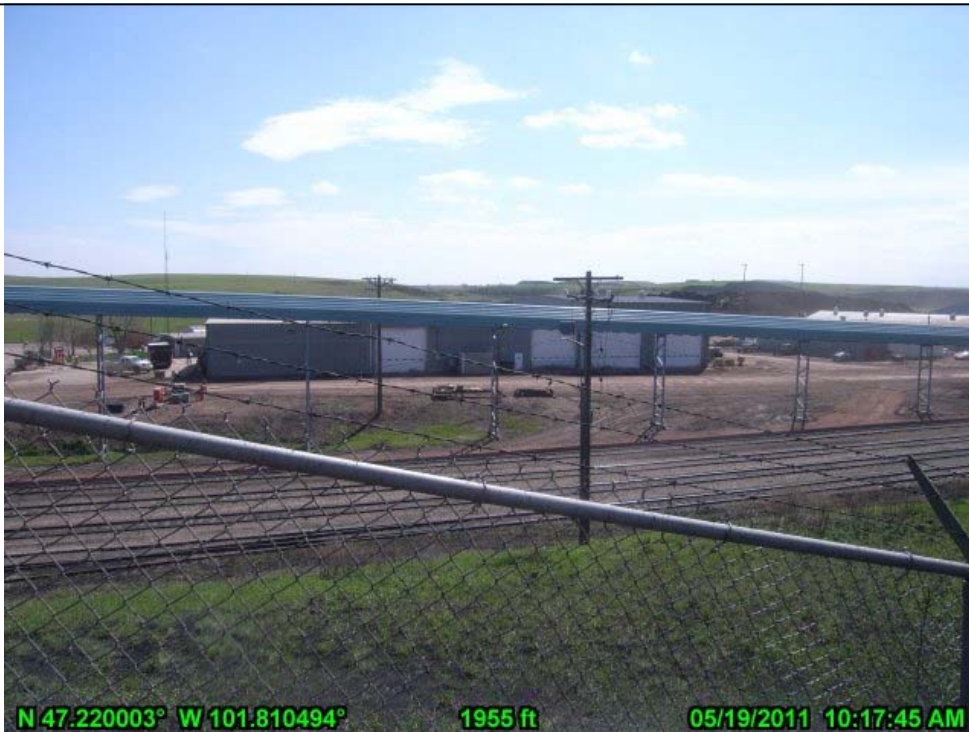
13-Continued Down Gradient Railroad Adjacent to the Nelsen Pond (looking SE)

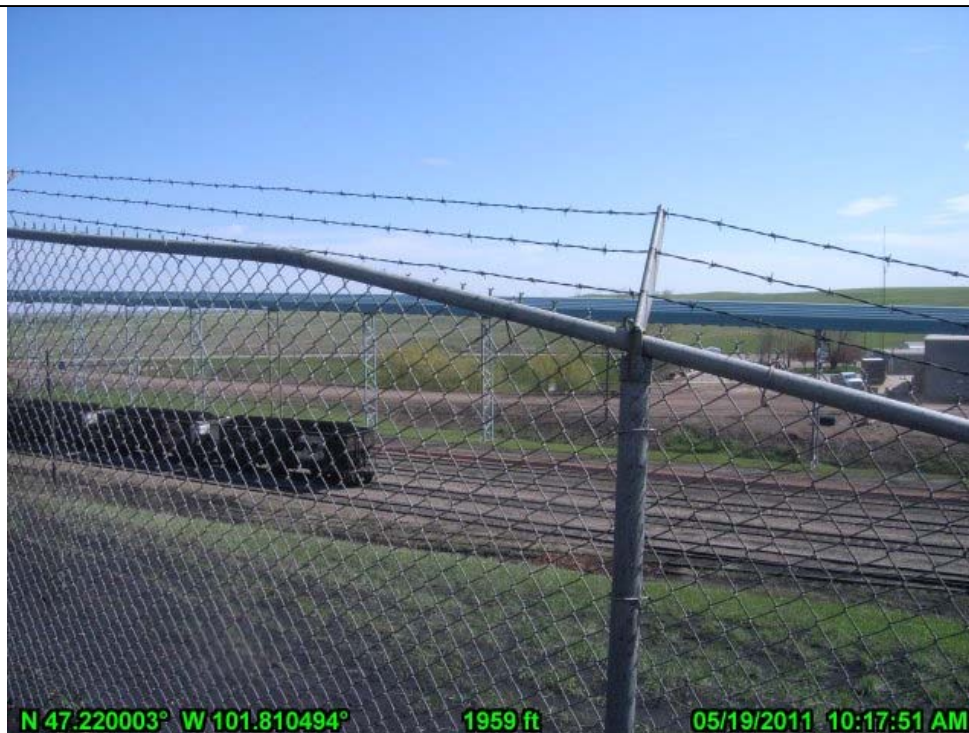
14-Continued Down Gradient Railroad Adjacent to the Nelsen Pond (looking NE)

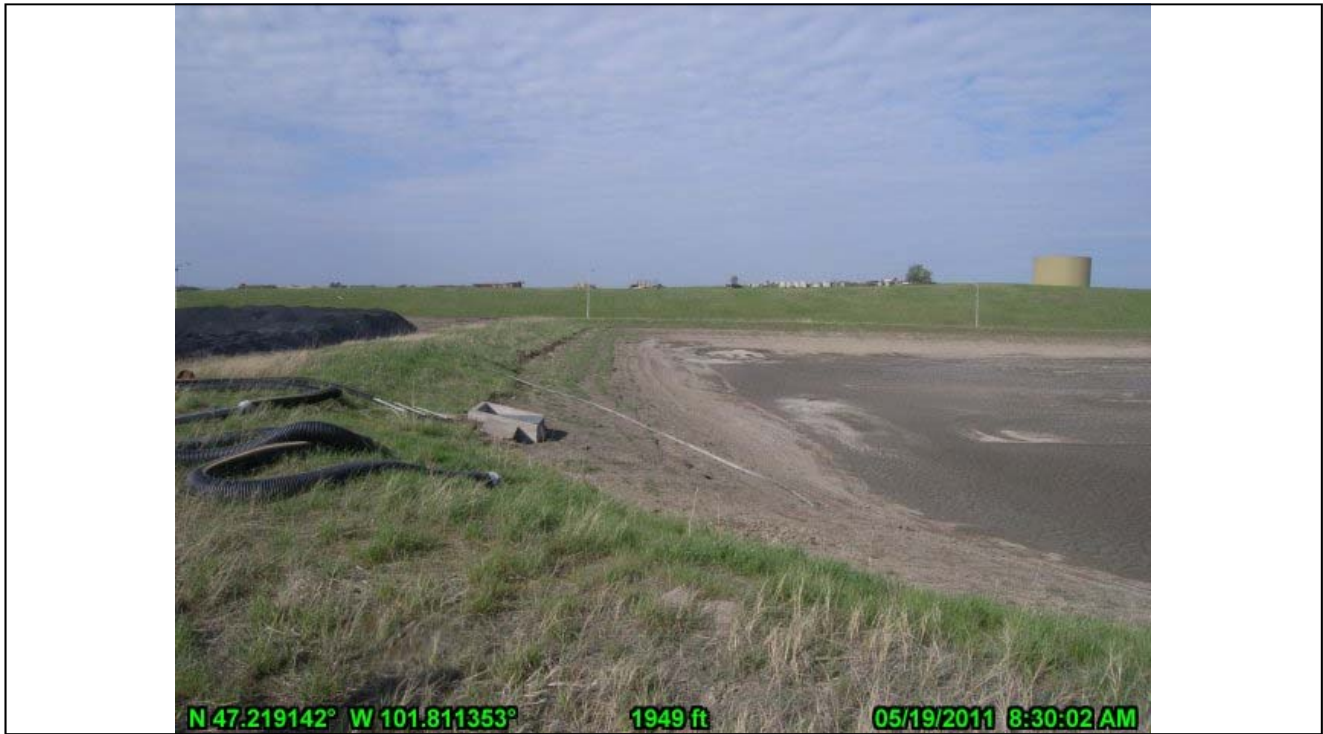
Overall, the upstream slope of the impoundment was in Satisfactory condition. Photos 1, 3, 7, 15, 21, and 22 show the conditions of the upstream slope. Specific observations include:

Overall, the crest of the impoundment was in Satisfactory condition. Photos 1, 2, 7, 15, 19, 21, and 22 show the condition of the crest. Specific observations include:

15-Nelsen Pond South Waterside Embankment with Overflow Inlet Structure (looking SW)

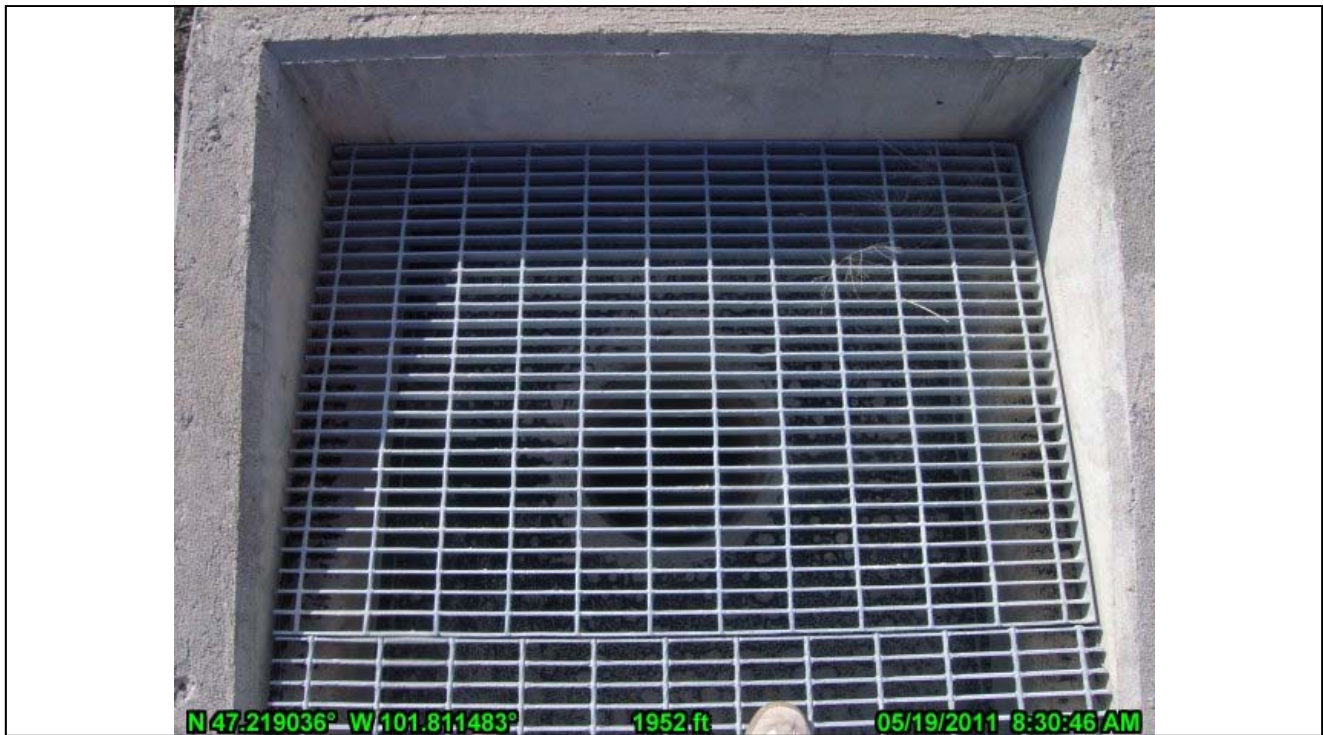
16-Nelsen Pond Overflow Structure and Trashrack

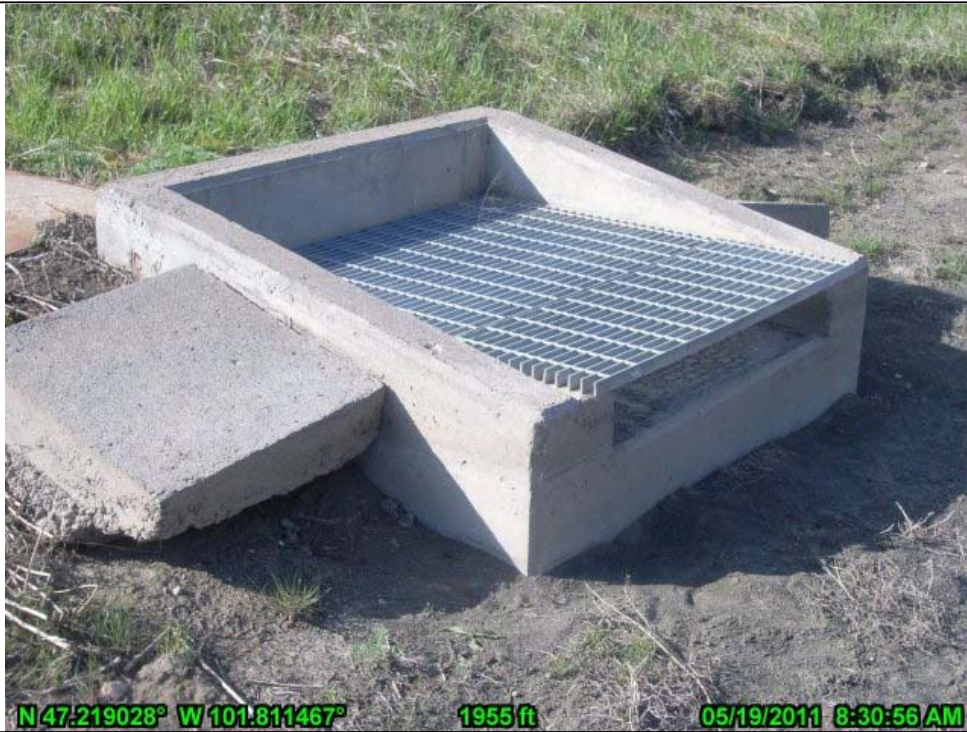
17-Nelsen Pond Overflow Inlet Structure

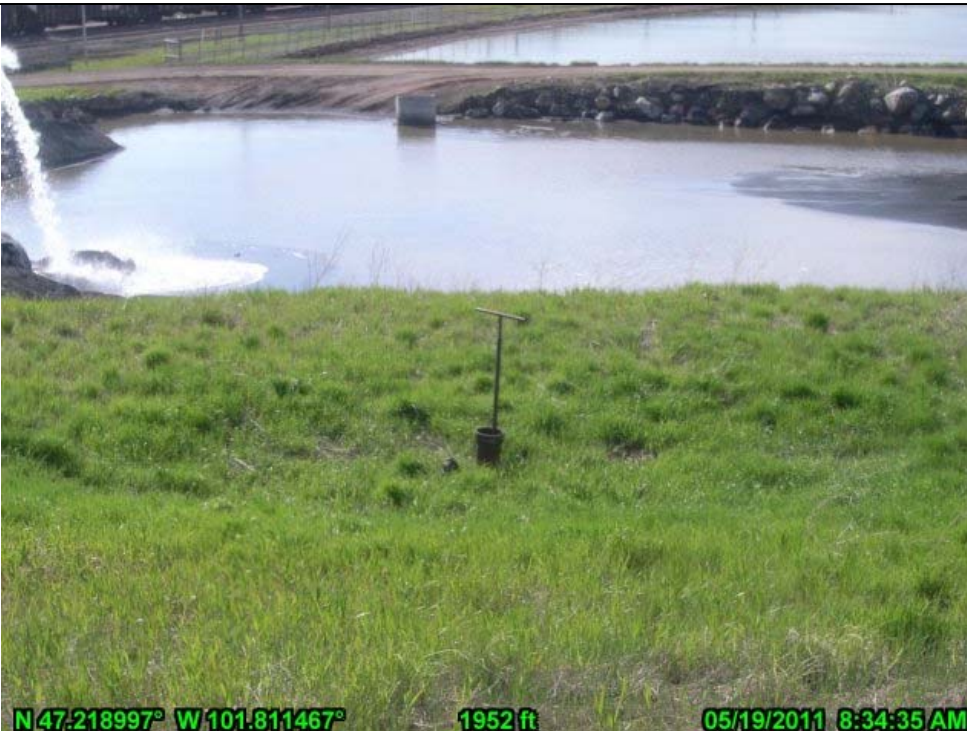
18-Valve Operator between Nelsen and Sluice Pond (looking SE)

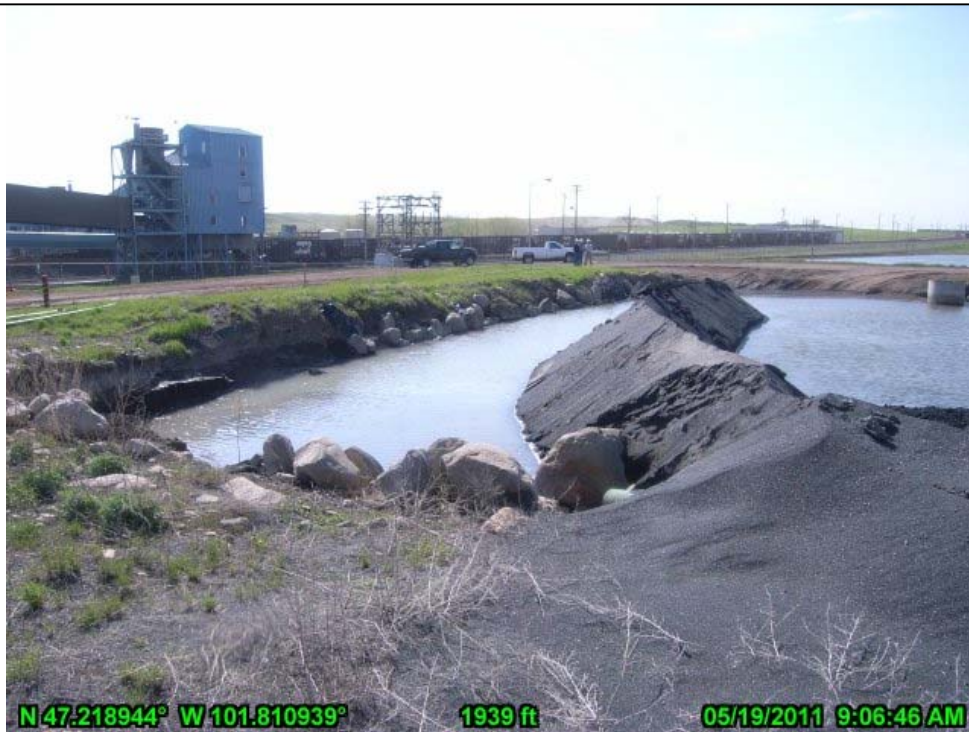
The Sluice Pond is incised and was not assigned a Hazard Classification; therefore, the upstream slopes were not given a condition rating, however they appeared to function properly. Photos 28 through 34 show the condition of the upstream slope within the pond. The eastern side of the pond is also an access road for mining trucks, and because the pond is constructed on sloping land, the east side is primarily incised with roadway embankment. Specific observations include:

The Sluice Pond is incised and was not assigned a Hazard Classification; therefore, the crest was not given a condition rating, but appeared to function properly. Photos 28 through 34 also show the condition of the perimeter crest. Specific observations include:

31-Sluice Pond Economizer Inlet Channel (looking SE)

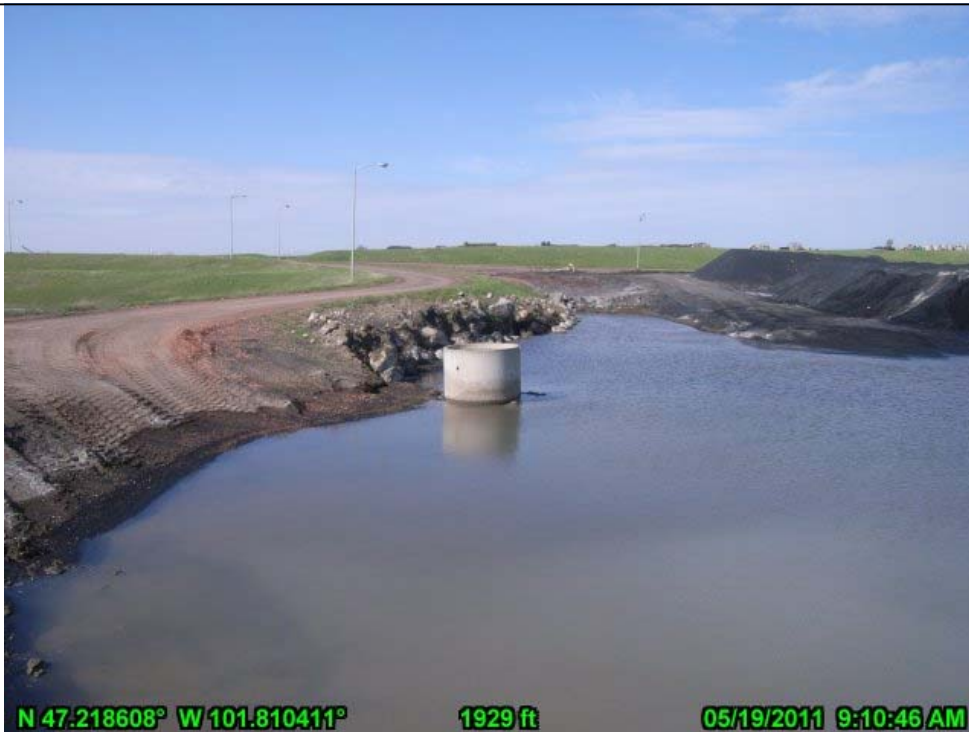
33-Sluice Pond and Original Outlet Intake (looking SW)

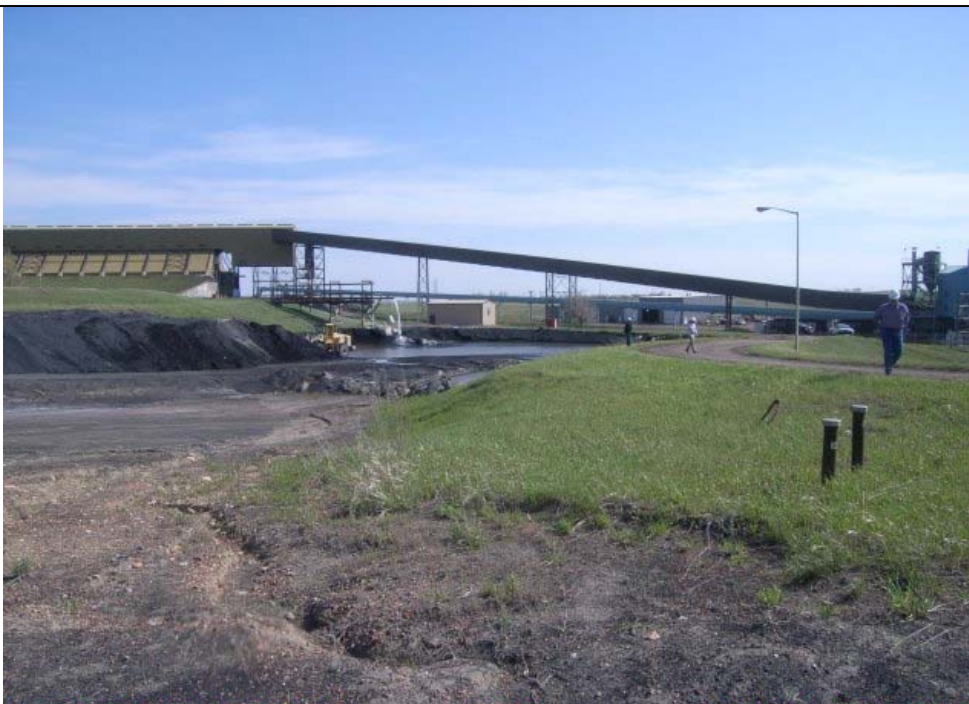
36-Sluice Pond from Southern Corner with Slag Pile (left) and Monitoring Wells (right)

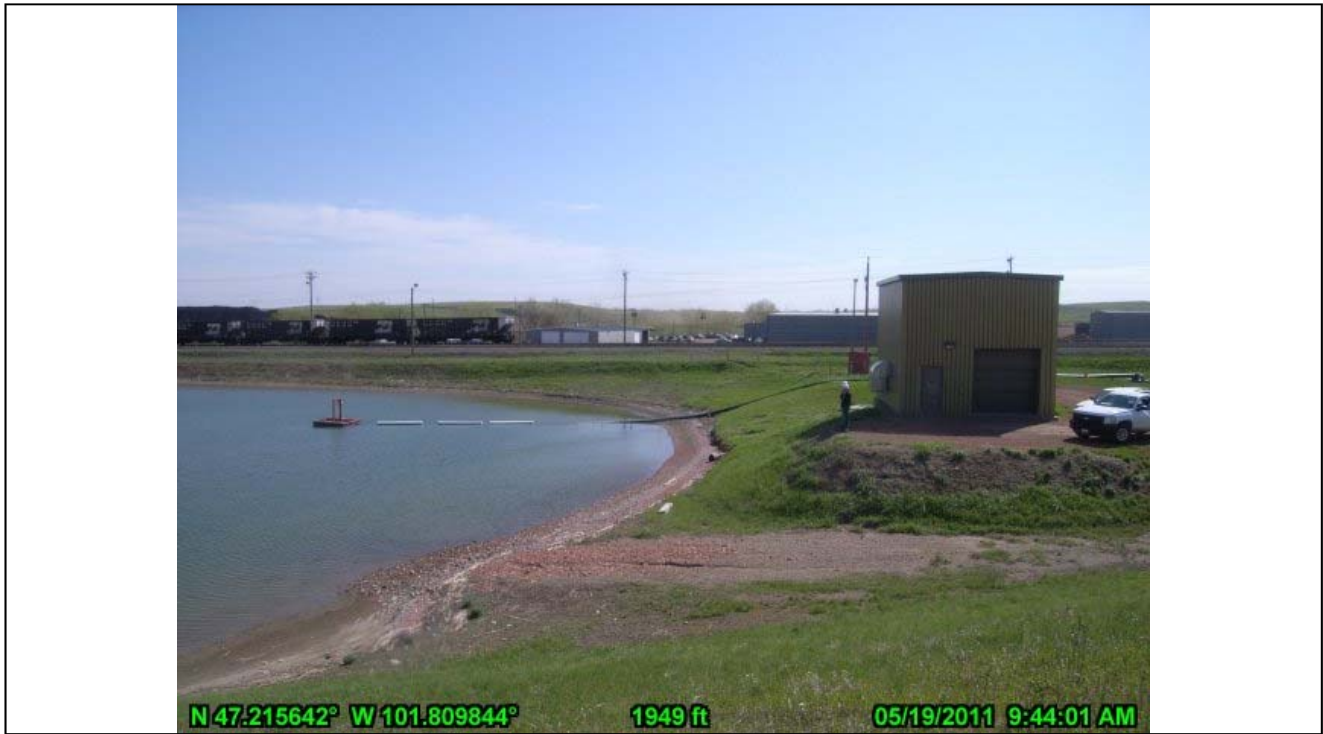
The Ash Pond is incised and was not assigned a Hazard Classification; therefore, the upstream slope was not given a condition rating, but appeared to function properly. Photos 39, 40, and 42 through 46 show the conditions of the upstream slope. Specific observations include:

43-Ash Pond South Waterside Embankment and Pump Station (looking E)

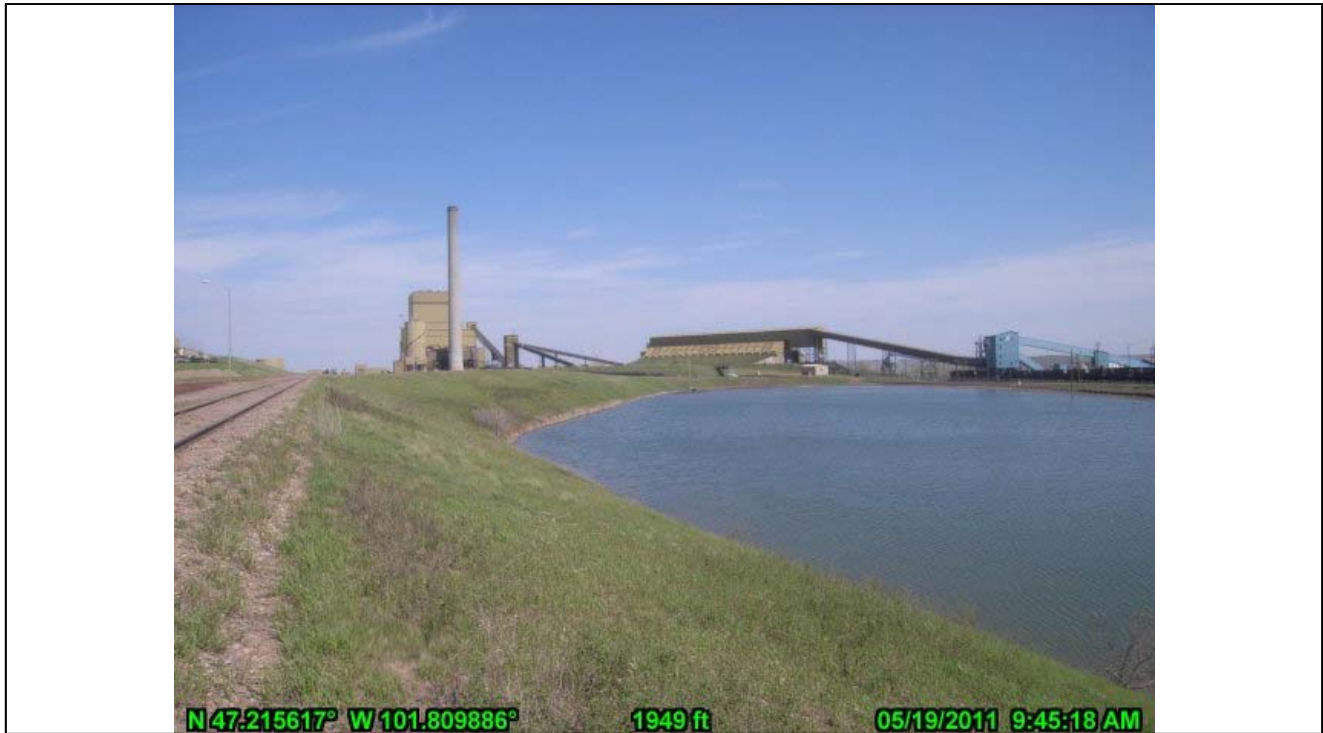
44-Ash Pond West Waterside Incised Embankment (looking N)

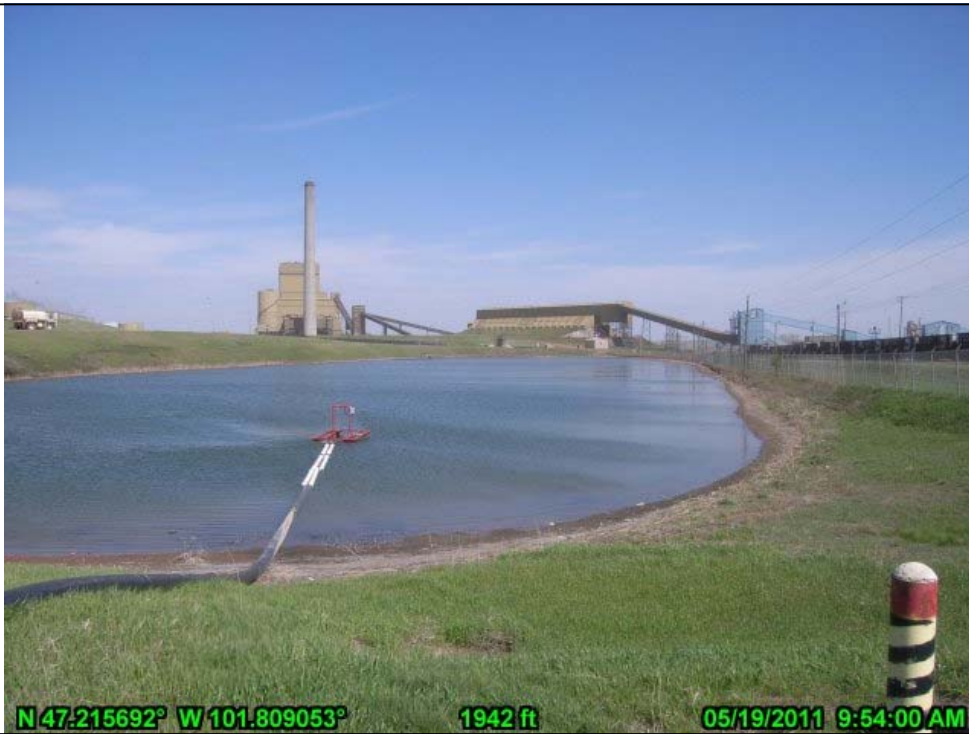
45-Ash Pond East Waterside Incised Embankment (looking N)

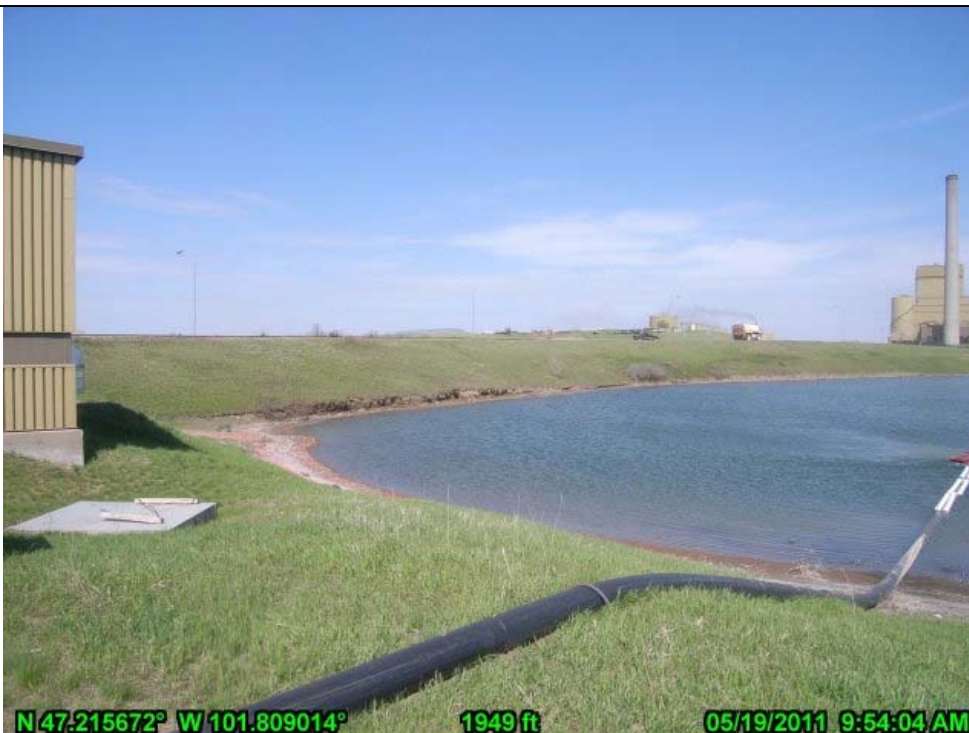
46-Ash Pond West Waterside Incised Embankment (looking NW)
