Assessment of Dam Safety of Coal Combustion Surface Impoundments (Task 3) Draft Report

Ohio Valley
Electric Corporation

Kyger Creek Power Station

December 9, 2009

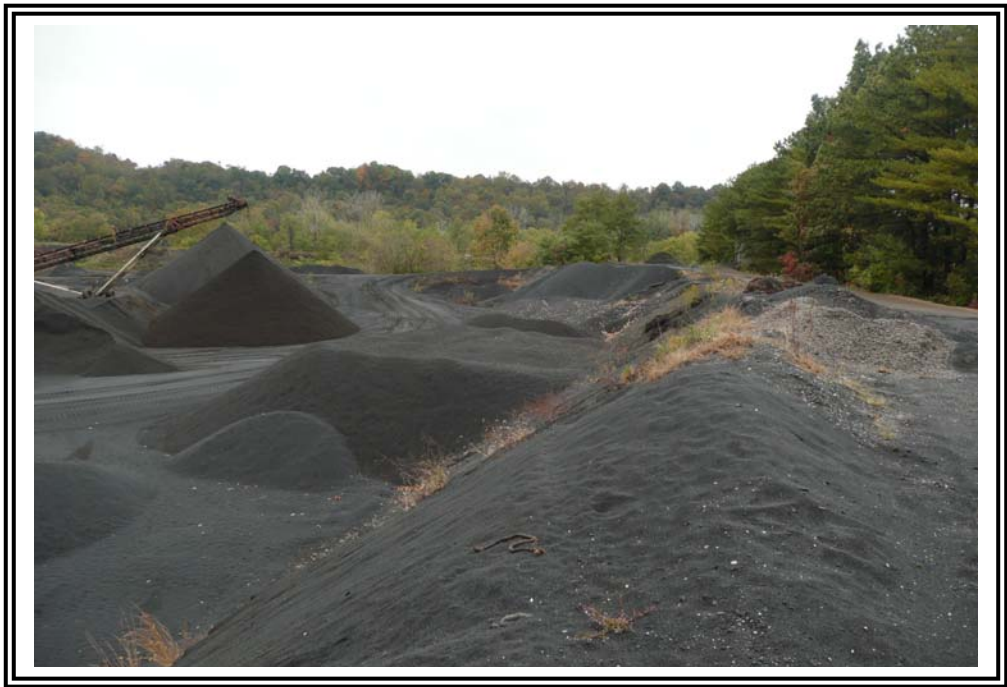
6

Interior slope and crest of north dike at northeast corner of the pond,
looking west. Left side of photo is bottom ash stockpiling area.

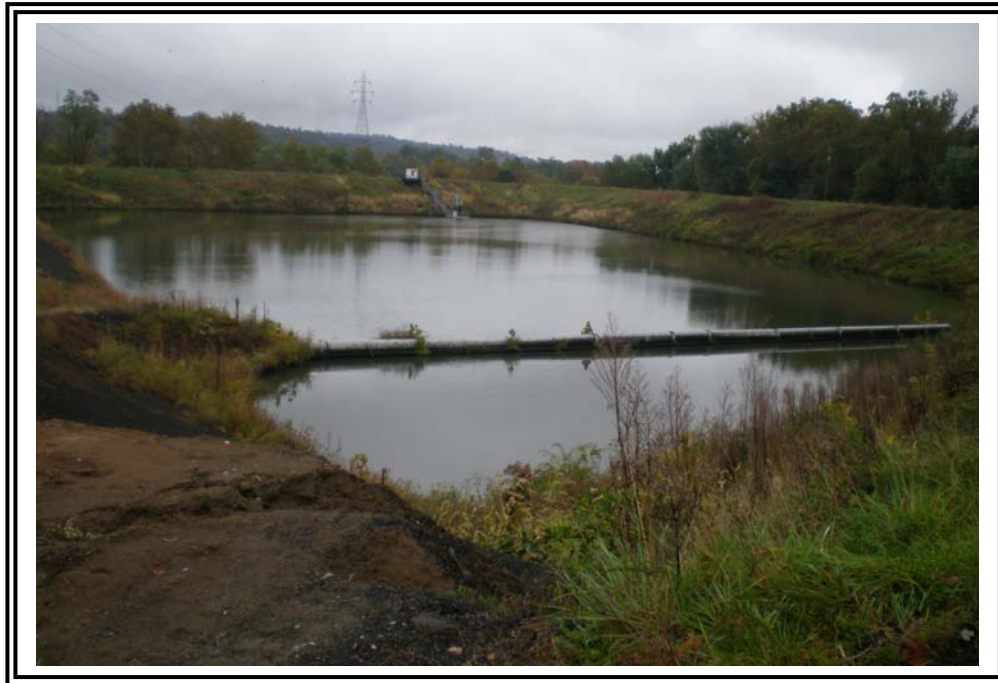
33

Clearwater Pond, facing southwest.

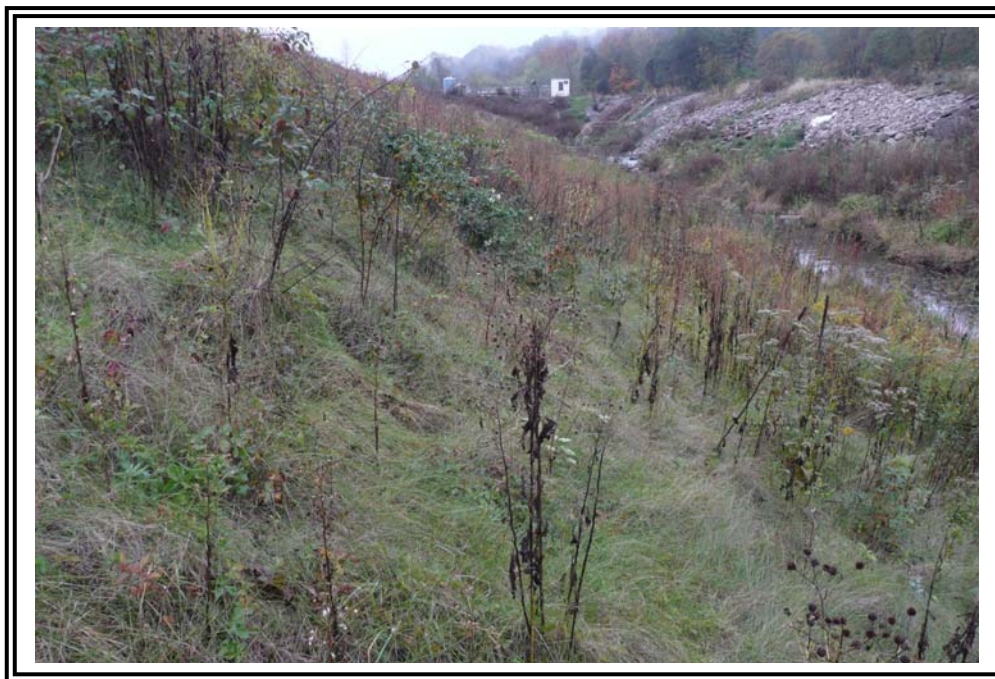
53

Exterior slope of west dike, looking south. Drainage feature at toe was collecting water during site visit.
