Assessment of Dam Safety Coal Combustion Surface Impoundments (Task 3) Final Report

Progress Energy
Carolinas
Cape Fear Plant

Moncure, North Carolina

September 14, 2009

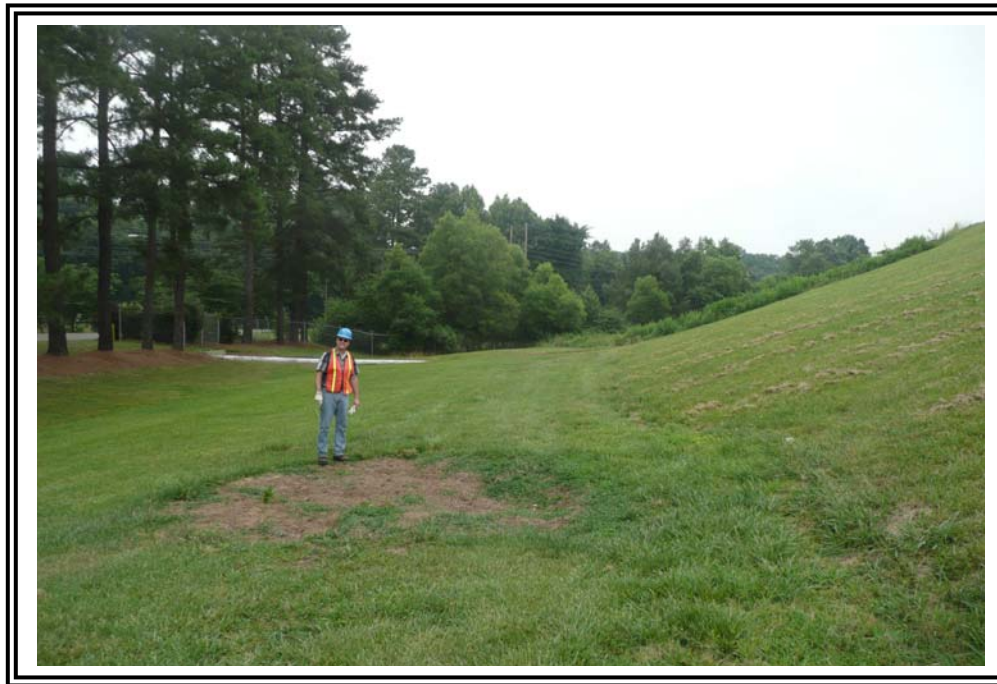
22

Toe of the North Dike of the 1985 Ash Pond, looking northeast.
Note: Bare patch at the toe of the Dike.

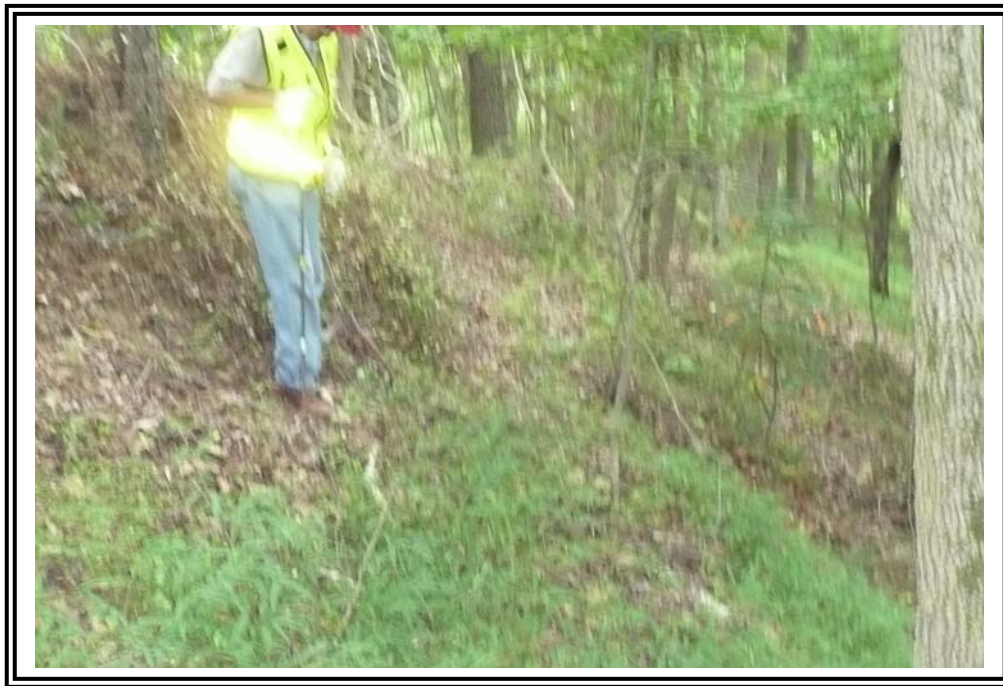
99

Same location as the previous photo with a person for scale.

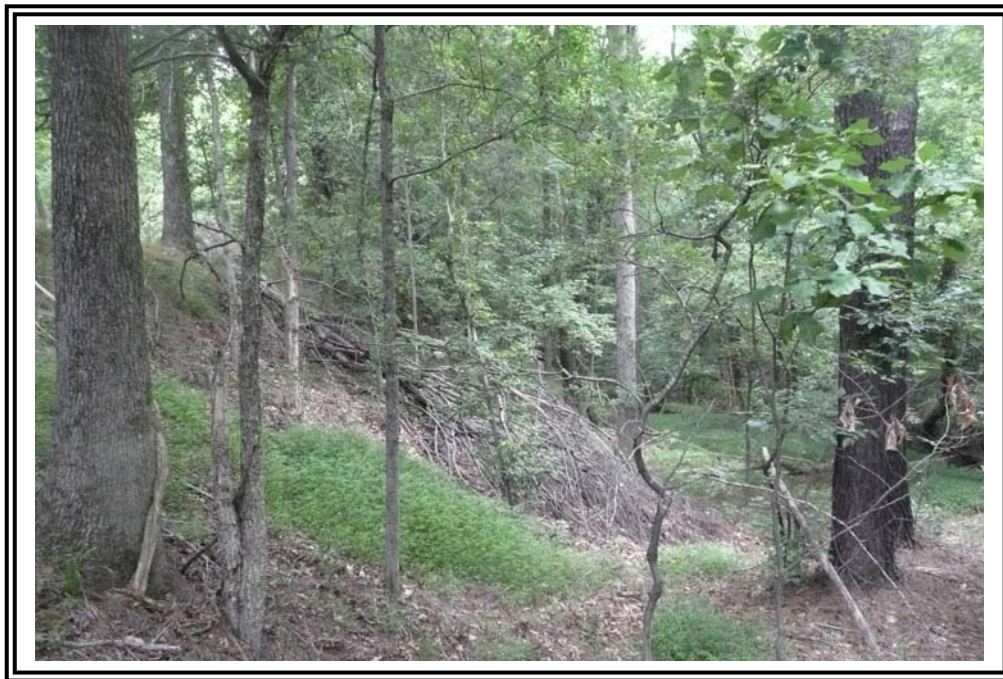
103

Typical slope sloughing and erosion on the 1956 Ash Pond Dikes.
