**Coal Combustion Residue Impoundment
Round 9 - Dam Assessment Report**

Weatherspoon Steam Electric Plant

Ash Pond Embankment

Progress Energy Carolinas, Inc.

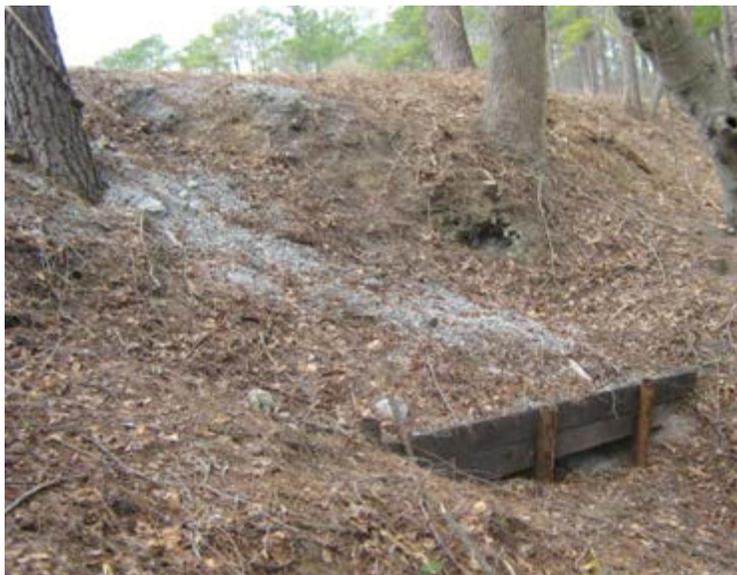
Areas of the northern and northeastern slopes were eroding, in disrepair and had large trees established within the embankment. This area required remediation. We were informed by Progress Energy that subsequent to the field visit a plan was developed, approved by NCDENR and implemented to remediate the embankments.

Downstream slope – Northern Ash Area

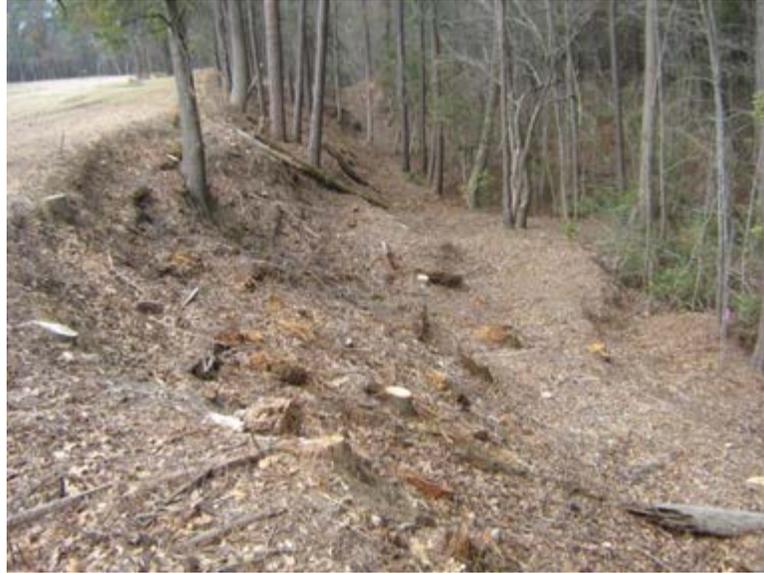
Downstream slope – Northern Ash Area

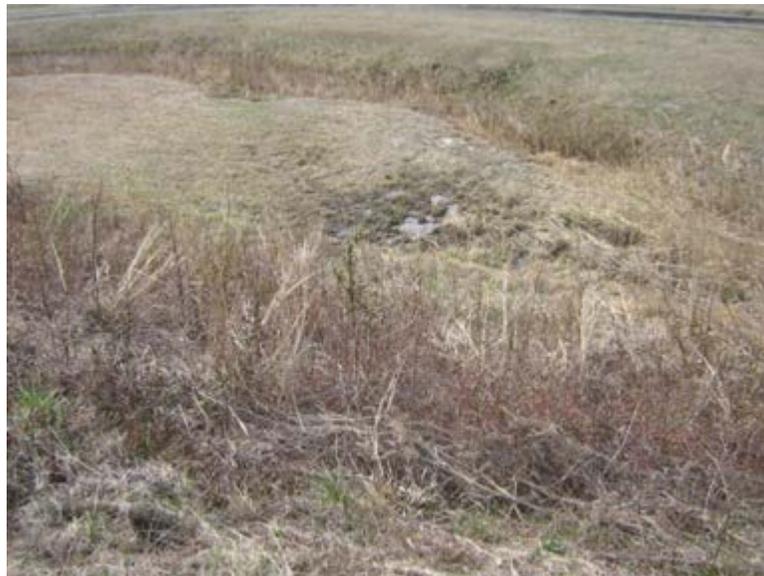
No scarps, sloughs, depressions, bulging or other indications of slope instability or signs of erosion were observed. It is recommend the power plant install animal guards for the toe drains. Seepage was observed at a few locations and this needs to be monitored.

Potential seepage along downstream toe – Southern Ash Area

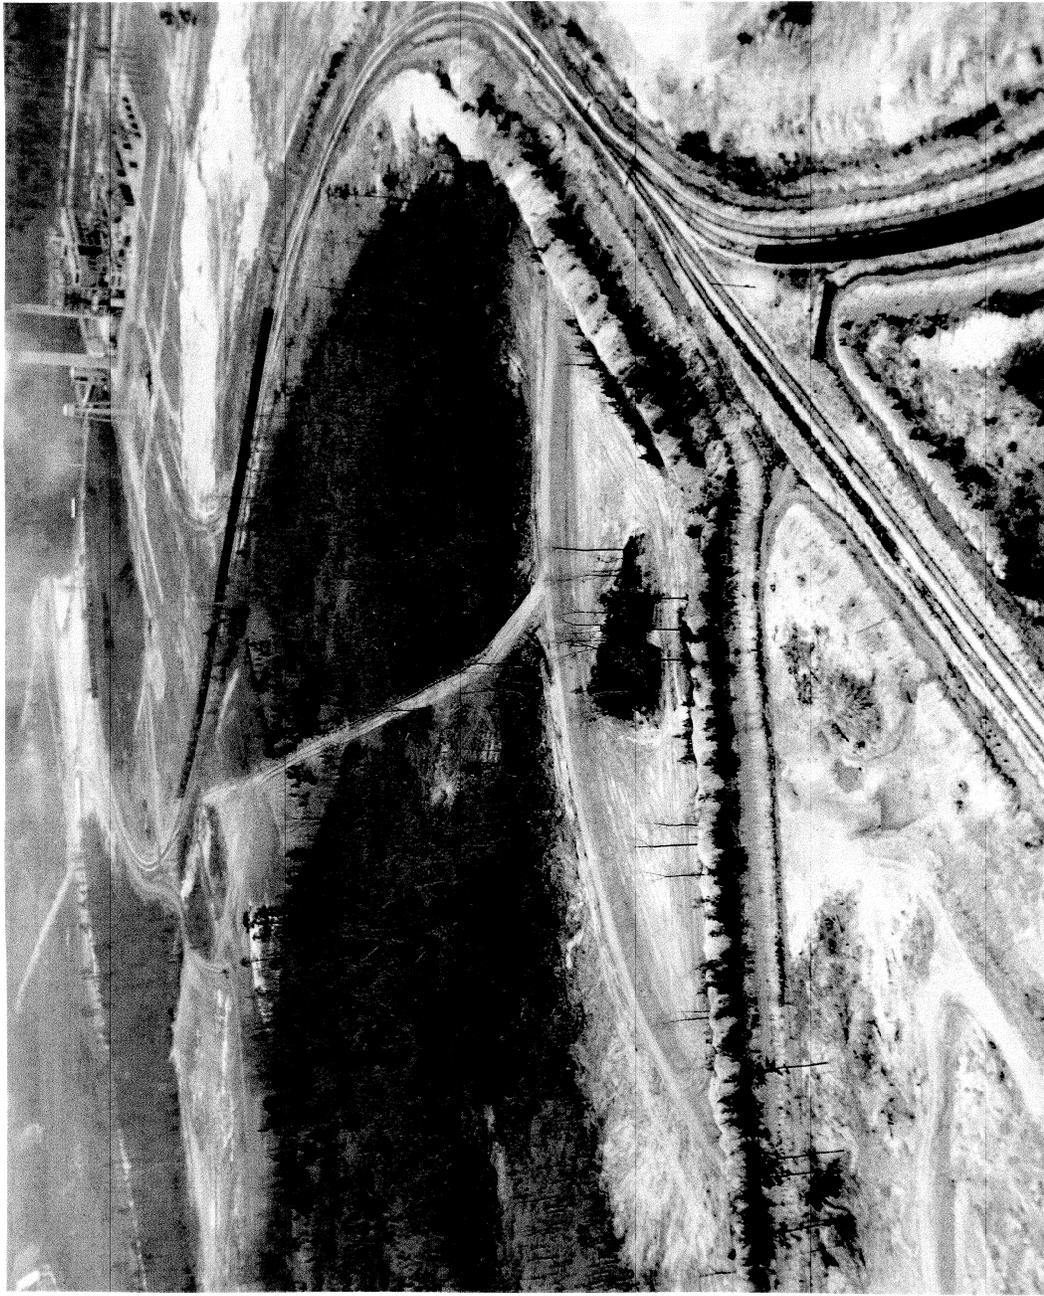
Construction photograph from 2/28/1955 showing "New ash disposal area..completed retaining dyke tying into old railroad cut spoil banks and new pipeline to disposal area."

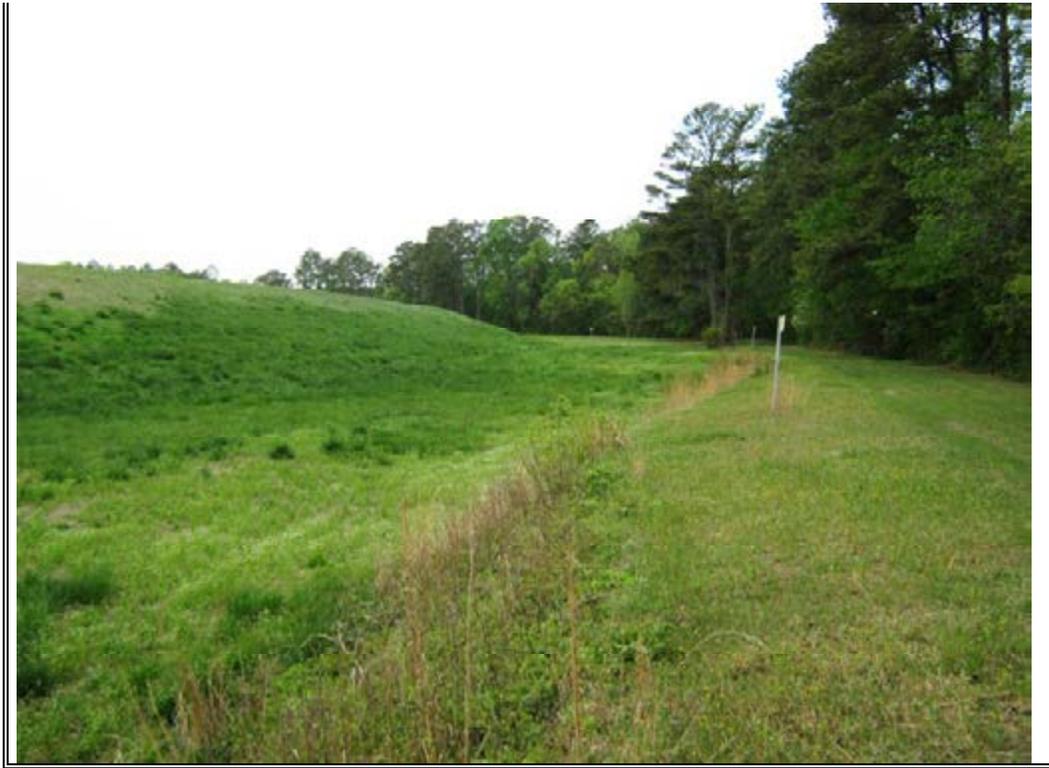
Photograph 1: Crest and interior area – Northern Ash Area, north dike.

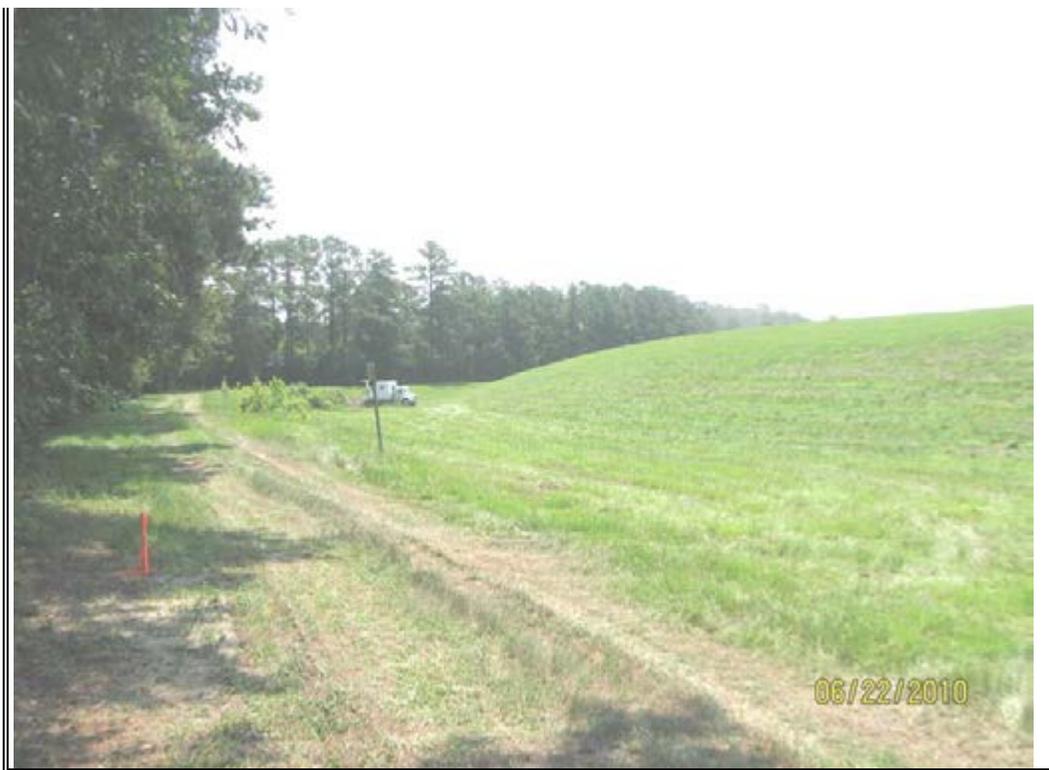
Photograph 2: Crest and interior area – Northern Ash Area, north dike.

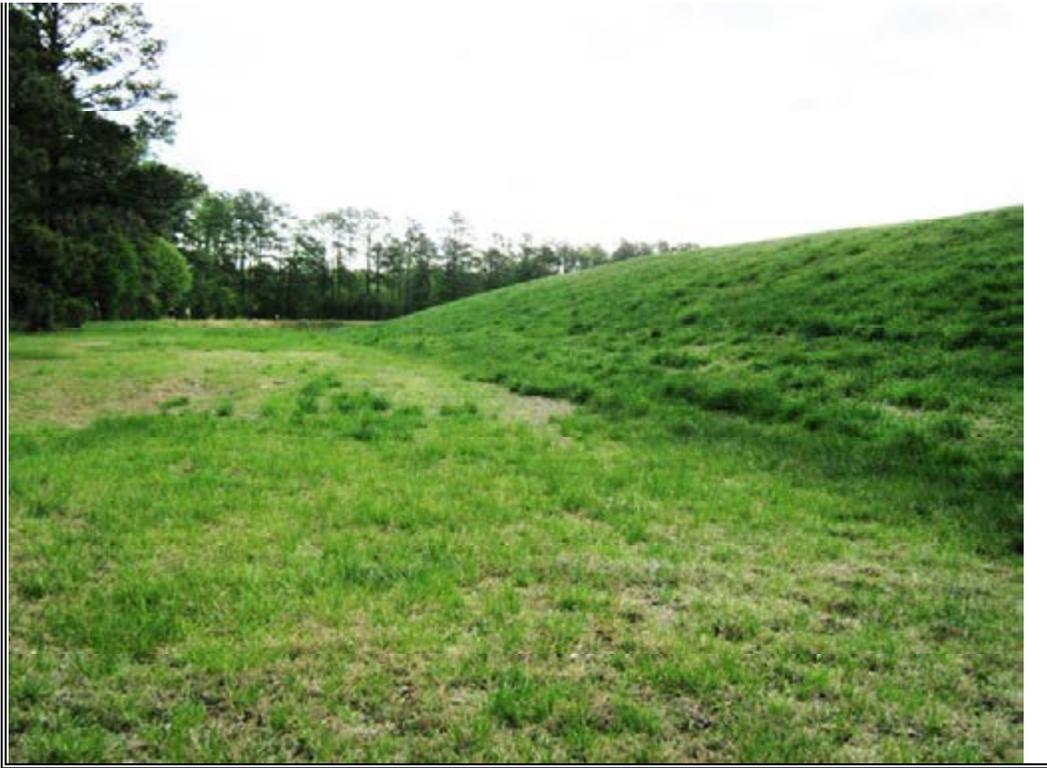
Photograph 3: Interior drainage swale – Northern Ash Area, north dike.

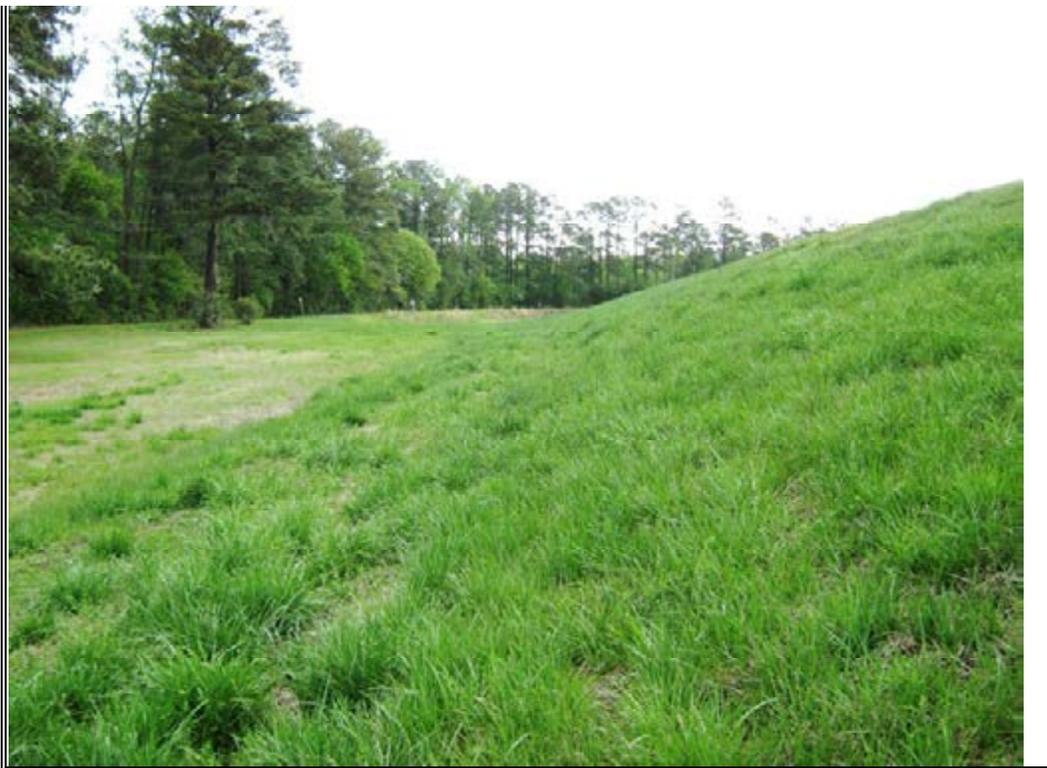
Photograph 4: Interior area, local tree presence – Northern Ash Area, north dike.

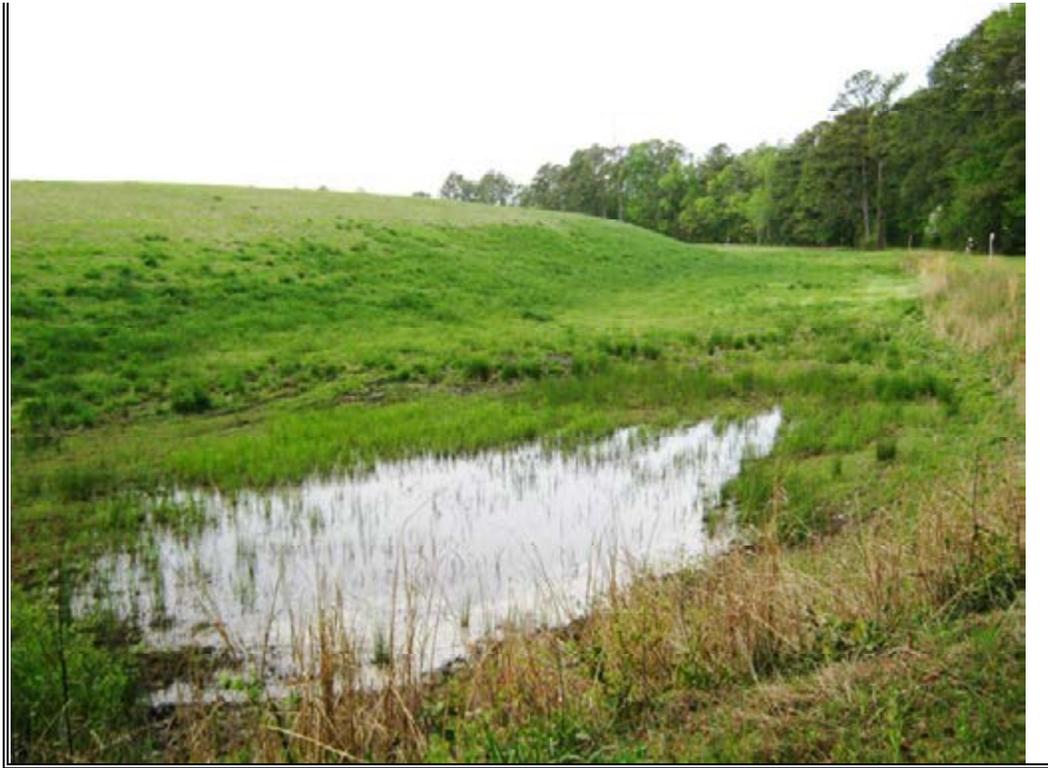
Photograph 5: Local standing water near old pond discharge – Northern Ash Area.

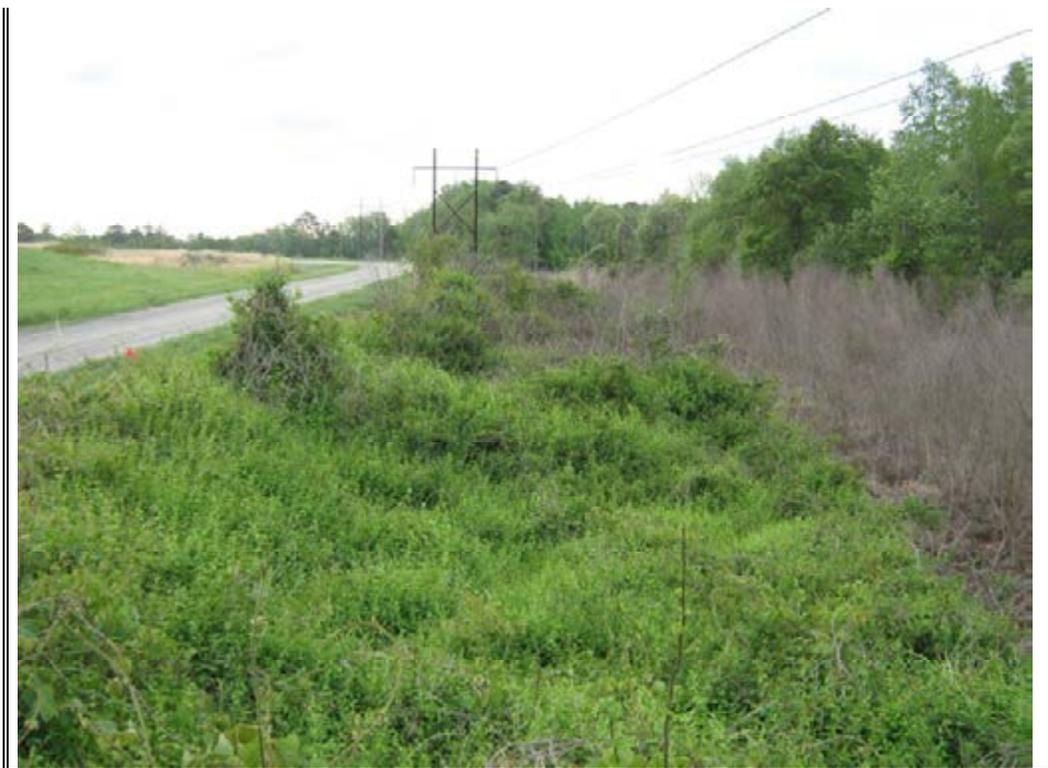
Photograph 6: Exterior slope – Northern Ash Area, west dike. Note vegetation.

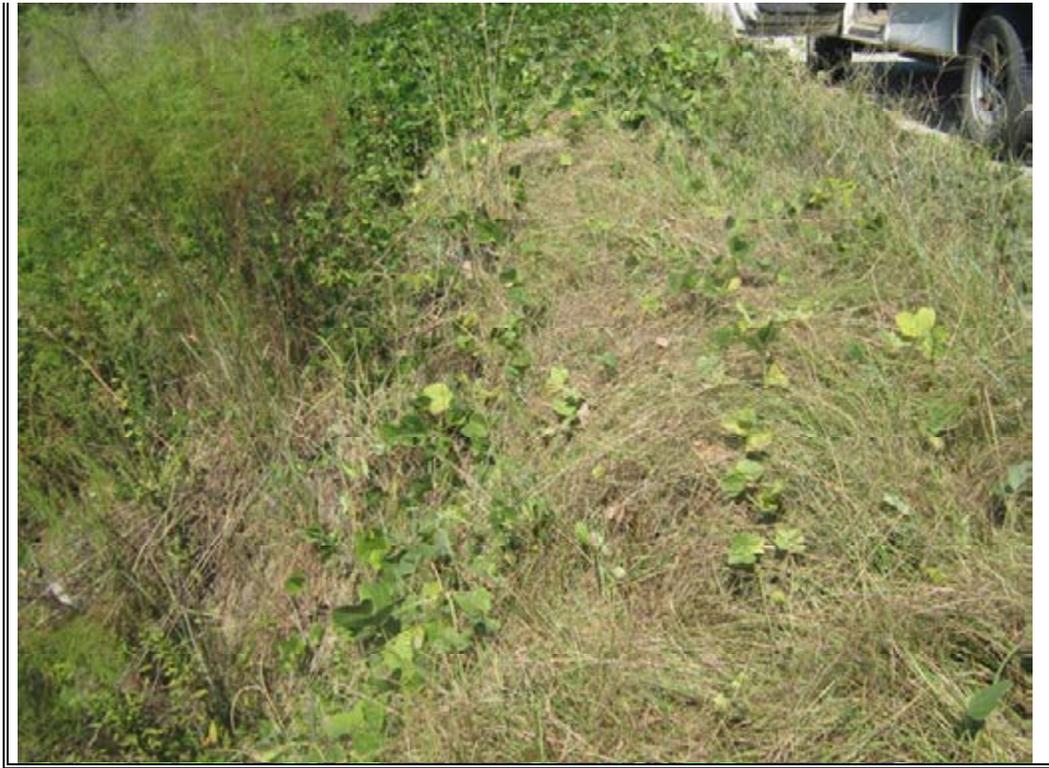
Photograph 7: Local steep scarp on exterior slope – Northern Ash Area, west dike.

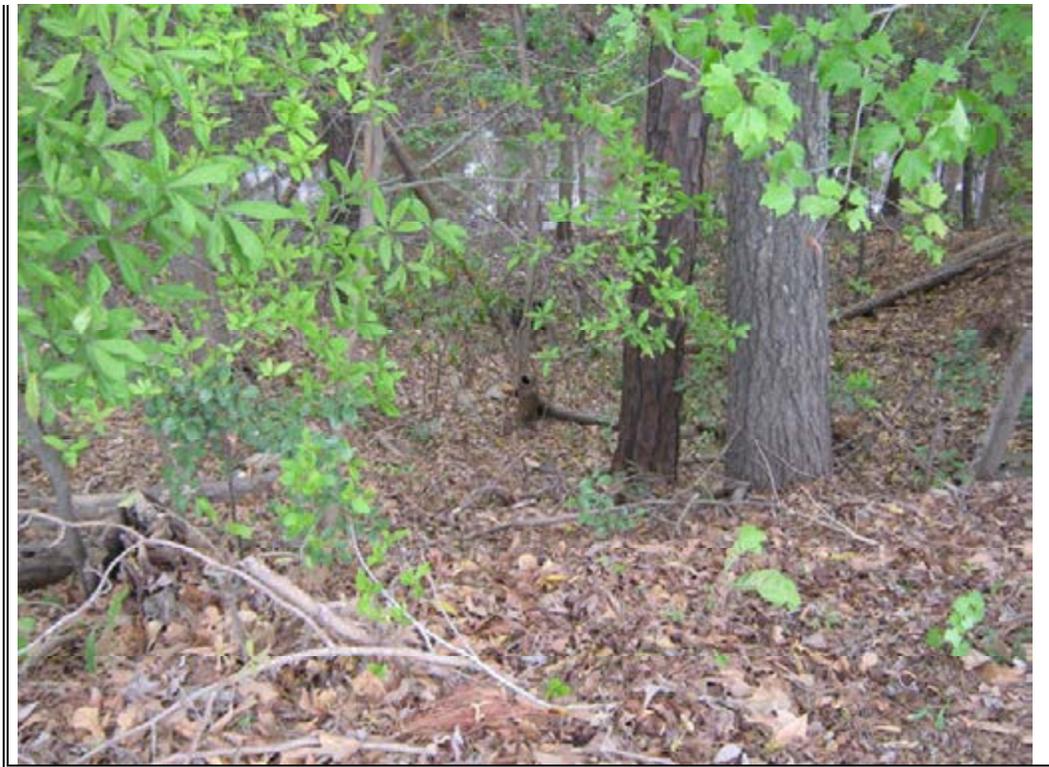
Photograph 8: Tree growth on exterior slope – Northern Ash Area, north dike.

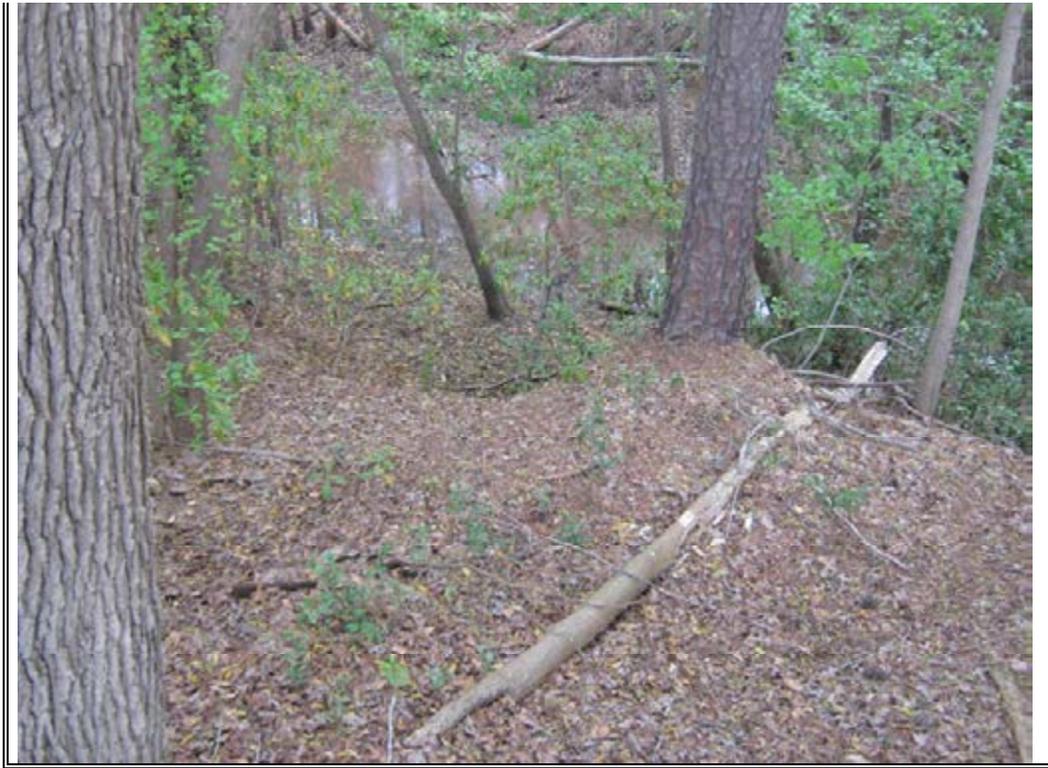
Photograph 9: Typical bench and tree growth – Northern Ash Area, west end north dike.

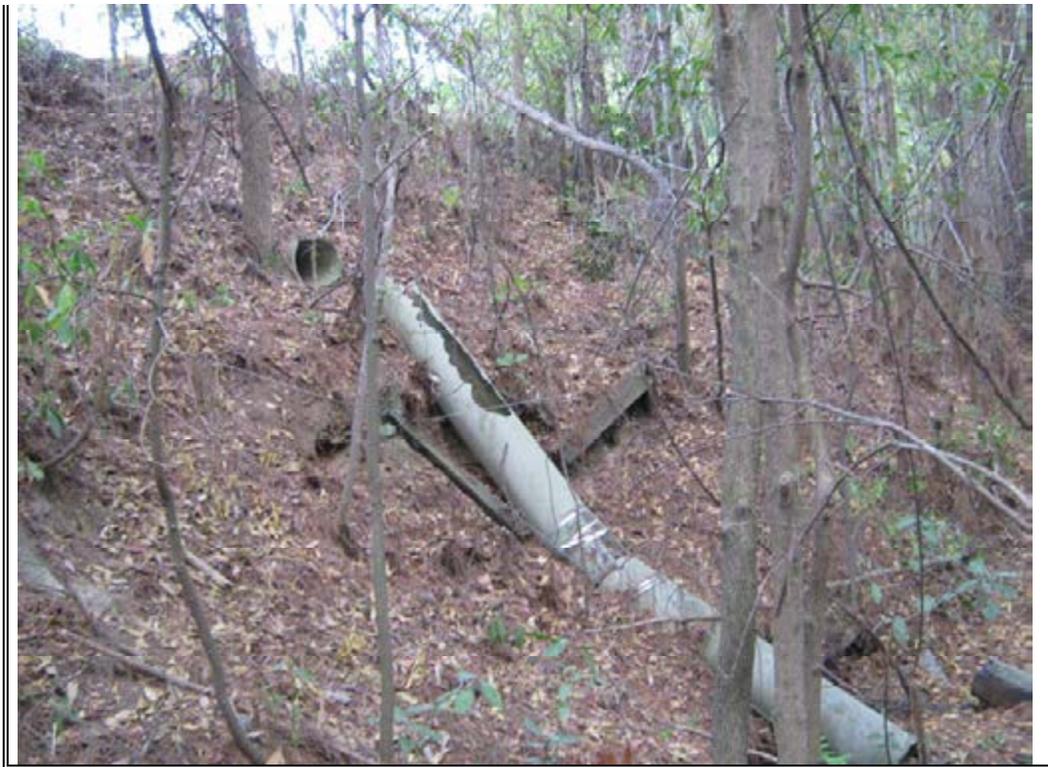
Photograph 10: Remnants of old pond discharge pipe – Northern Ash Area, east dike.

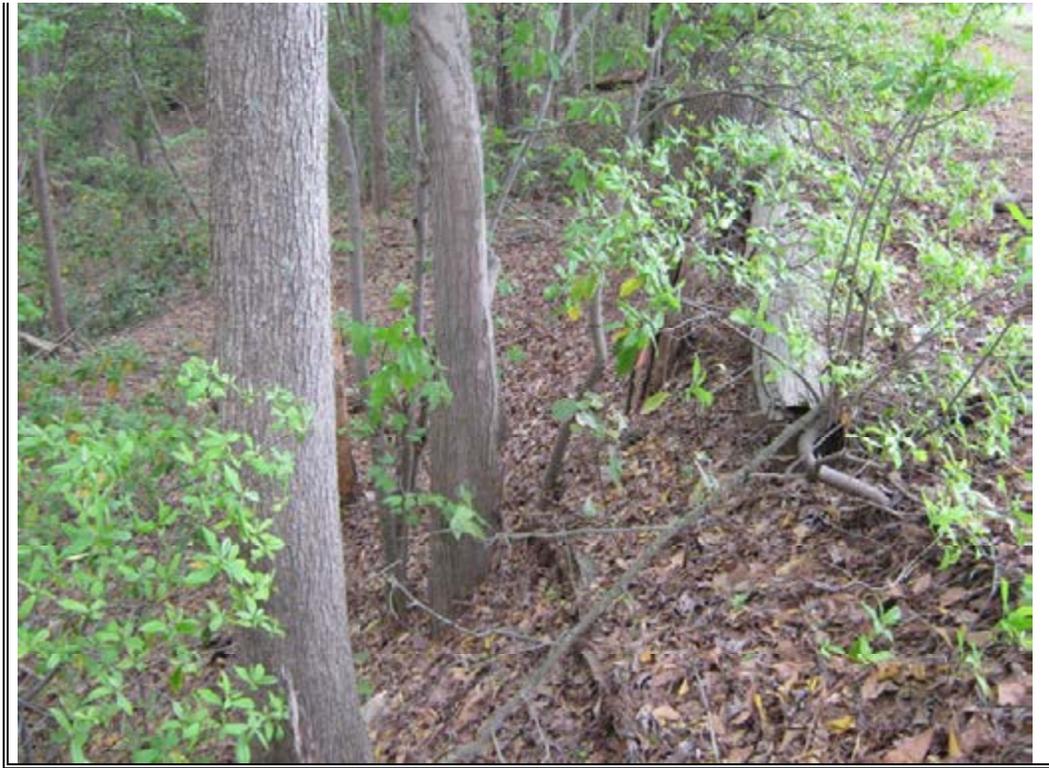
Photograph 11: Local timber restraint at crest level – Northern Ash Area, north dike.

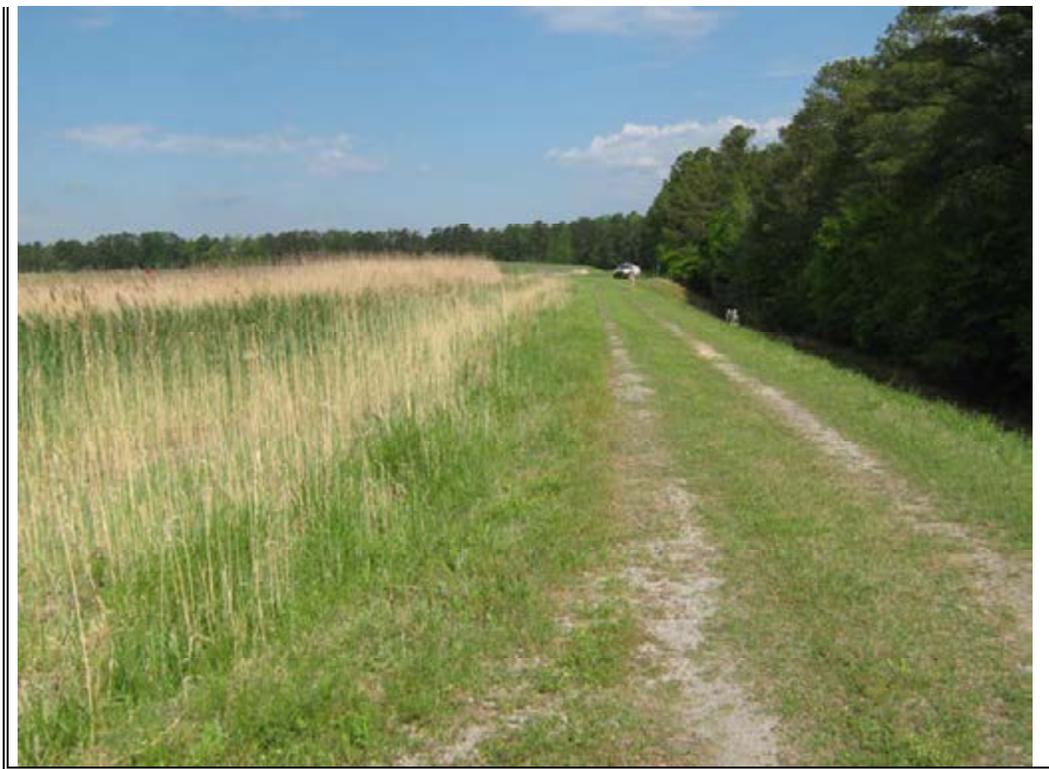
Photograph 12: Crest and interior slope – Southern Ash Area, east dike.

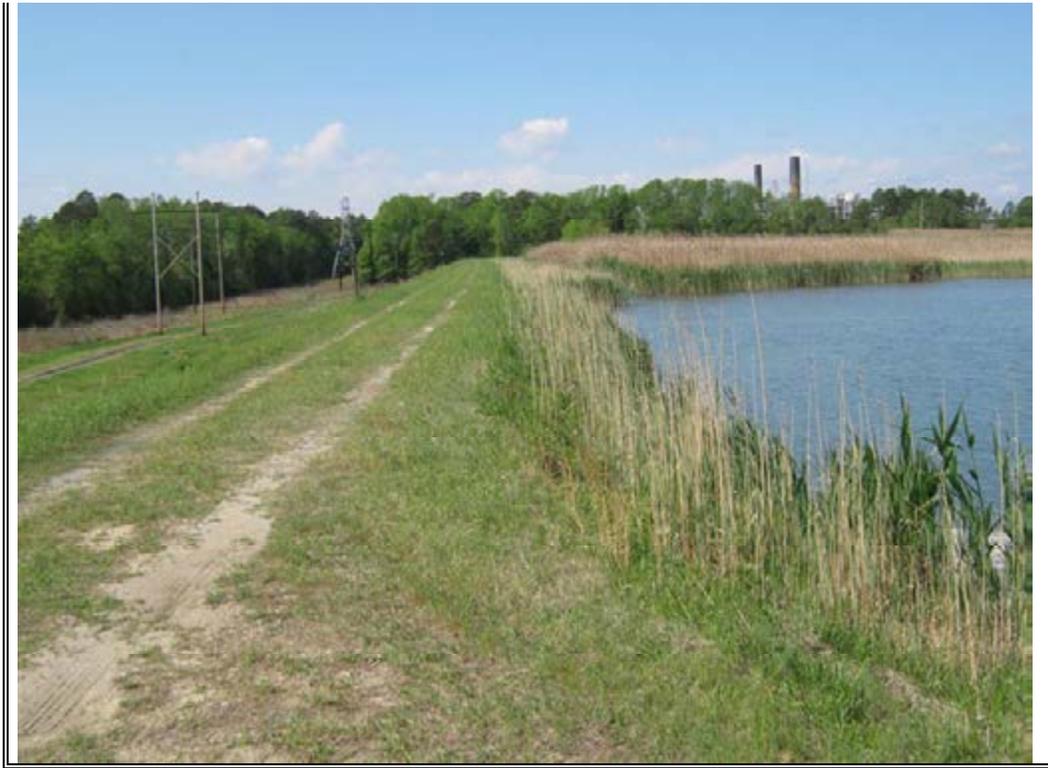
Photograph 13: Crest and interior slope – Southern Ash Area, south dike.

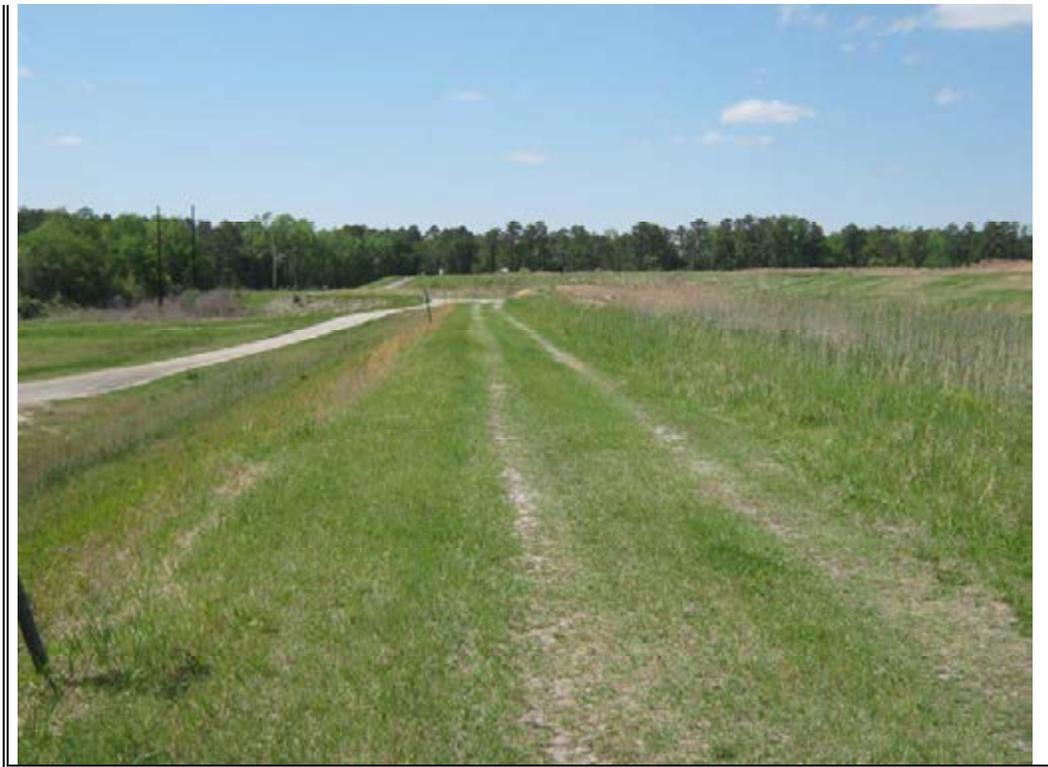
Photograph 14: Crest of west dike, Southern Ash Area.

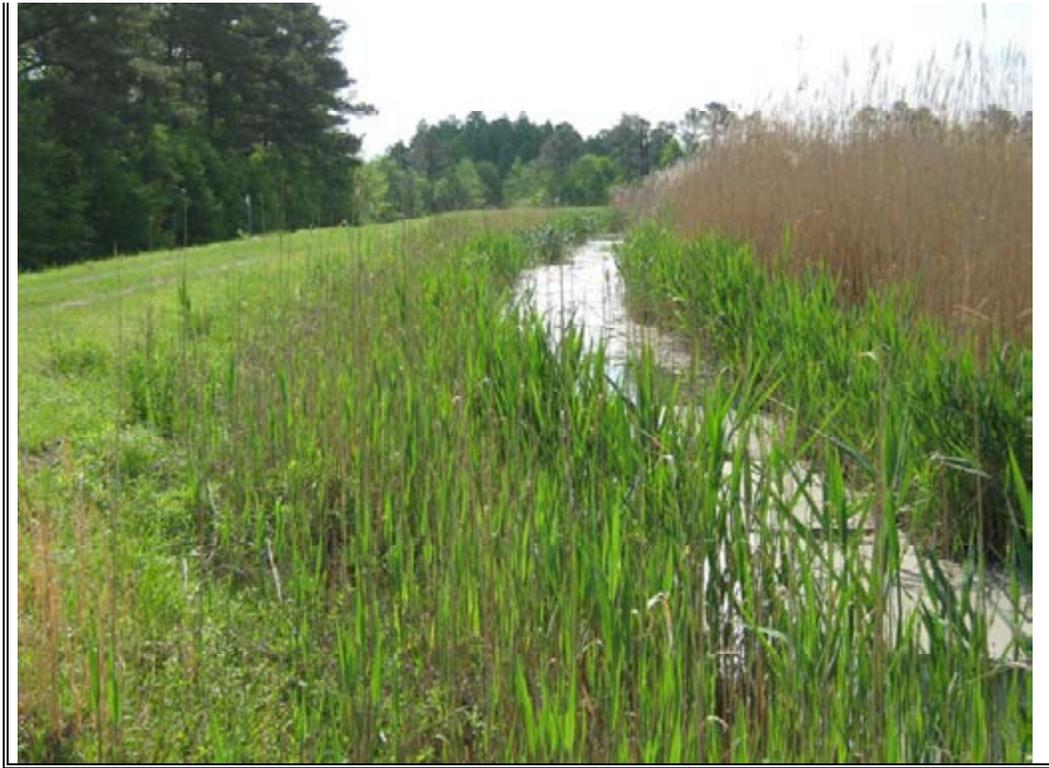
Photograph 15: Interior slope and ash/water channel – Southern Ash Area, east dike.

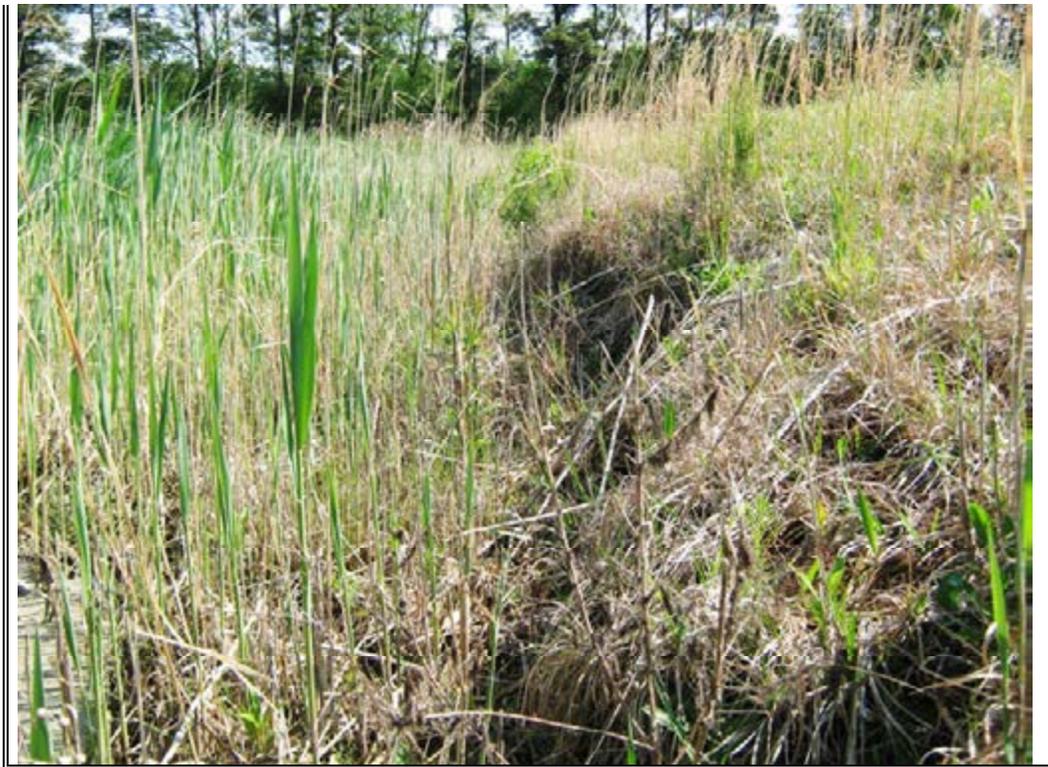
Photograph 18: Old beaching erosion on south dike – Southern Ash Area.

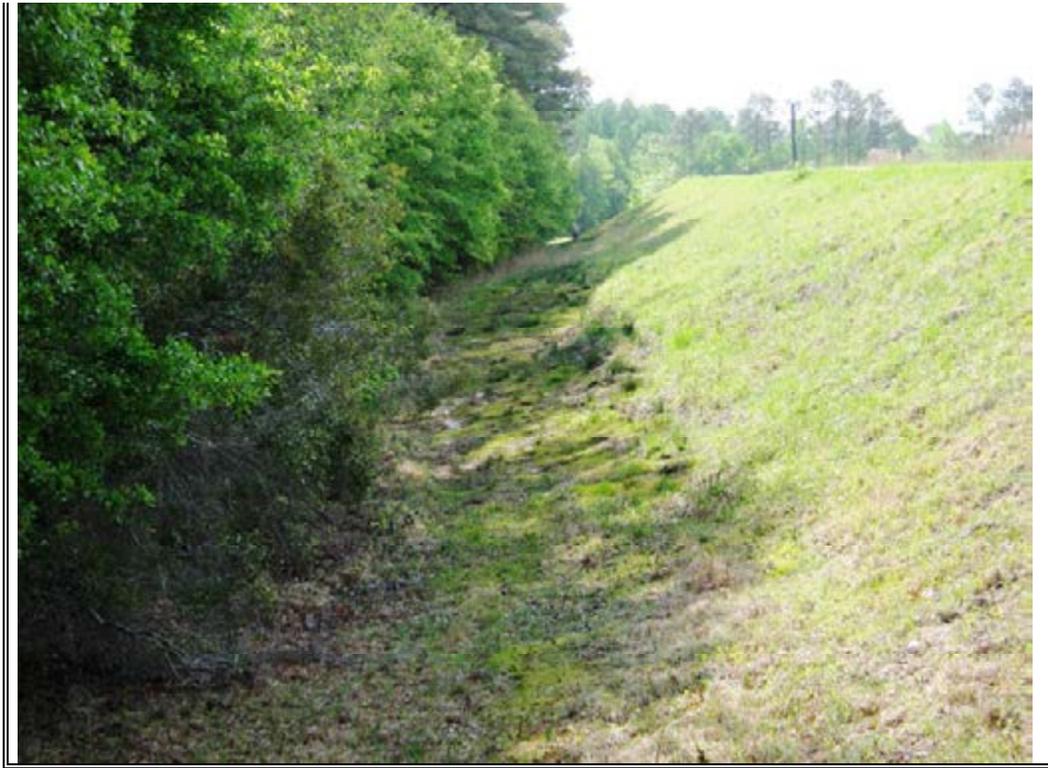
The east dike exterior slope and area adjacent to the toe have a history of wet areas. The area was as seen before with some soft, wet spots but no active seepage (Photograph 19). The wet areas extend a maximum of five feet up the dike from the toe.

Photograph 19: Exterior slope and toe wet area – Southern Ash Area, east dike.

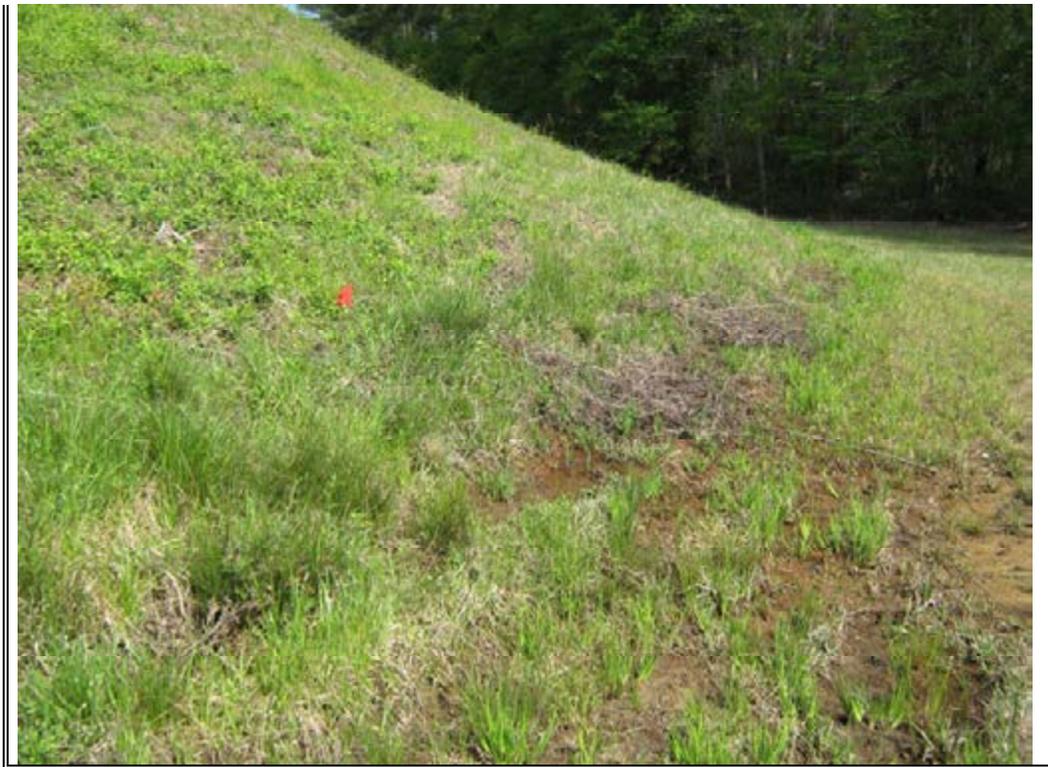
Photograph 22: Local wet areas and slight seepage – Southern Ash Area, southeast corner at settling basin dike.

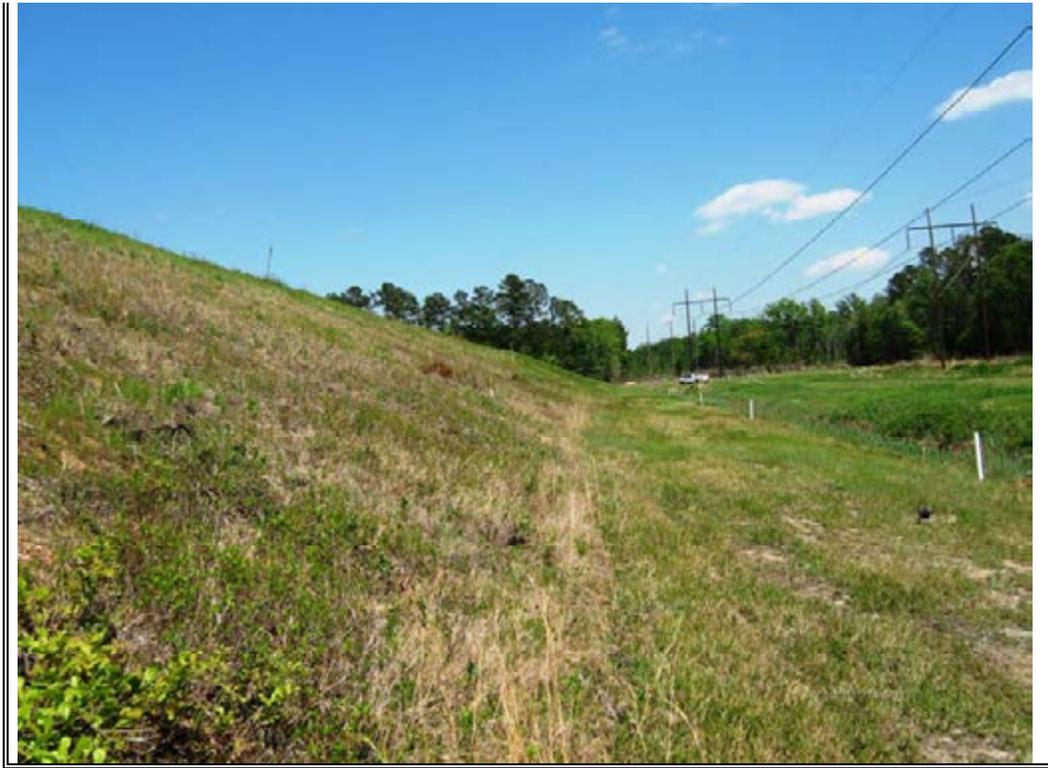
Photograph 23: Toe of south dike – Southern Ash Area.

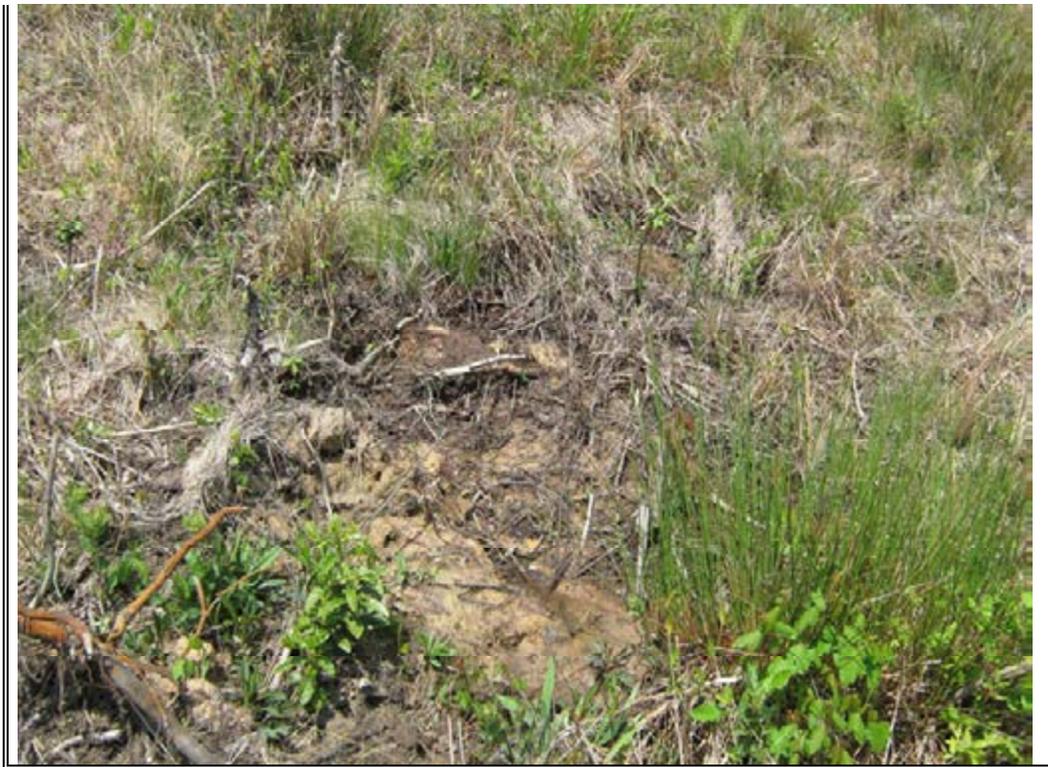
Photograph 24: Seepage spot on dike toe – Southern Ash Area, south dike.

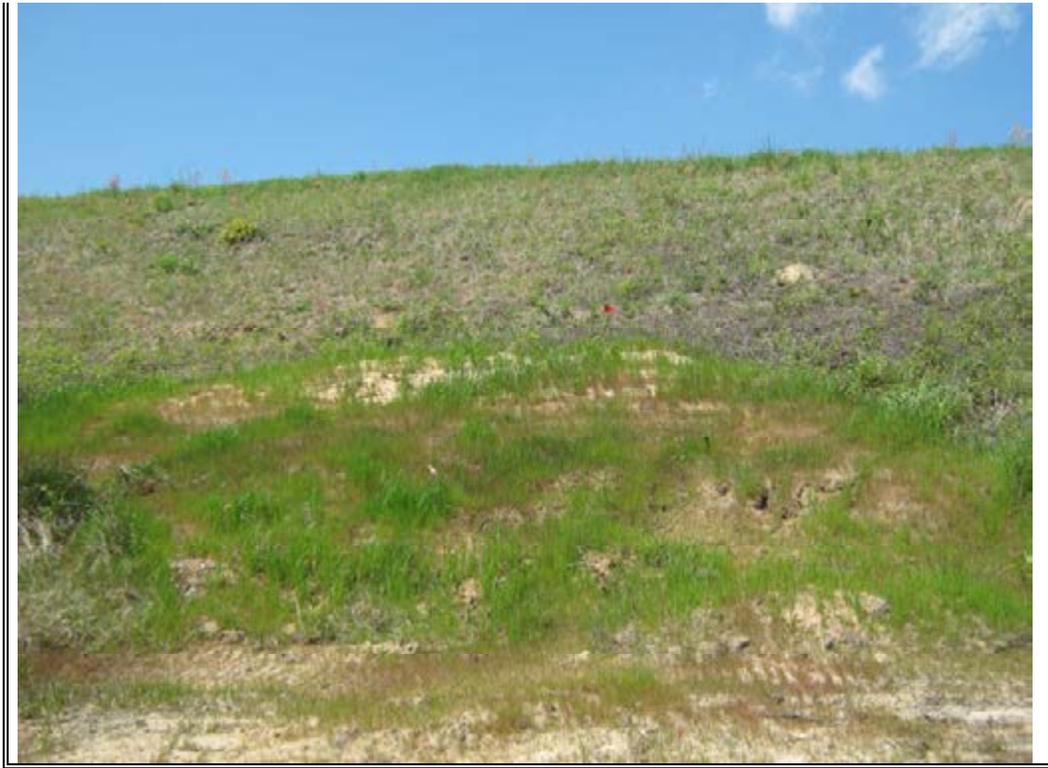
Photograph 25: Sand fill placed on seepage area – Southern Ash Area, south dike.

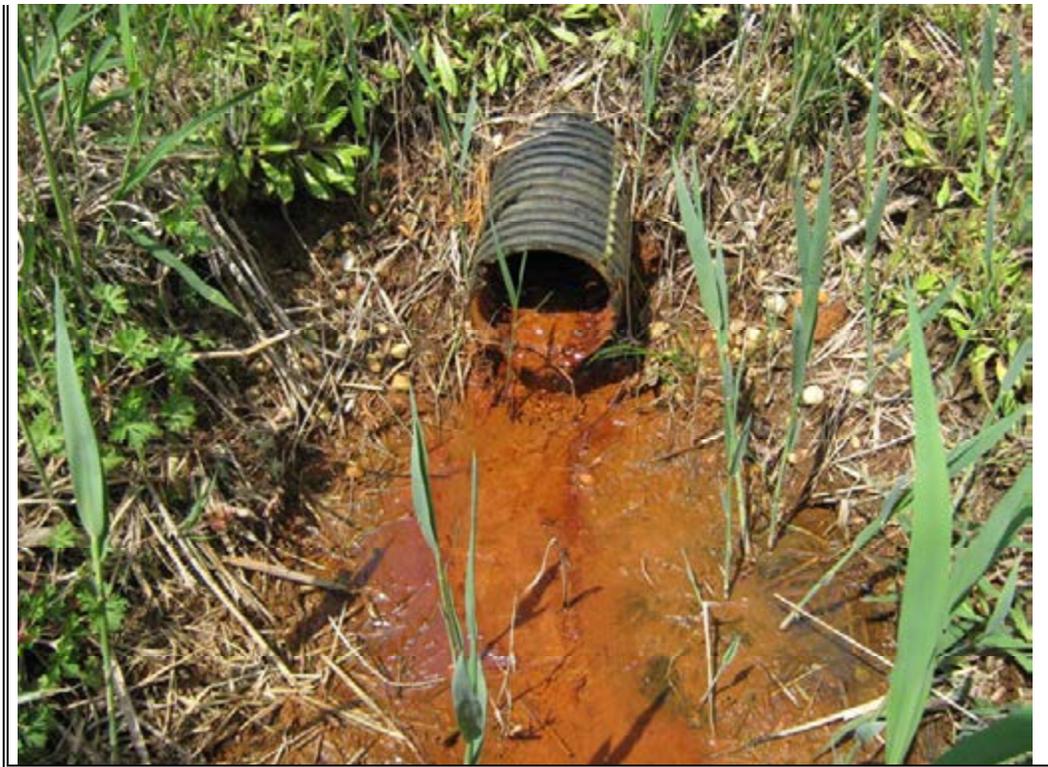
Photograph 26: Toe drain outlet pipe after cleaning – Southern Ash Area, south dike.

Photograph 26 shows the outlet after soil removal. We recommend that all of the outlet pipes be cleaned out.

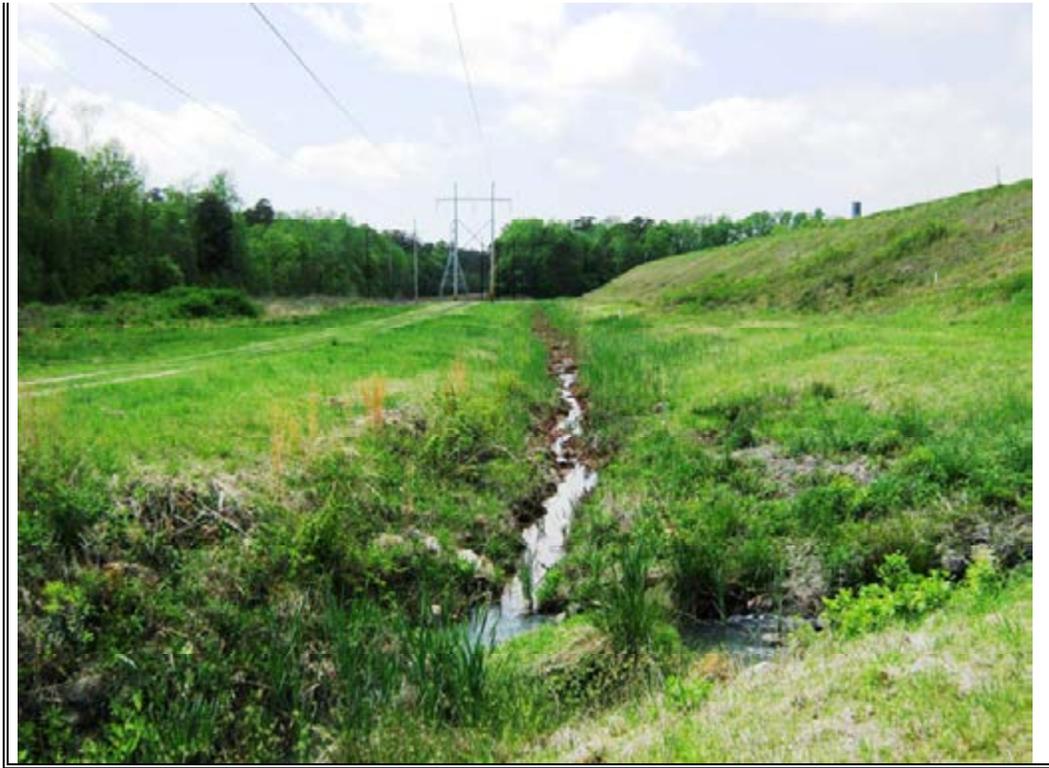
The ditch that carries the flow from the toe drain outlets and surface runoff was sufficiently clear of potential vegetation that would block flow into the outfall ditch (Photograph 27).

Photograph 27: Drainage swale along toe or south dike – Southern Ash Area.

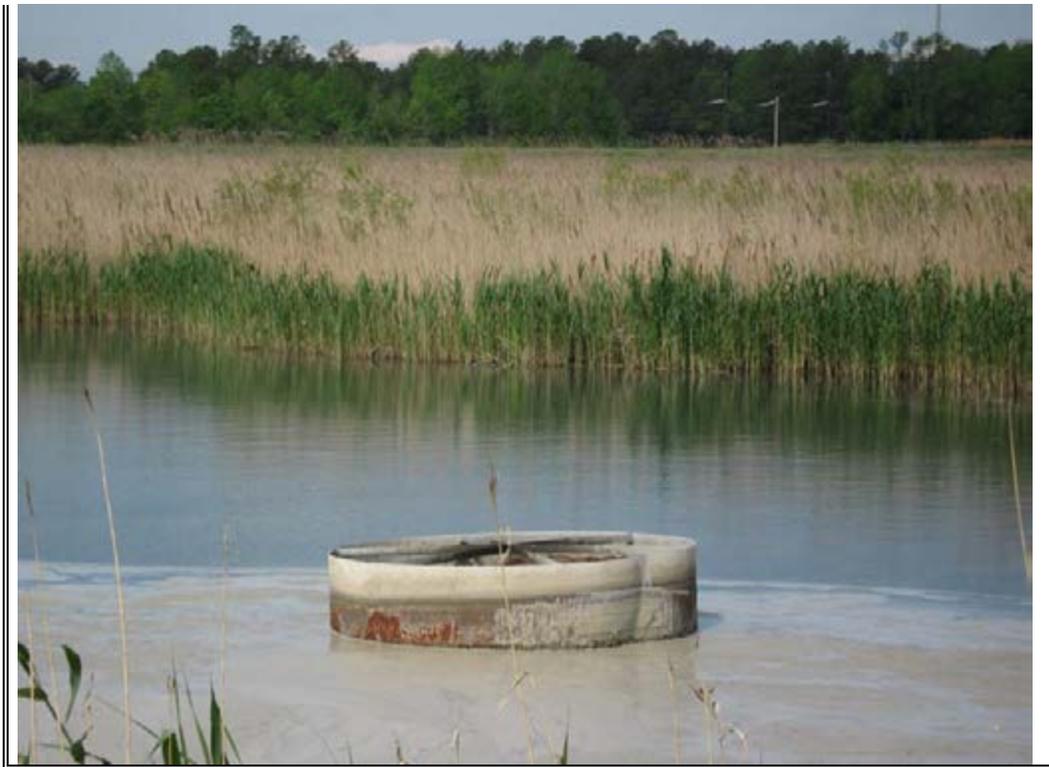
The pond water flows through a skimmer discharge structure to a settling pond. Water from the settling pond flows into a skimmer type inlet and discharges through a 24-inch diameter concrete pipe. Both skimmer structures are in good condition (Photographs 28 and 17). The skimmer for the main pond is slightly tilted as a result of a slight mis-alignment during recent removal in anticipation of a hurricane in 2009 and replacement. The mis-alignment does not impact the function of the vertical riser. The outflow pipe from the settling basin is in good condition at the outlet end (Photograph 29) and no signs of water flowing around the exterior of the pipe were seen.

Photograph 28: Skimmer structure for Southern Ash Area.
