**Coal Combustion Residue Impoundment
Round 9 - Dam Assessment Report**

Weatherspoon Steam Electric Plant

Ash Pond Embankment

Progress Energy Carolinas, Inc.

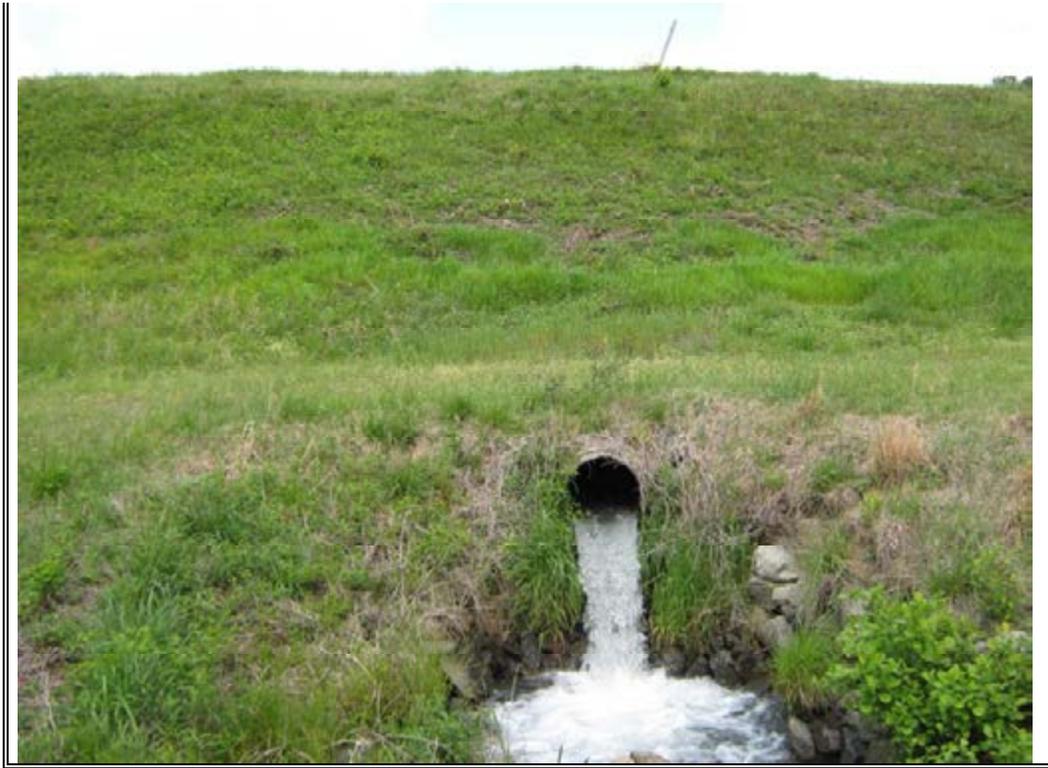
The pond water flows through a skimmer discharge structure to a settling pond. Water from the settling pond flows into a skimmer type inlet and discharges through a 24-inch diameter concrete pipe. Both skimmer structures are in good condition (Photographs 28 and 17). The skimmer for the main pond is slightly tilted as a result of a slight mis-alignment during recent removal in anticipation of a hurricane in 2009 and replacement. The mis-alignment does not impact the function of the vertical riser. The outflow pipe from the settling basin is in good condition at the outlet end (Photograph 29) and no signs of water flowing around the exterior of the pipe were seen.

Photograph 29: Discharge pipe outlet from Settling Basin – Southern Ash Area.

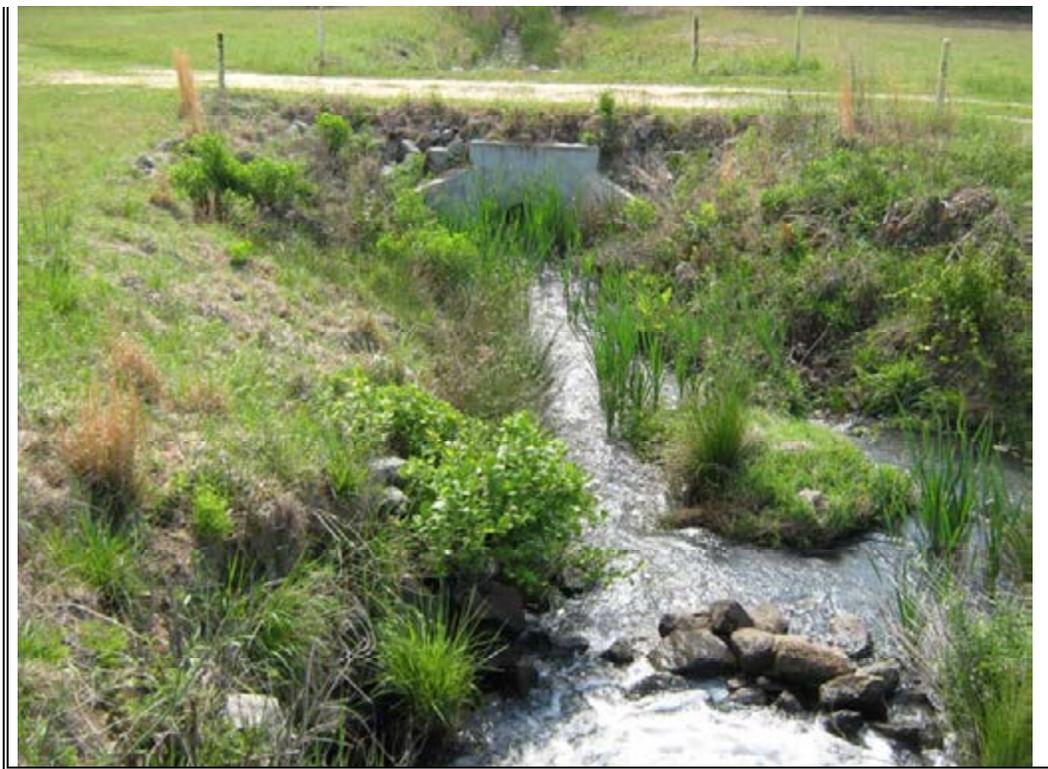
The outflow from the discharge pipe flows in a channel which has rip rap and vegetation, and then through a culvert under the access road to the Cooling Lake (Photograph 30). The timber headwalls for this culvert were replaced by concrete walls since the 2005 inspection.

Photograph 30: Outflow channel toward Cooling Lake – Southern Ash Area.

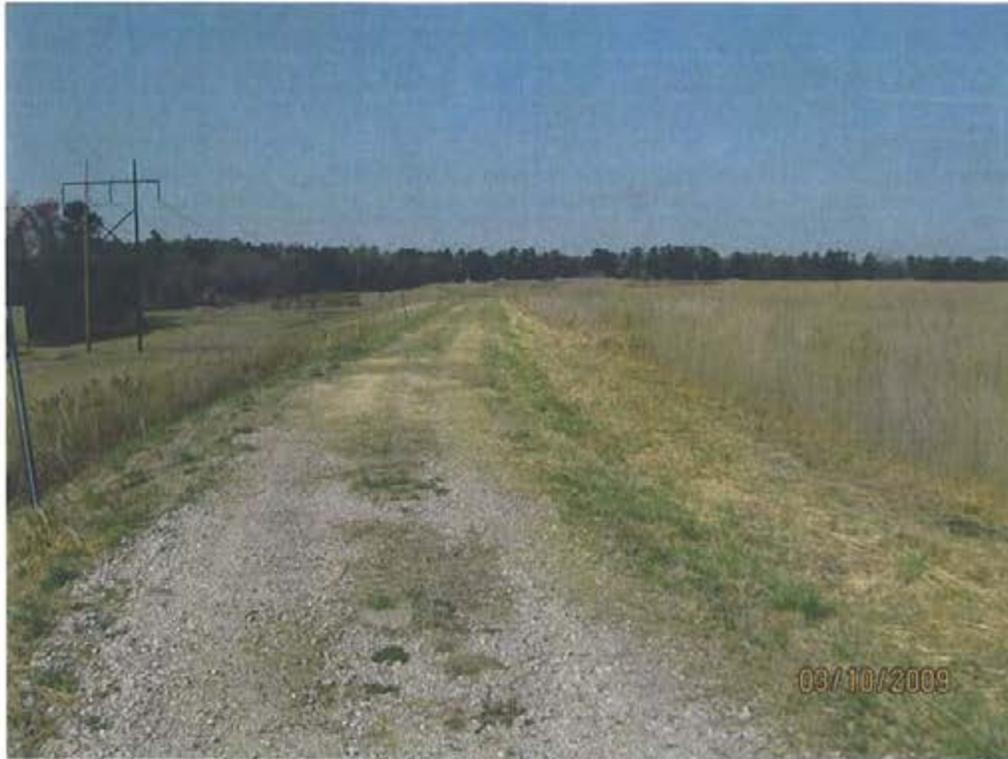
1. Ash Pond – Crest-West Dike looking North

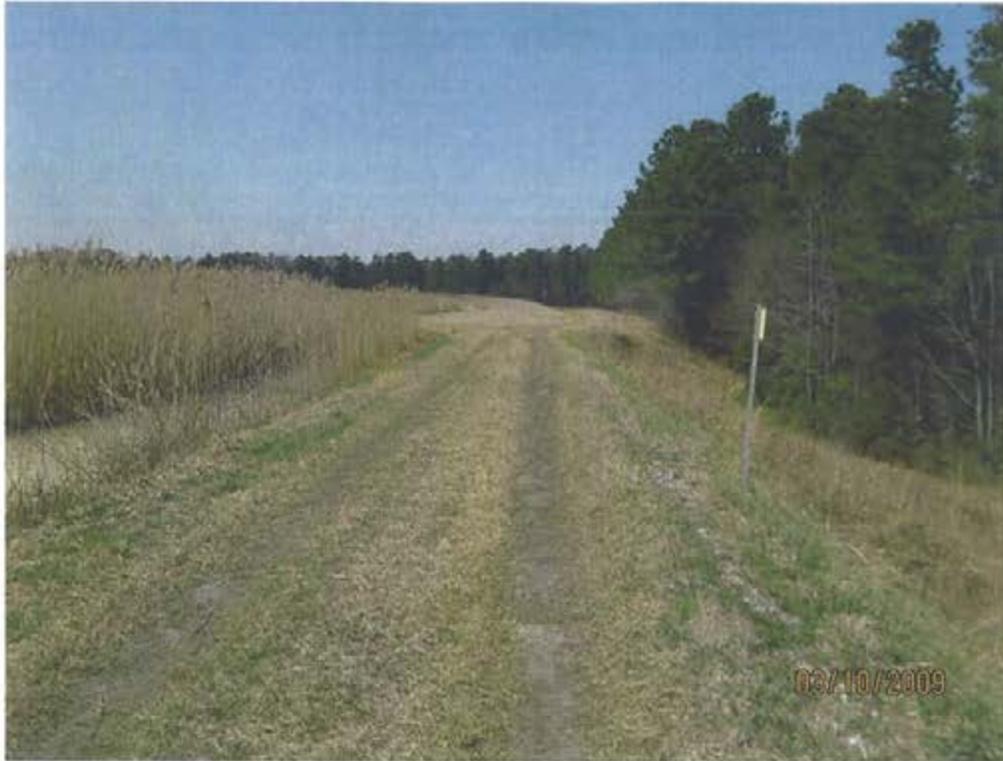
3. Ash Pond – Crest and interior slope -East Dike looking North

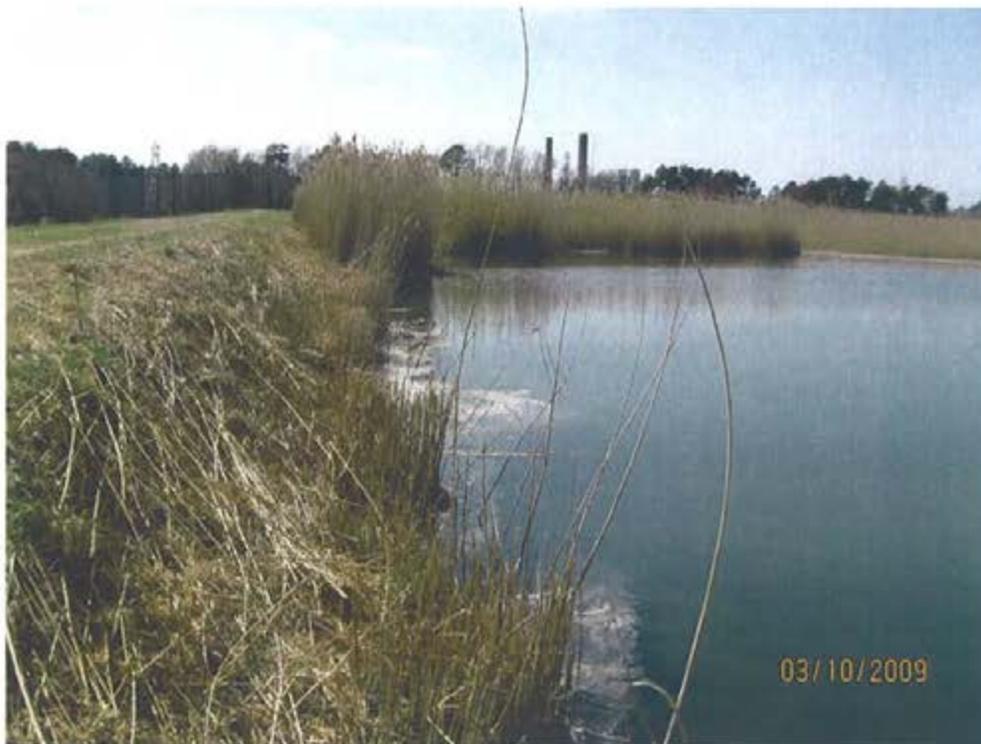
4. Ash Pond – Interior slope-South Dike looking West

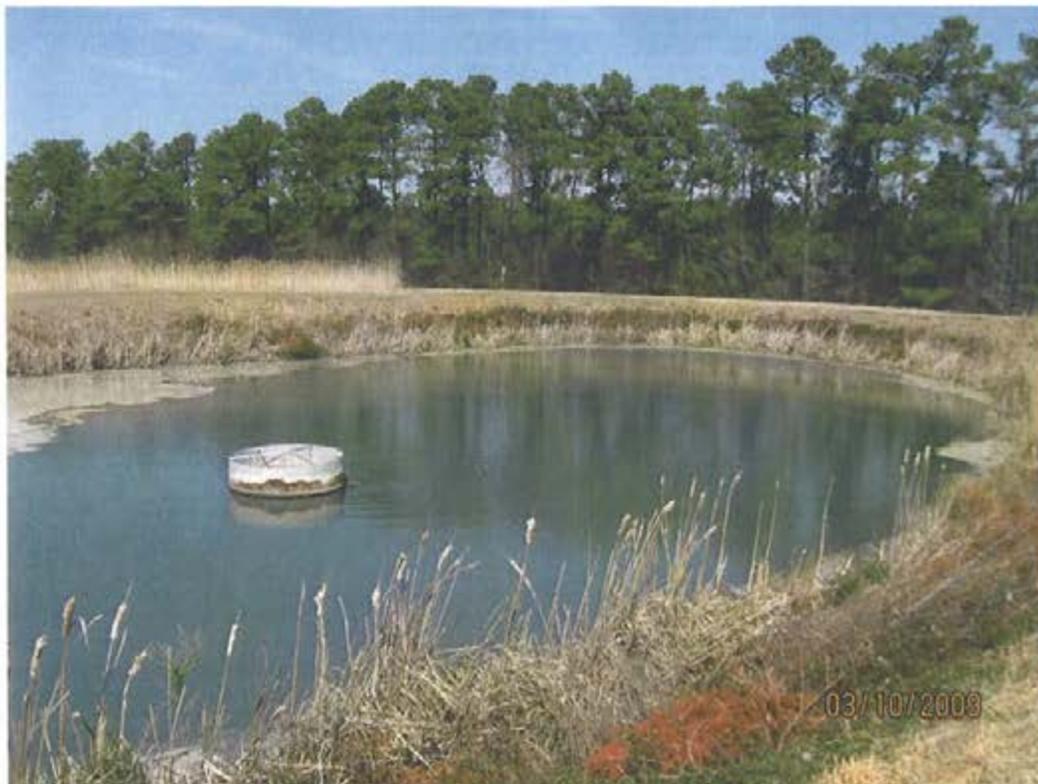
5. Ash Pond - Interior slope secondary settling pond dike

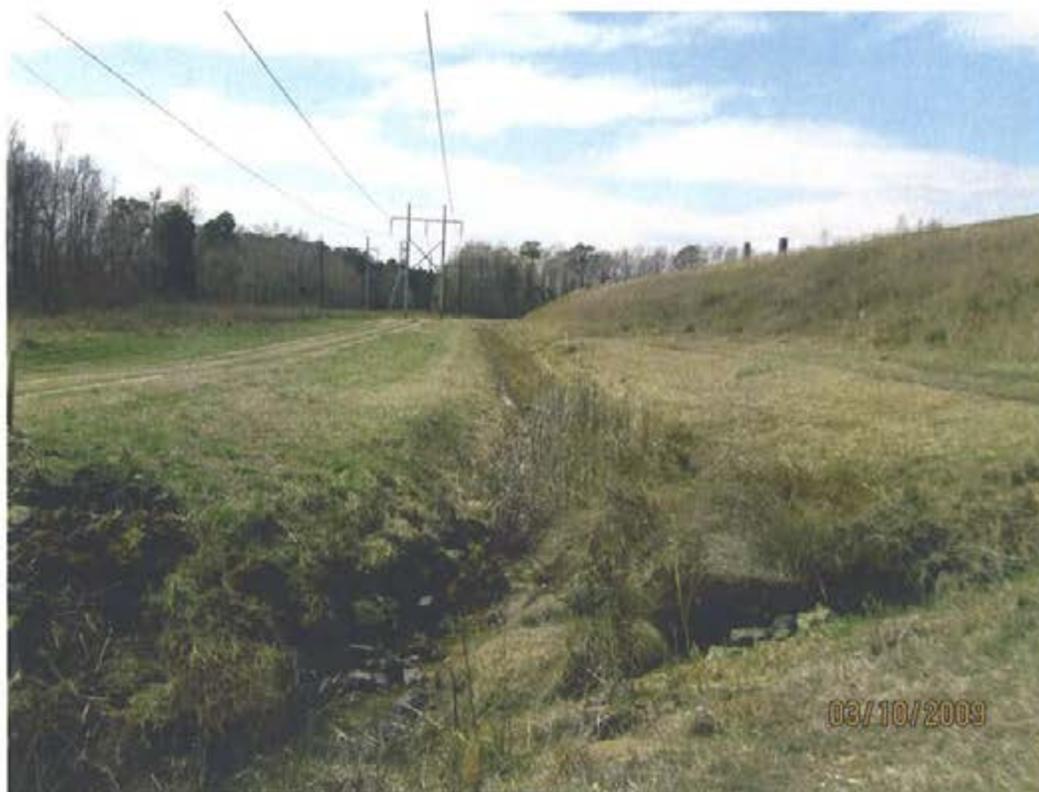
6. Ash Pond – Exterior slope, berm and drainage ditch – South Dike

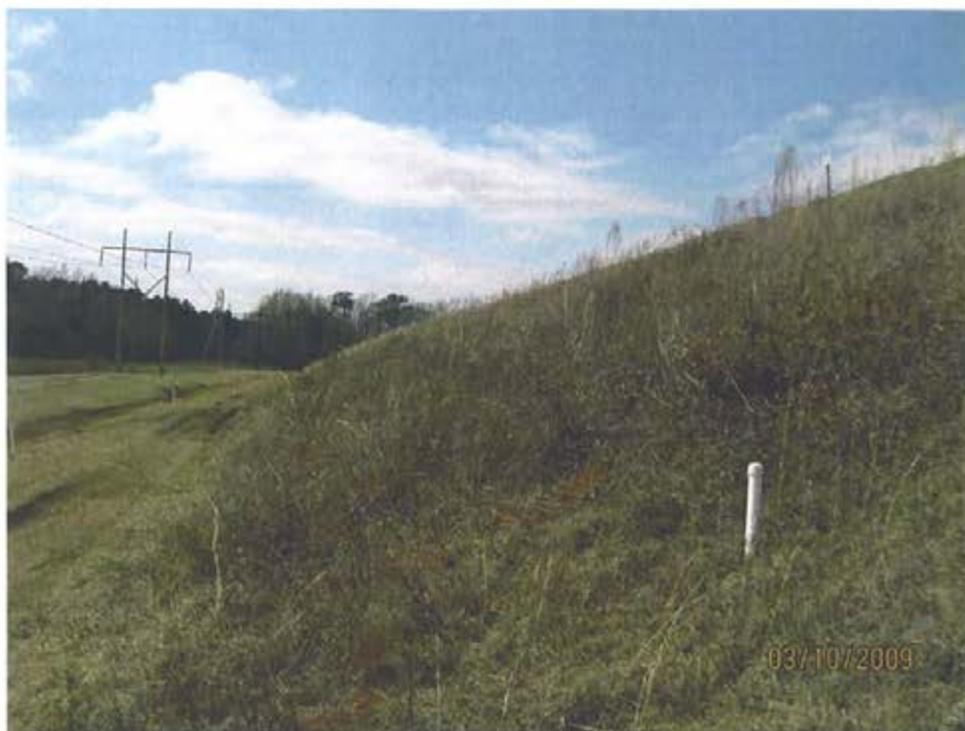
7. Ash Pond – South Dike-Exterior slope looking West

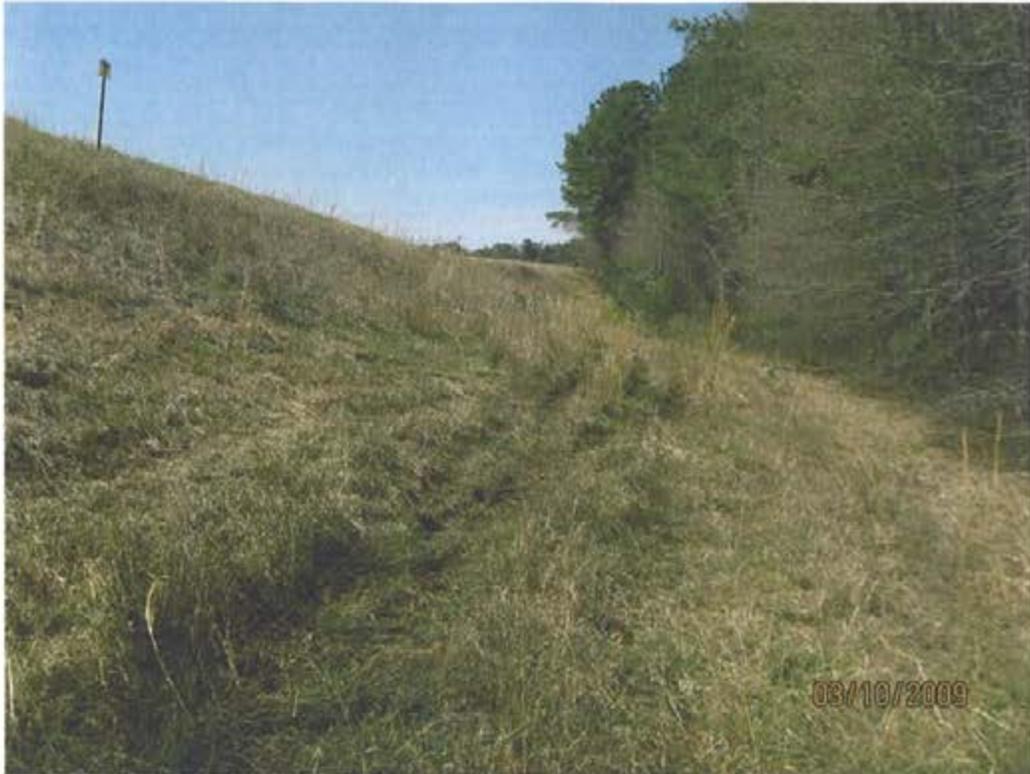
9. Ash Pond – East Dike-Exterior Slope looking North from south end

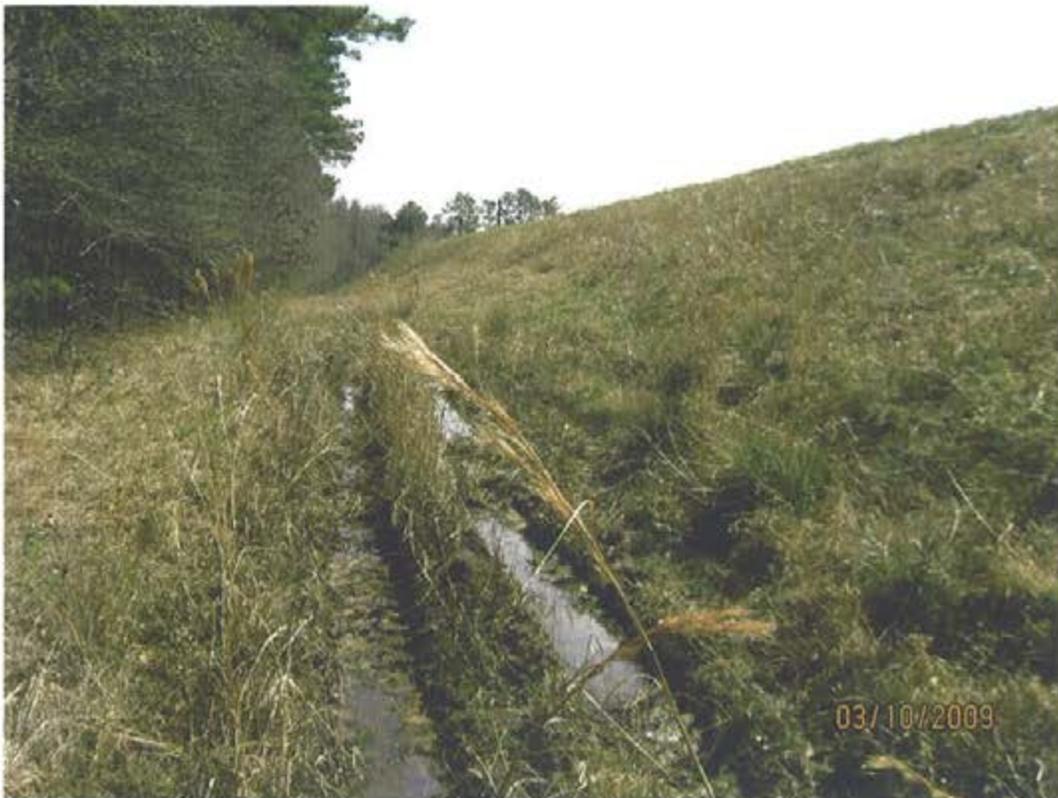
10. Ash Pond – East Dike looking south-Wet area at toe of slope

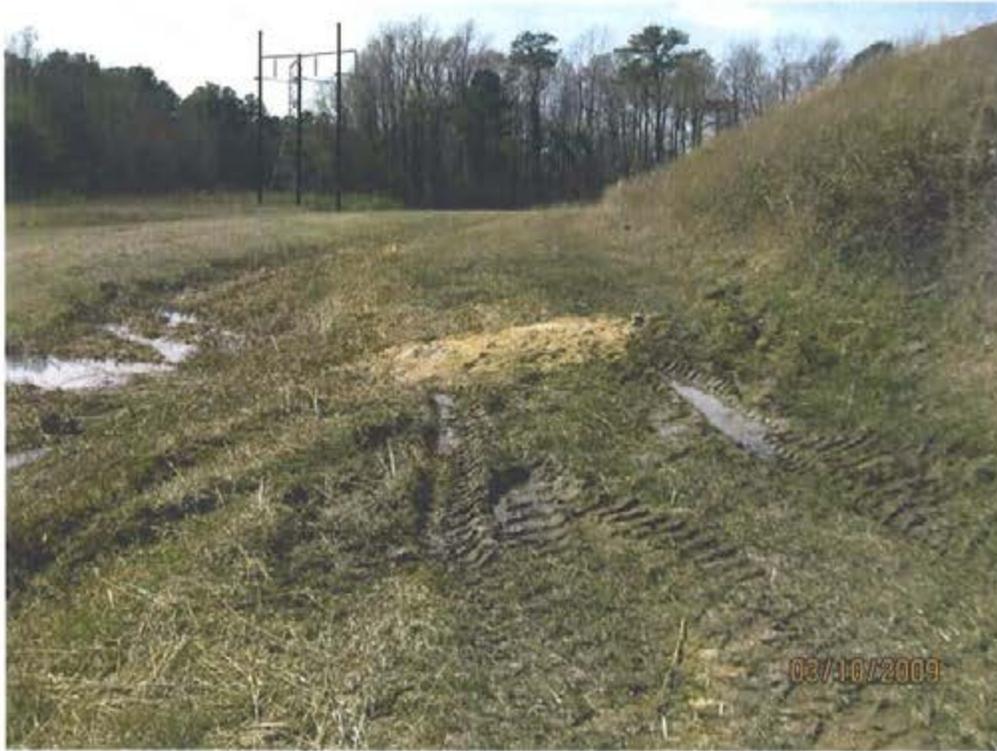
11. Ash Pond – South Dike-West end with ruts from mowing

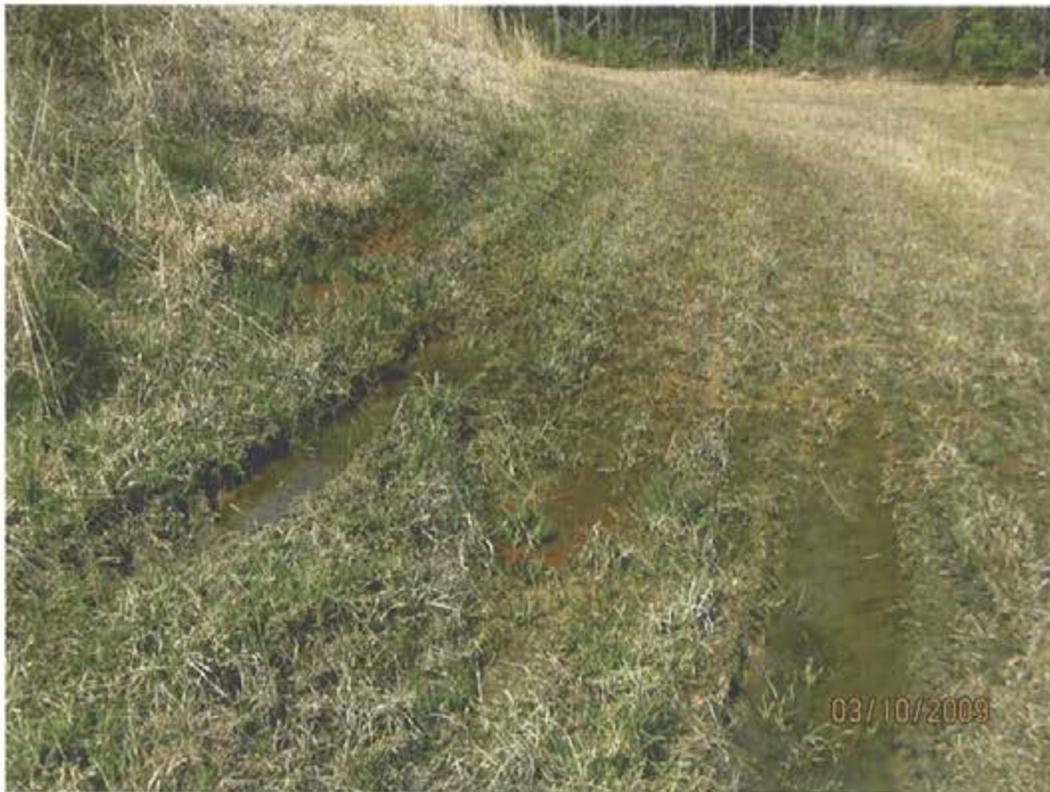
12. Ash Pond – Southeast corner-wet area (normally seen)

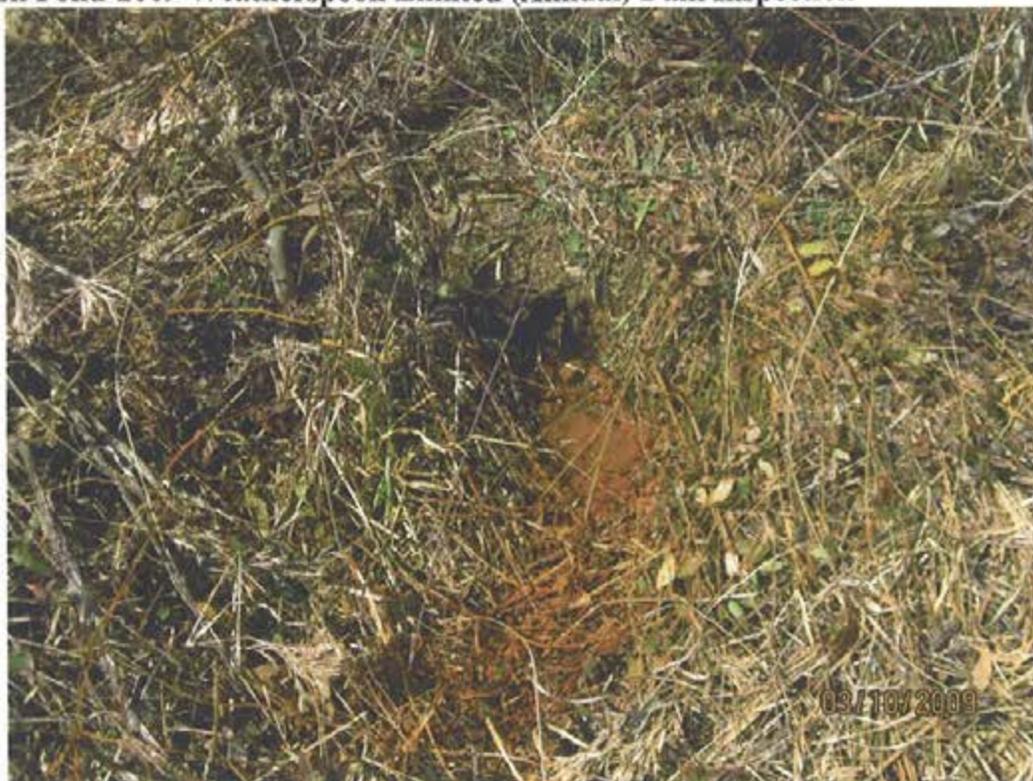
13. Ash Pond – Localized seep on south slope dike

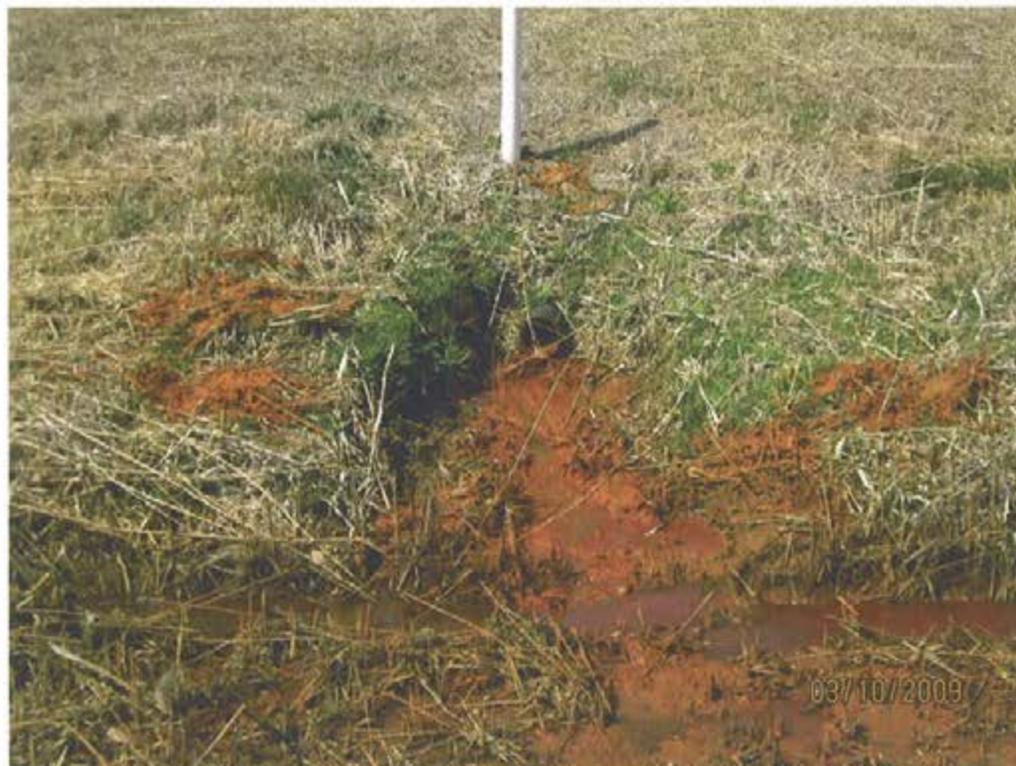
14. Ash Pond – South Dike-outlet from toe drain (typical)

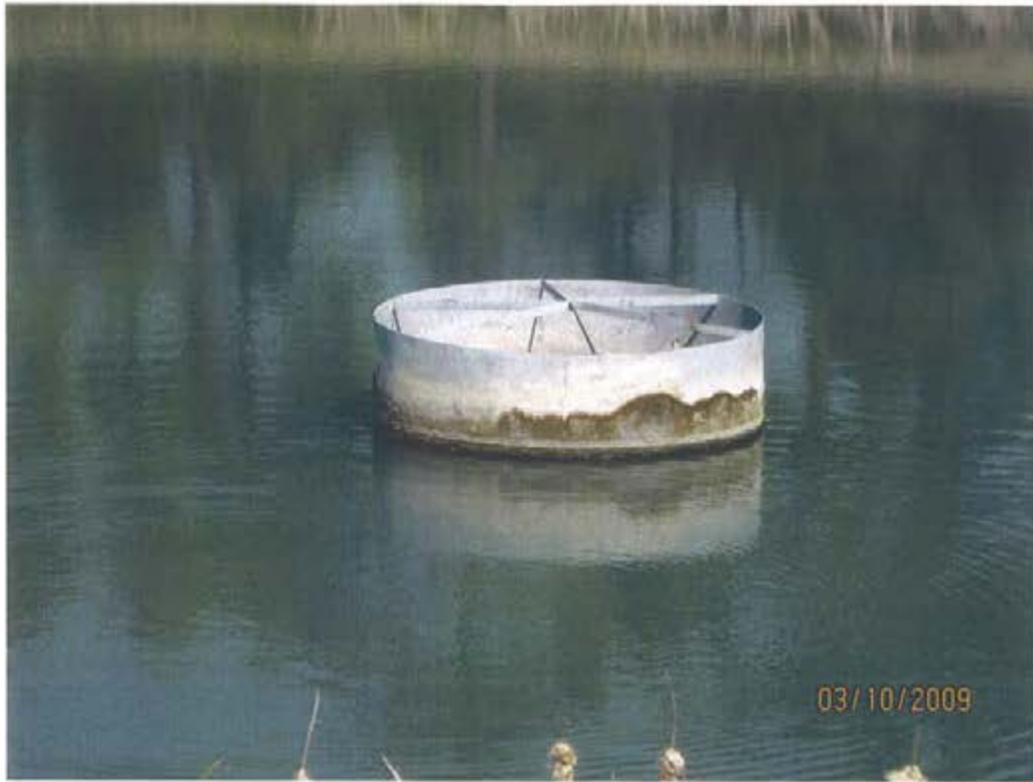
15. Ash Pond – Secondary Settlement Pond Skimmer on Riser

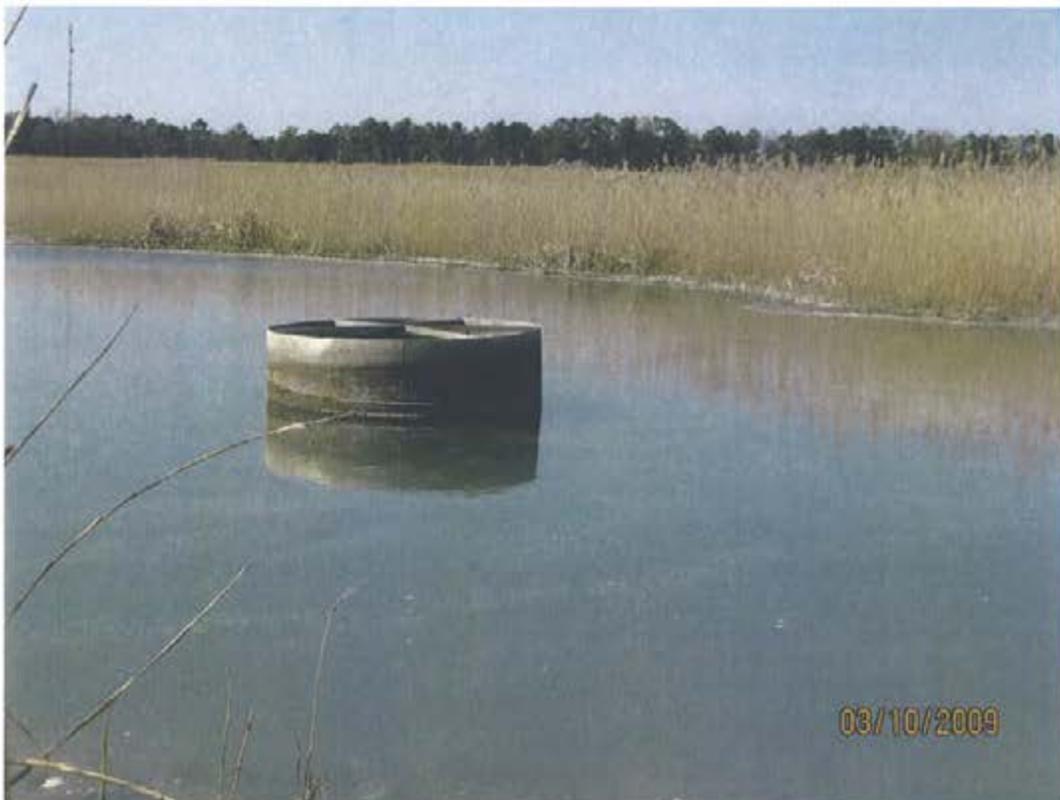
16. Ash Pond –Main Pond Skimmer on Riser

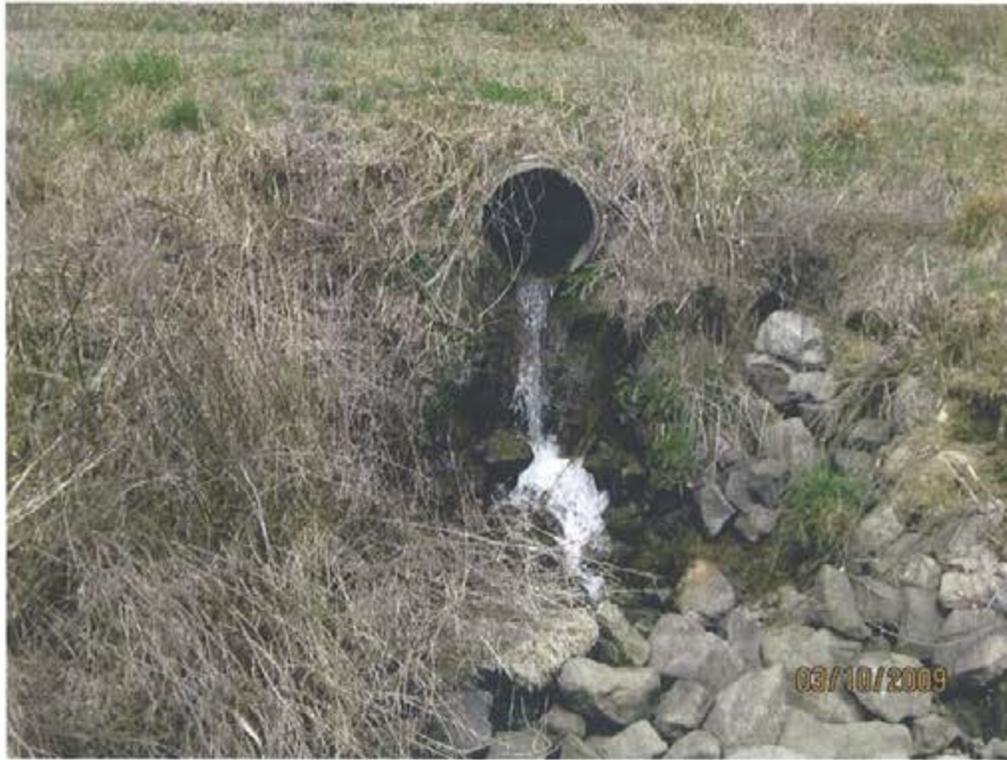
17. Ash Pond – Discharge from secondary settling basin

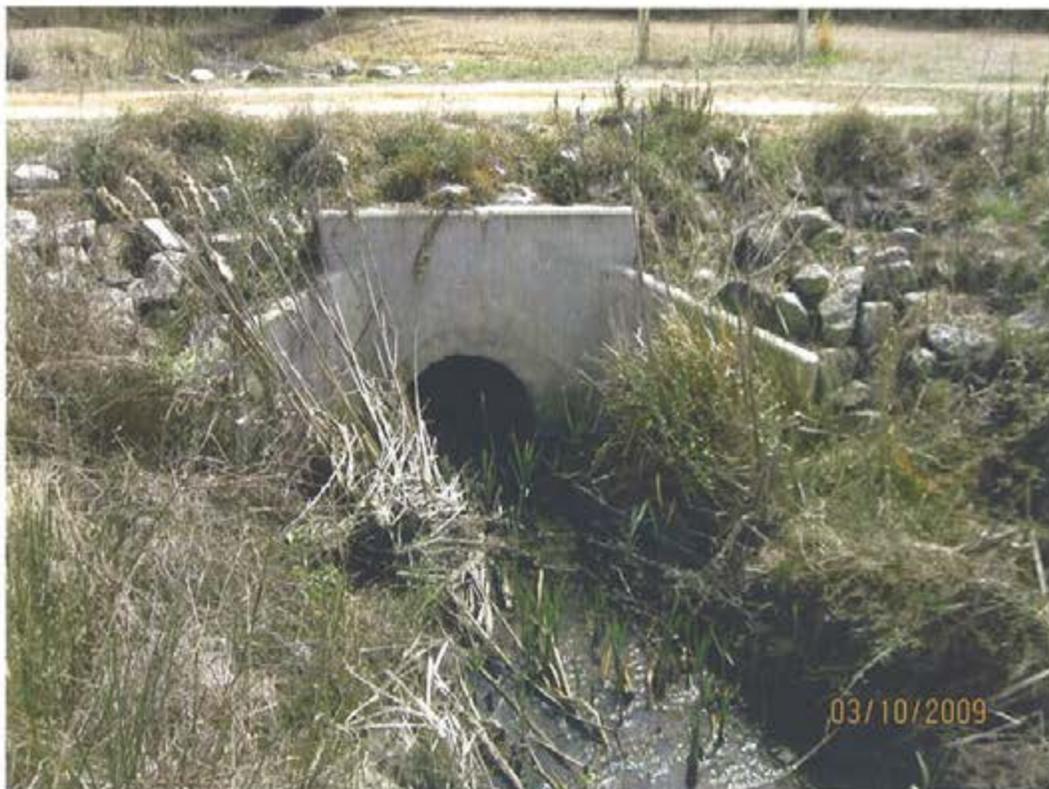
18. Ash Pond – Headwall for drainage pipe leading to cooling pond.
