**Coal Combustion Residue Impoundment
Round 11 - Dam Assessment Report**

Cumberland Fossil Plant
Dry Ash Storage / Ash Pond
TVA
Cumberland City, Tennessee

Dewberry Consultants LLC
Fairfax, Virginia

April 2013

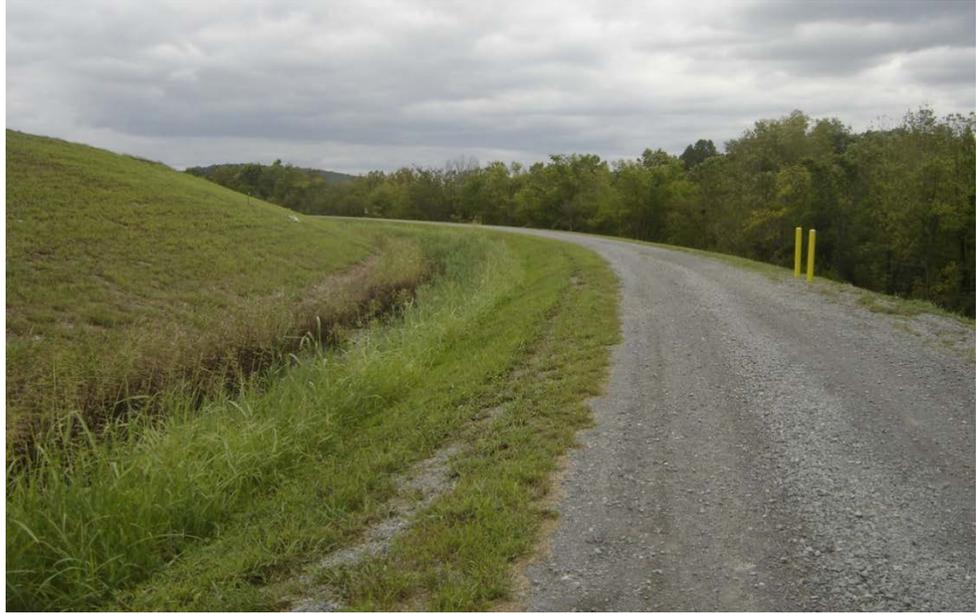
Figure 5.2.2-2 Photo showing inside slope, South Dike

There were no observed scarps, sloughs, bulging, cracks, or depressions or other indications of slope instabilities or signs of erosion. Figures 5.2.2-1 and 5.2.2-2 show the general condition of the inside slope. Vegetation should be installed to help minimize erosion in bare areas and maintained to allow for inspection of the slopes.

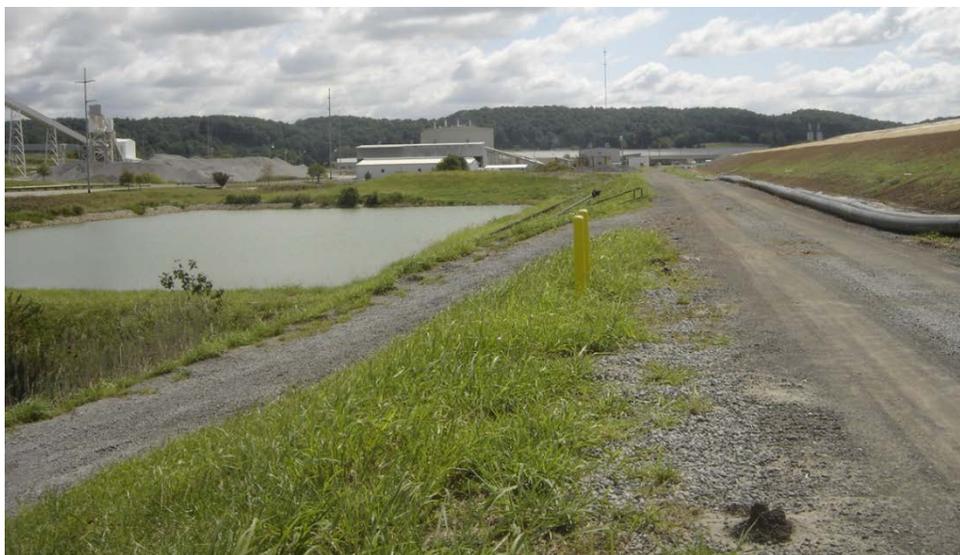
There were no observed scarps, sloughs, bulging, cracks, or depressions or other indications of slope instabilities or signs of erosion. Figures 5.2.3-1, 5.2.3-2 and 5.2.3-3 show general conditions of the outside slope.

Figure 5.2.3-2 Photo showing outside slope, North Dike. Incised Bottom Ash Pond is on left side of the photo

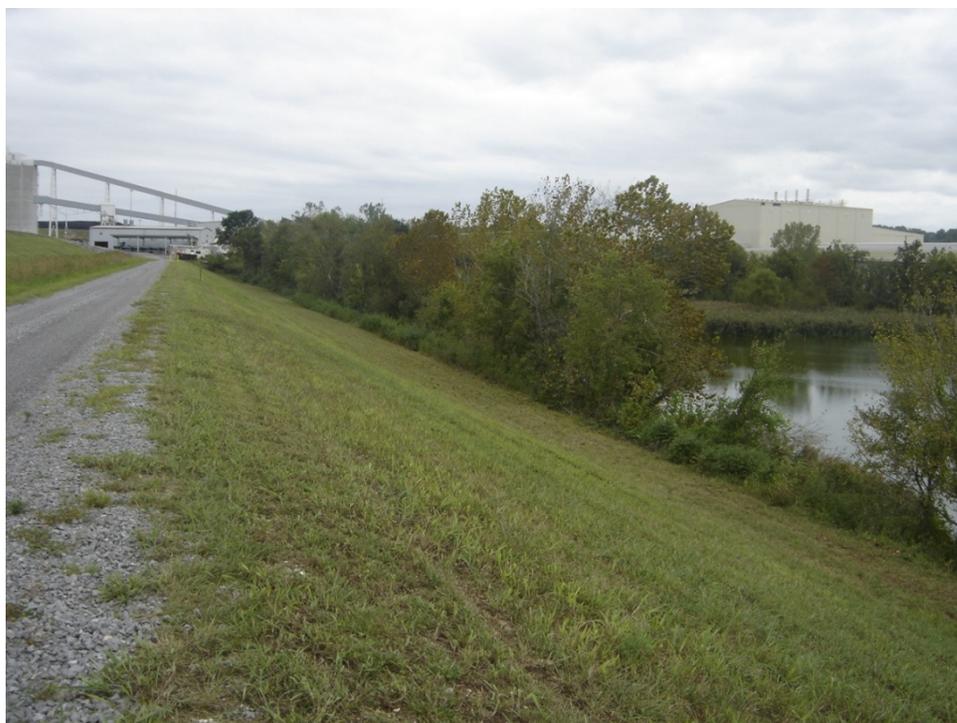
Figure 5.2.3-3 Photo showing outside slope, East Dike

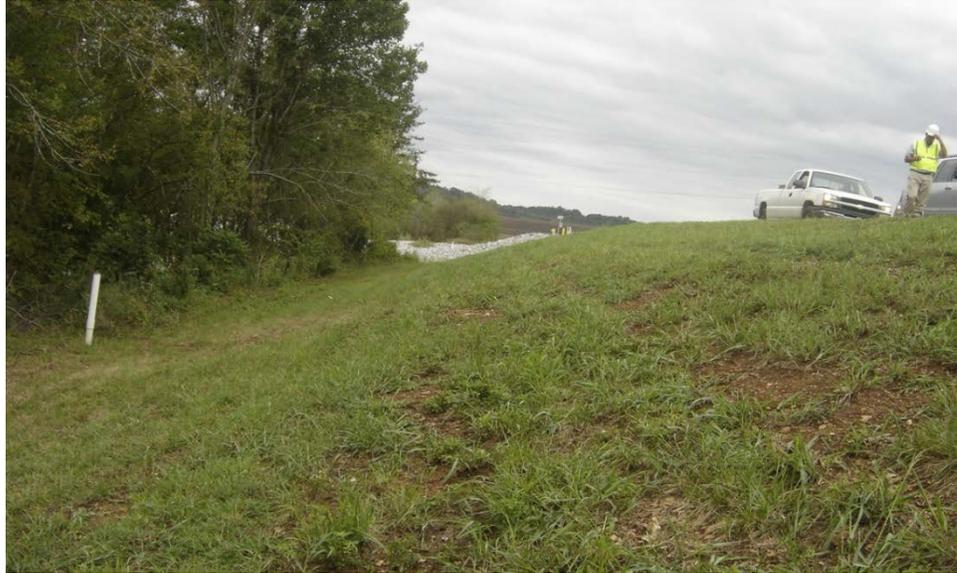
Figure 5.3.3-2 Photo showing outside slope, South/West Dike

There were no observed scarps, sloughs, bulging, cracks, or depressions or other indications of slope instabilities or signs of erosion. Figures 5.3.3-1 and 5.3.3-2 show the general condition of outside slope. Vegetation should be installed to help minimize erosion in bare areas and maintained to allow for inspection of the slopes.

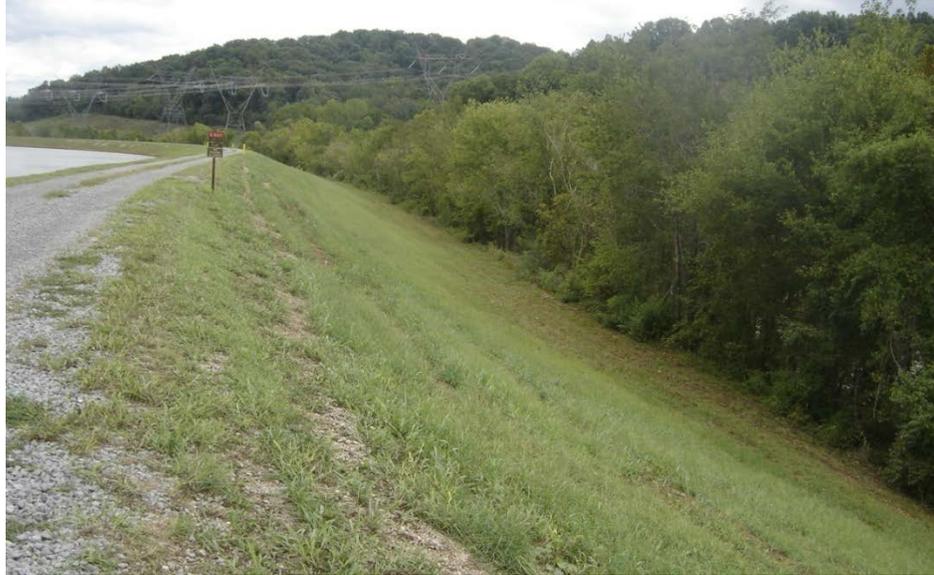
Figure 5.4.3-2 Photo showing outside slope, West Dike

There were no observed scarps, sloughs, bulging, cracks, or depressions or other indications of slope instabilities or signs of erosion. Figures 5.4.3-1, 5.4.3-2 and 5.4.3-3 show the general condition of outside slope.

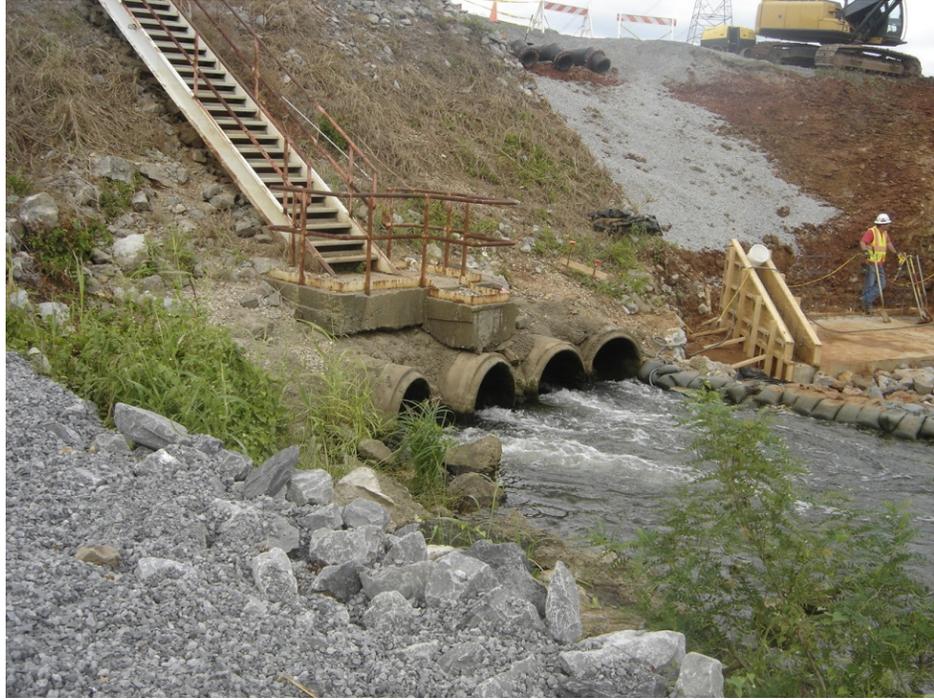
Figure 5.5.2 -1 Photo showing Outlet Conduits

The outlet pipes appeared to be operating normally with no signs of clogging and the water exiting the outlets was flowing clear.

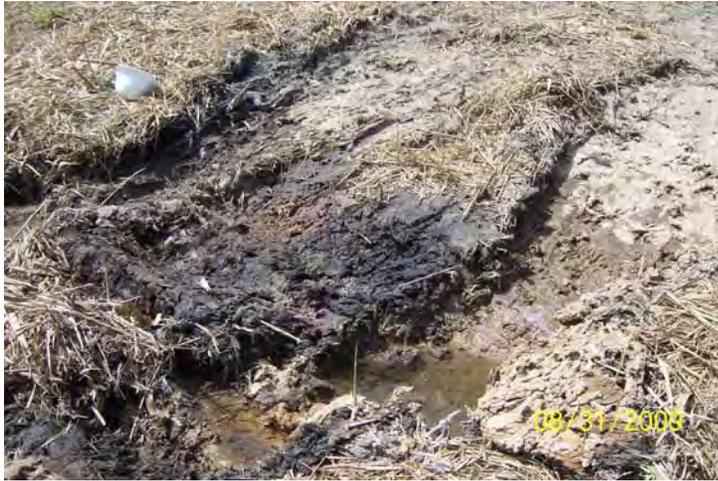
Area of Concern 1

Seepage along the southeast toe of dike.

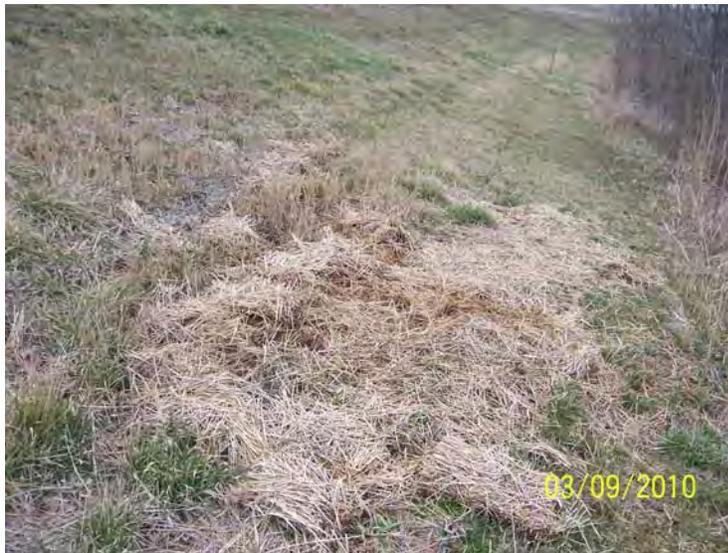
Area of Concern 1

Seepage along the southeast toe of dike.

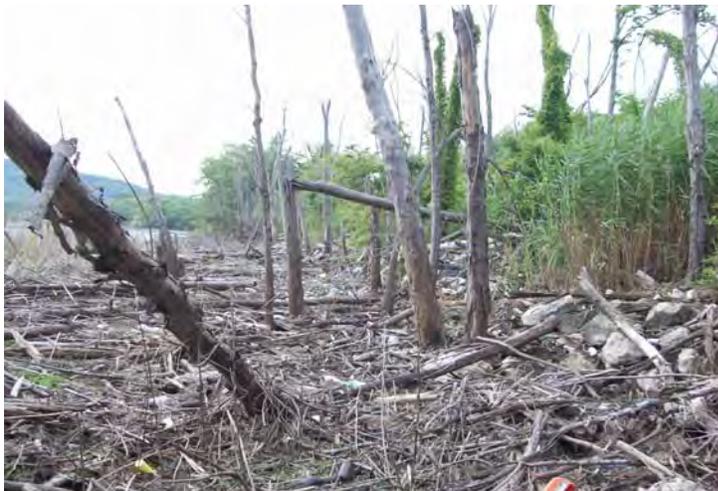
Area of Concern 2

Slope failure located along the perimeter of the southwest corner of the complex.

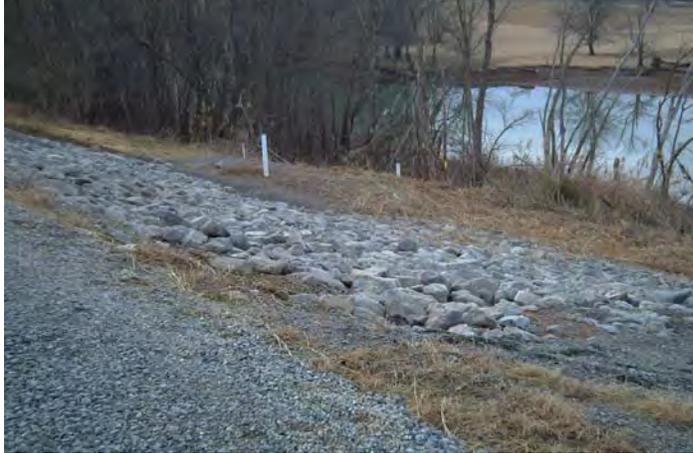
Area of Concern 2

Slope failure located along the perimeter of the southwest corner of the complex. Rip-rap placed over failure.

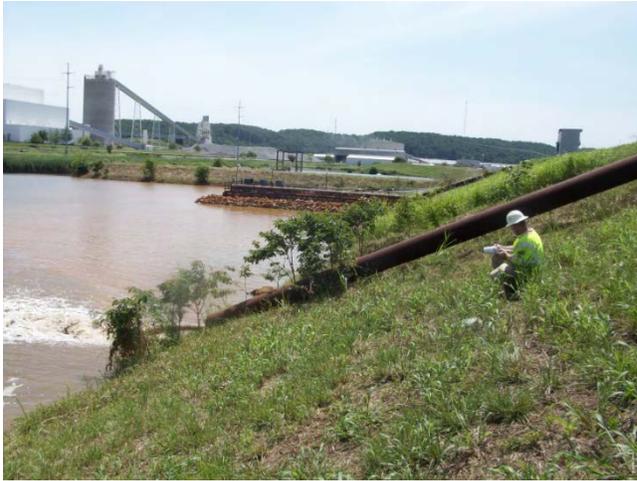
Photo 1

Small tree growth along the south slope of the Coal Yard Drainage Basin (CYDB).

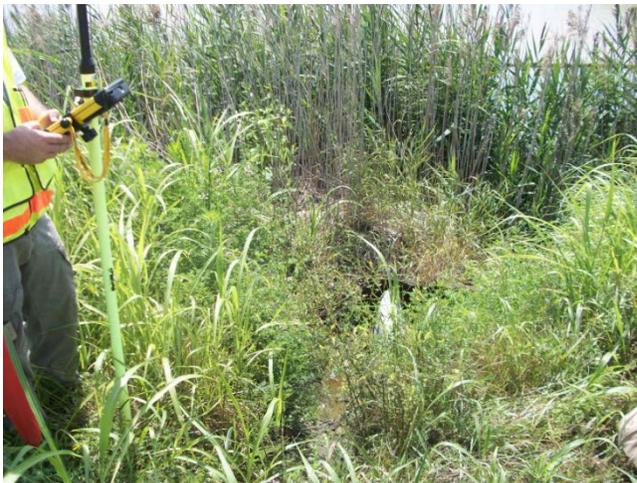
Photo 2

Erosion at drainage feature on the west slope of the CYDB.

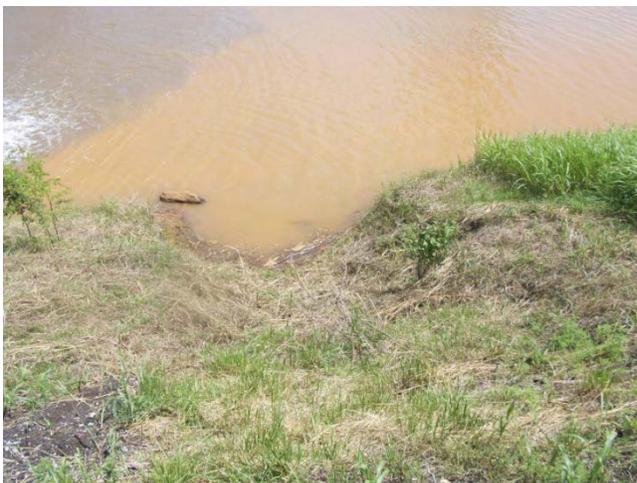
Photo 3

Depression in dike face. Not previously noted due to vegetation coverage.

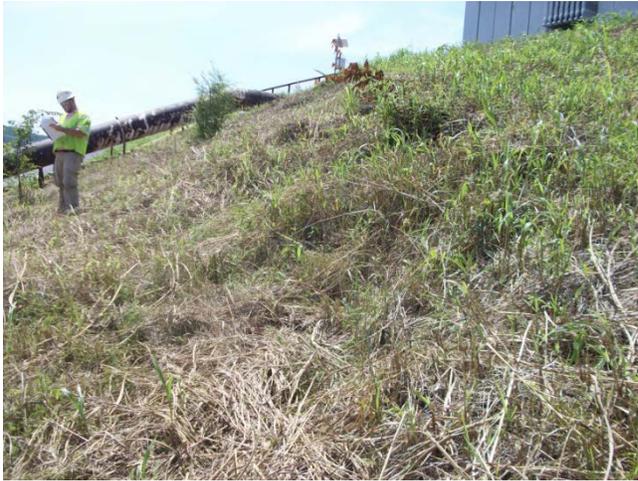
Photo 4

Minor surface slip on the south interior dike face.

- The observed slope instability in the face of the south slope should be re-graded and vegetated (see Photo 4). (Priority 3)
- The animal burrows observed on the interior slopes on the east and northeast sides of the CYDB should be repaired in accordance with the guidelines given in Enclosure G. (Priority 3)

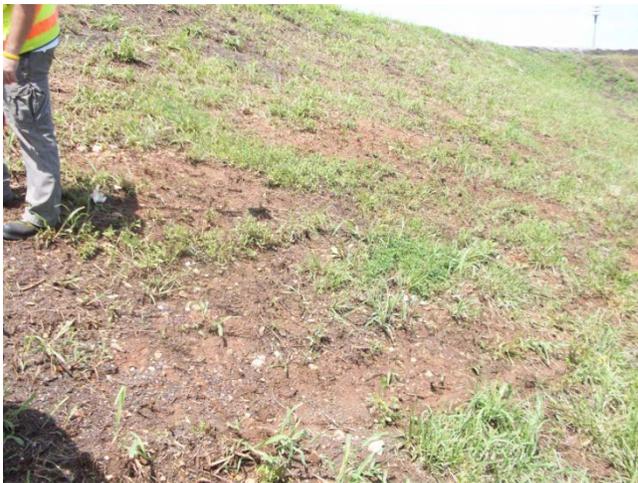
Photo 5

Rutting and sparse vegetation on the south interior slope face.

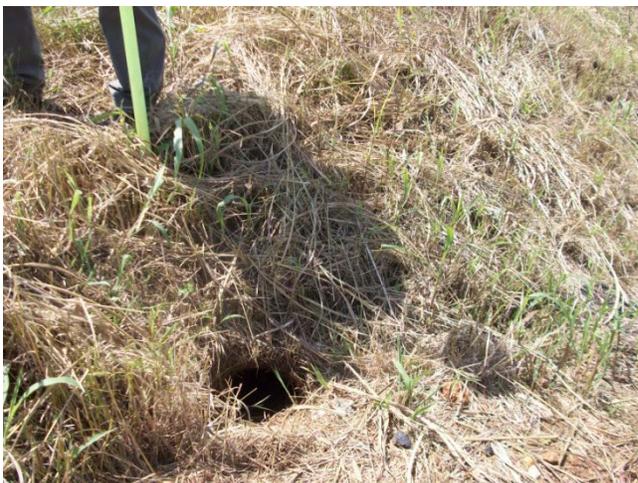
Photo 6

Animal burrow observed on the east slope.

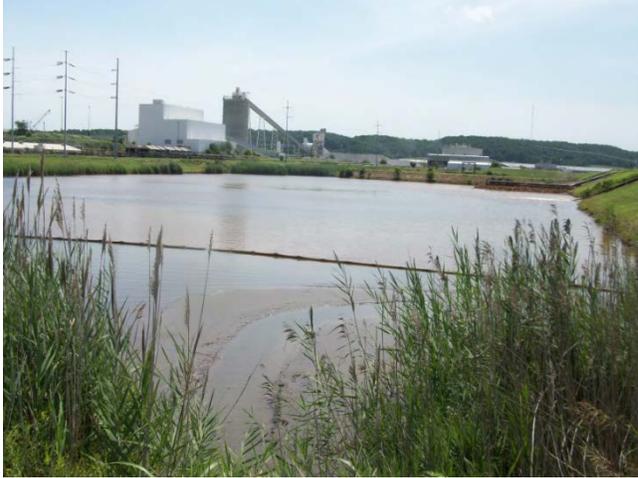
Photo 7

Sediment accumulation at primary inlet of CYDB.

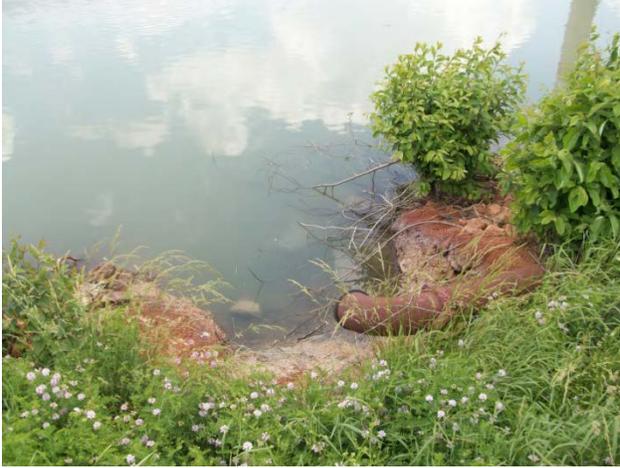
Photo 1

Recirculation pipe and concrete gutter at the east slope of the pond.

- It is recommended that the area around the concrete gutter at the outlet of the recirculation pipe on the east slope of the pond be monitored for erosion (see Photo 1). This area should be examined during recirculation in order to determine if the gutter is capable of containing the flow. If the gutter is overtopped or if splashing occurs causing the water not to be contained in the gutter, the gutter should be widened. (Priority 5)

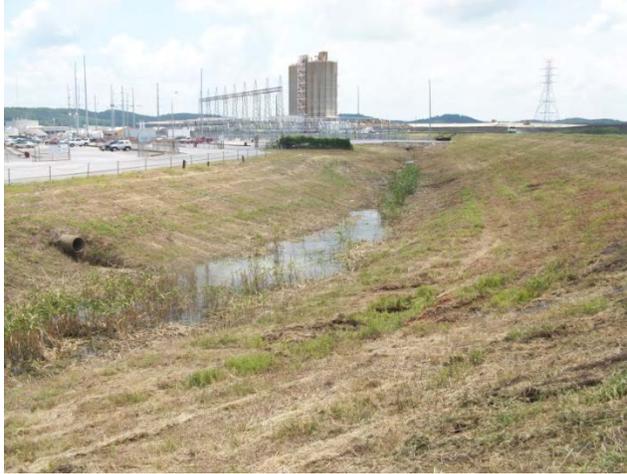
Photo 1

Standing water and phragmites in exterior ditch on the east side of the Active Ash Pond.

- The drainage ditch on the east side of the Active Ash Pond should be cleaned of phragmites and any accumulated sedimentation. The slope of the ditch in this area should be evaluated to assess if better flow is possible to alleviate the standing water observed. (Priority 4)

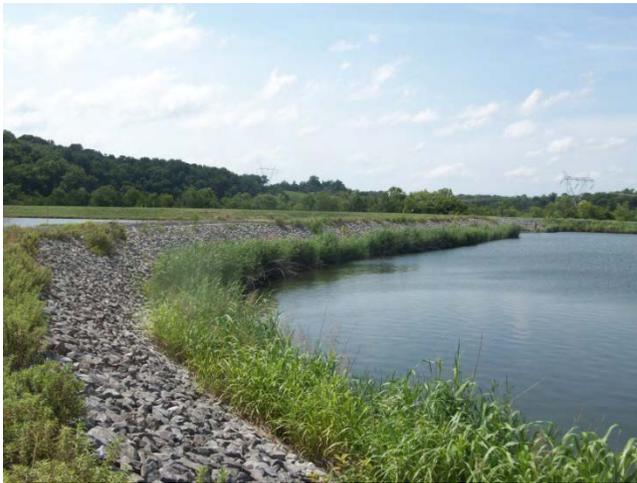
Photo 2

View of the interior divider dike within the Active Ash Pond. Few small trees visible.

- The trees observed on the interior divider dike should be removed in accordance with the guidelines given in Enclosure F (Priority 4).

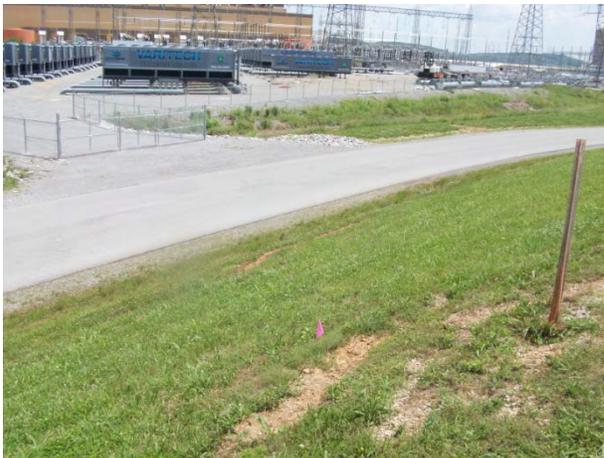
Photo 3

Rutting and absent vegetation on the exterior slope on the east side of the Stilling Pond.

- Areas where tire rutting is observed along both the interior and exterior slopes should be repaired and reseeded as described in Enclosure H. Special care should be taken, if possible, to not perform maintenance on the slopes of the ponds during conditions that could result in rutting. (Priority 5)

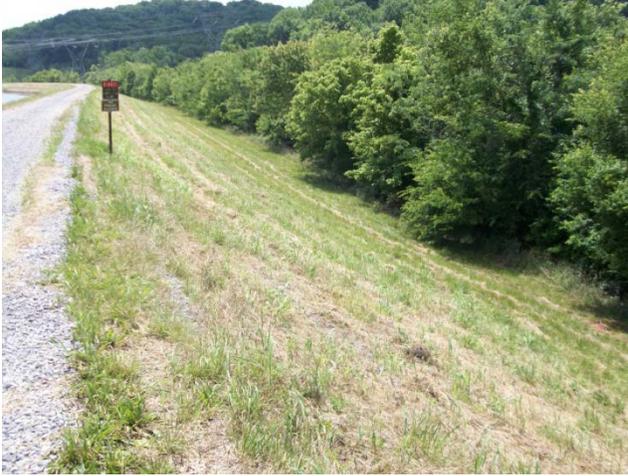
Photo 4

Area at the exterior midslope and toe of the Active Ash Pond where moist/damp areas were observed.

- Observation of the moist areas on the midslope and toe of the west exterior slope of the Active Ash Pond should continue to determine if these are seeps or if they are moist from recent precipitation. Any changes in the flow or color of these areas should be reported to Fossil Engineering Design Services (EDS). This should be completed in accordance with the Seepage Action Plan.

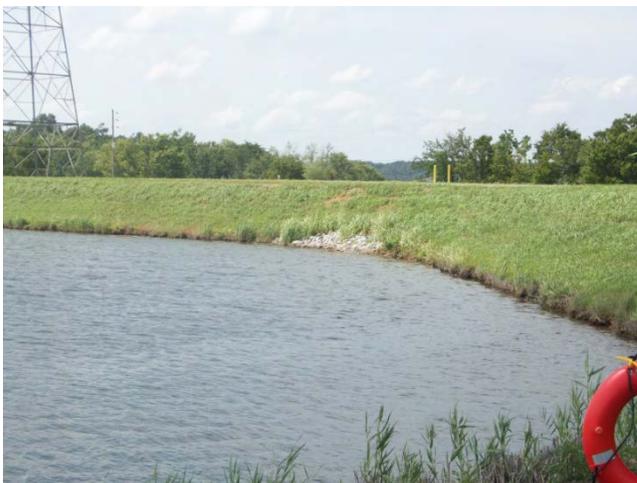
Photo 6

Wave action erosion repaired using rip-rap.

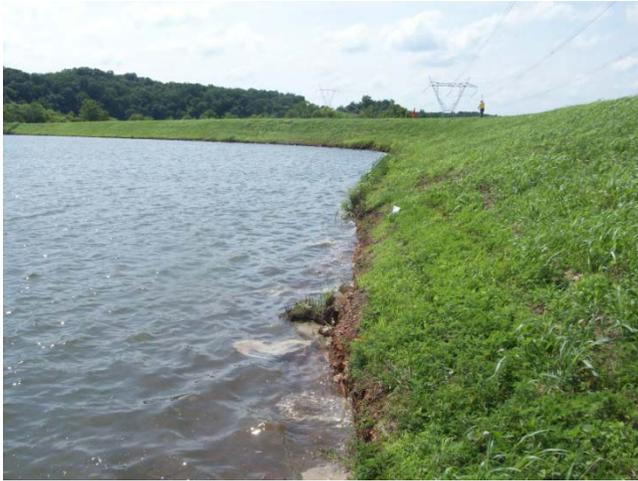
Photo 7

Wave action erosion is present.

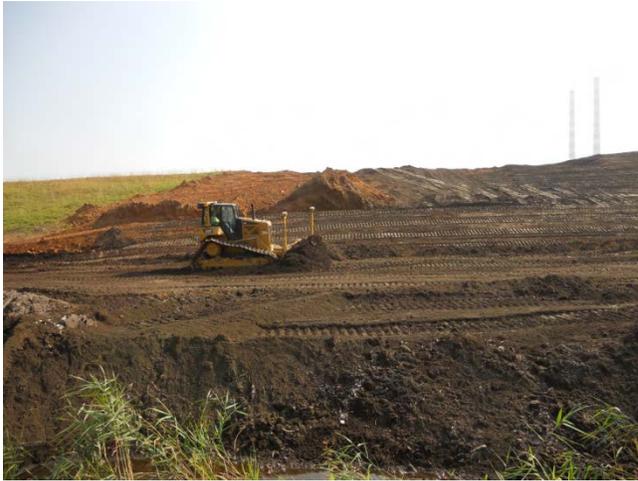
Photo 1

Vegetation and soil cover being removed as part of WP 11

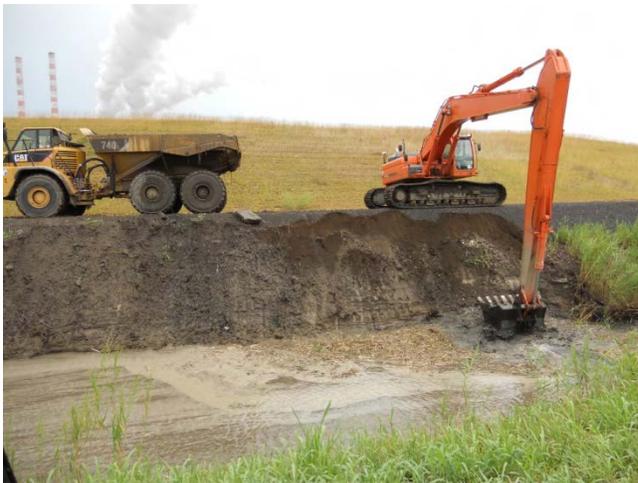
Photo 2

Construction access road and vegetation removal from ditch.

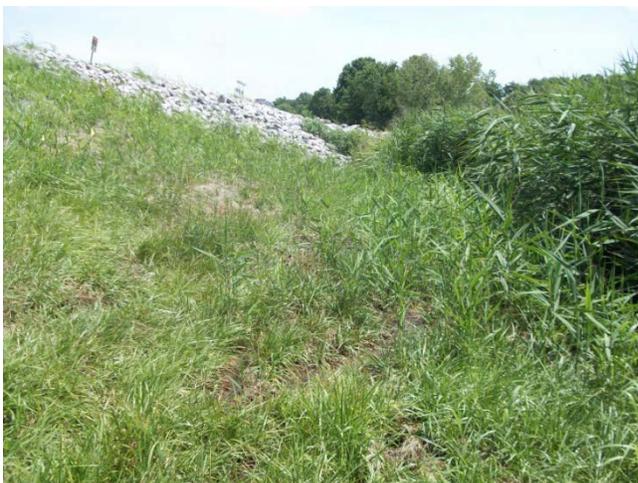
Photo 3

Seep #15 adjacent to the completed slope repair project.

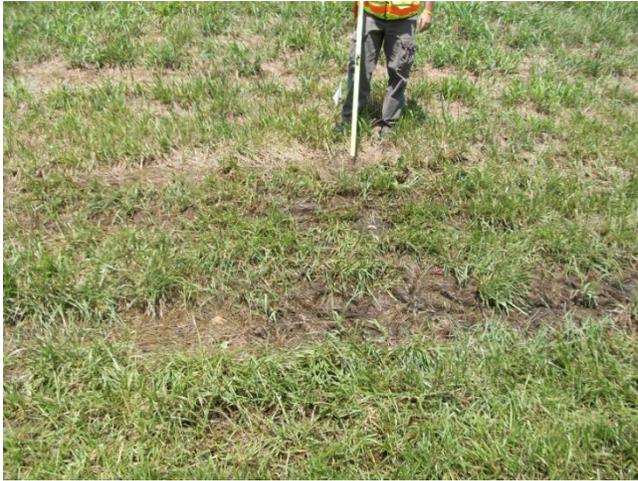
Photo 4

Wet area noted just above the bench on the exterior slope.

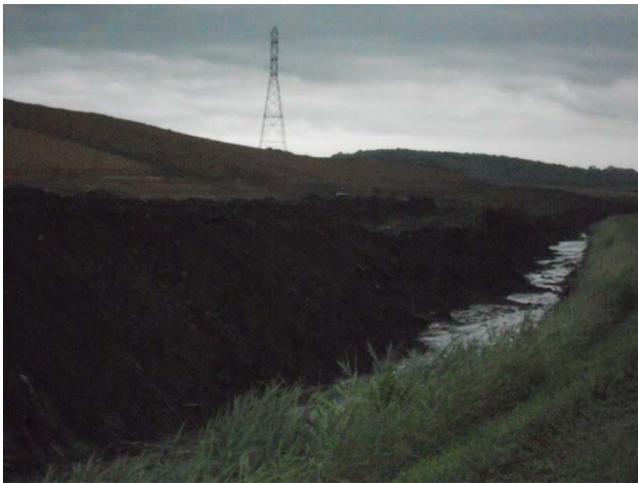
Photo 5

Sedimentation in Ditches: Sedimentation from construction activities was observed in the perimeter drainage ditch (see Photo 5). The side slopes of the ditch show shallow sloughs and scarps due to excavations along the ditch to clean them.

Sedimentation and obstructions observed in perimeter ditch.

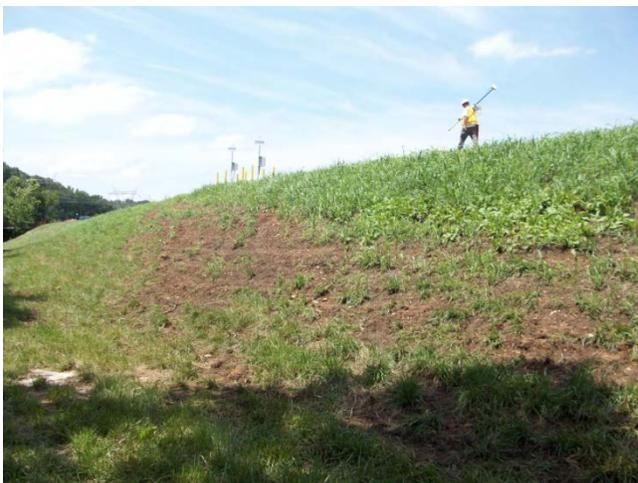
Photo 6

Sparse vegetation on the slope.

- The area of sparse vegetation (see Photo 6) observed on the south west exterior slope of the stack should be monitored as part of TVA's Inspection Program and repaired as conditions warrant. This area should be reworked, graded, and a new soil cover be installed suitable to support vegetation. The area should then be seeded. (Enclosure F)

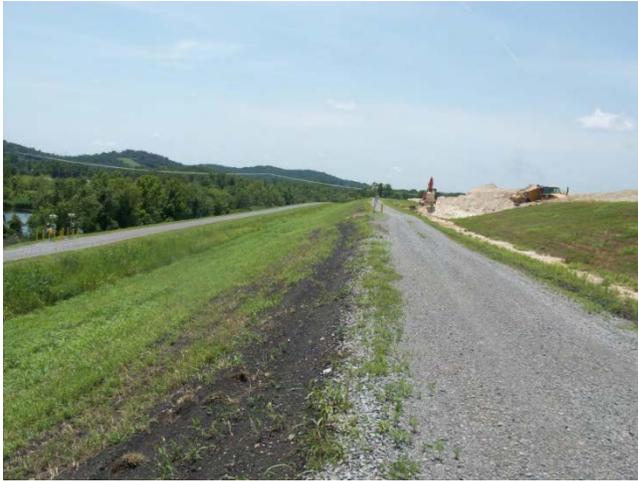
Photo 1

Vegetation and rutting along bottom ash road dike crest.

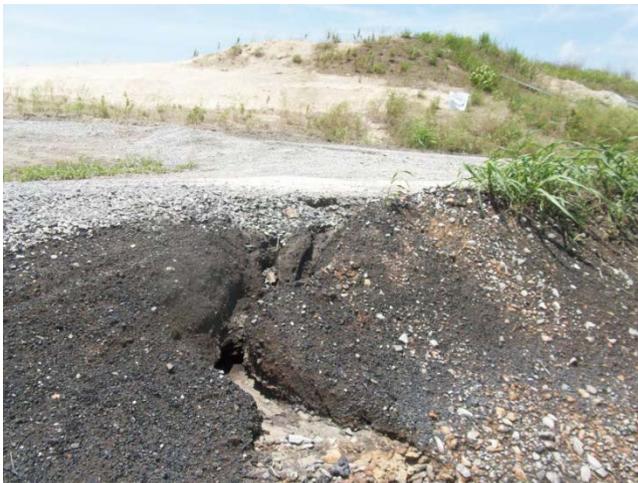
Photo 2

Erosion of road at the northeast corner of the complex.

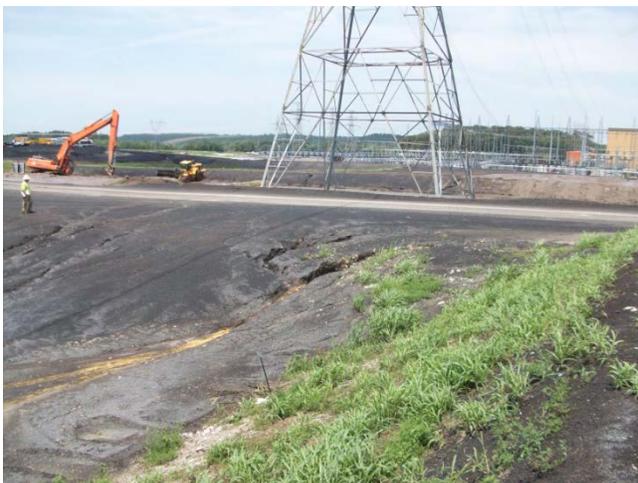
Photo 3

Erosion at north end of the diversion ditch between Dry Fly Ash Stack and Gypsum Stack Complex.

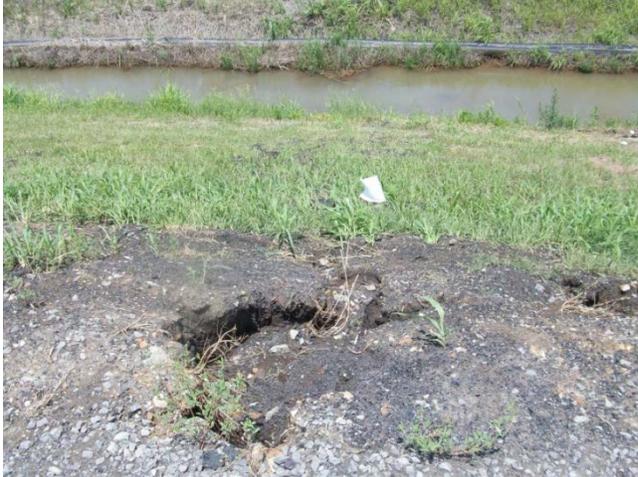
Photo 4

Erosion on bottom ash road dike above the
CYDB pump station

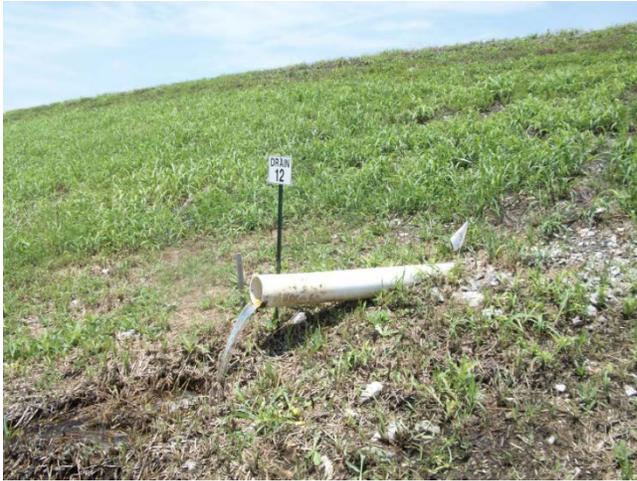
Photo 6
Erosion noted below subdrain 12.

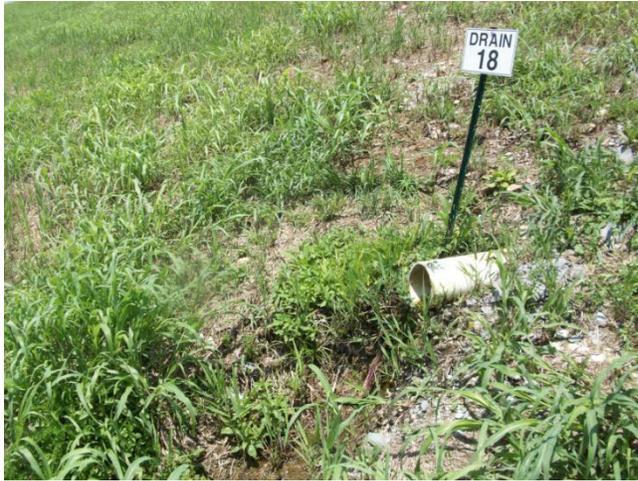
Photo 8
Erosion noted below subdrain 18.

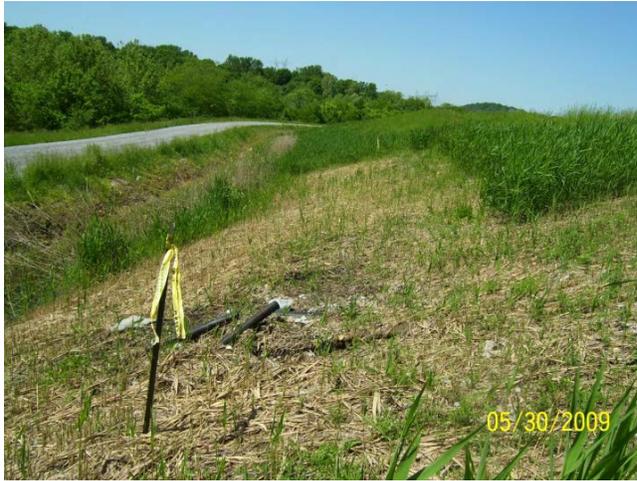
Photo 10

Area of recent seep activity located on the perimeter ash dike on the south side of the complex.

- It is recommended that the seeps (TVA-CUF Seep Log) along the perimeter clay dike at the southwest corner of the complex and the perimeter ash dike on the south perimeter clay dike (see Photo 10) be monitored for signs of movement or changes in seepage that may be indicative of slope failure. Any changes should be reported to Stantec.

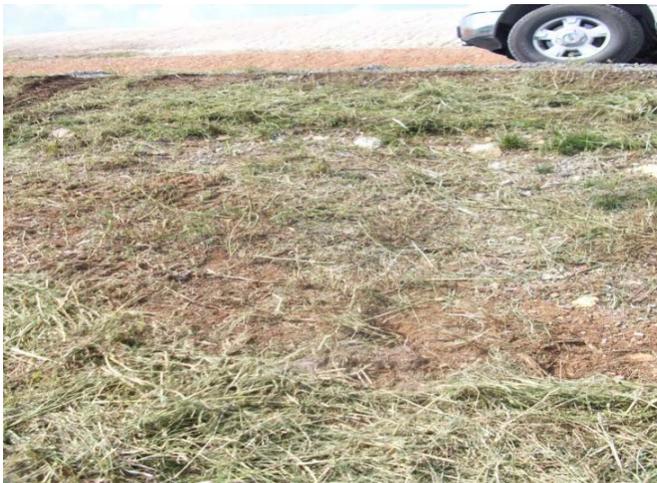
Photo 11

Area of barren soil located on the perimeter ash dike on the south side of the complex.

- It is recommended that a work plan be prepared that would address the areas of barren cover soil (see Photo 11) along the exterior slopes of the complex. This work should be conducted in accordance with the guidelines presented in Enclosure F (Priority 4)

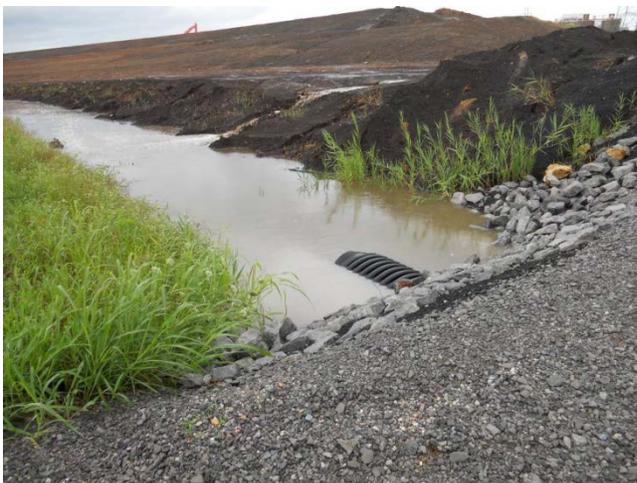
Photo 12

Culvert at access crossing between Gypsum Stack/Dry Ash Stack Diversion and Perimeter Dikes.

- The inlet and outlets of all drainage pipes should be monitored as part of TVA's Inspection Program and cleared as conditions warrant (see Photo 12).

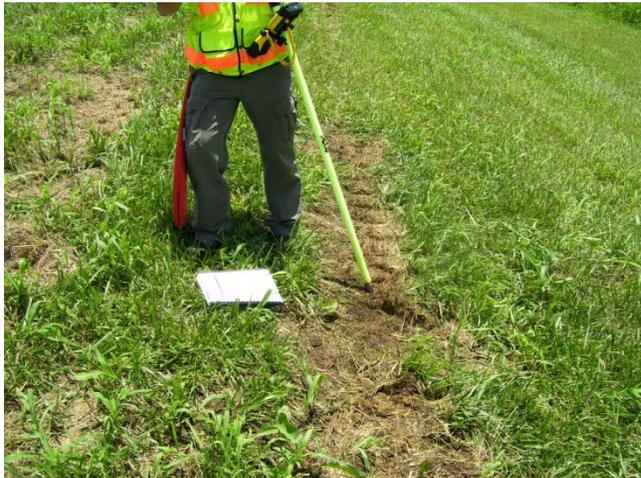
Photo 13
Rutting on exterior slope of the dike

- It is recommended that the observed rutting be repaired in accordance with the general guidelines presented in Enclosure H. Additionally, alternate mowing procedures should be used for the complex to prevent surface rutting of the vegetation cover. (See Photos 9, 13 and 14)

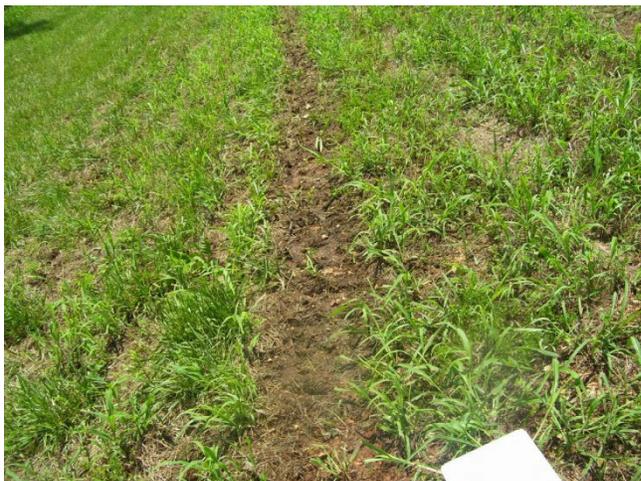
Photo 14
Rutting on exterior slope of the dike

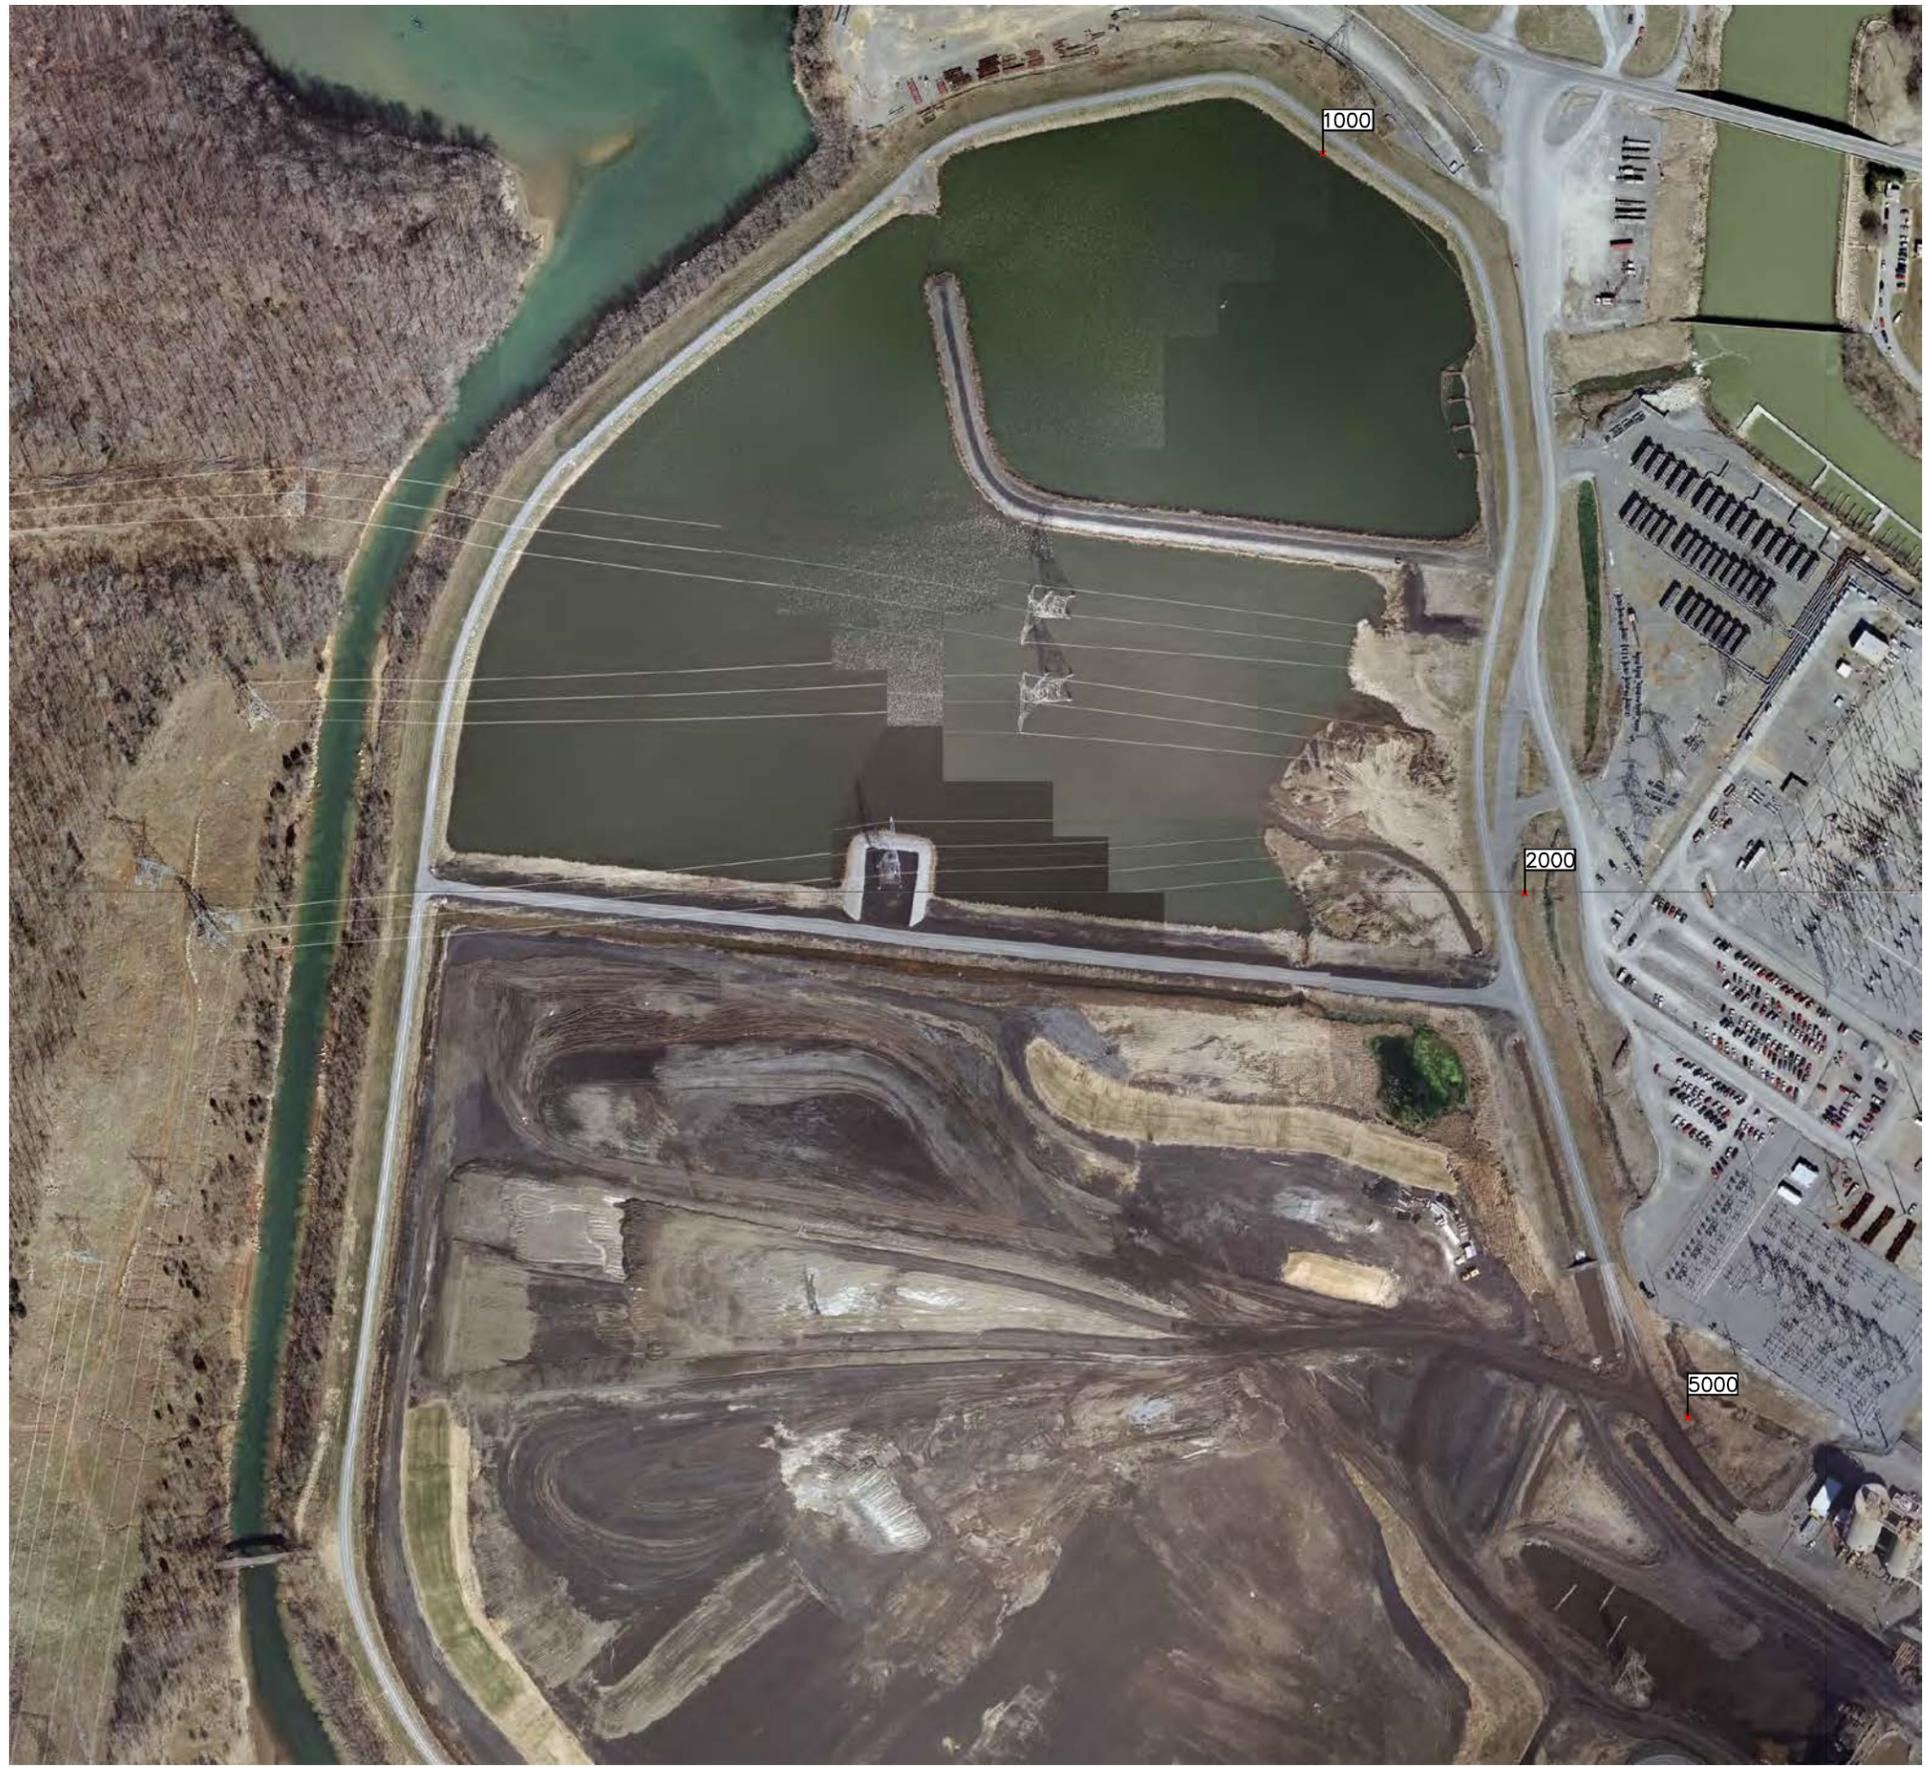
IMG_1085.jpg

ITEM NO.	DESCRIPTION	PICTURE NO.	POINT NO.	NORTHING	EASTING	Recommendations
3rd Quarter - Ash Pond						
1	Wave erosion	1179	1000	733431.71	1511088.16	To be addressed as part of WP-7
2	Possible seepage area (5' x 15')	1085	2000	732097.84	1511453.16	Monitor to determine if seep. If so notify Engineering and add to Seepage Log
3rd Quarter - Coal Yard Drainage Basin						
3	Several small trees on slope	1086	2001	730414.07	1512726.13	Repair in accordance to the General Guidelines
3rd Quarter - Chemical Treatment Pond						
4	(2) Animal burrows	1087	2002	730244.73	1512923.23	Repair in accordance to the General Guidelines
3rd Quarter - Dry Fly Ash Stack and Bottom Ash Pond						
5	Possible seepage area (50' L)	5707	5000	731152.02	1511747.64	Monitor to determine if seep. If so notify Engineering and add to Seepage Log
3rd Quarter - Gypsum Disposal Complex						
6	Erosion (typical of top of slope)	5708	5001	730352.60	1512581.31	Repair in accordance to the General Guidelines

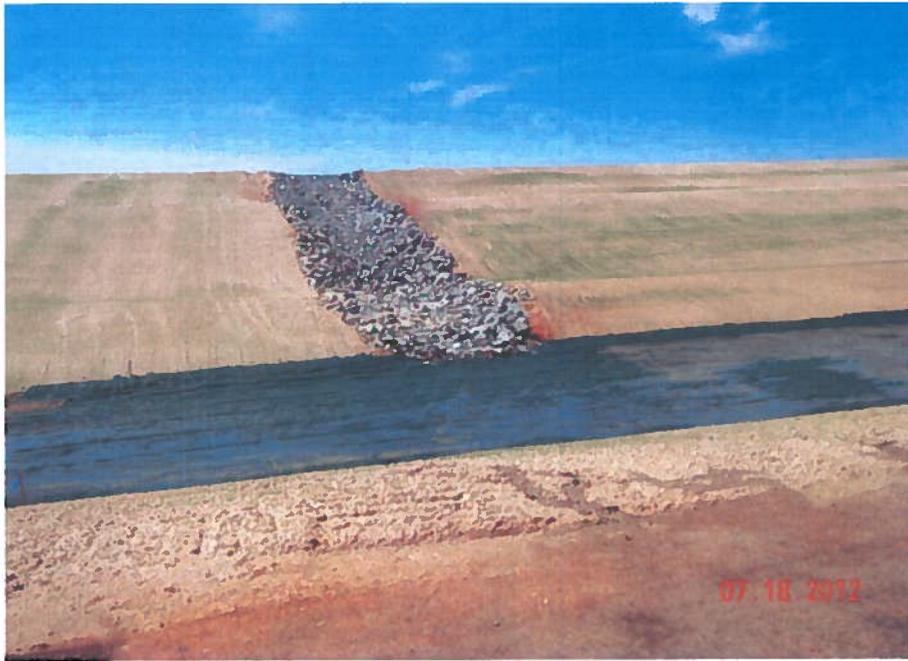
Erosion Repair and Perimeter Ditch Improvements from CUF Work Plan 11

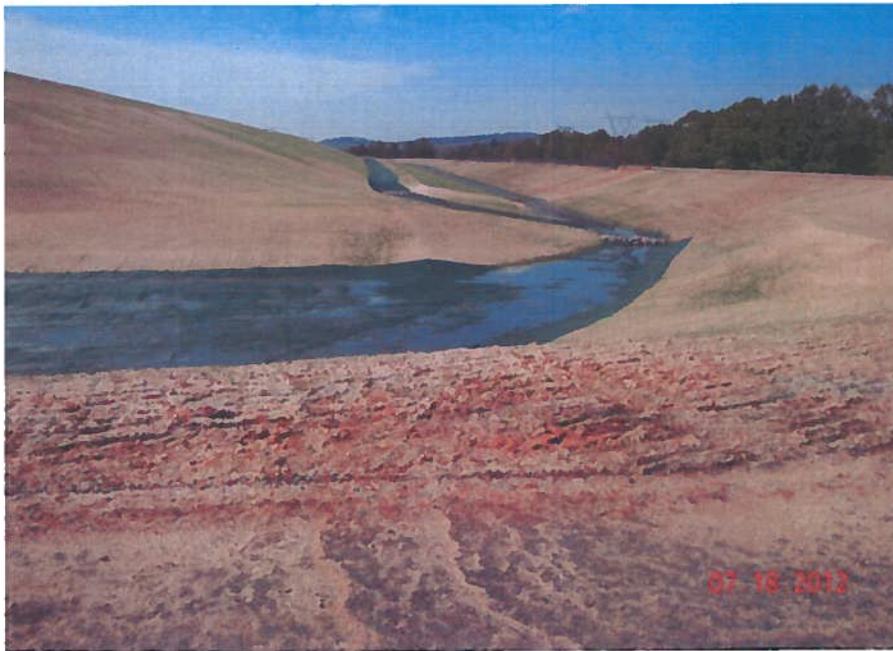
Perimeter Ditch Improvements from CUF Work Plan 11
