**Coal Combustion Waste Impoundment
Round 7- Dike Assessment Report (Site #007)**

Lawrence Energy Center

Ash Impoundment Dike

Westar Energy

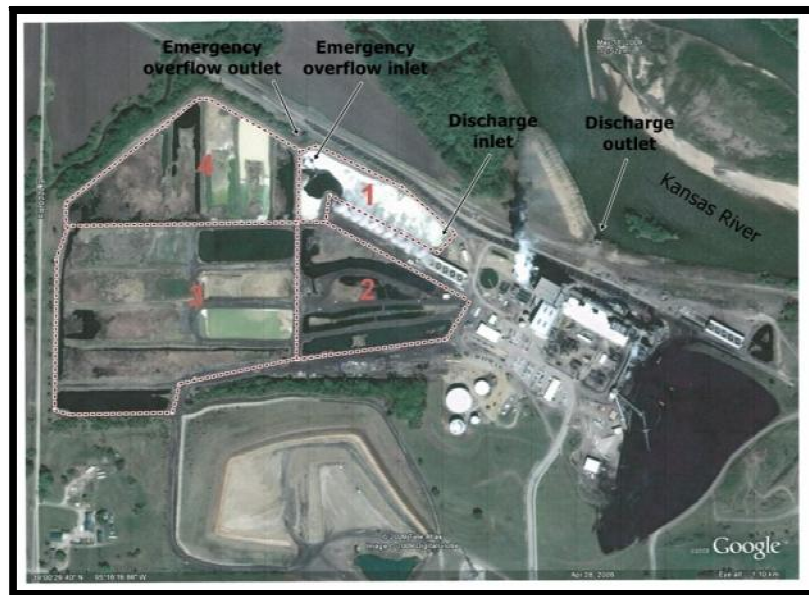
Figure 2.1-1: Configuration of Ash Ponds at Lawrence Energy Center, Lawrence, KS.

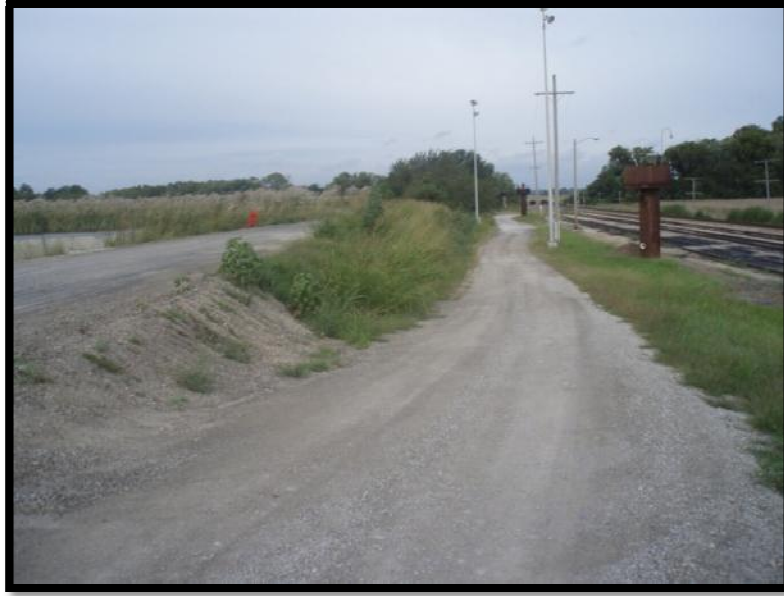
The outside slope of the north dike embankment is bordered by a small ditch that drains to Baldwin Creek and the coal supply railroad, see Figure 5.2.3-1. The outside slope is covered with various species of tall grass and other vegetation. The steepness of the slope makes access difficult. Dewberry inspectors were not able to access parts of the toe of the embankment.

Figure 5.2.3-1: Outside Slope of North Dike. (Area 1).

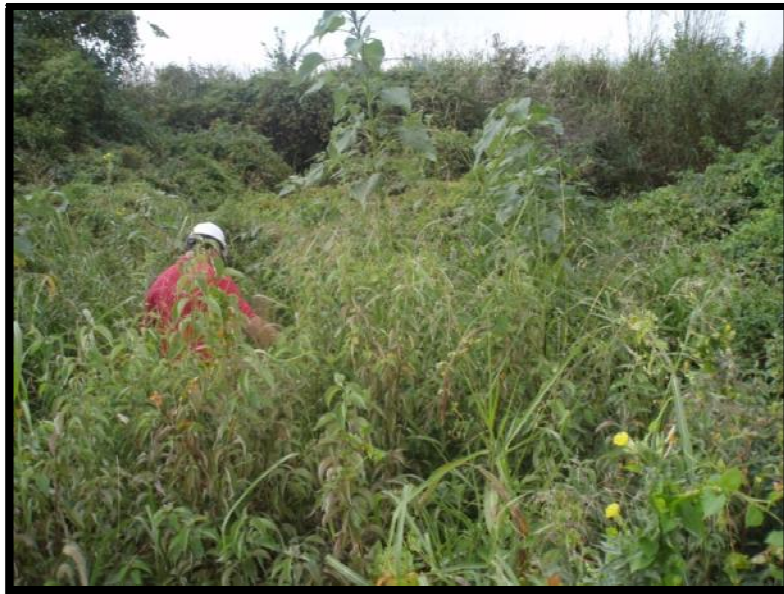
The emergency overflow outlet discharges at the base of the northern slope. The heavy vegetation made access to this area impossible, see Figure 5.2.3-2.

Figure 5.2.3-2: Vegetative Growth in the Area of the Overflow Outlet.

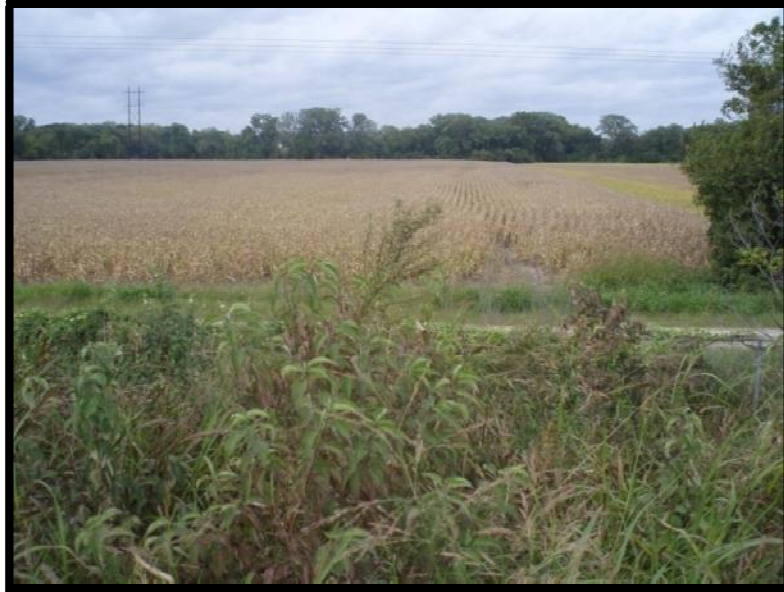
Figure 5.3.3-2: Agricultural Land West of the Ash Ponds.

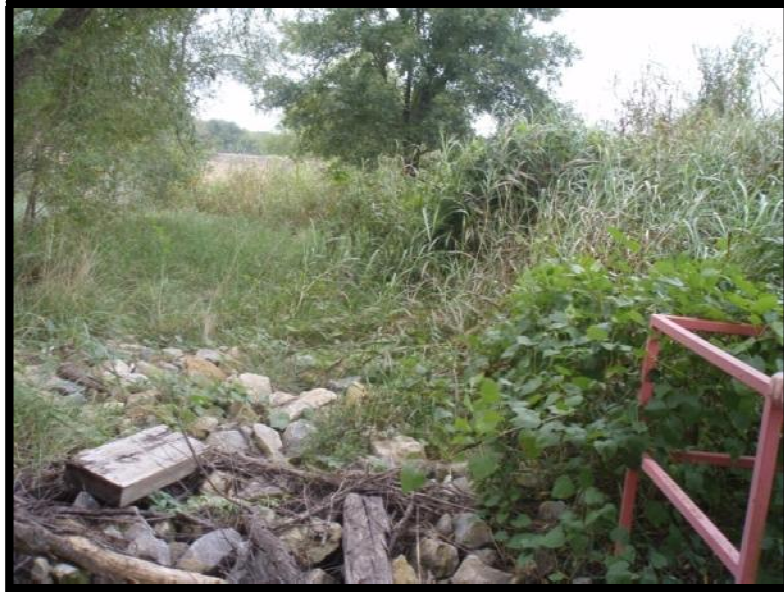
The south side of Area 3 is bordered by a storm water pond, which also has a small embankment along the south side, see Figure 5.4.3-1.

Figure 5.4.3-1: Outside of the Stormwater Pond Embankment on South Side.

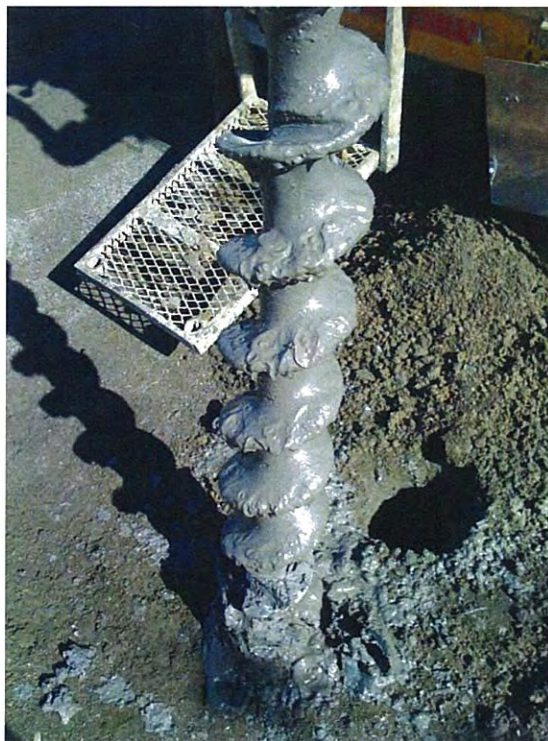
Photograph 5 – Drilling Borehole LEC-5 (looking west)

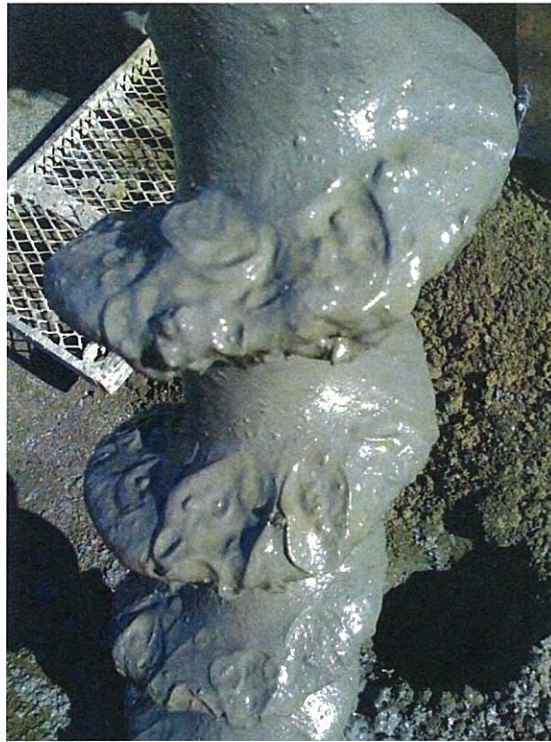
Photograph 6 – Soft saturated clay found in Borehole LEC-7 (looking northeast)

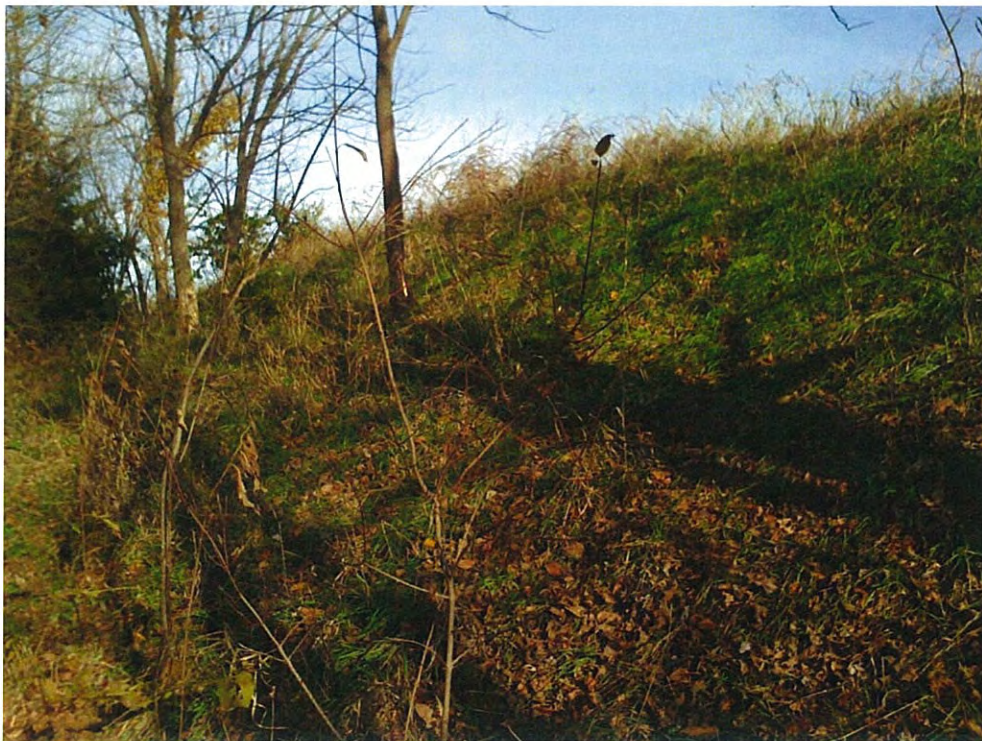
Photograph 6 – Downstream berm slope northwest of CCP storage facilities (looking east)

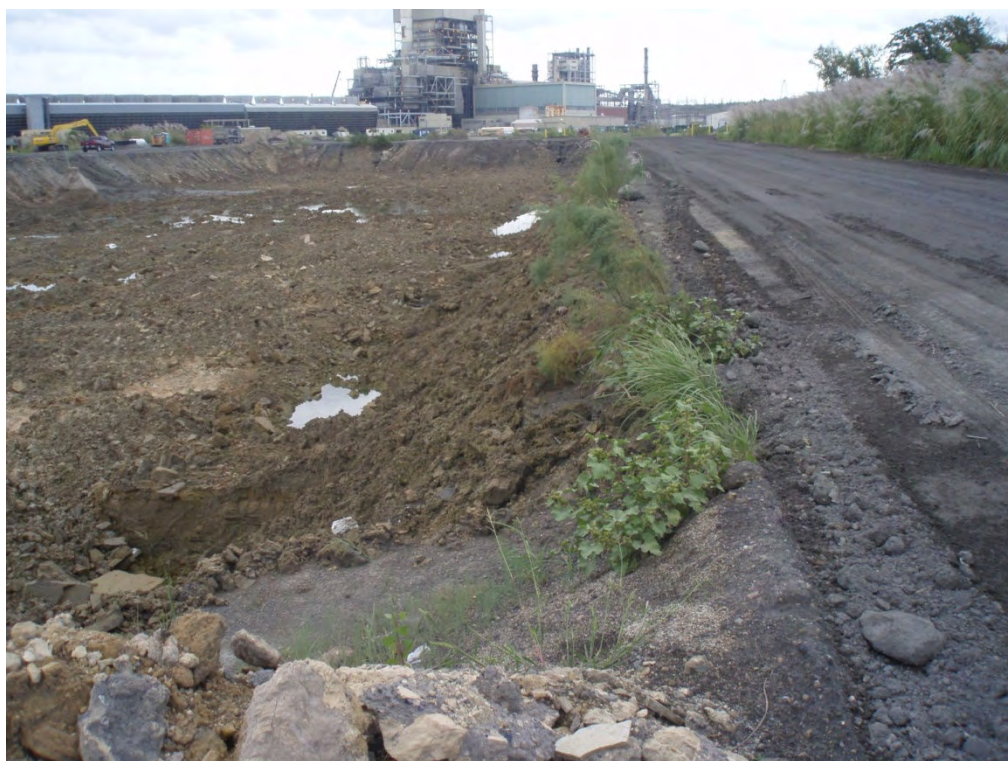
28. Interior tie-in of south dike to existing grade/road embankment.

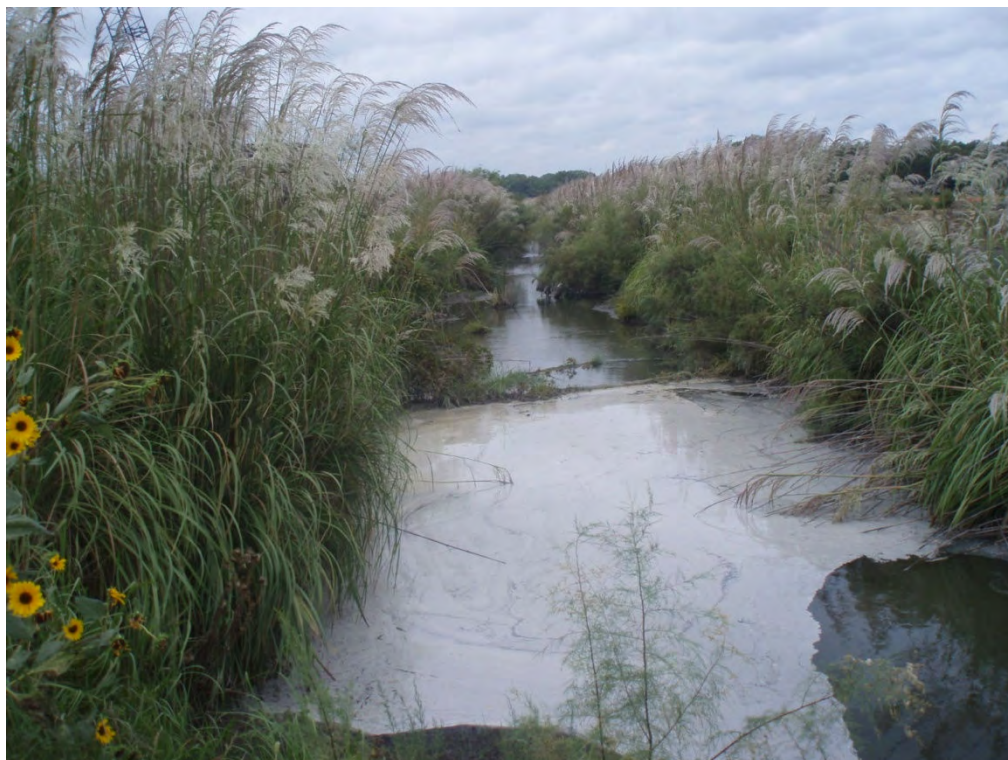
29. Area 2/middle cell – Taken from west end looking east.
