Program Audit Report
Las Vegas Valley Storm Water Management Program:
Clark County Regional Flood Control District; Clark County; City of Las
Vegas; City of North Las Vegas; and City of Henderson
(NPDES Permit No. NV0021911)

September 19-23, 2005

Prepared for:
EPA Region 9
75 Hawthorne Street
San Francisco, CA 94105

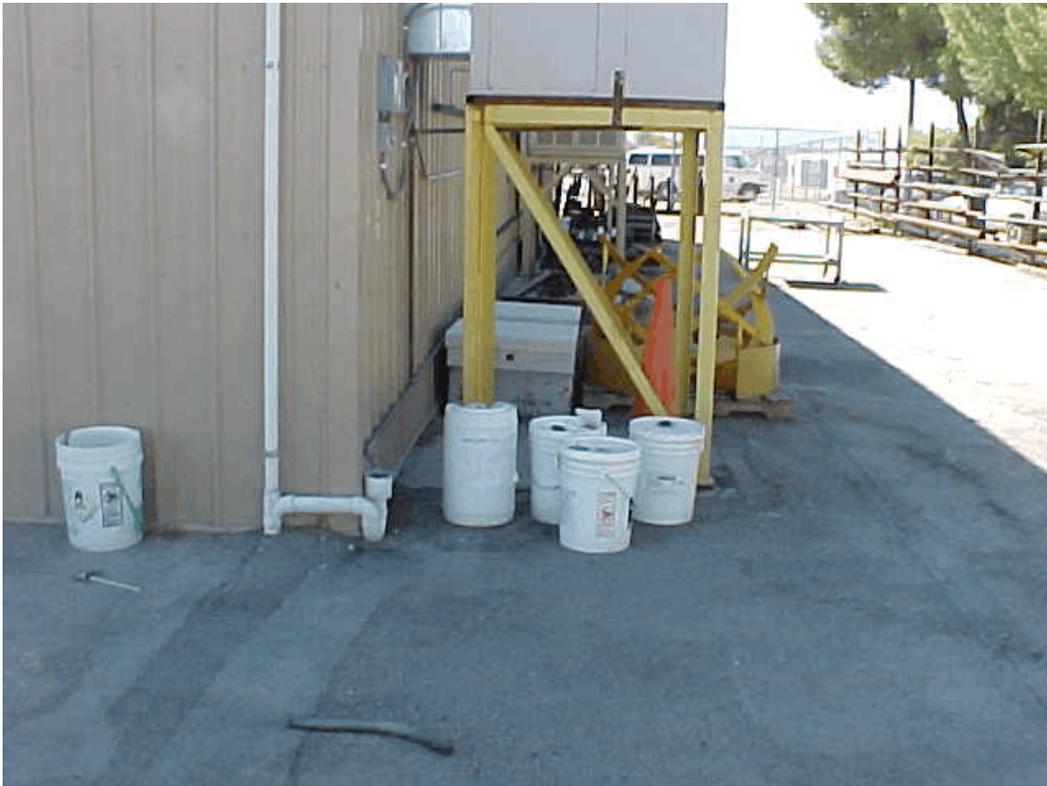
Photo 3. Fleet (primary) facility: Four uncovered and uncontained 5-gallon pails of truck wash chemical.

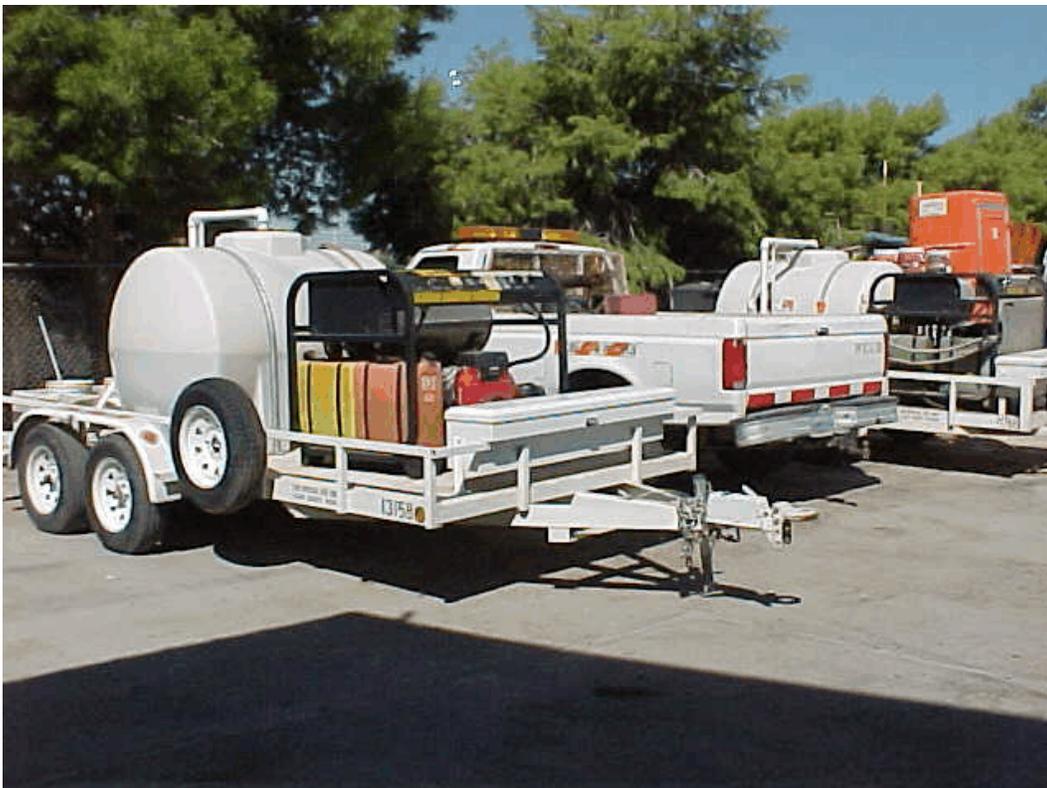
Photo 4. Fleet (primary) facility: Power washer for trucks.

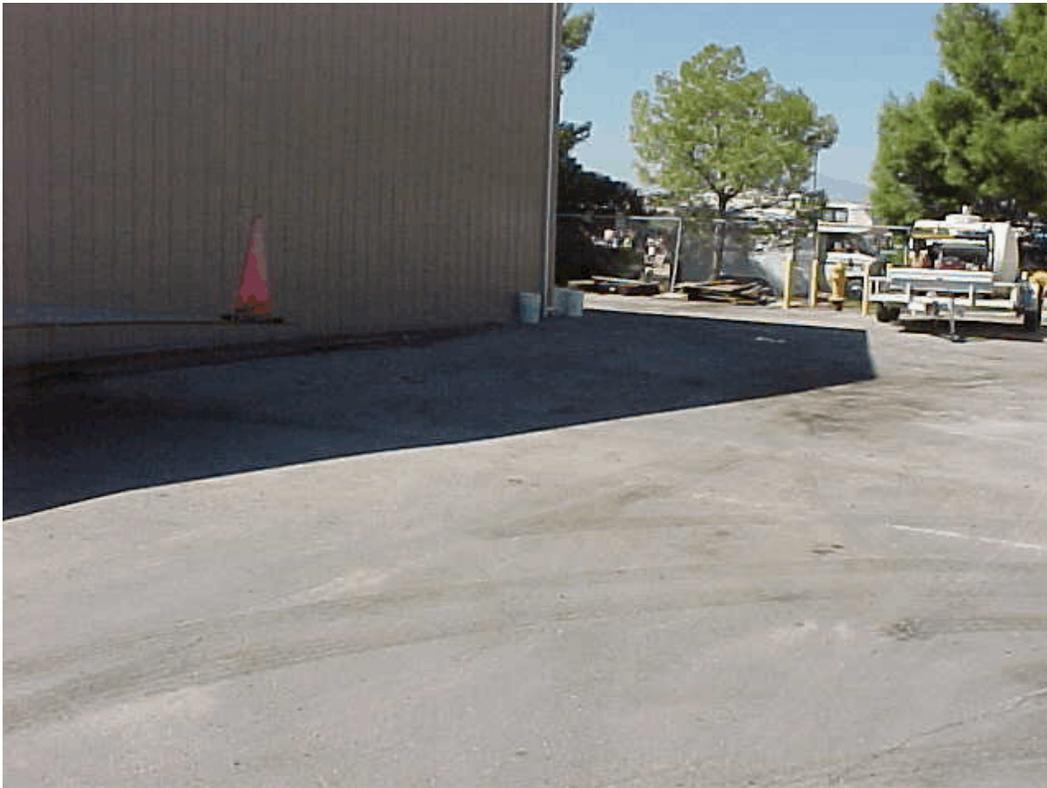
Photo 5. Fleet (primary) facility: Truck wash area is outside, uncontained, uncovered.

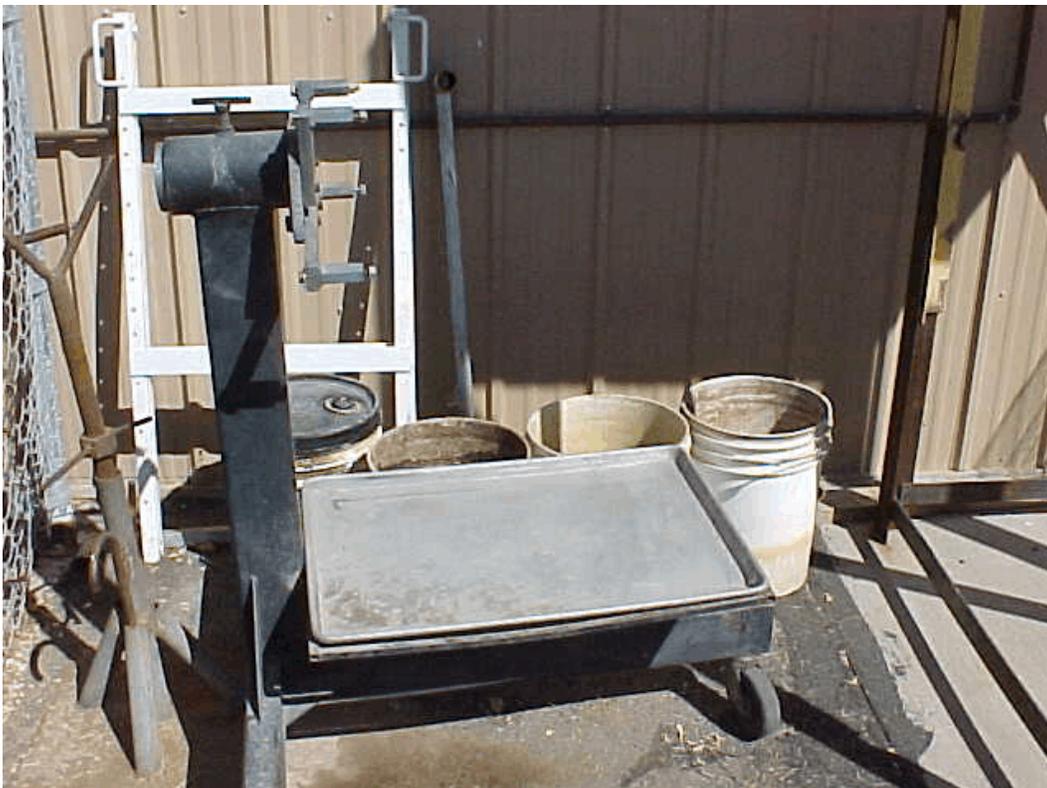
Photo 6. Fleet (primary) facility: Four 5-gallon pails stored outside. One, without a lid, is 50% full of used petroleum product.

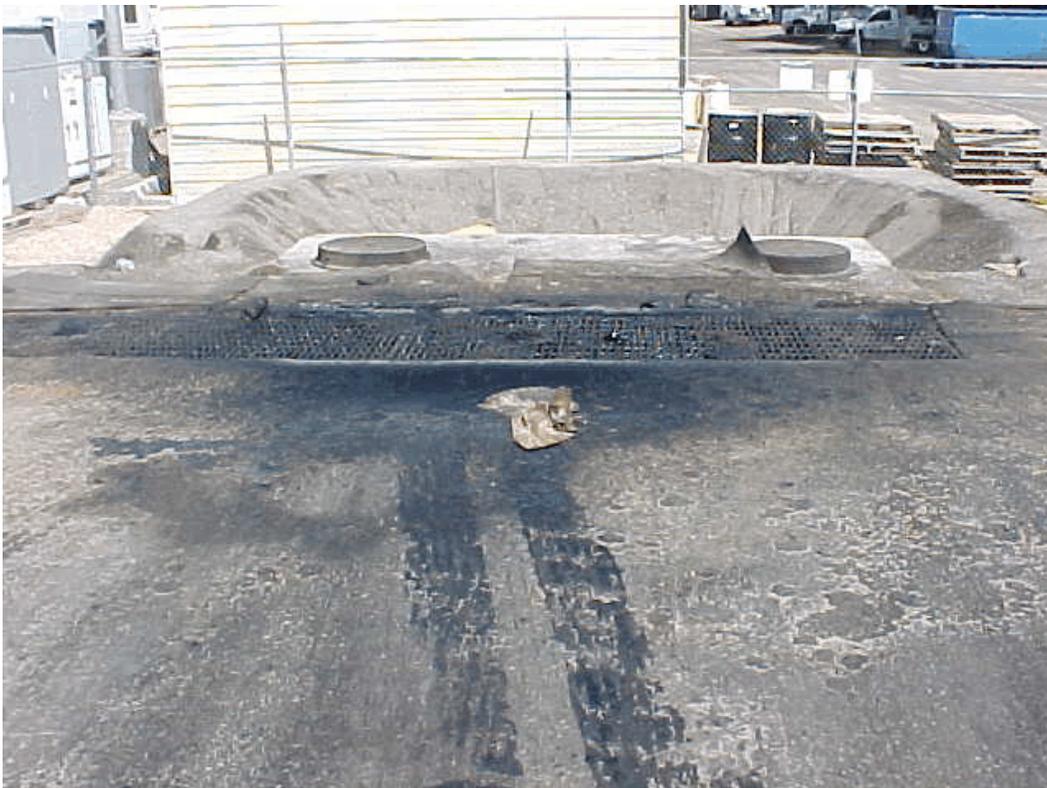
Photo 16. Fleet (secondary) facility: Abandoned asphalt washout area.

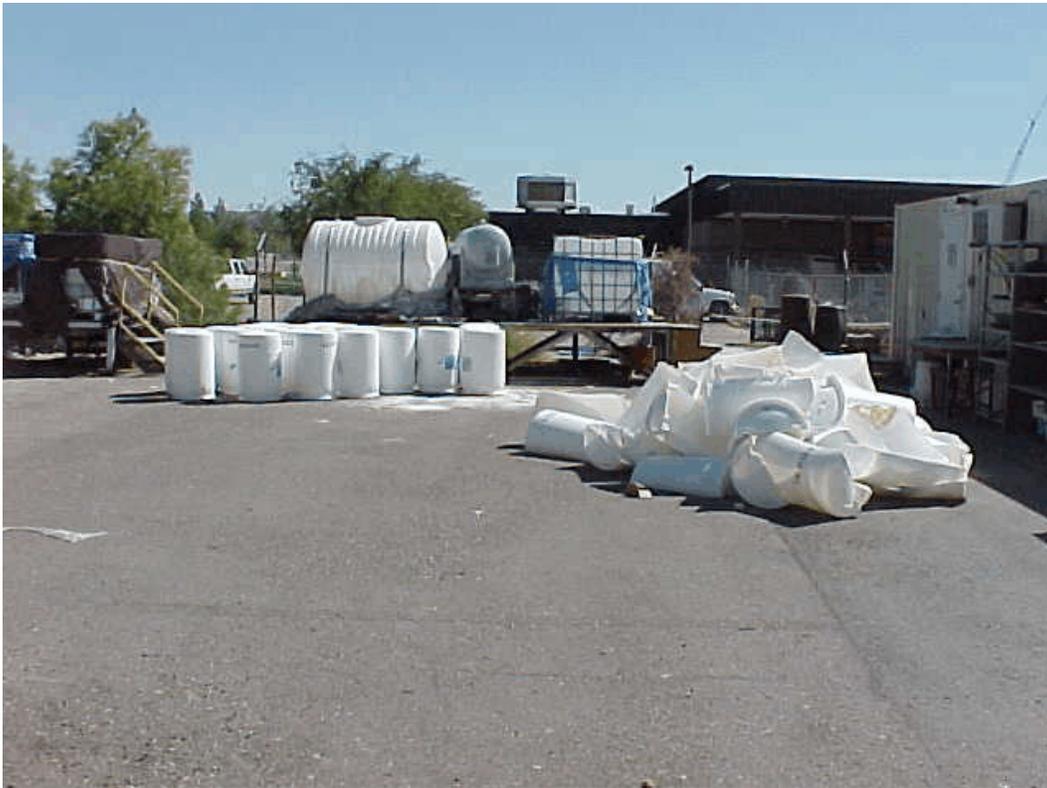
Photo 17. Vector Control facility: Empty drums of larvicide had been cut open in an uncontained location and residue spilled to the pavement.

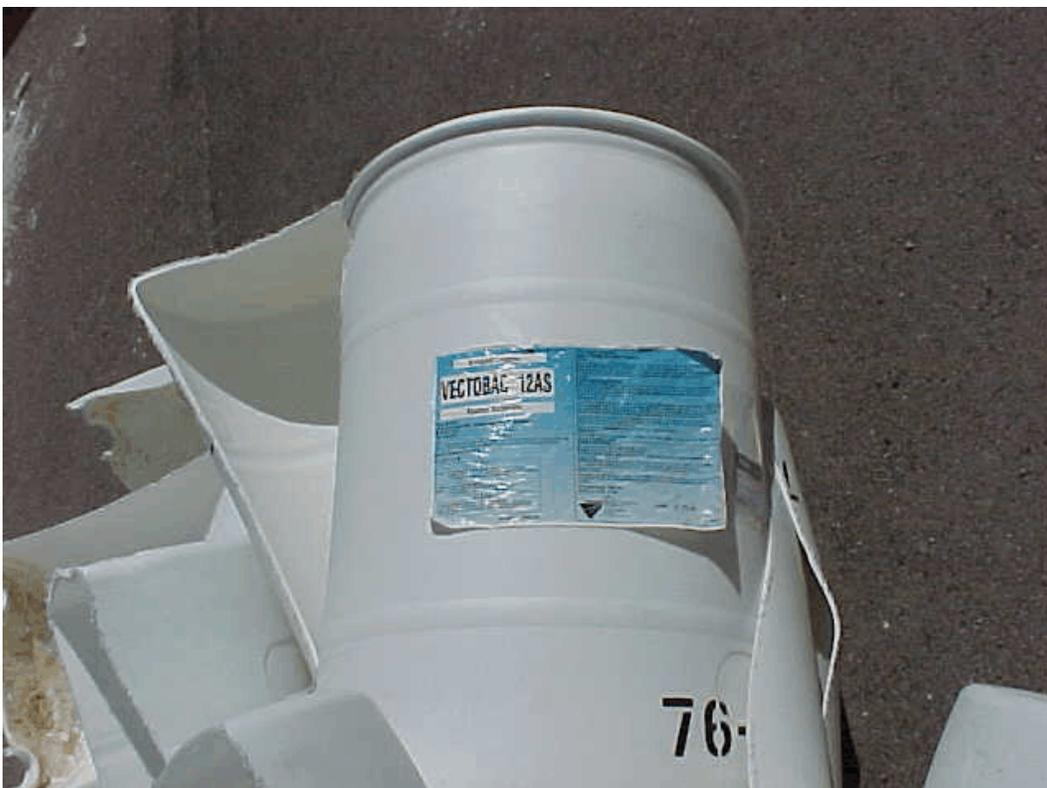
Photo 18. Vector Control facility: Empty drums of larvicide had been cut open in an uncontained location and residue spilled to the pavement.

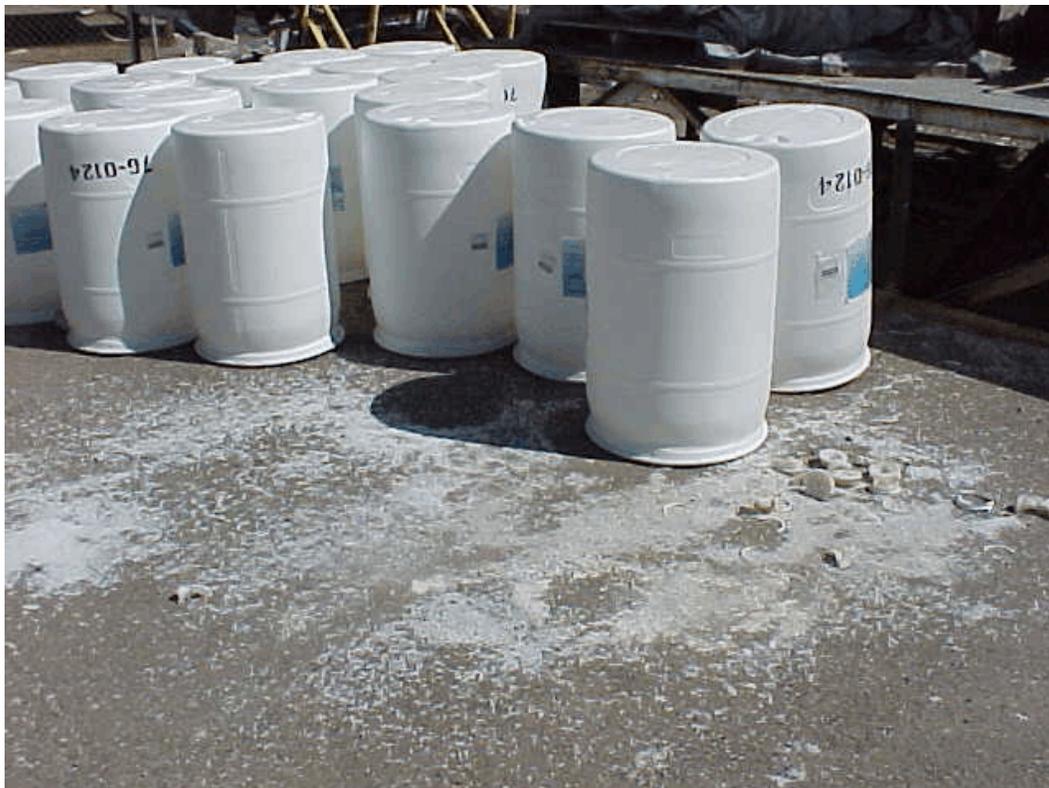
Photo 20. Vector Control facility: Empty drums of larvicide had been cut open in an uncontained location and residue spilled to the pavement.

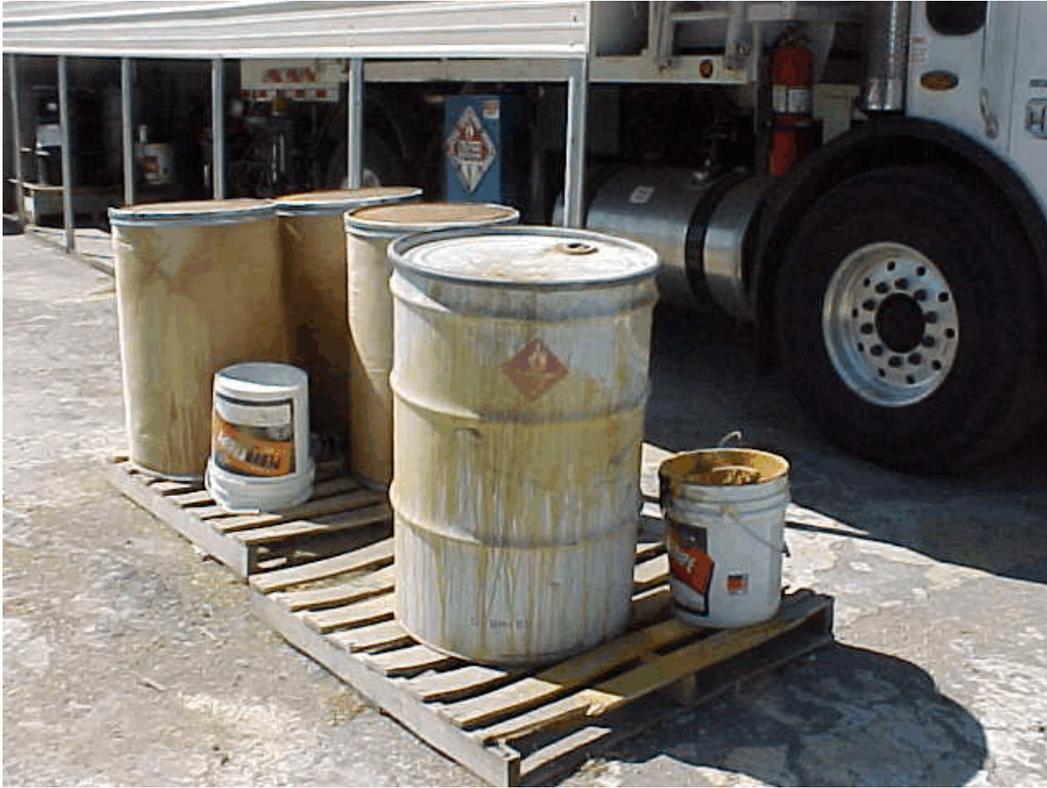
Photo 21. Traffic facility: One 55-gallon drum of flammable contents and three fiber drums of unknown contents were uncovered and uncontained.

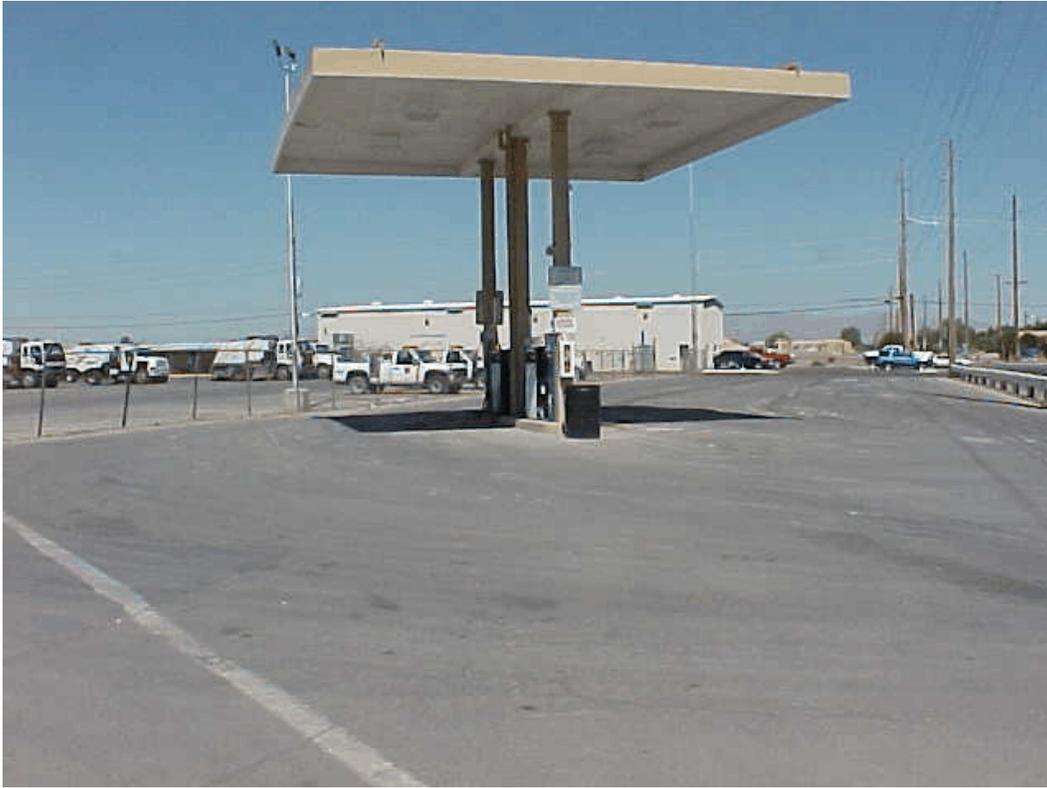
Photo 5. View of fuel island.

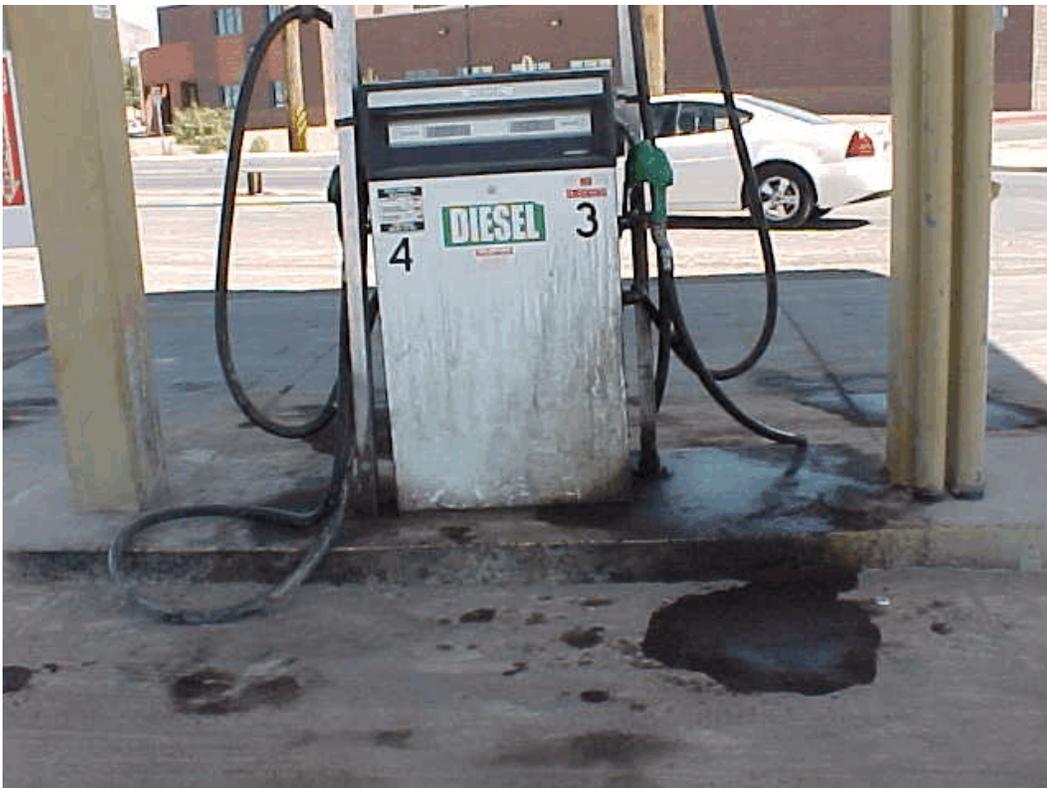
1. The Automotive Repair facility had minimal staining of pavement from petroleum spills/leakage. The facility had used batteries located outside, uncontained, and uncovered.
2. The Fuel Point area had several fresh spills. The audit team did not observe a spill kit or emergency shutoff at the fuel island. Signage directed calling 911 in case of a fuel spill.

1. Exposed and uncontained used batteries at the Automotive Repair facility had the potential to lose acid to storm water runoff.
2. The spillage at the Fuel Point area was under the canopy, but had the potential to be tracked out of the canopy area and be carried to the adjacent street by storm water.

Photo 6. Spillage at fuel island.

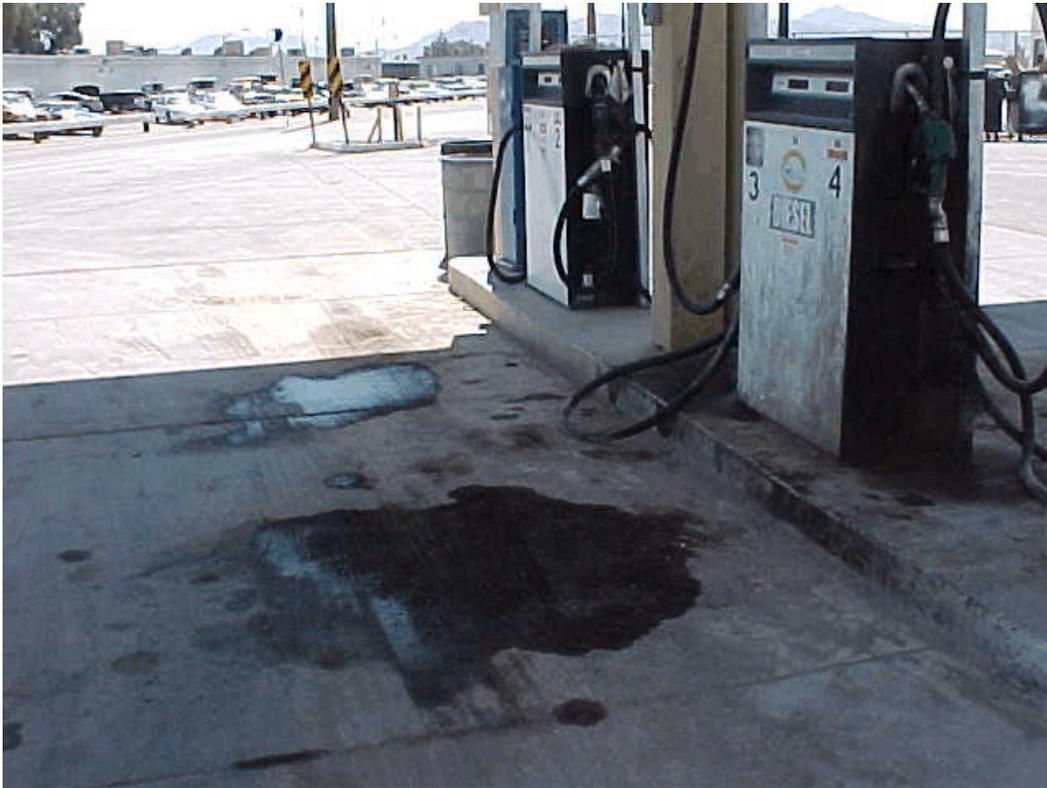
Photo 7. Spillage at fuel island.

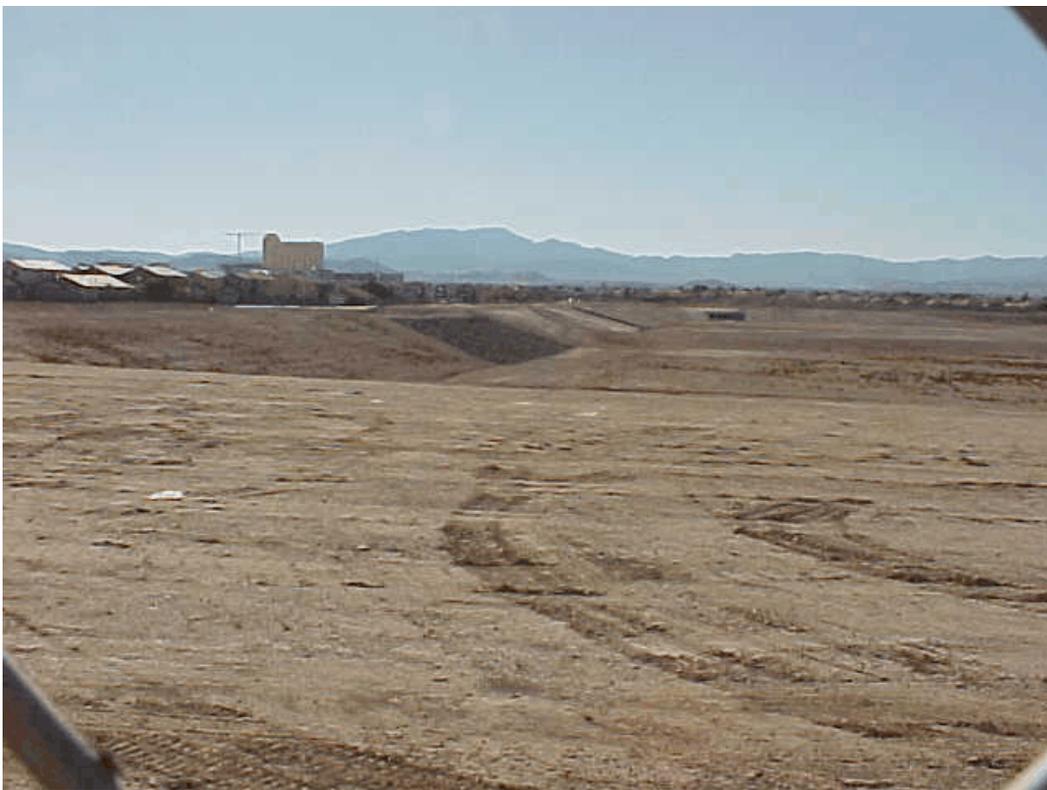
Photo 2. Southwest view of the detention basin from the east fence.

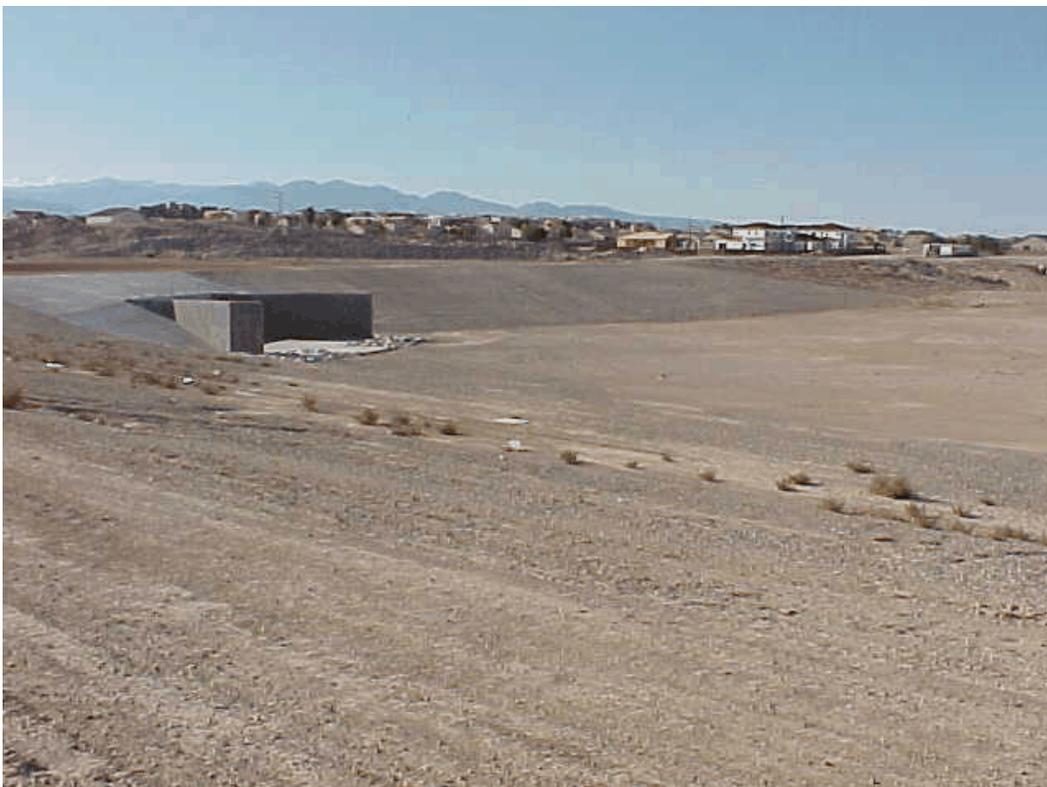
- Installation of discharge pipes to the detention basin may result in erosion where the pipe enters the basin and may cause scouring of the basin floor at the discharge point. Loose soils will potentially be carried by storm water to Duck Creek Channel when a rain event occurs.

Photo 6. Inlet to detention basin at southwest corner.

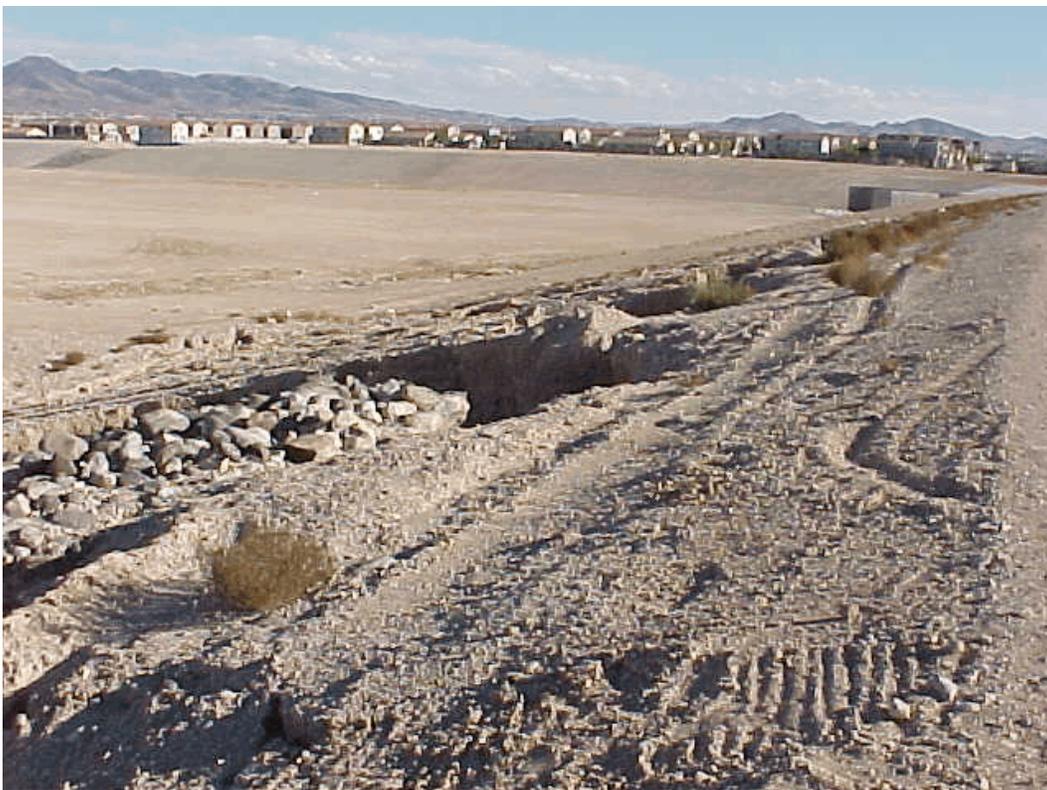
1. Erosion into the detention basin was observed at several locations. Some erosion channels in the west wall of the detention basin were at least four feet deep and six feet wide. Mr. Suckow stated that the erosion in the west wall had occurred several months ago.
2. Utility work was ongoing outside the east fence of the detention basin. The heavy equipment was parked inside a locked gate to the detention basin area. Mr. Suckow was unaware of the ongoing work.
3. An approximately 36-inch pipe for storm water discharge to the detention basin had recently been installed at the northwest corner of the detention basin. The pipe appeared to have been installed by the developer of an adjacent subdivision. Mr. Suckow was unaware of the installation.

1. Clark County is not actively repairing erosion into the detention basin and has not implemented Best Management Practices (BMPs) such as stabilization and/or riprap of the basin walls. Loose soils eroded into the basin will potentially be carried by storm water to the Duck Creek Channel when a rain event occurs.

Photo 8. Erosion on west wall of detention basin.

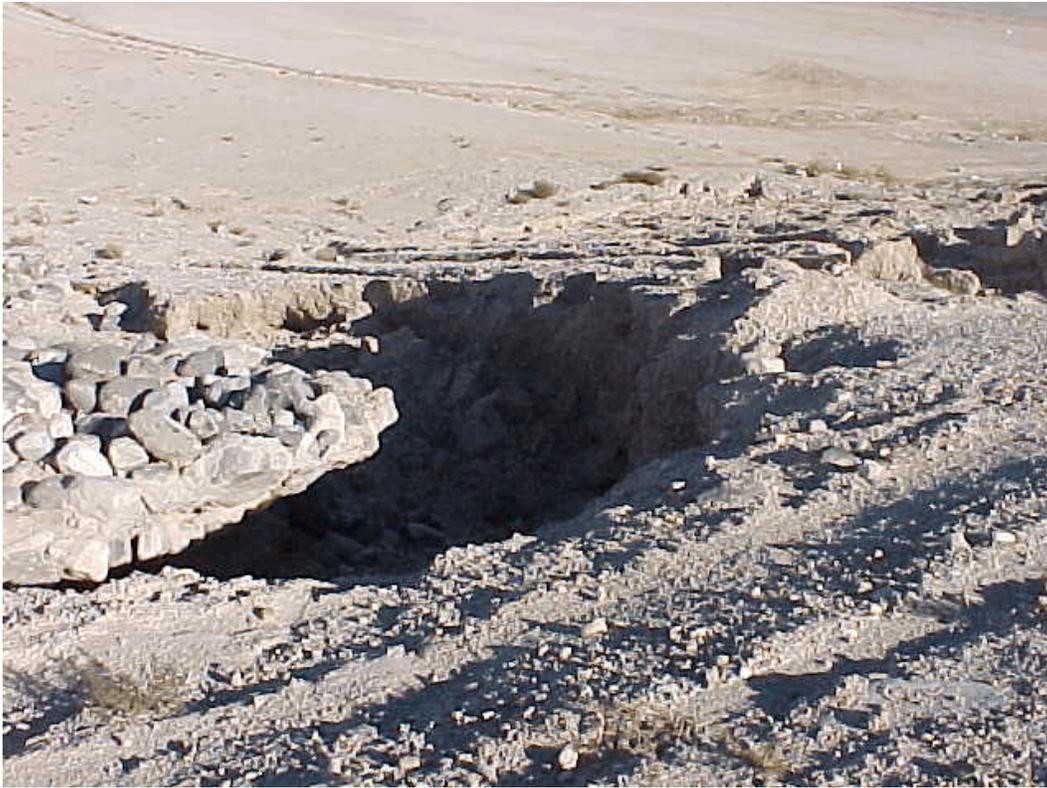
Photo 9. Erosion on west wall of detention basin.

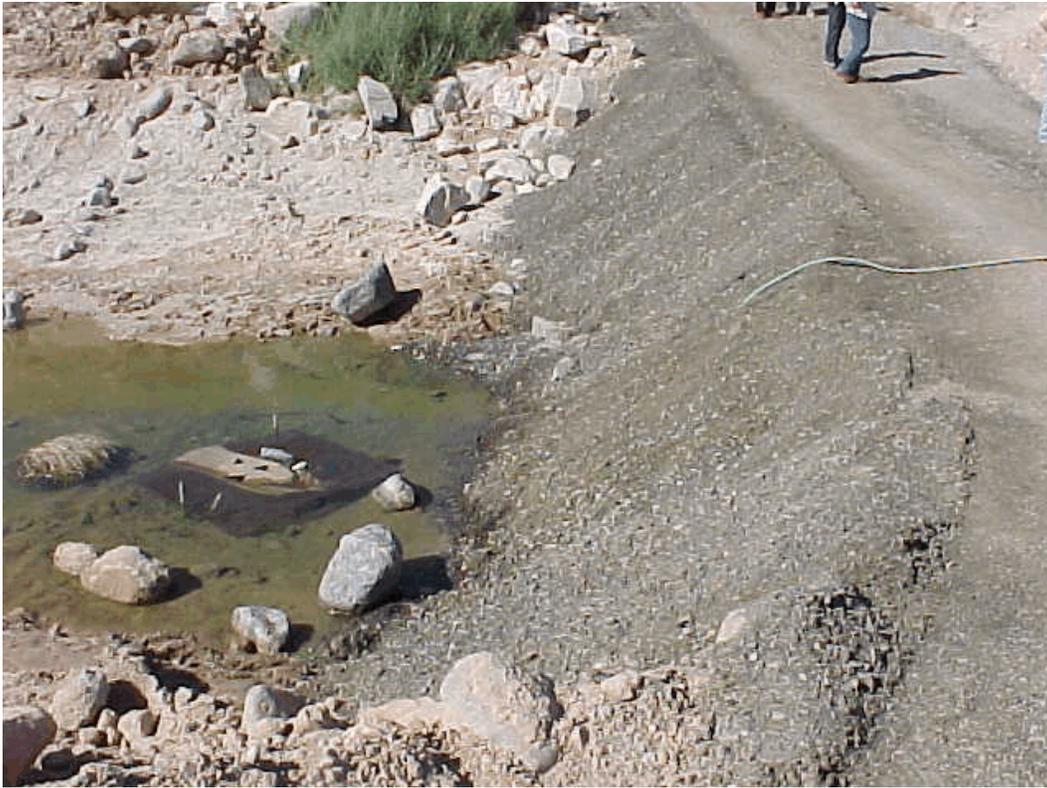
Photo 1. Diversion inlet (photo left) and earthen dam.

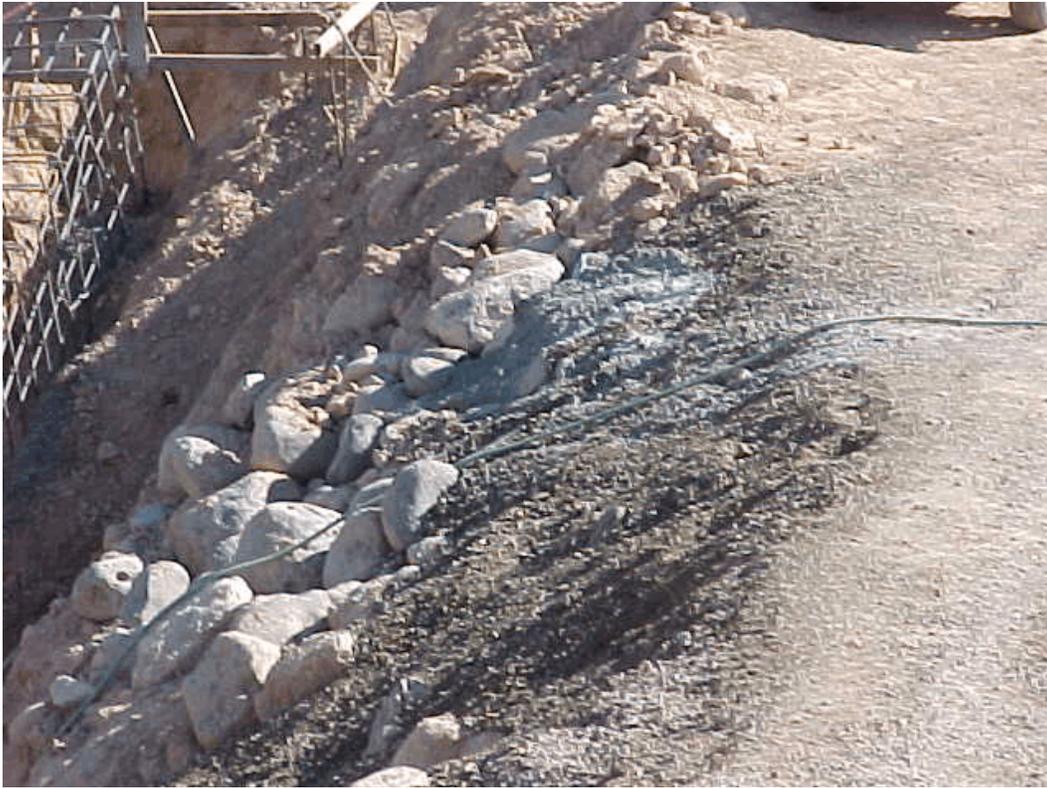
4. Concrete washout had occurred above the sump and likely concrete washout runoff was pumped to the diversion and entered the Duck Creek Channel waters below the project area.
5. Chemicals (e.g., concrete chemicals, gasoline) were not contained and/or located to minimize the potential for accidental spillage and loss to the soil or Duck Creek Channel.
6. The staging areas included disturbed soils that are part of the project and must be protected and inspected for storm water.

Photo 3. Closeup view of concrete washout on downstream face of earthen dam. A sump is located at the toe of the dam face (photo left).

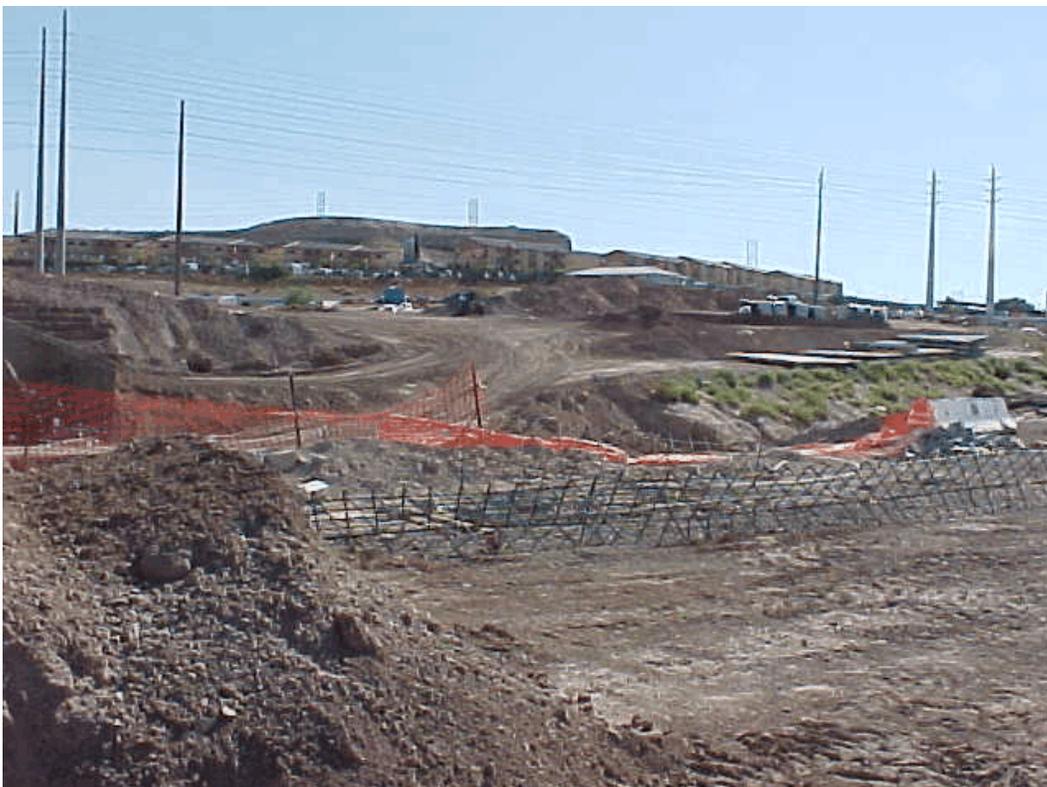
Photo 6. Staging area. Note the soil disturbance and no BMPs.

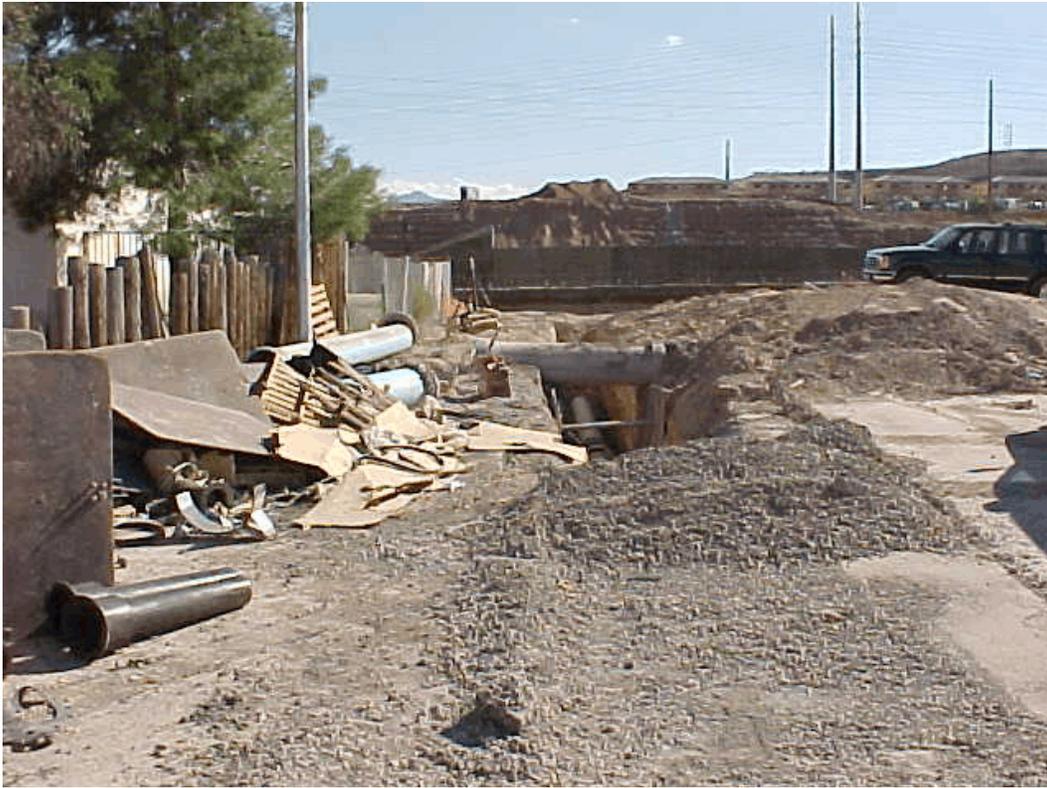
Photo 7. Additional staging area. Note uncontained five-gallon gas can (photo center).

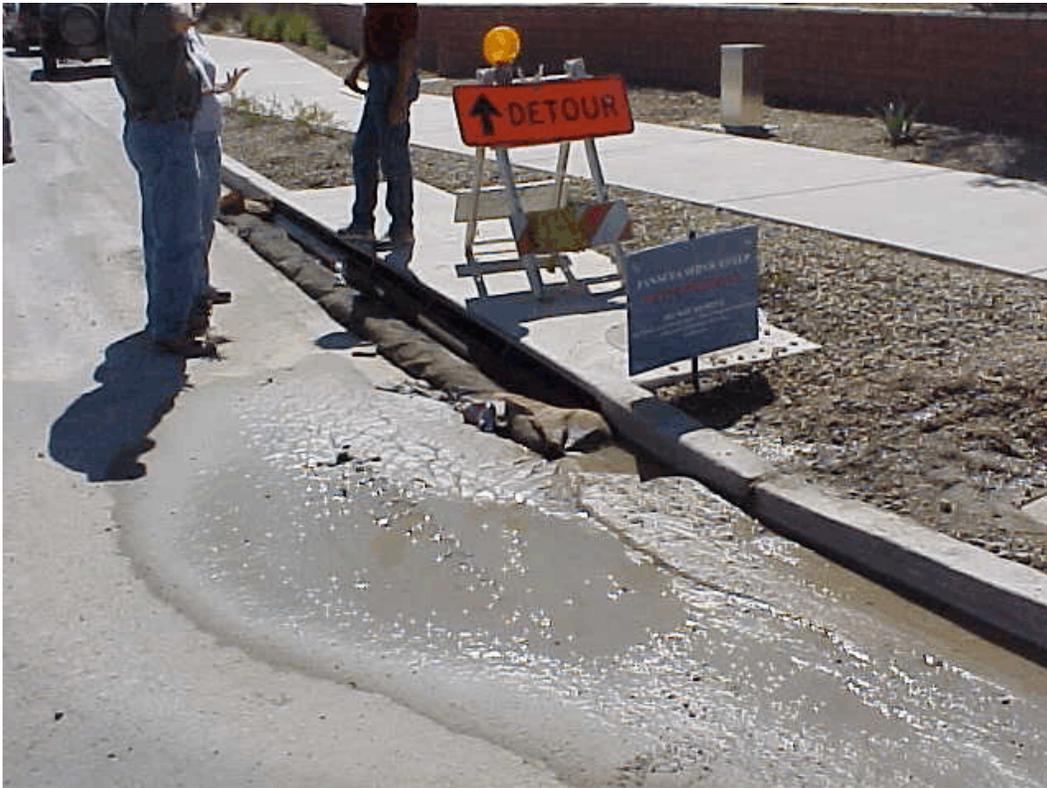
Photo 1. Street inlet protection that is poorly maintained by Landtec LLC.

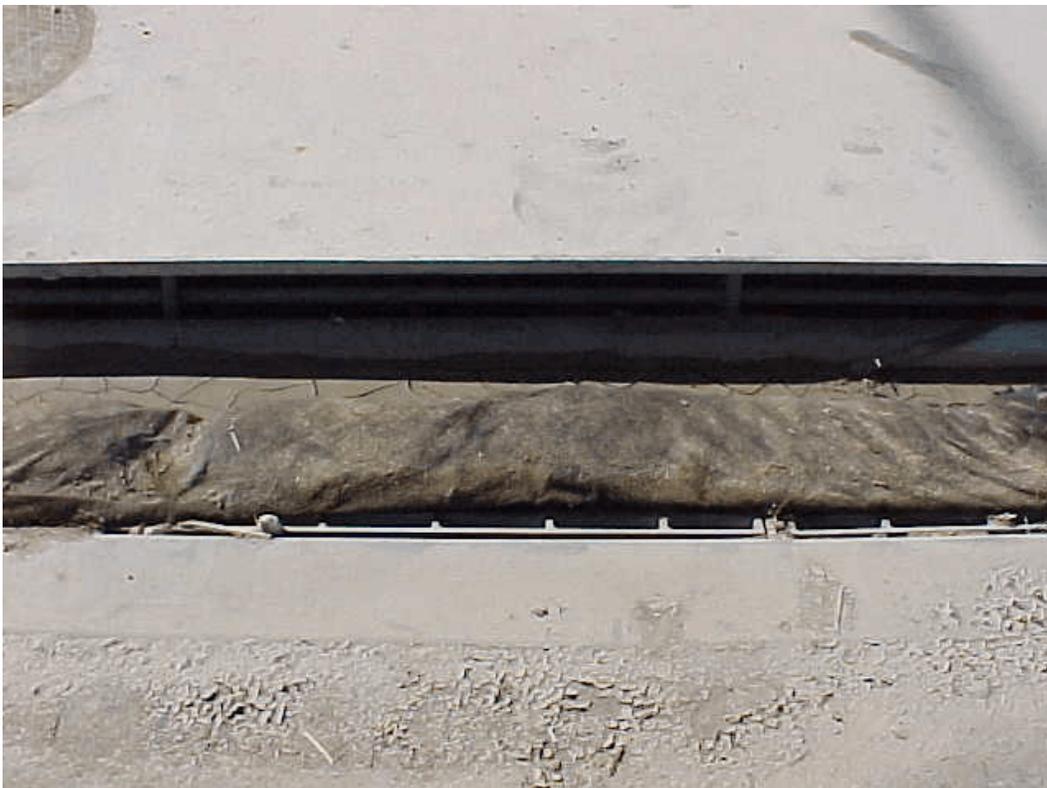
Photo 2. Street inlet protection that is poorly maintained by Landtec LLC.

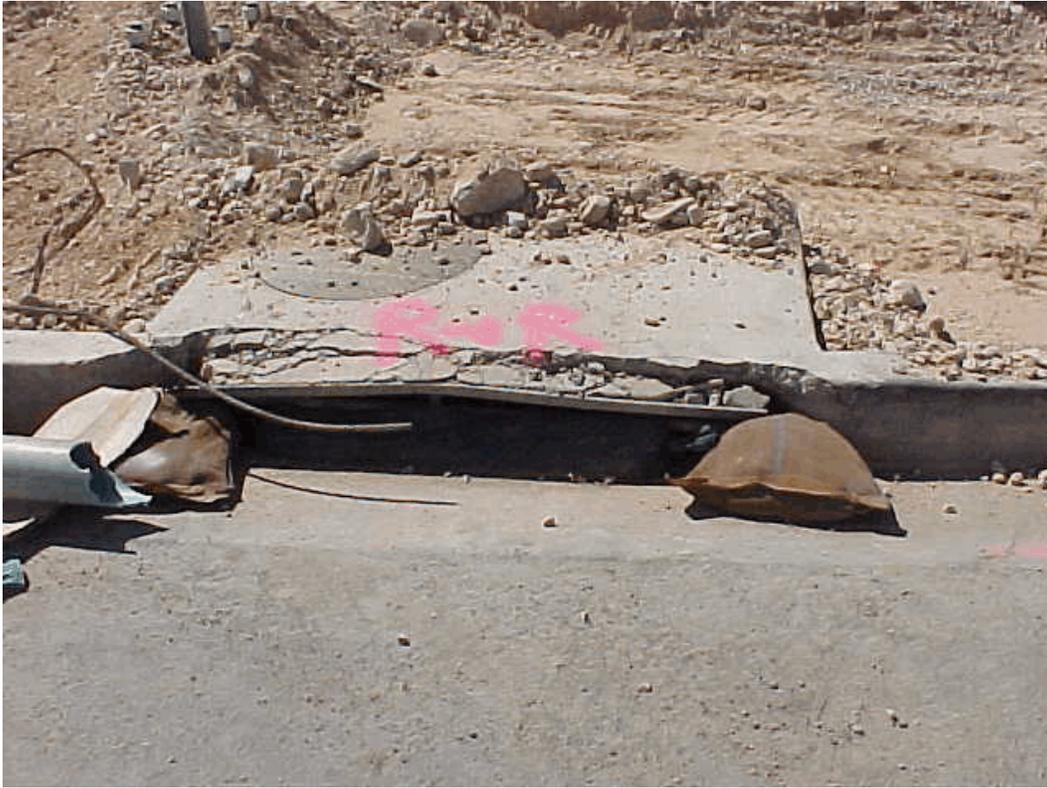
Photo 3. Street inlet protection that is poorly maintained by Landtec LLC.

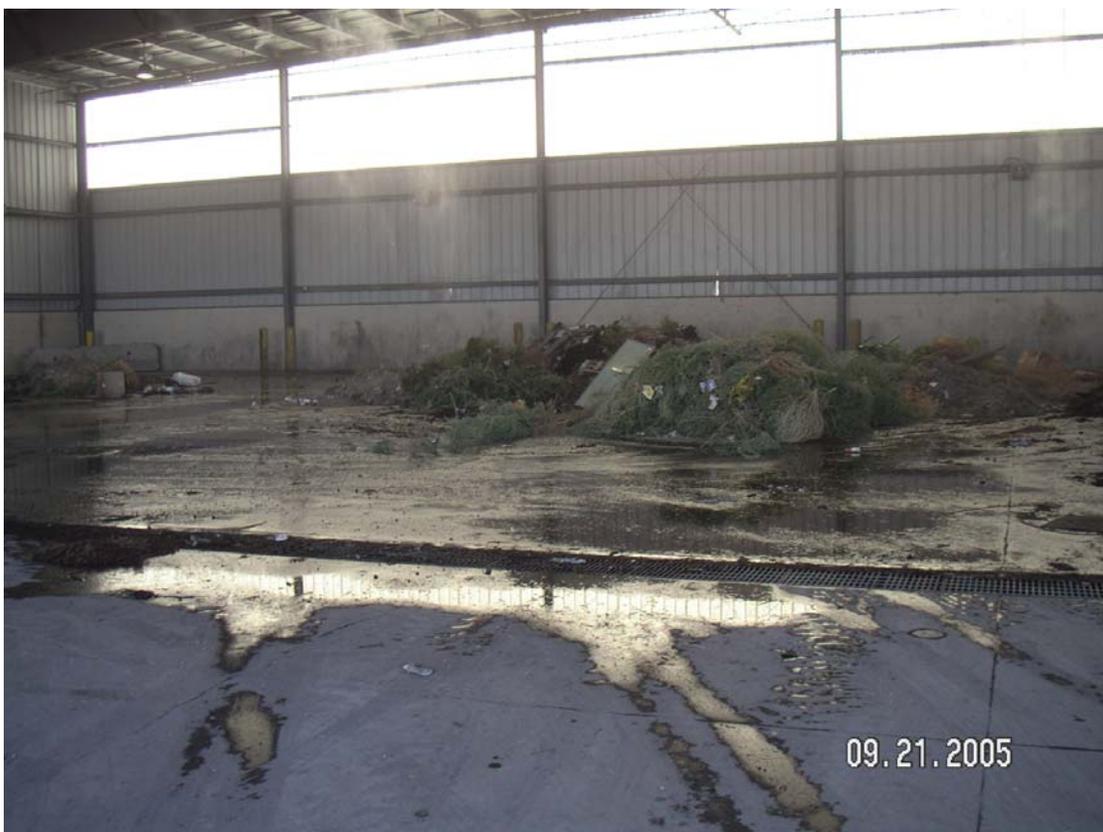
Photo 2. Inside transfer station.

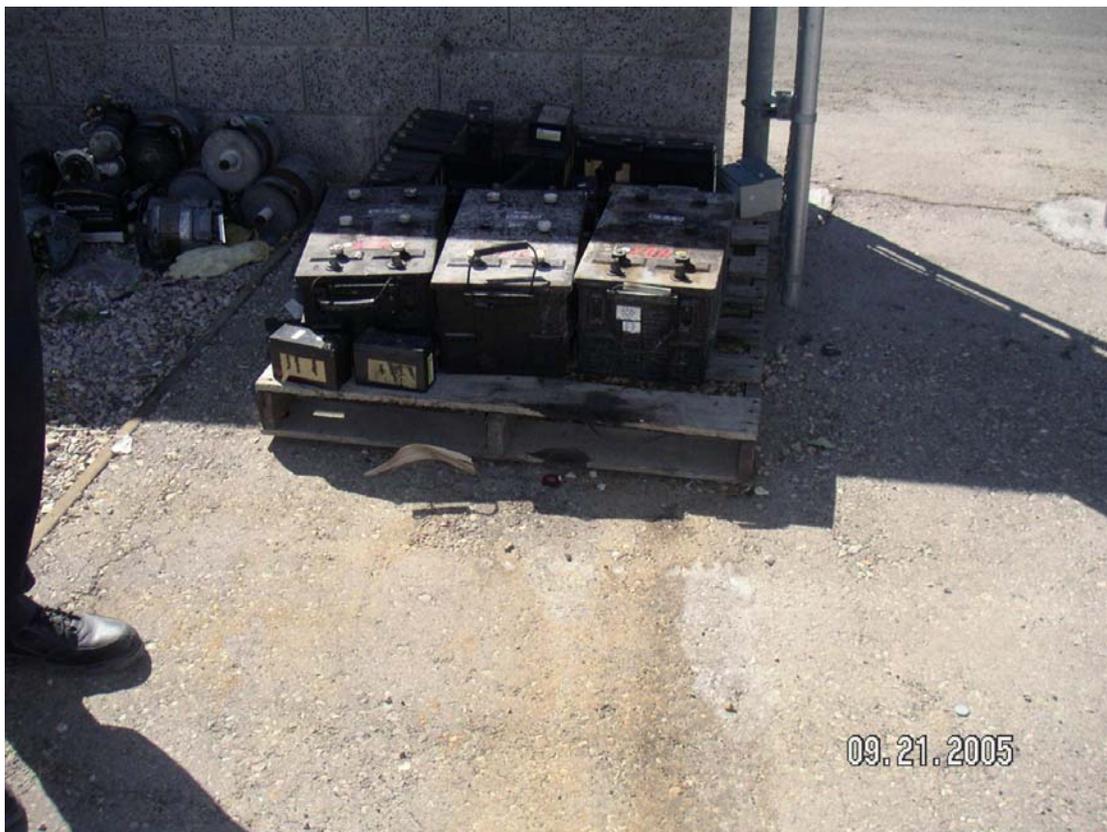
Photo 6. Batteries waiting to be recycled.

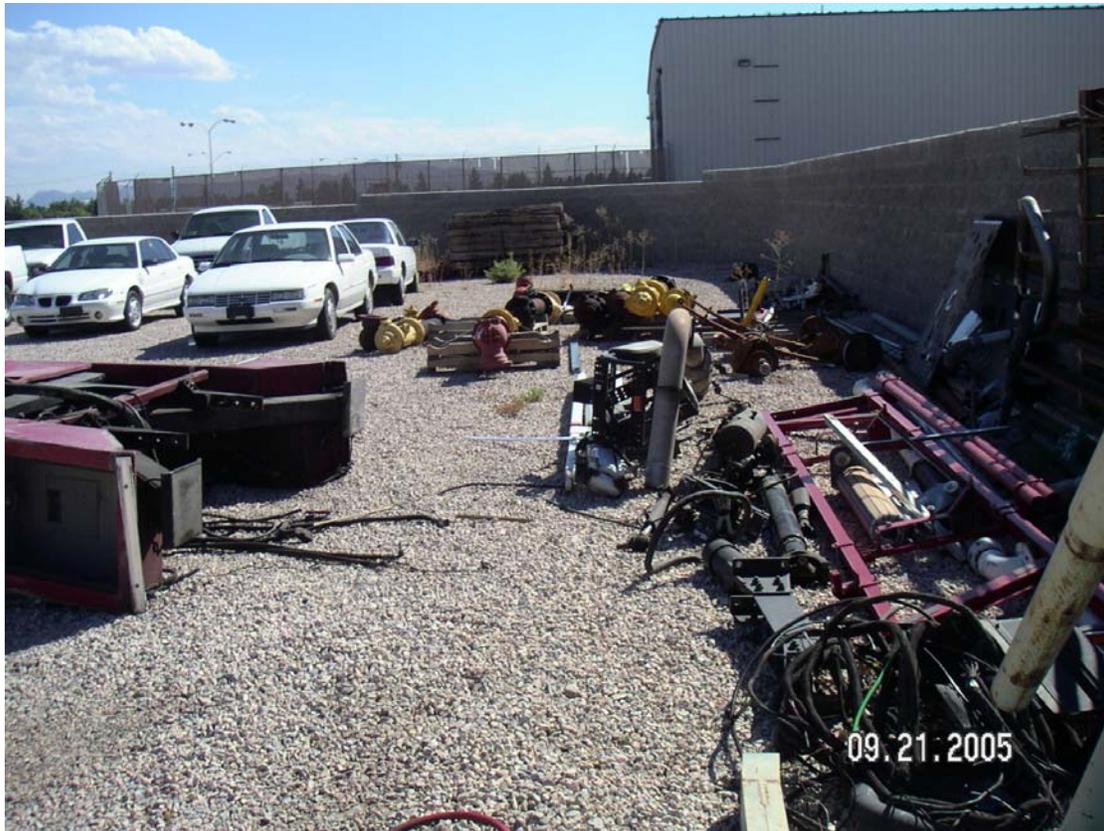
Photo 7. Materials stored on gravel pad.
