Program Audit Report
Las Vegas Valley Storm Water Management Program:
Clark County Regional Flood Control District; Clark County; City of Las
Vegas; City of North Las Vegas; and City of Henderson
(NPDES Permit No. NV0021911)

September 19-23, 2005

Prepared for:
EPA Region 9
75 Hawthorne Street
San Francisco, CA 94105

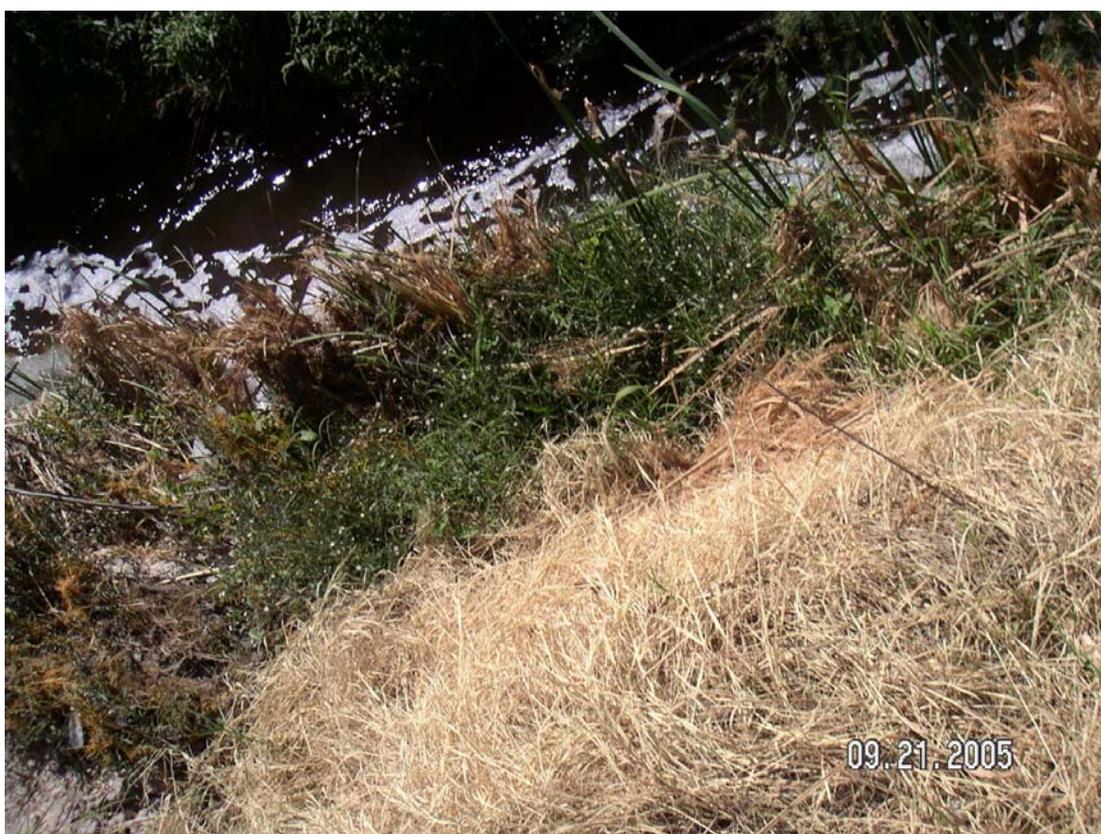
Photo 4. Las Vegas Wash - Appearance is brown with suds.

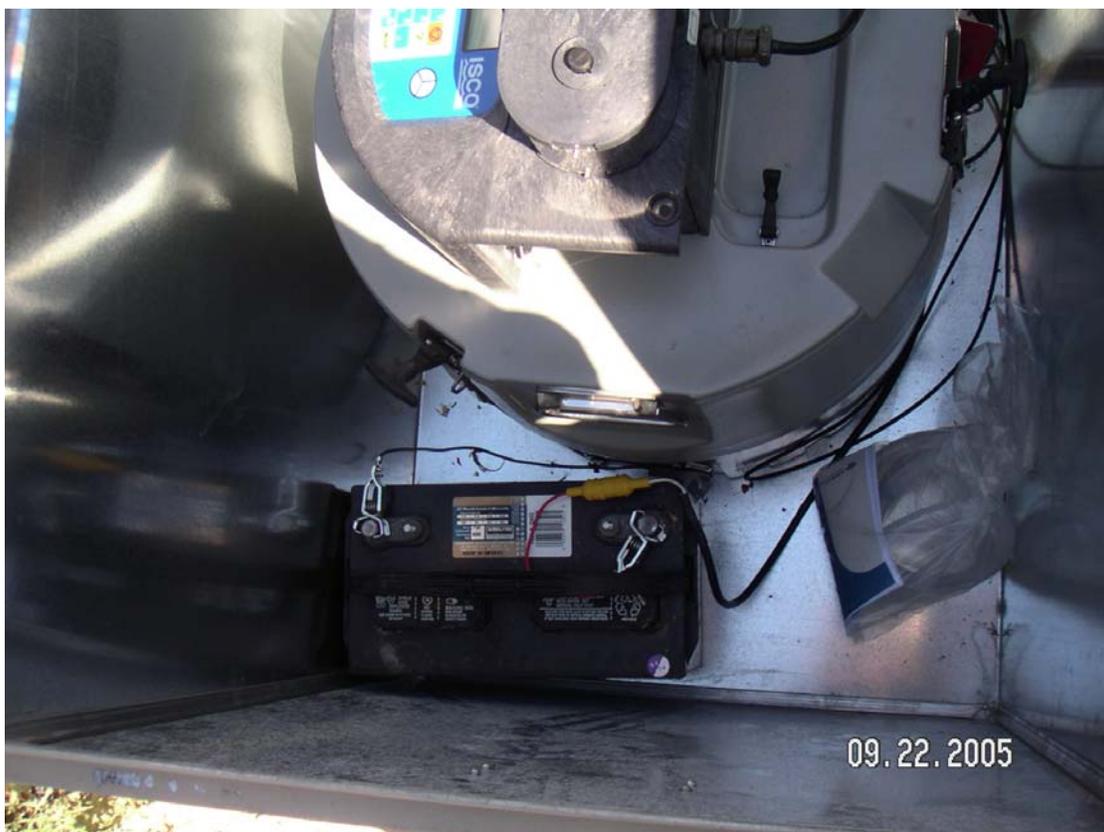
Photo 12. Meadows Detention Basin - marine battery in sampler.

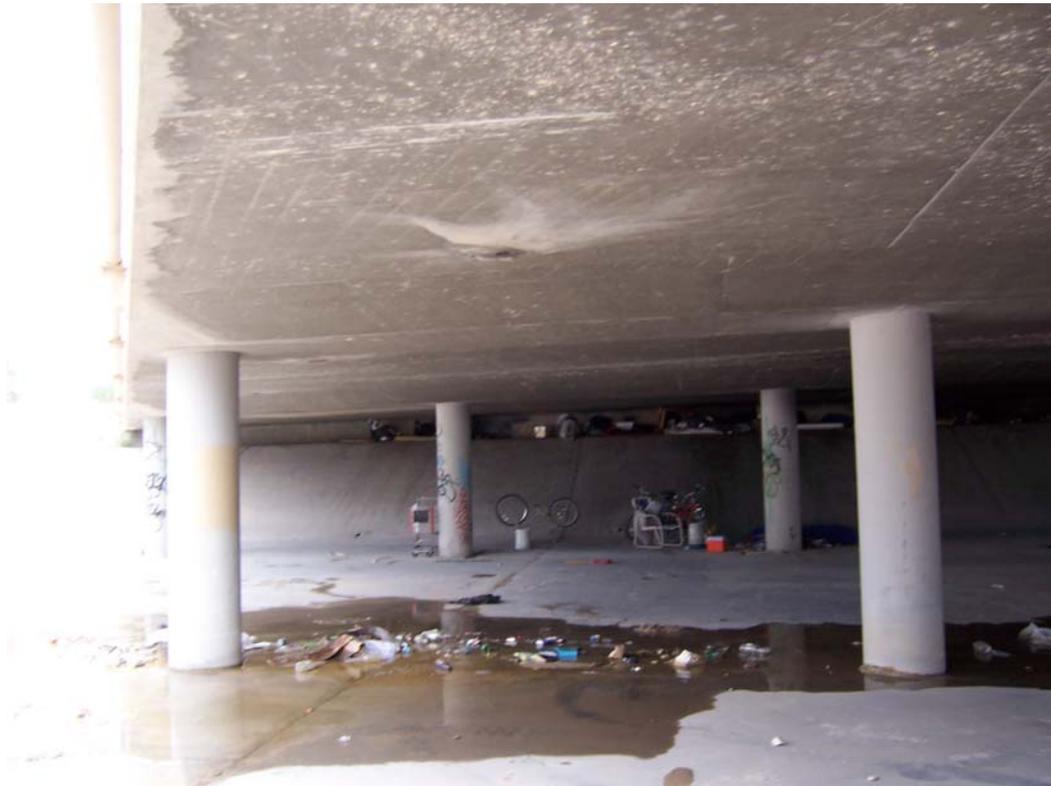
Photo 3. Homeless individuals living between Losse overpass roadway and upper apron of the wash. Bicycles, shopping carts, and debris in the wash are likely from these individuals.

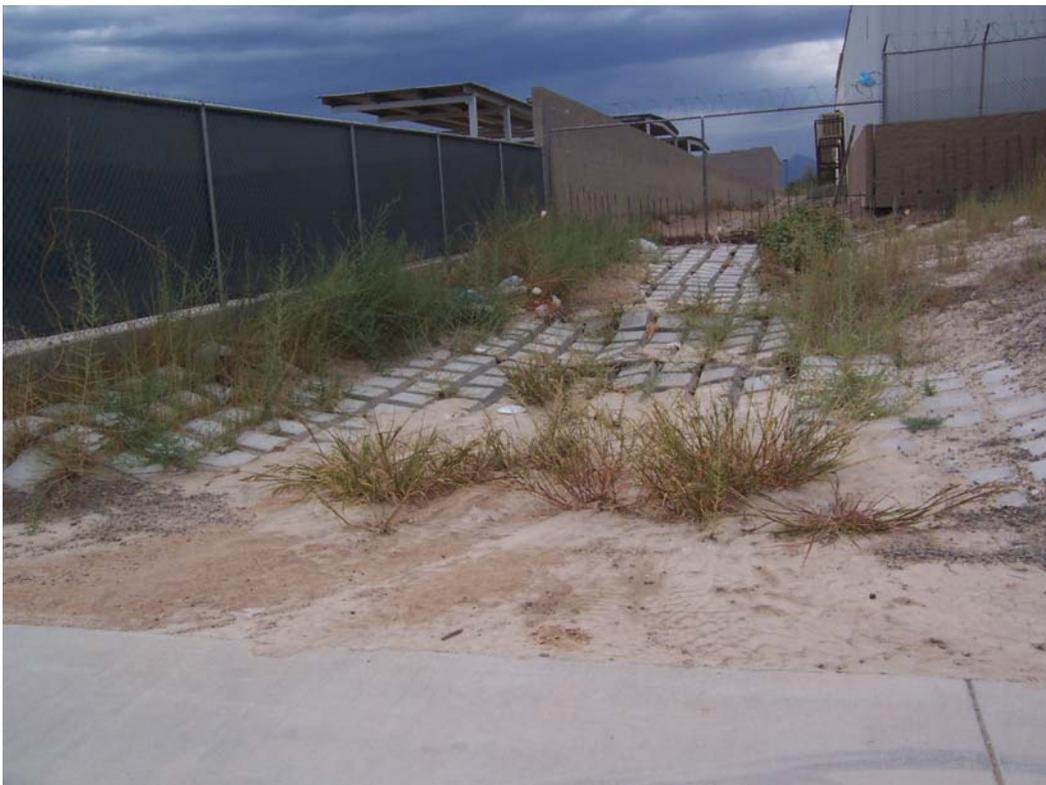
Mr. Rura did not note several areas where soil erosion appears to be entering the wash. In response to a question, he stated that soil erosion was not identified or addressed as part of the wash walks.

Photo 4. Riprap channel between commercial properties. Note lower end of channel appears to be clogged with sediment.

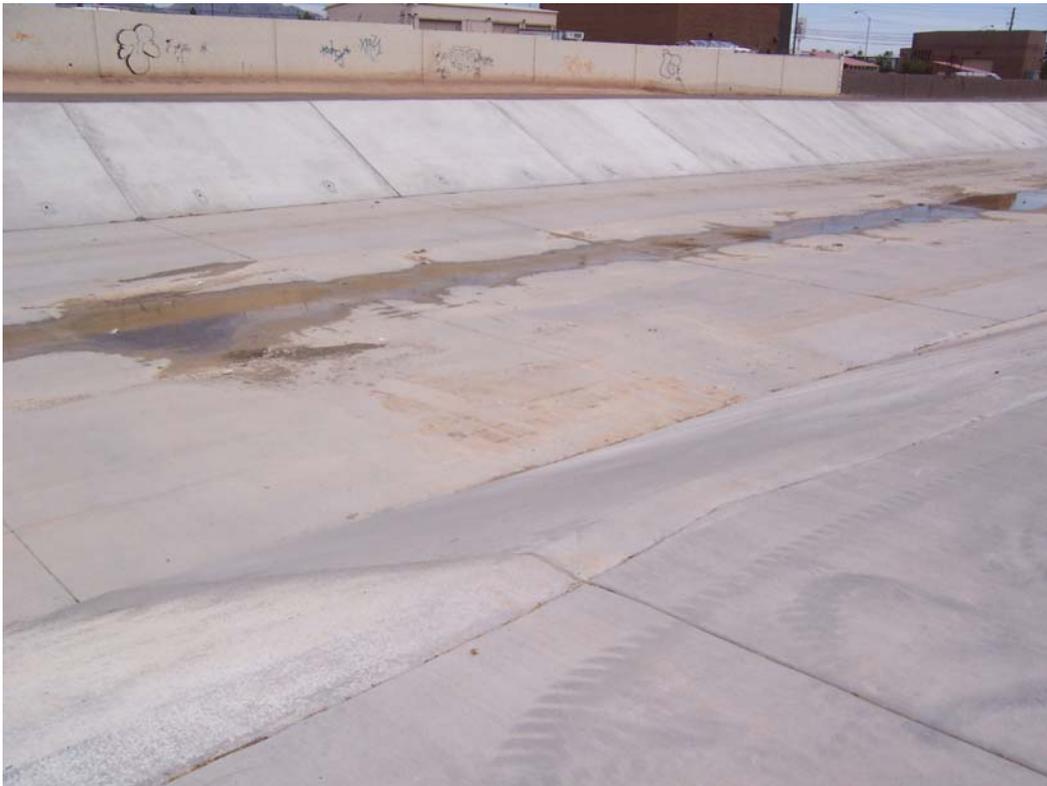
Photo 5. Portion of wash adjacent to the channel in Photo 4 where sediment appears to have entered the wash from the channel.

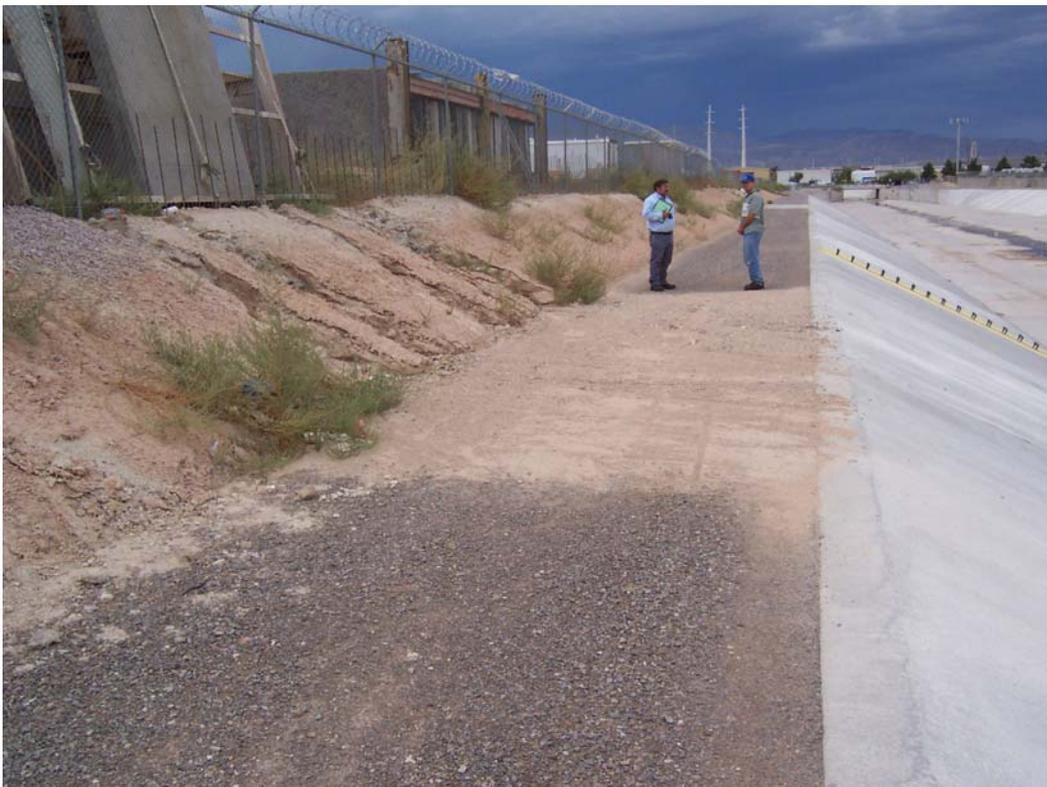
Photo 6. Area where soil erosion on the bank to the left of the wash appears to have entered the wash.

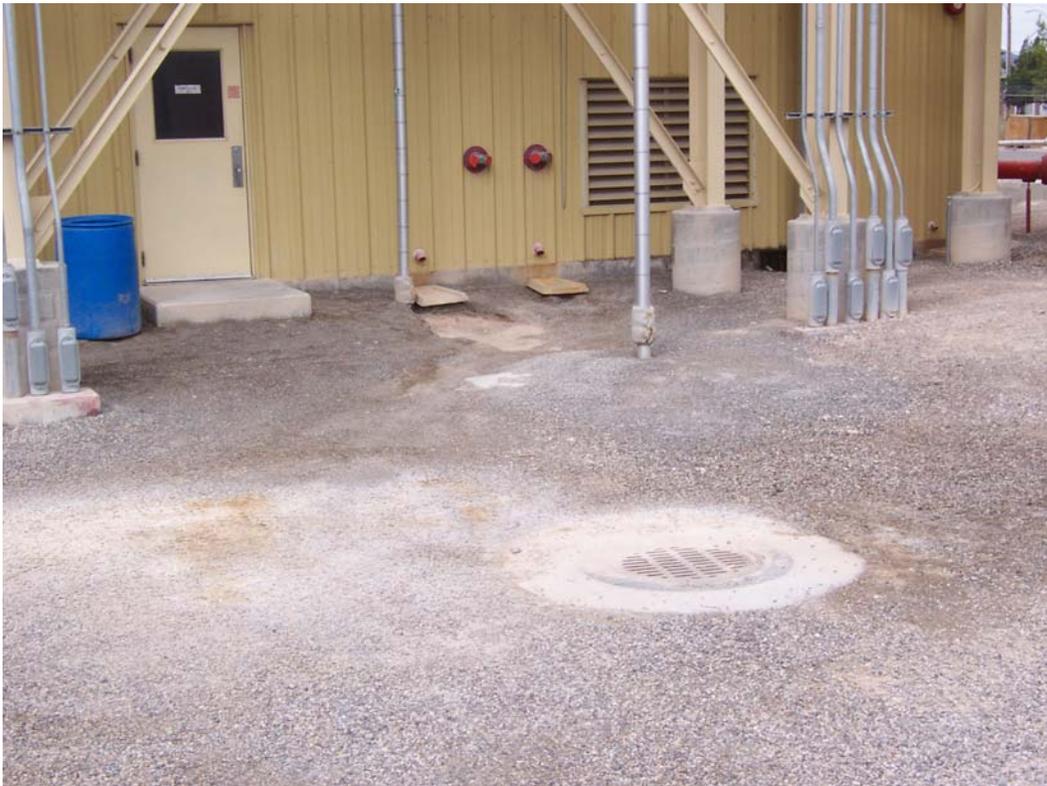
1. Mr. Rura did not note an area next to a building where a roof downspout was causing soil erosion that appeared to be going directly to a yard drain.

Photo 1. Inspector did not note evidence of soil erosion at roof drain discharge (to the right of the doorway) that appeared to be going directly to the area storm inlet.

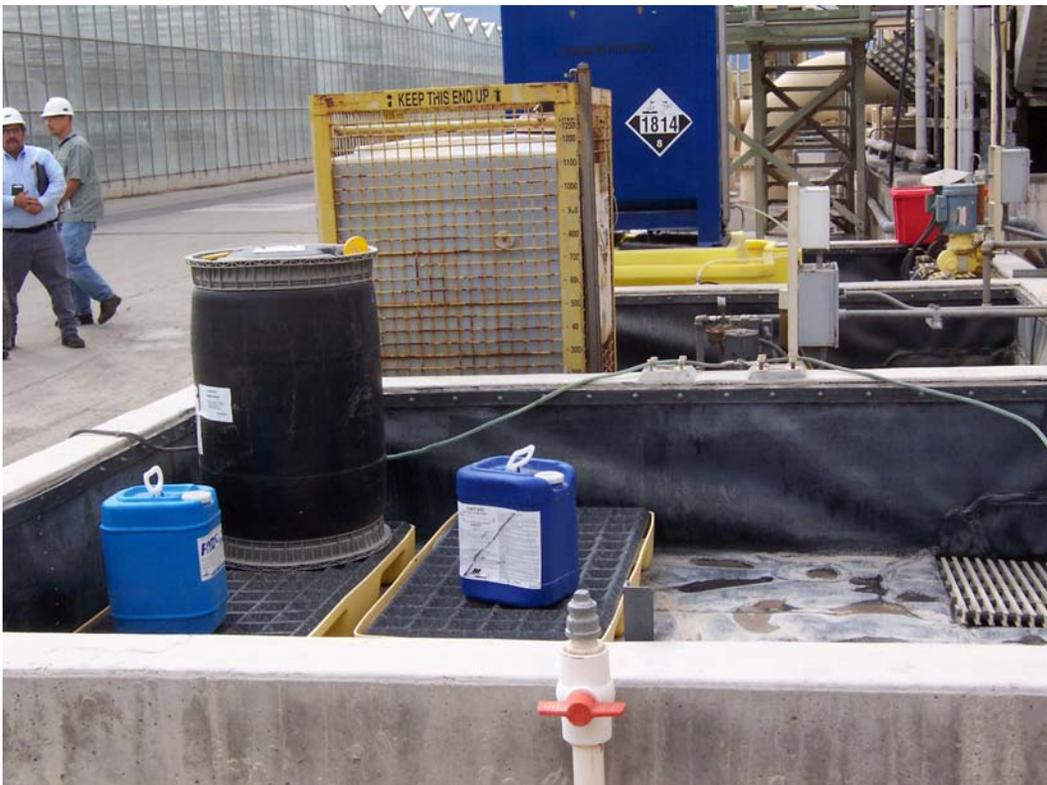
Photo 2. The inspector did note that all containers five gallons or larger have been provided with secondary containment as required by local ordinance.

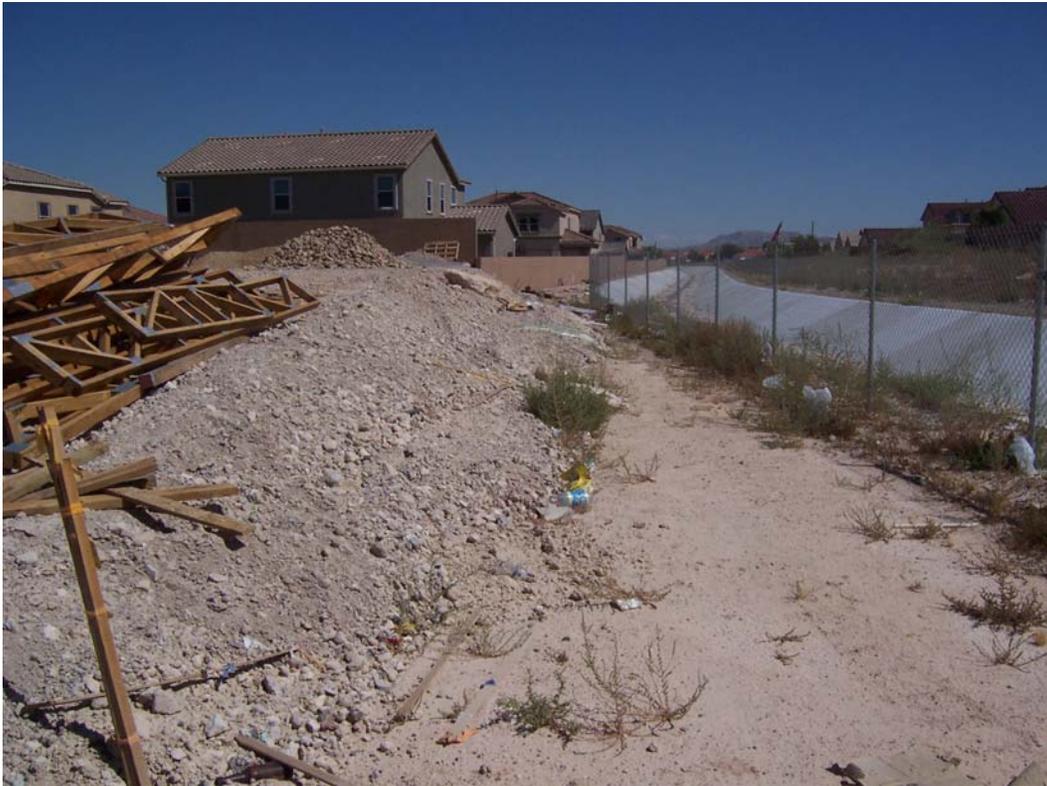
1. Mr. Melo did not comment on the presence of sediment in the wash next to the construction site.
2. Mr. Melo did not comment on the placement of a portable toilet next to a paved roadway. If knocked over by a construction vehicle, it would flow directly to a storm inlet.
3. The inspection form used asks if BMPs are in place. It is Mr. Melo's practice to check the "yes" box if any BMPs are in place, even if they are incomplete or do not cover all areas. Thus, he appears to be answering the question: Are any BMPs in place?
4. Mr. Melo indicated that he had received four hours of training in storm water control and that the subject had come up in at least two inspector meetings.
5. The audit team reviewed the SWPPP prepared for the site. It appeared complete, current, and well organized.

Photo 1. Dirt and debris piled adjacent to wash at the construction site.

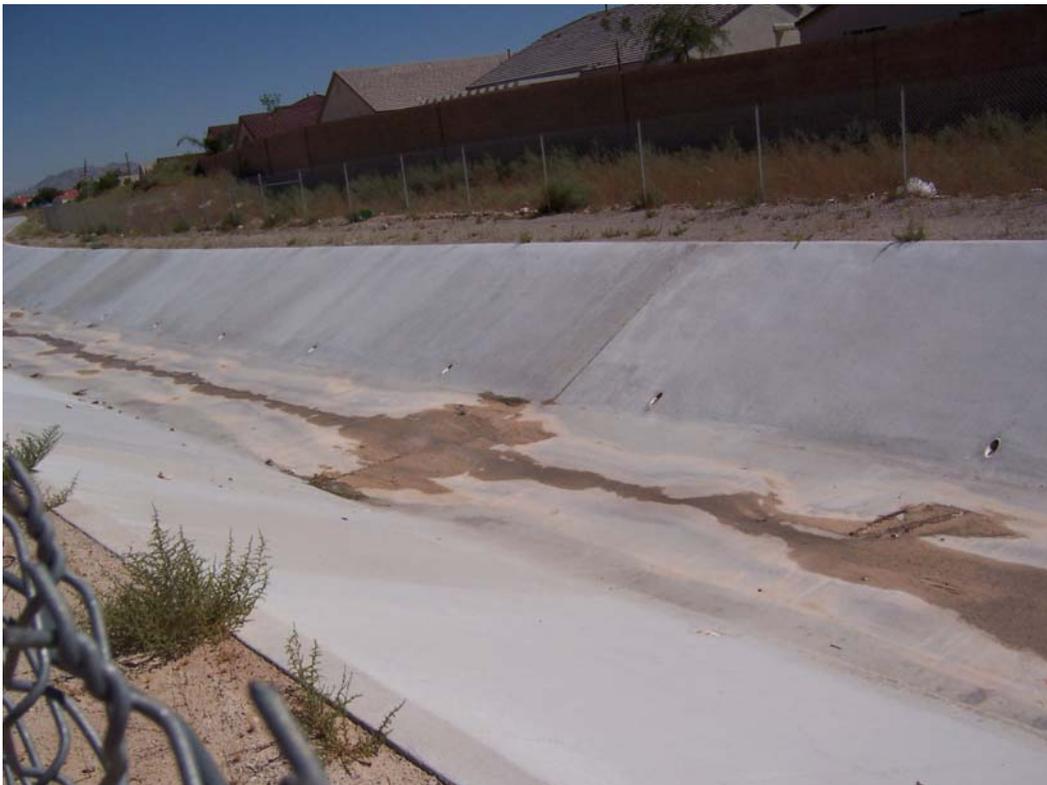
Photo 2. Wash adjacent to the construction site. Wash appears to contain sediment that may have come from the site.

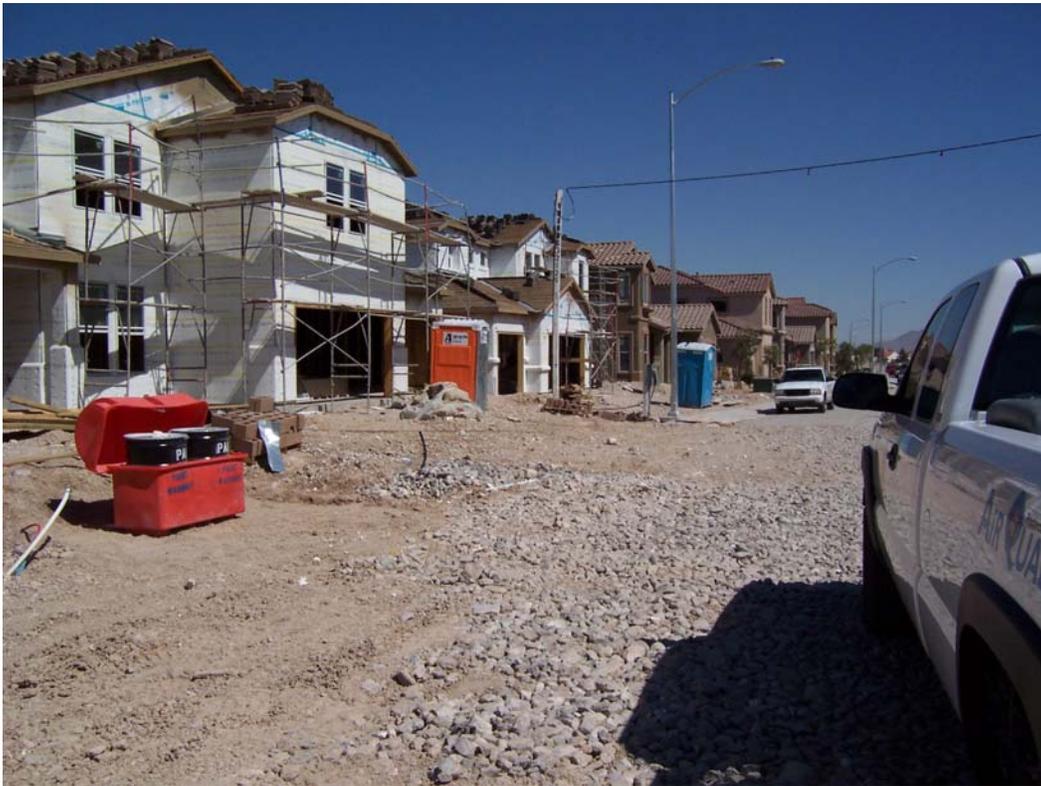
Photo 3. Note portable toilet (blue) in photo right center located immediately adjacent to the paved road upslope of inlets. Note also crush rock for trackout control located in front of pickup truck at photo right.

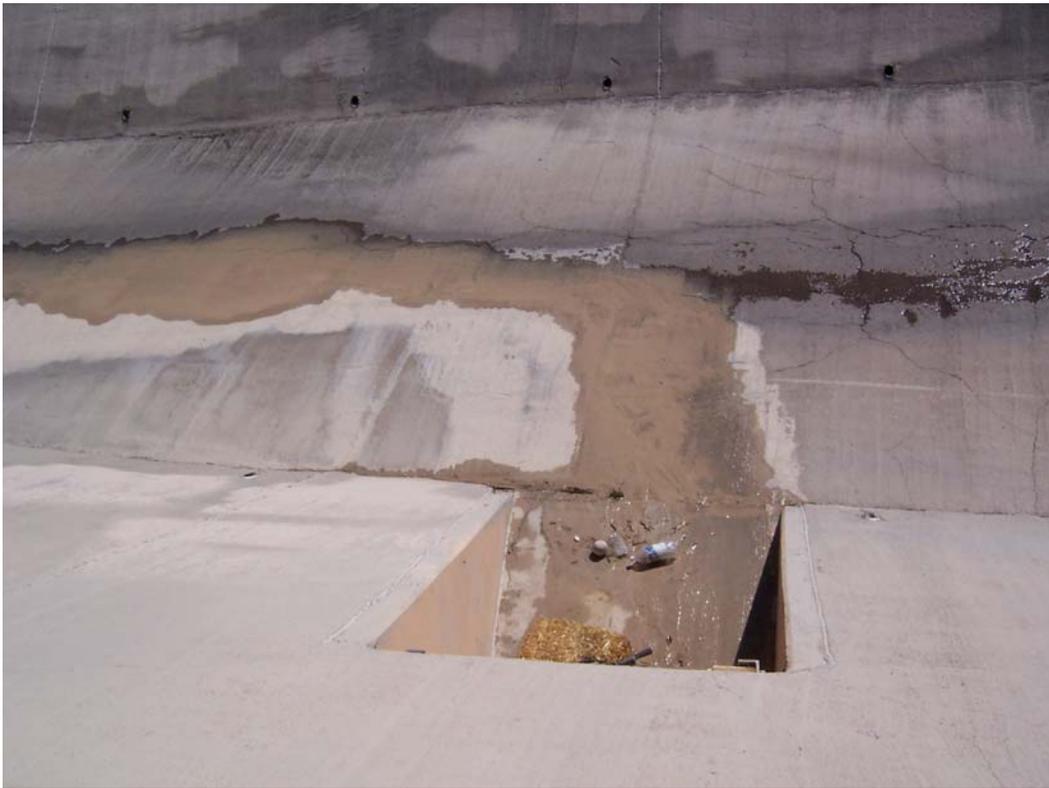
4. He noted that water and sediment were entering the wash from the storm drain that serves the paved roads of the site.
5. He noted that piles of dirt along the curb line were extended into the street. The street had recently been washed down, and sediment was entering a storm inlet through the sand bags intended for inlet protection. Sediment could also be observed entering a manhole on the street side of the inlet through the pick hole in the manhole cover.

Photo 1. Water and sediment from the construction site entering the wash.

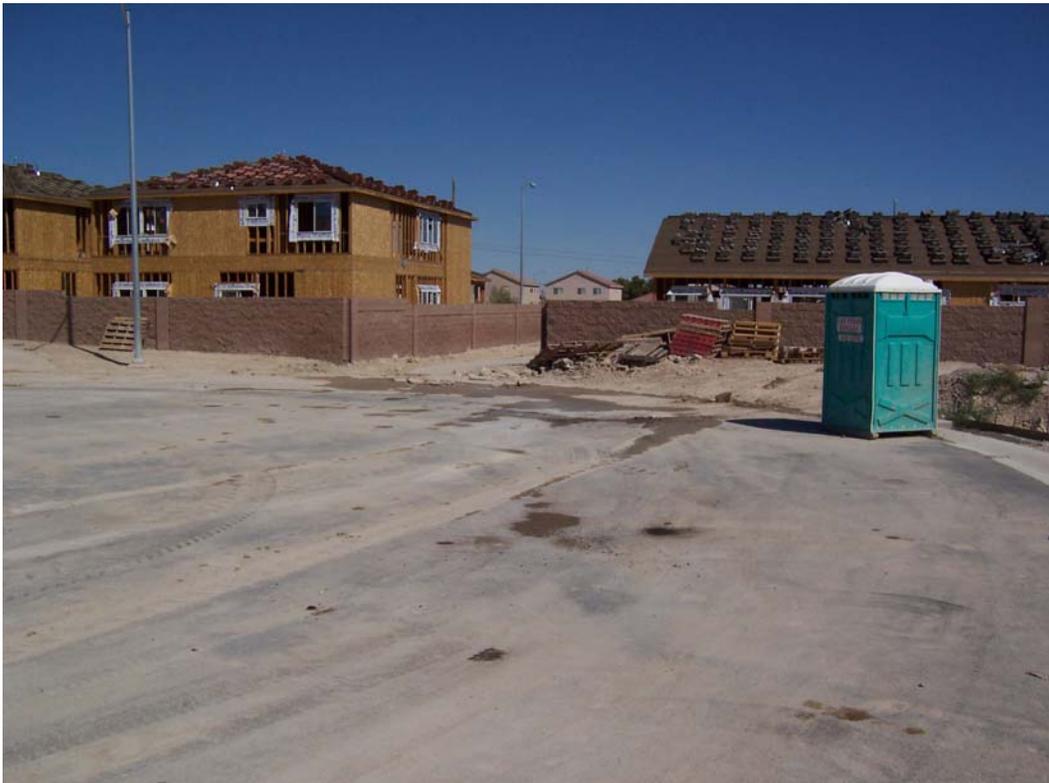
1. Mr. Melo did not note the presence of a portable toilet in the street not far from an inlet. If knocked over by a construction vehicle, it would flow directly to the storm inlet.
2. He did not note that several sand bags, which were placed at regular intervals along the curb apparently to catch sediment, were moved back several inches from the curb providing a gap for water to pass through, making them ineffective.

Photo 4. Portable toilet placed where spillage would go directly to storm inlet. Storm inlet is left center photo, at the end of the sidewalk to the cul-de-sac.

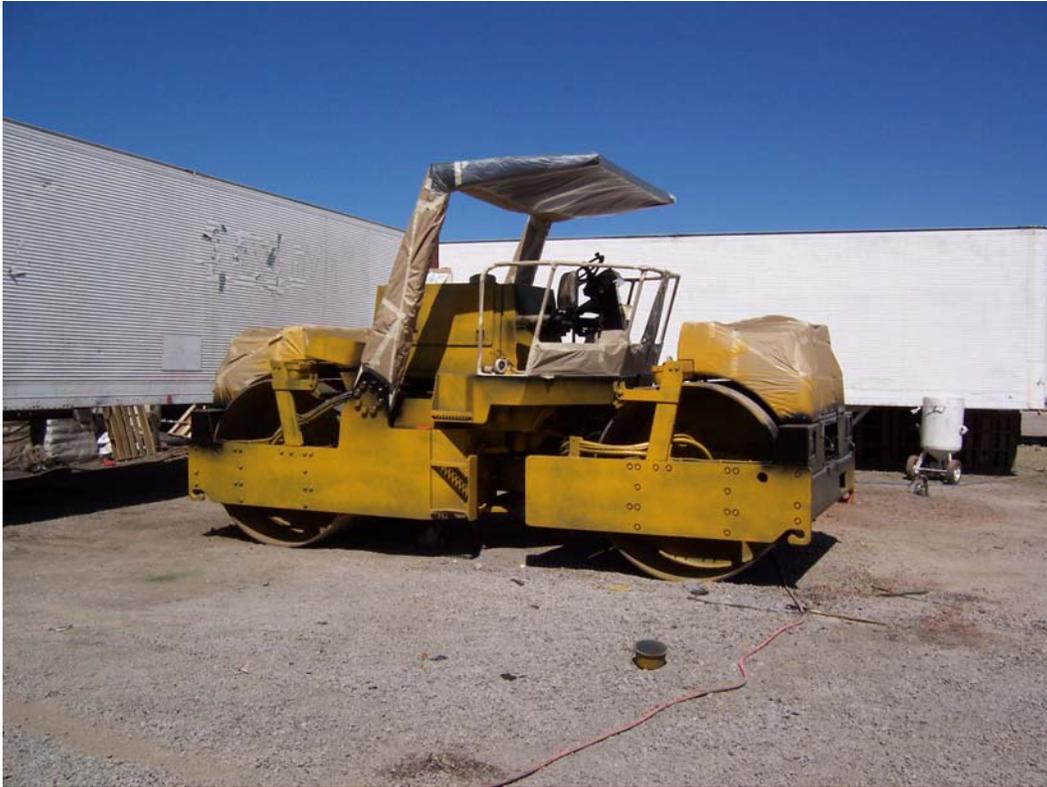
Photo 2. Roller masked for open air spray painting operation.

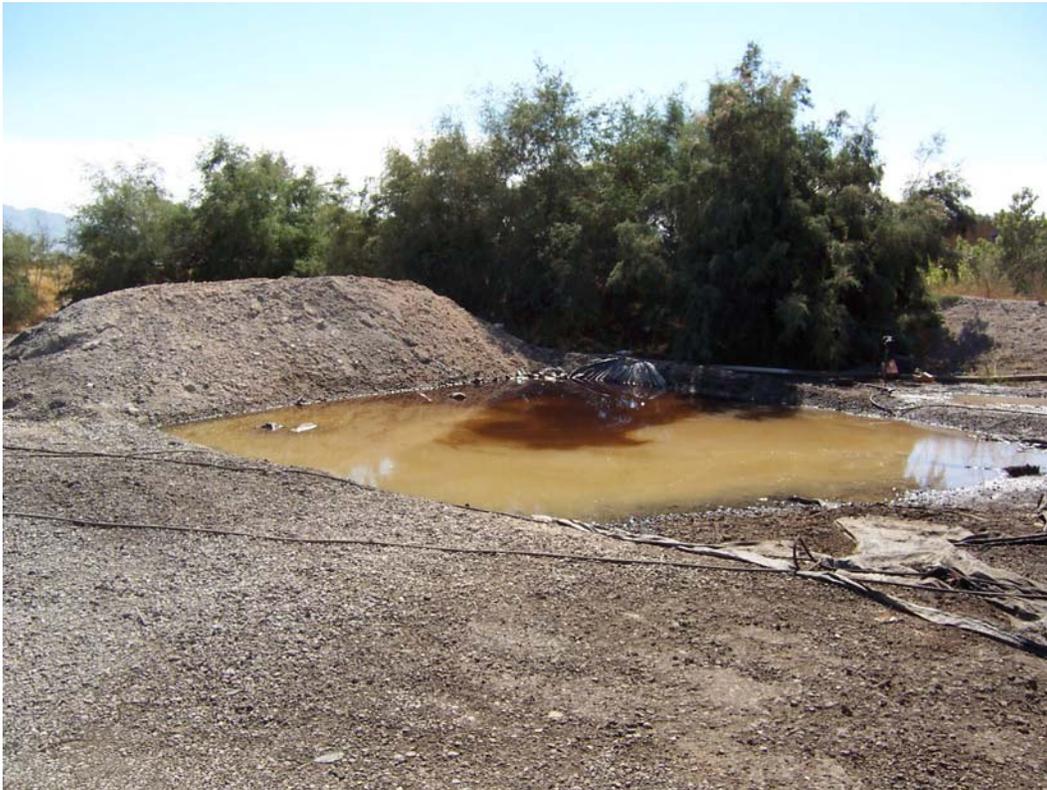
Photo 3. Temporary pit dug to contain wash water from equipment cleaning operation. Note floating oil on the surface of the water.

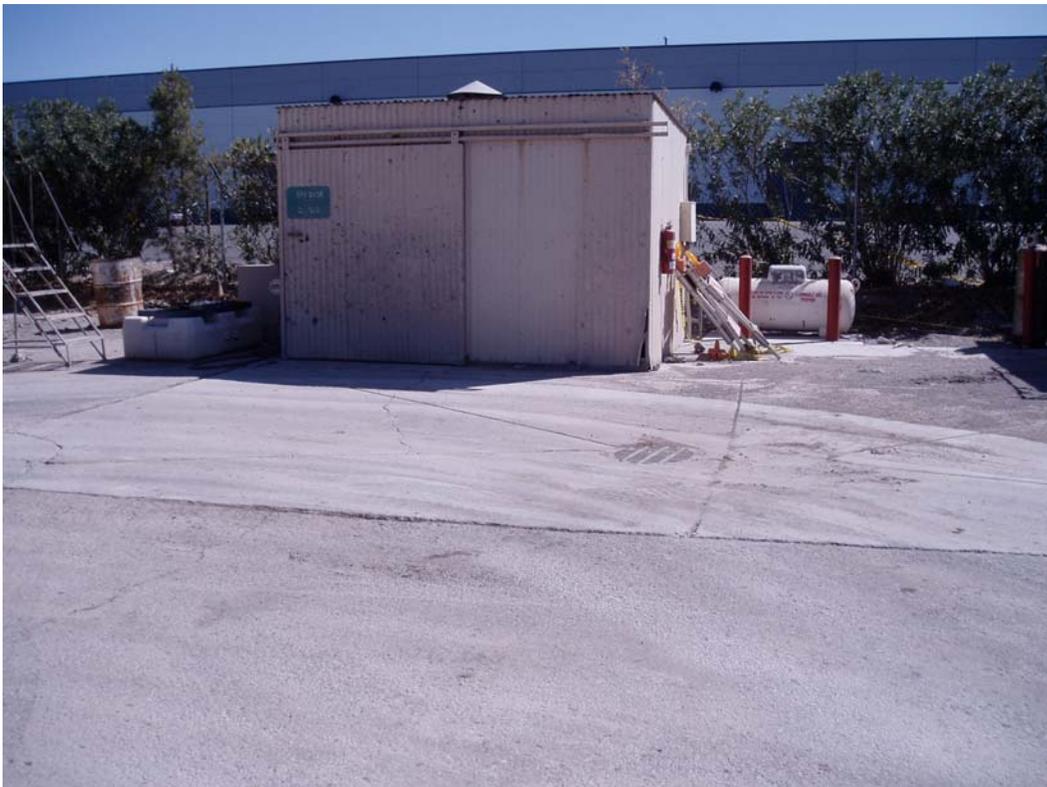
Photo 2. Car wash area. Drain flows to sanitary sewer.

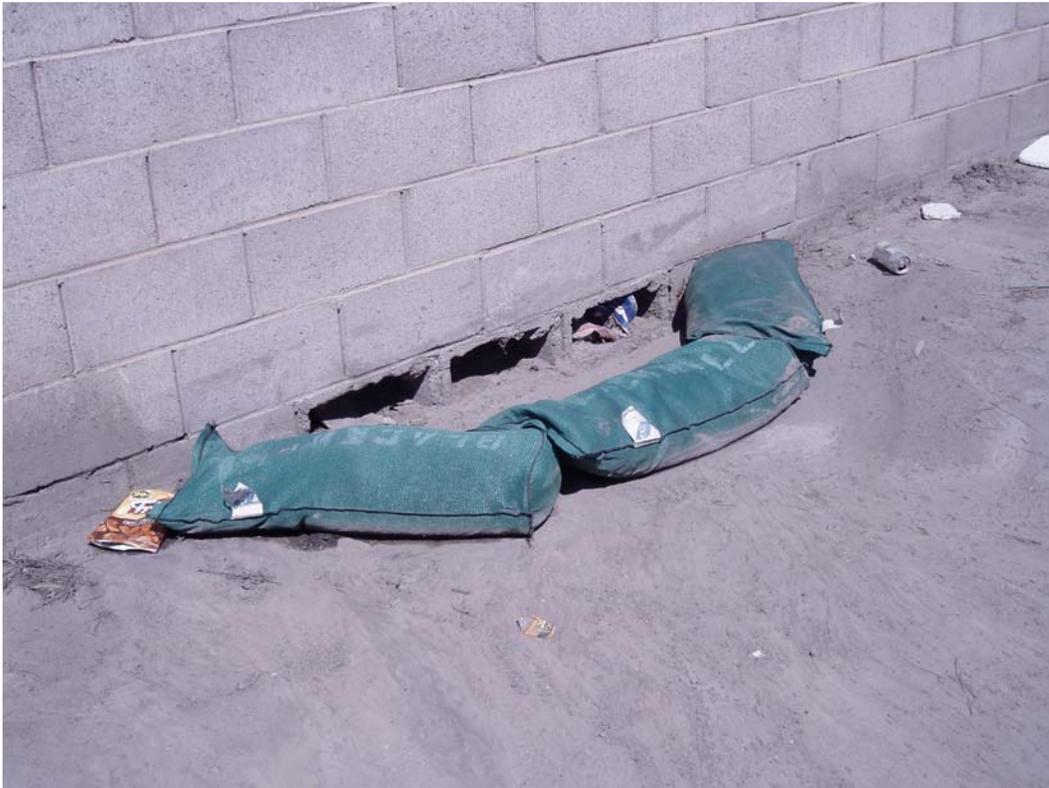
Photo 3. Drain to street in corner of parking lot.

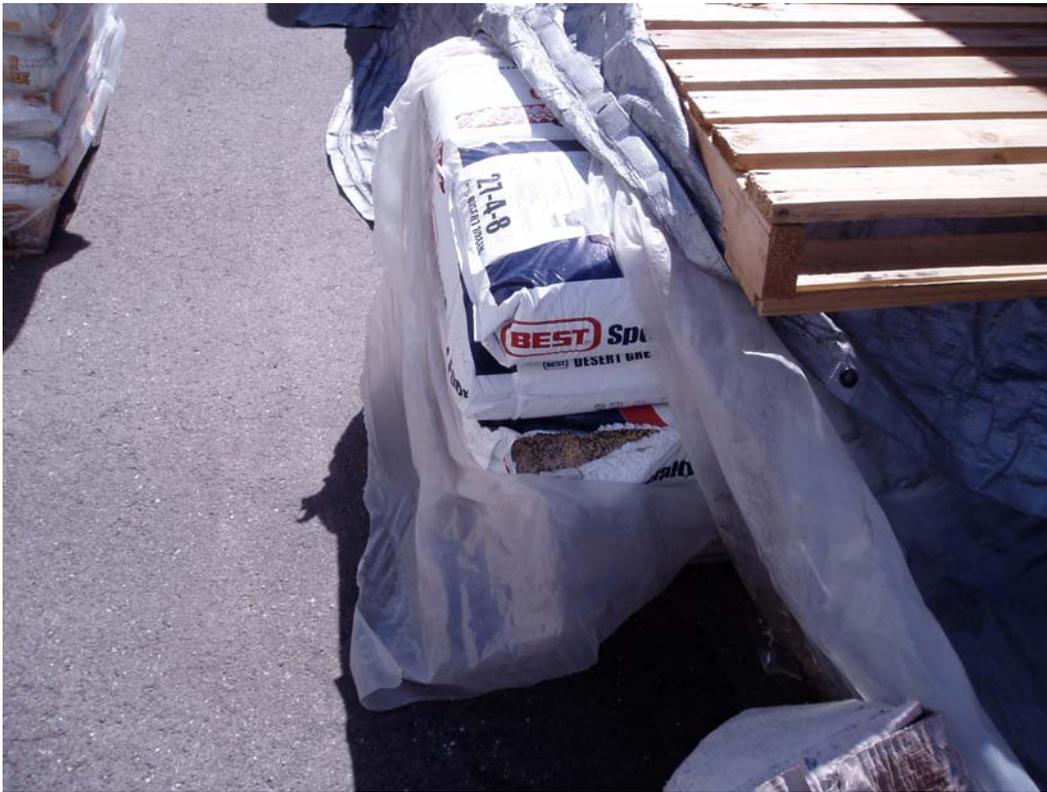
Photo 1. Fertilizer, note tear in package.

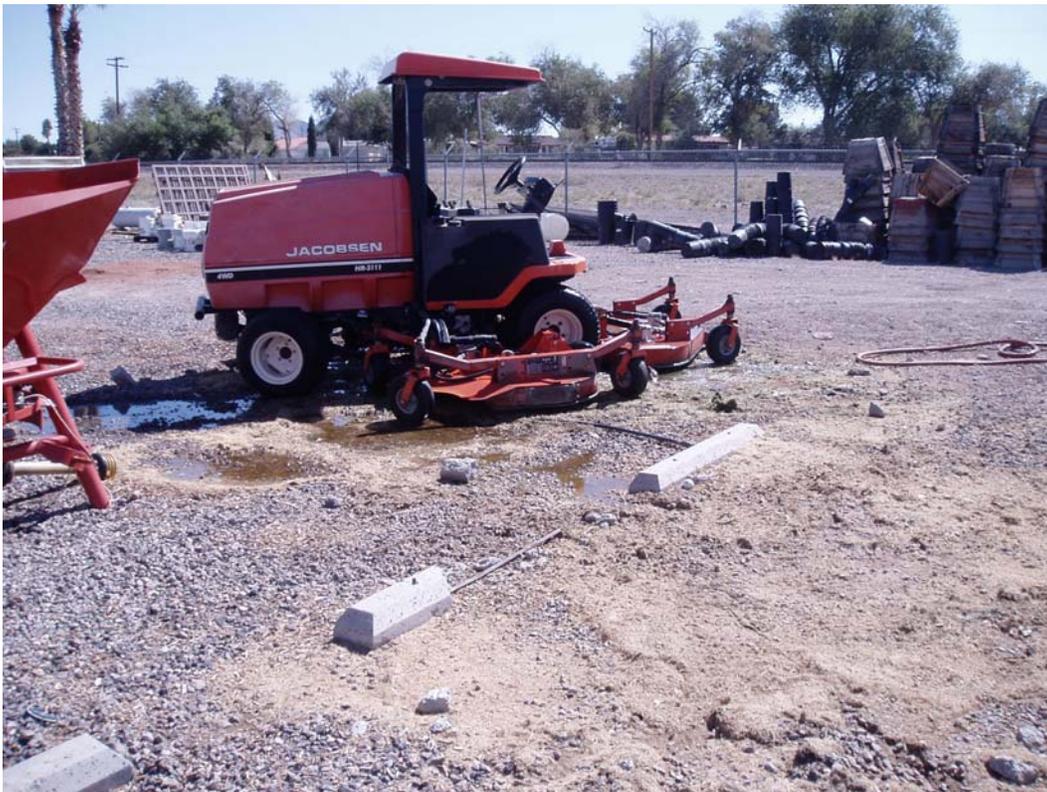
Photo 3. Vehicle that was being rinsed during the site visit. Note puddles of water.

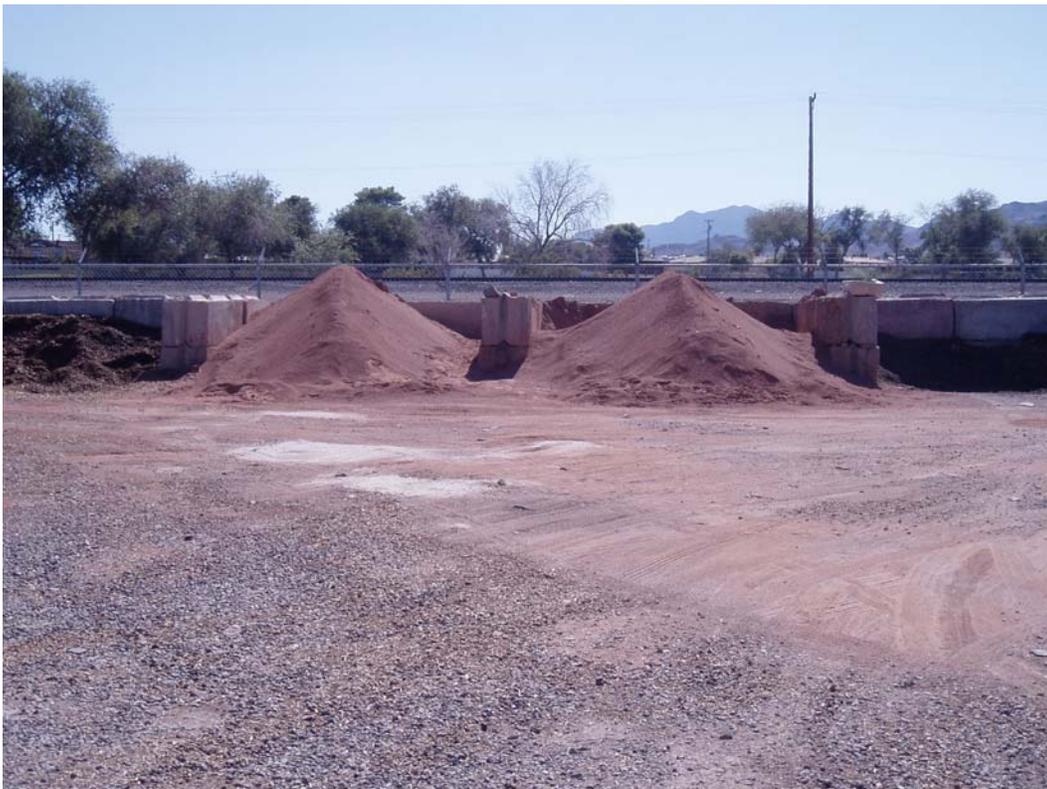
Photo 4. Sediment stockpiles. Grade is downhill toward the street.

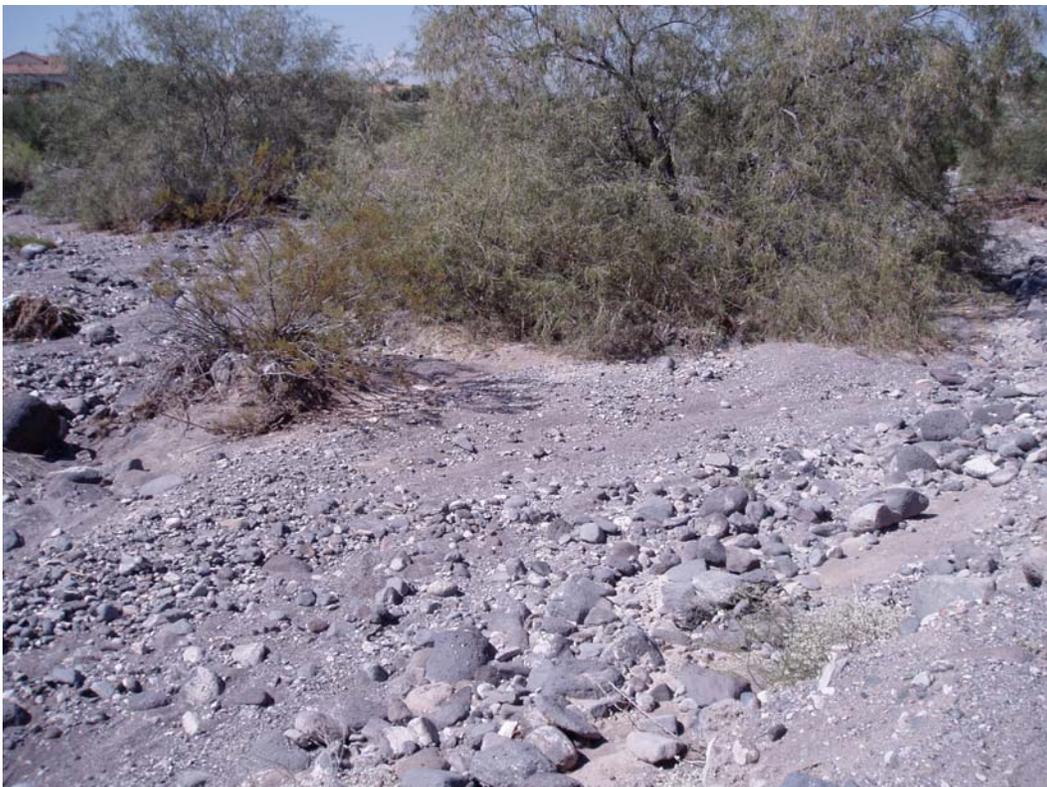
Photo 4. Invasive tamarisk.

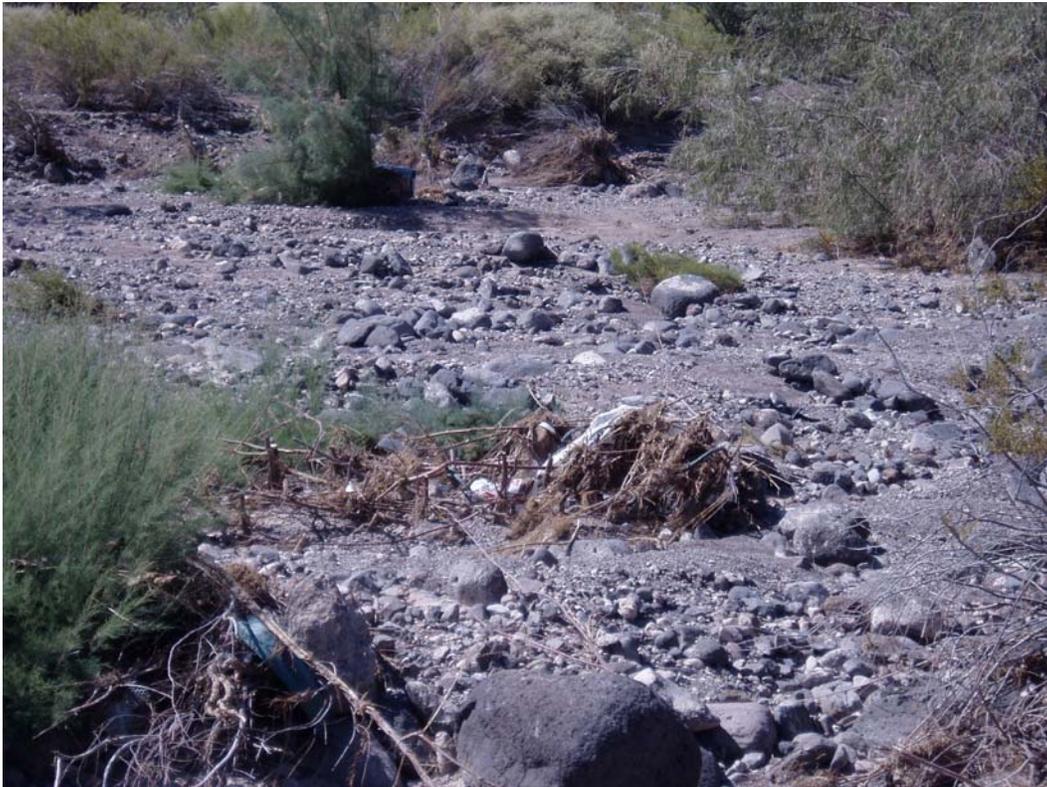
Photo 5. Tamarisk and debris in Project Green area of Pittman Wash.

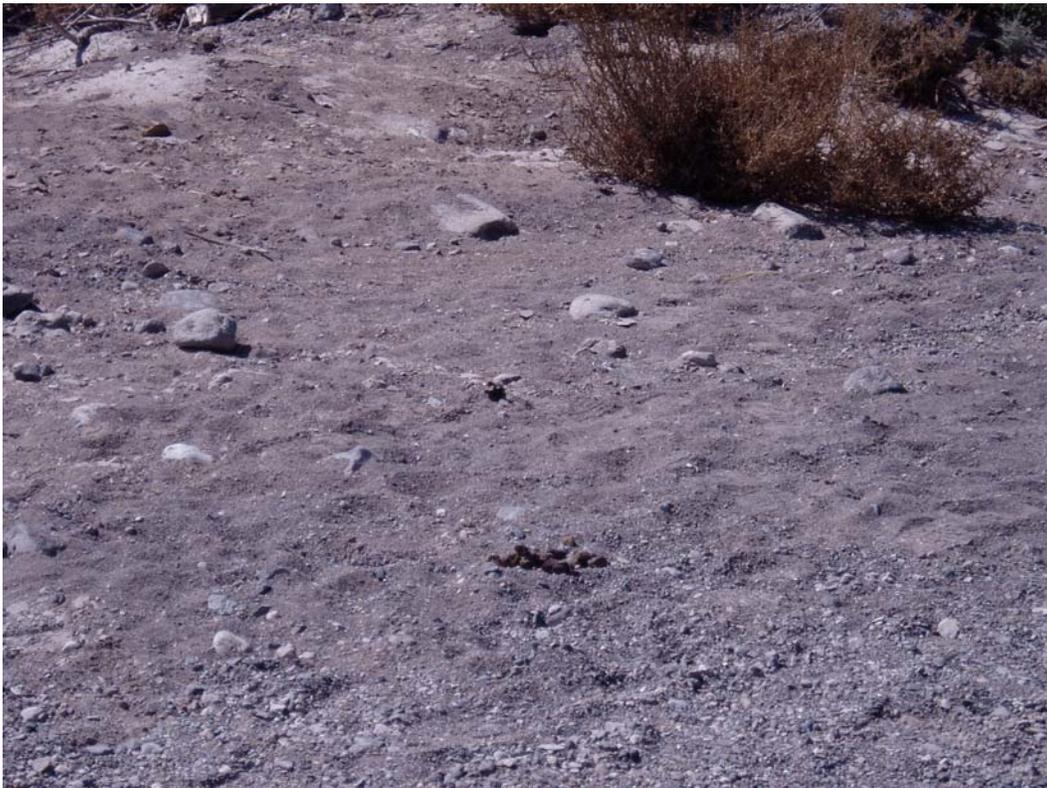
Photo 6. Pet waste (photo center towards the bottom) in Project Green area of Pittman Wash.

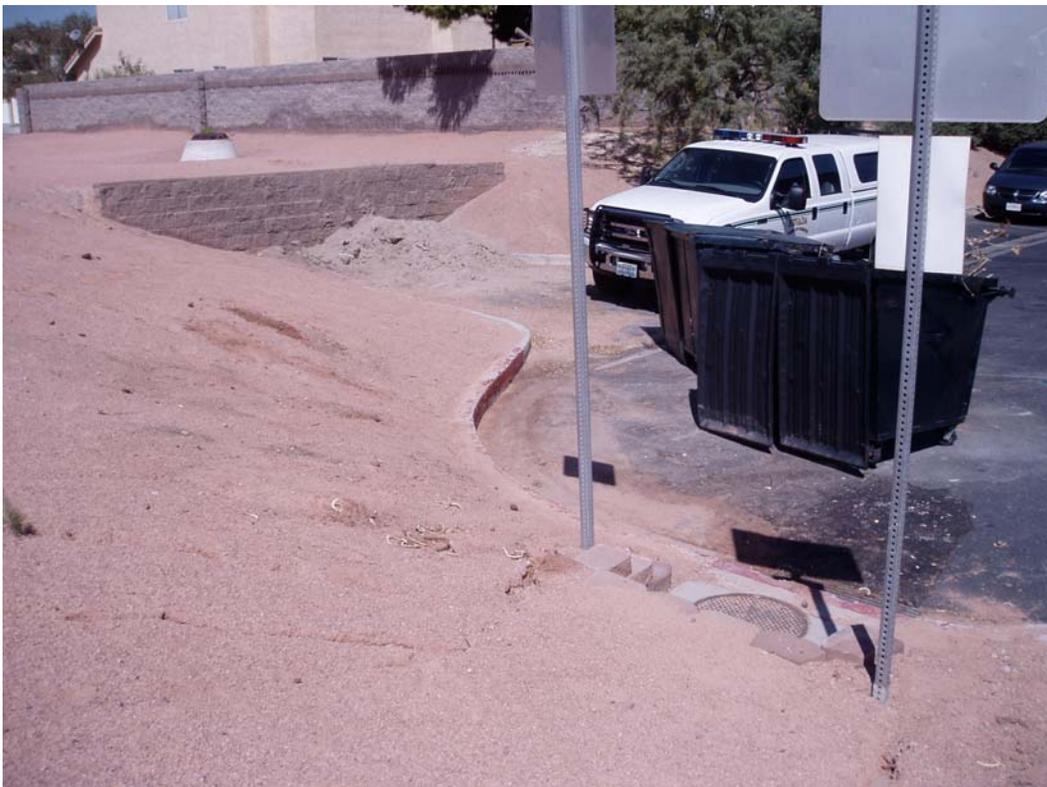
Photo 8. Parks and Recreation Department dirt storage. Trackout visible to inlet, which flows to outfall in Photo 7.

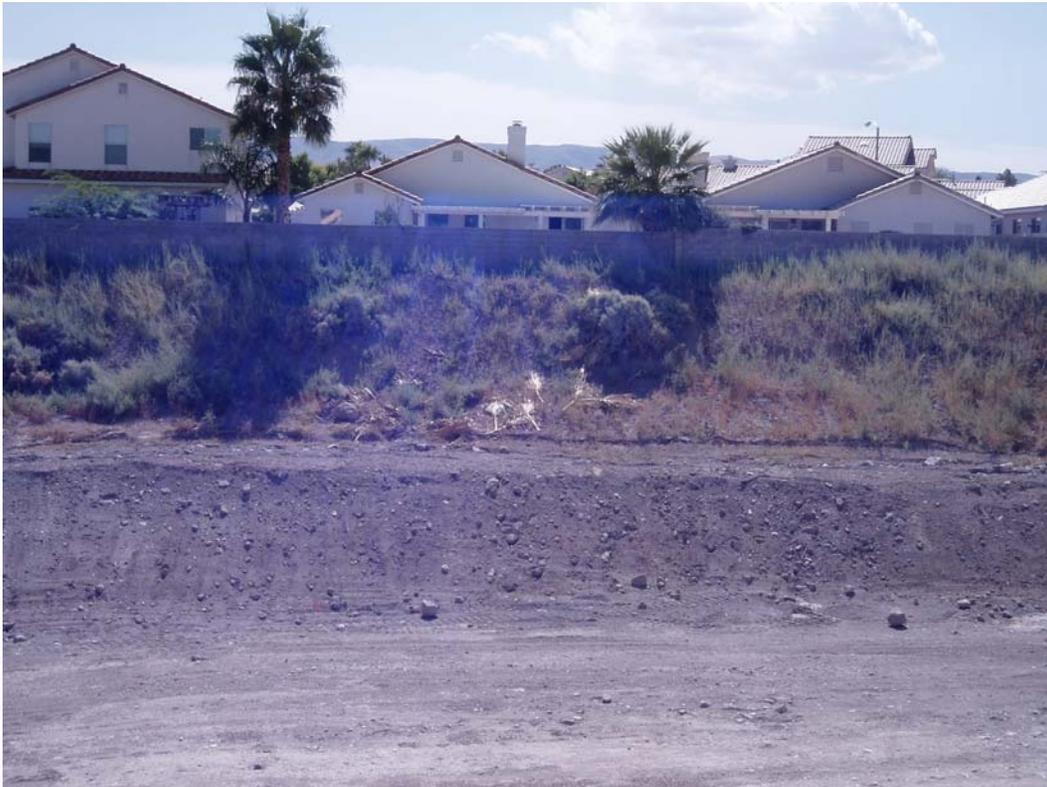
Photo 11. Palm fronds dumped in Upper Pittman Wash (photo center).

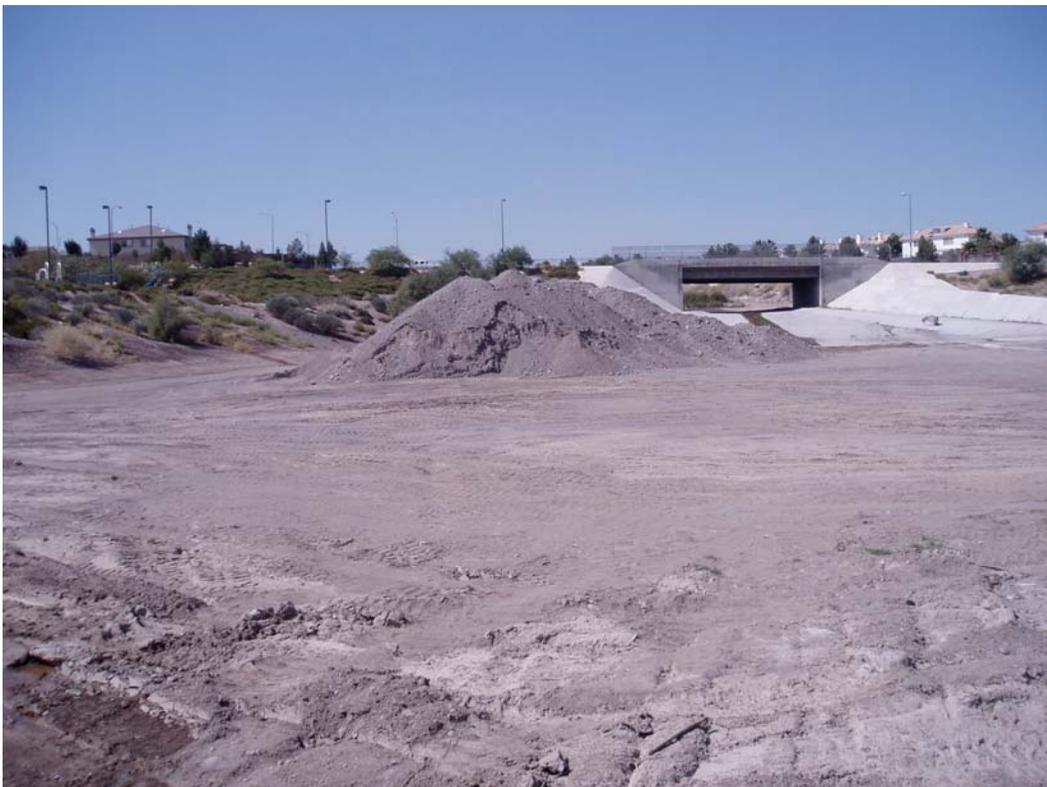
Photo 14. Sediment pile in Pittman Wash.
