Program Audit Report
Las Vegas Valley Storm Water Management Program:
Clark County Regional Flood Control District; Clark County; City of Las
Vegas; City of North Las Vegas; and City of Henderson
(NPDES Permit No. NV0021911)

September 19-23, 2005

Prepared for:
EPA Region 9
75 Hawthorne Street
San Francisco, CA 94105

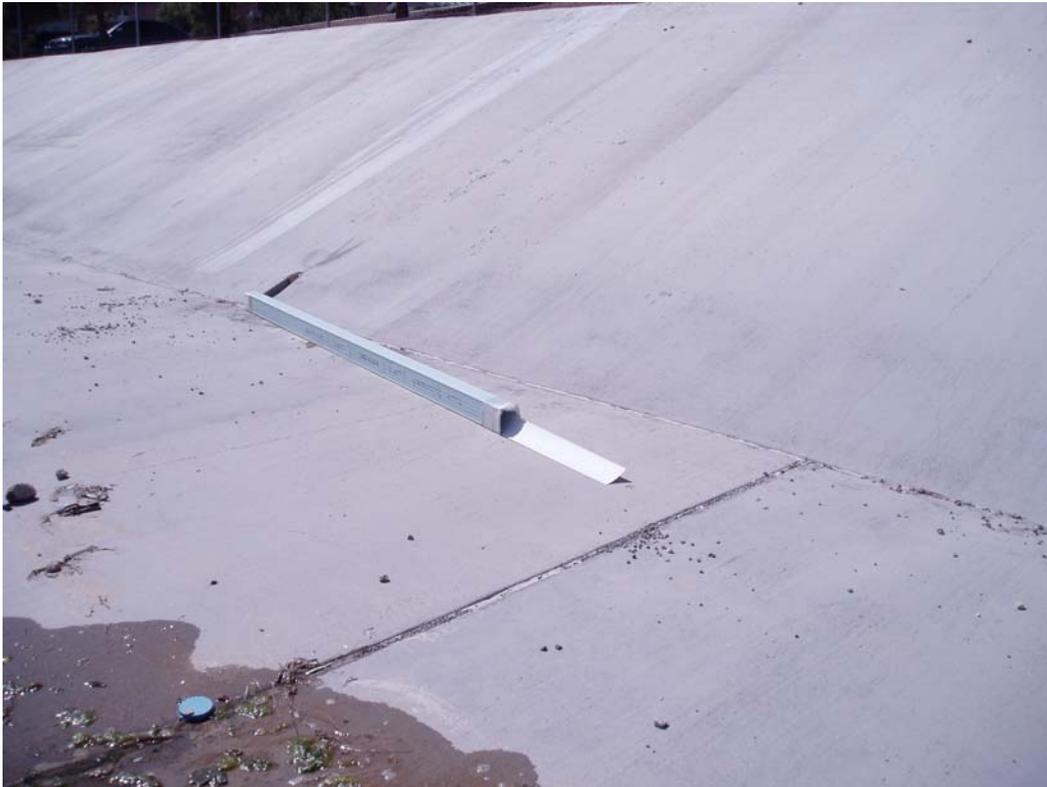
Photo 21. Empty box dumped in channel.

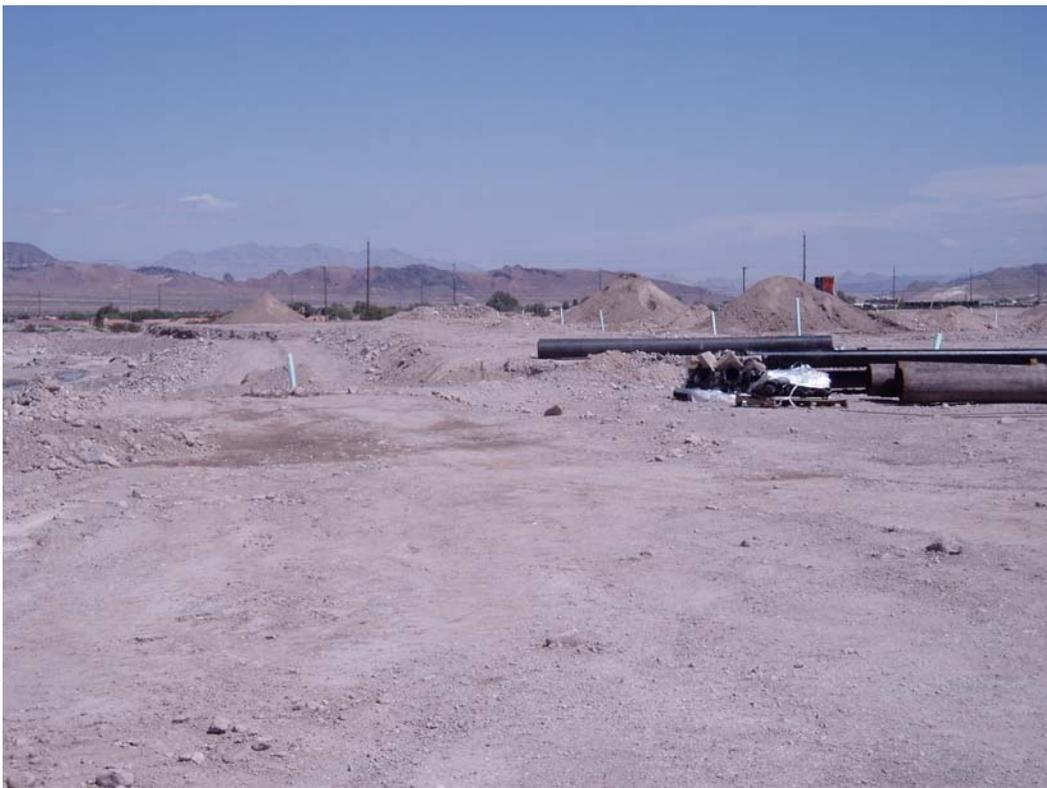
4. An industrial storage area and a residential construction site adjacent to Gibson Channel were not using Best Management Practices (BMPs) to minimize the potential for pollution to runoff into the channel.

Photo 26. Construction and sediment piles (photo right) adjacent to Gibson Channel (photo left).

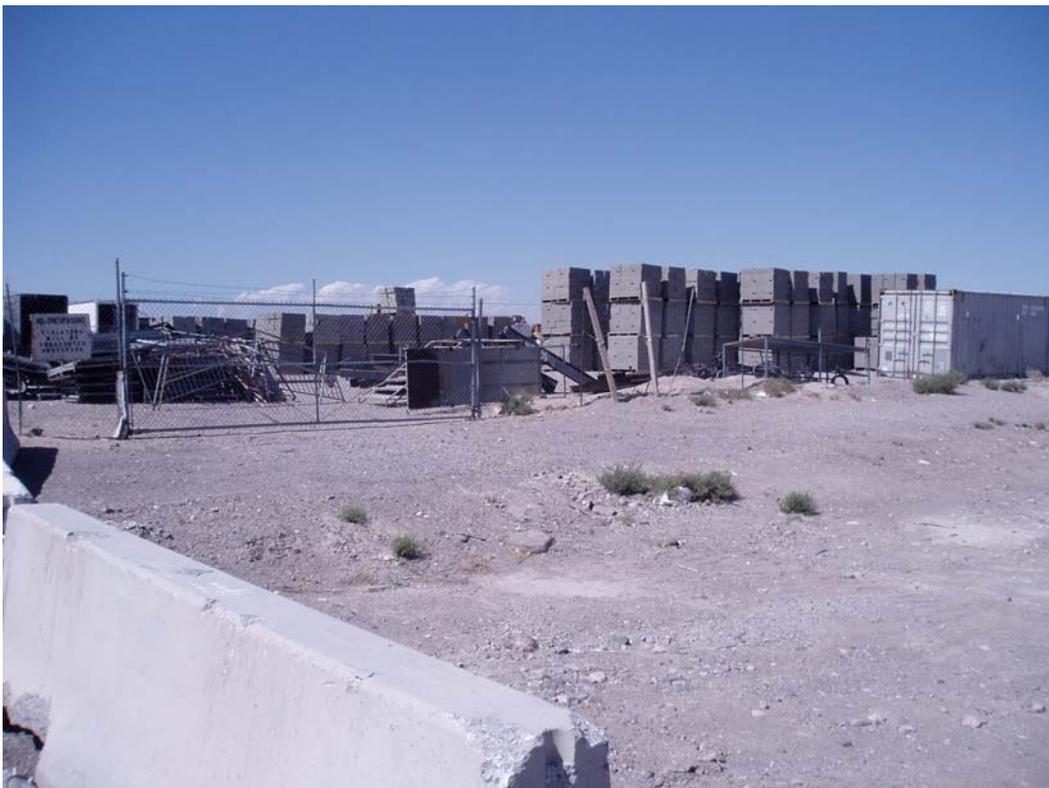
Photo 28. Storage along Gibson Channel.

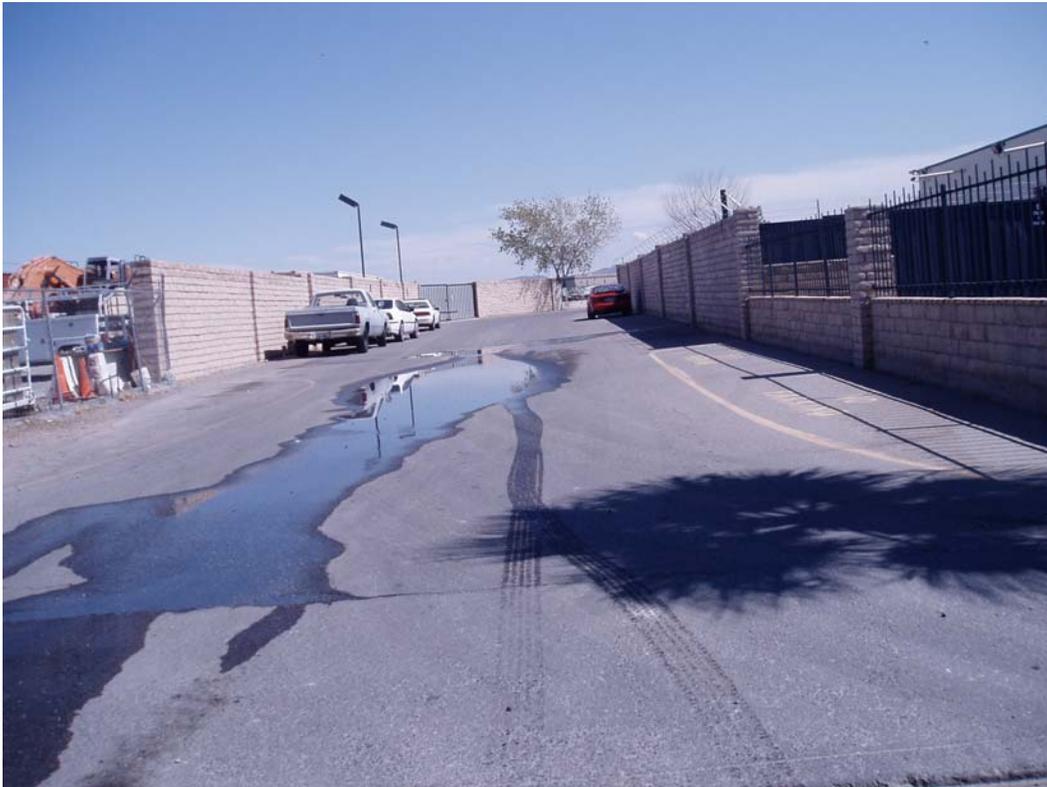
Photo 29. Discharge coming from B.Witt parking lot.

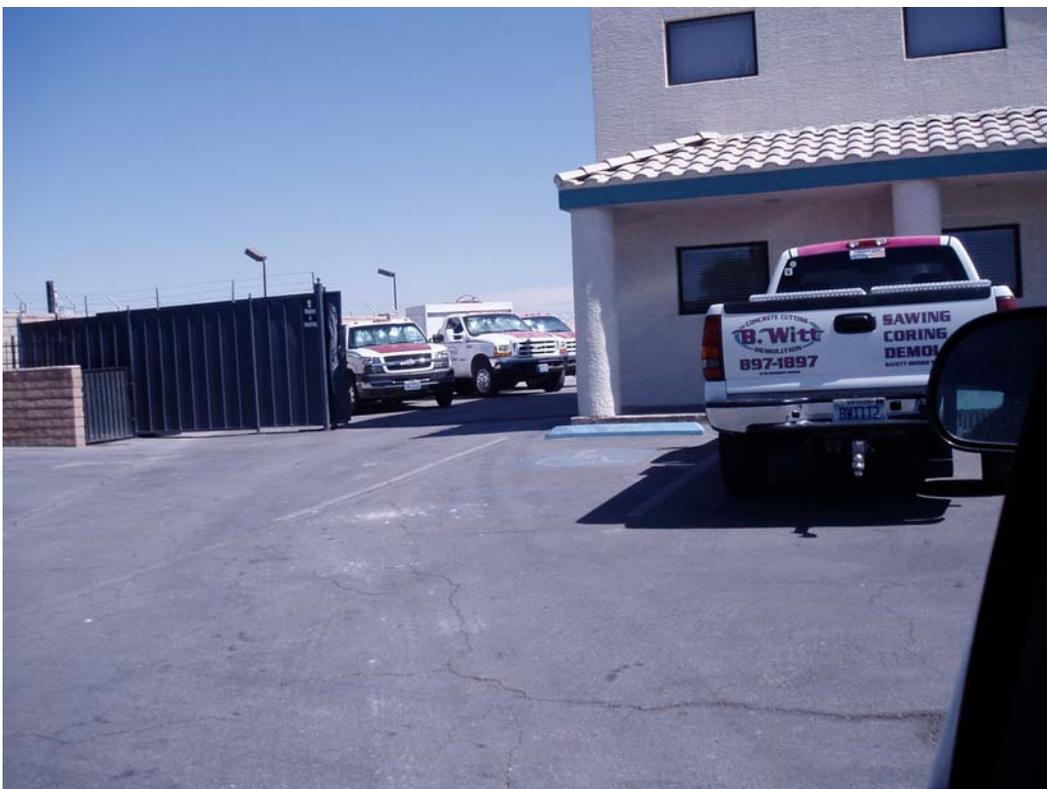
Photo 30. Parking lot source of discharge in Photo 29.

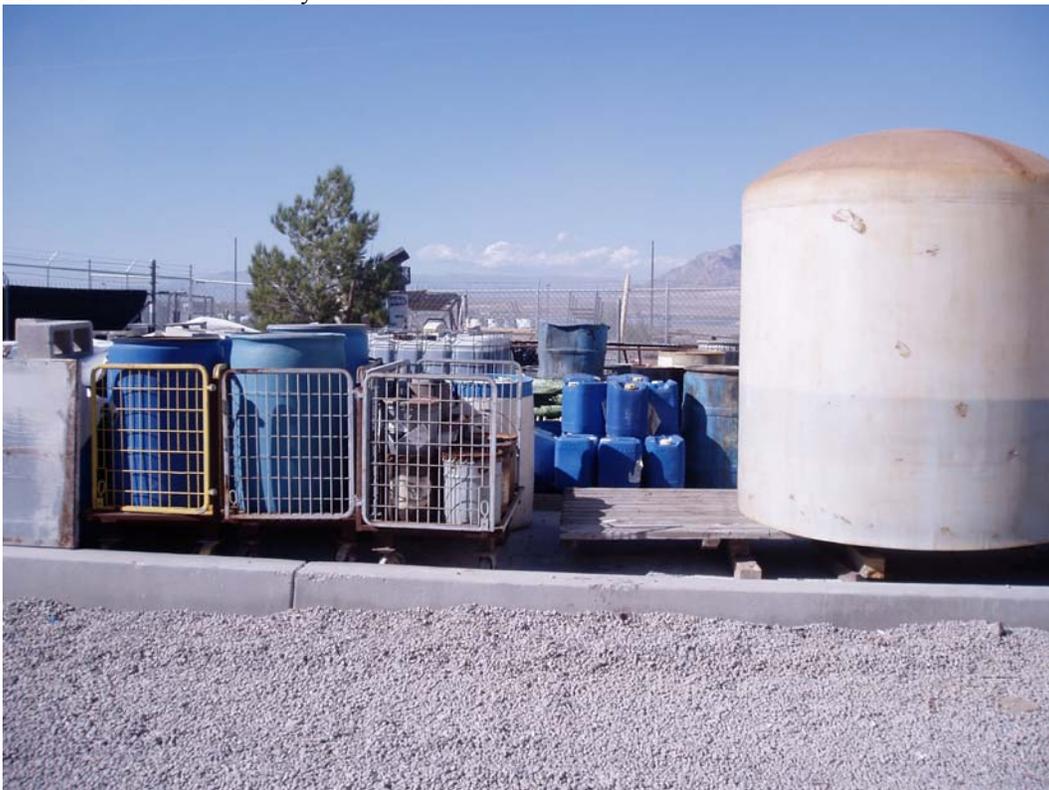
Photo 2. Bermed area for chemical storage.

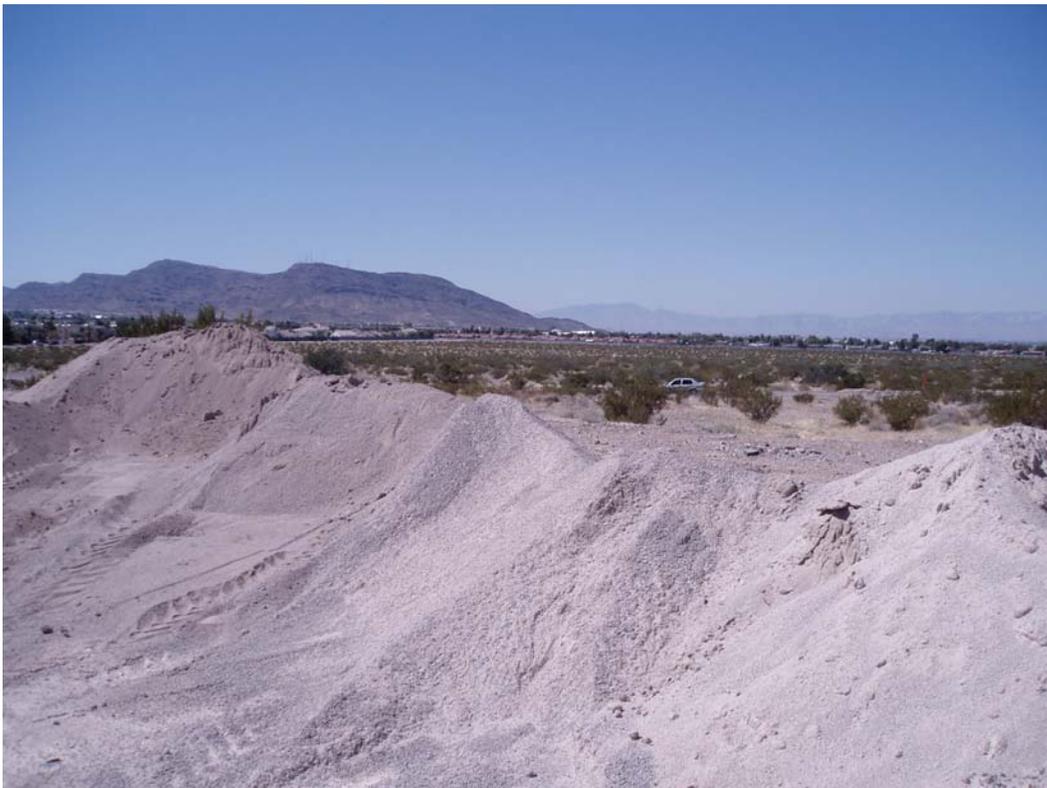
1. Mr. Ogle noted the debris at the construction site entrance.
2. Mr. Ogle noted that the soil stockpiles had the potential to runoff to the road. He said that he would ask the site superintendent to install a berm.
3. Mr. Ogle noted other construction debris throughout the site.
4. Mr. Ogle said that the site would be failed and a Notice of Violation (NOV) sent to the developer to install the berm and clean up the debris.

Photo 2. Sediment stockpiles. Note the ground slopes towards the road in the background.

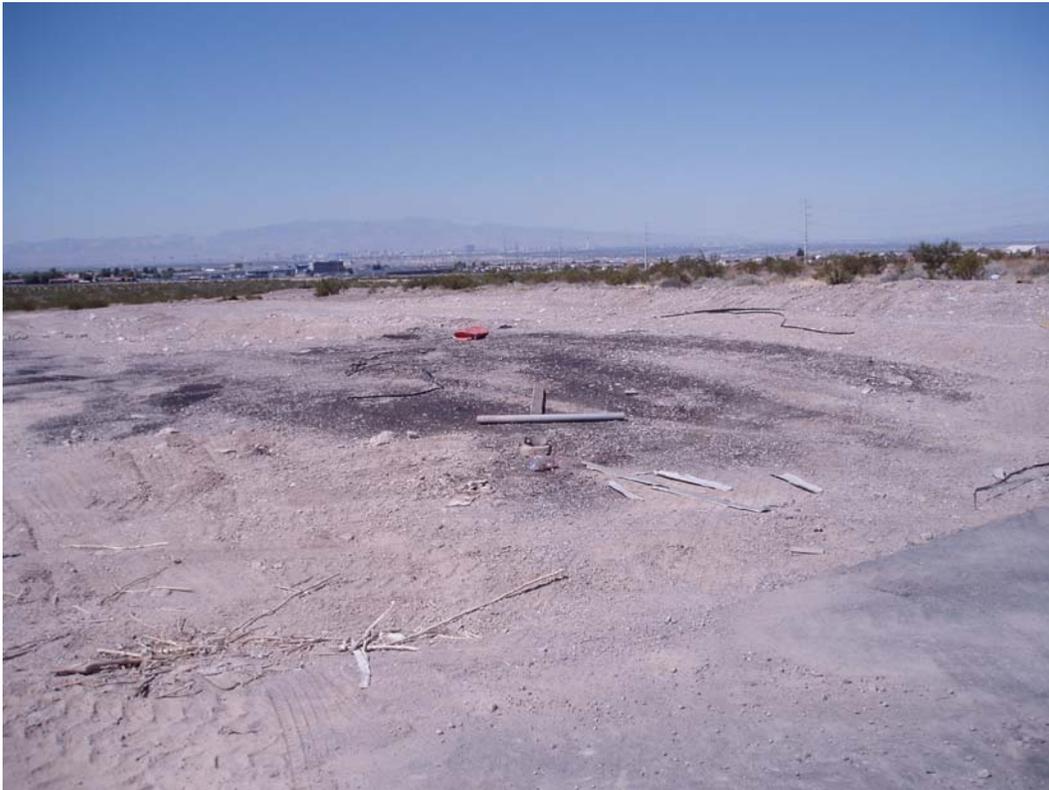
Photo 3. Construction debris.
