**RE: Auburn Road Landfill, Administrative Order,
Docket Number I-90-1092, Londonderry, New Hampshire**

**2012 SOURCE CONTROL
OPERATION & MAINTENANCE REPORT
AUBURN ROAD LANDFILL**

**FOR
TOWN OF LONDONDERRY, NEW HAMPSHIRE**

FEBRUARY 2013

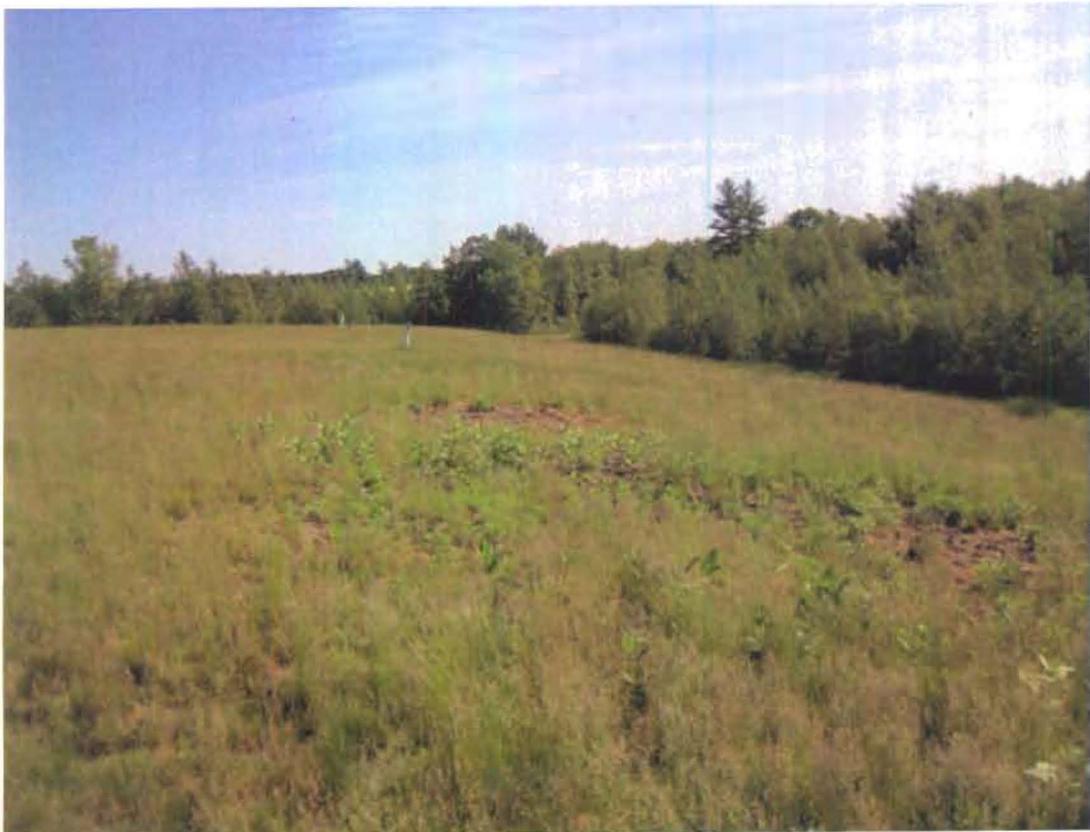
Photo No. 42: Tire Dump – Eastern Slope

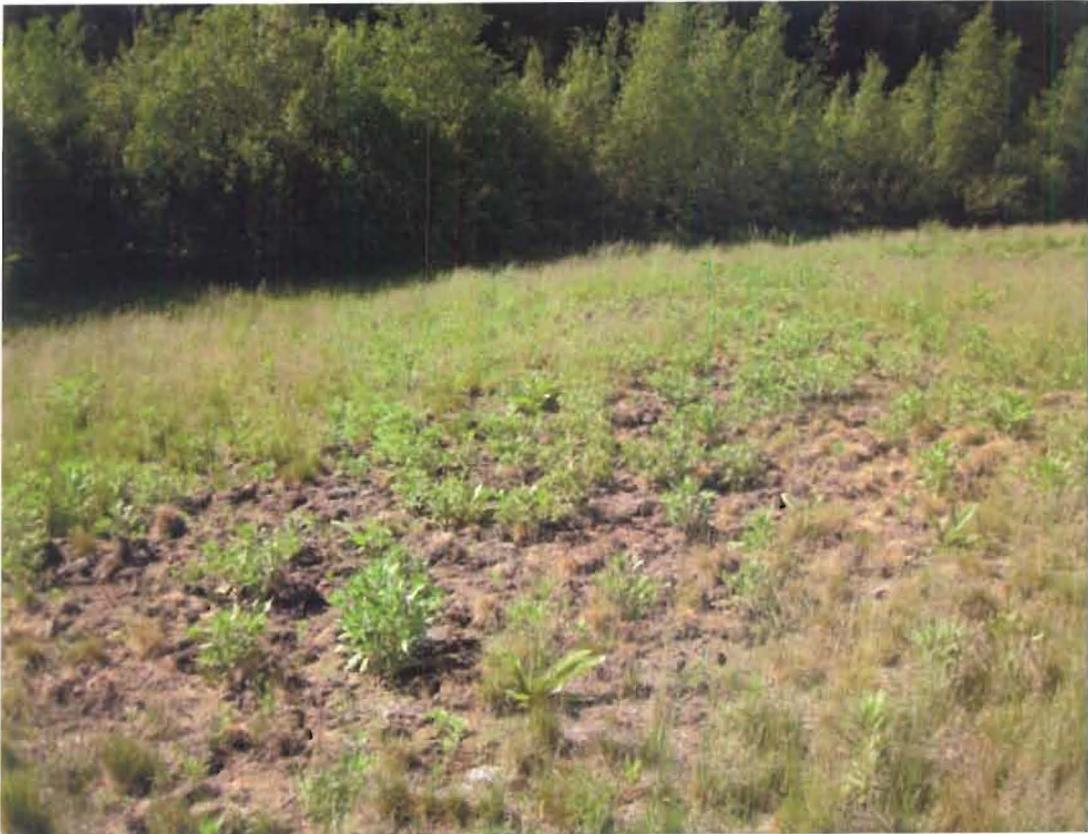
Photo No. 43: Tire Dump – Eastern Surface

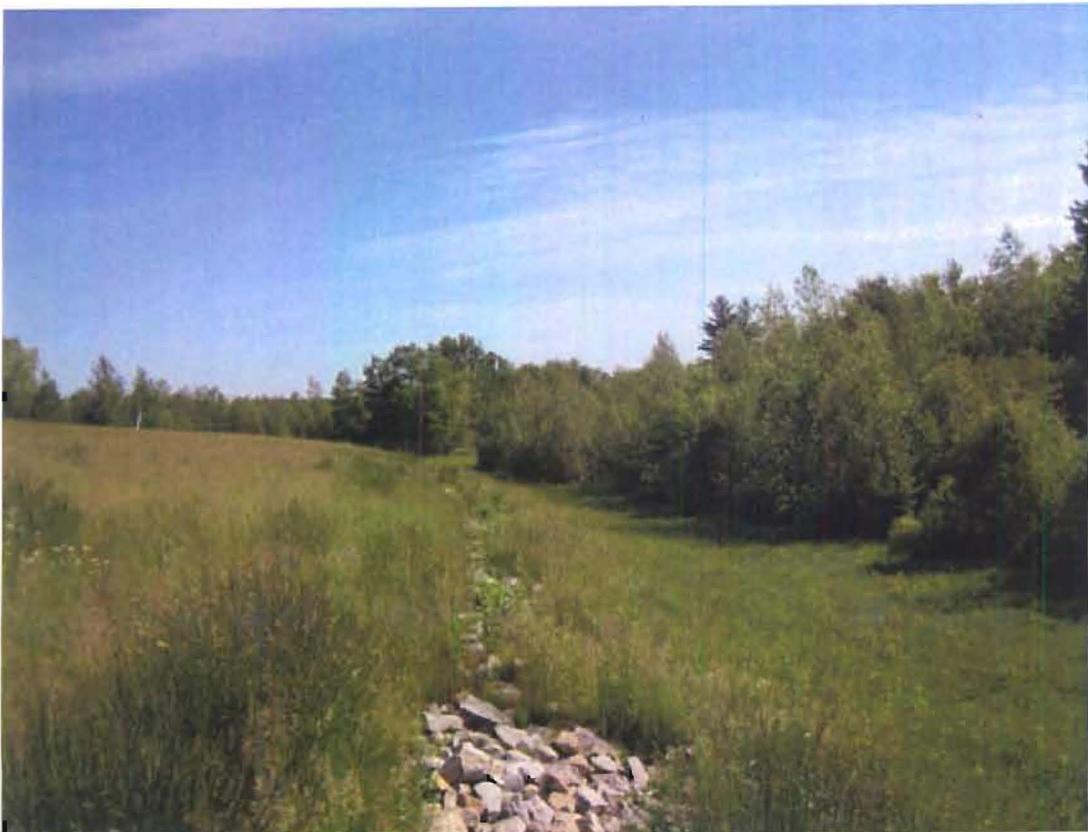
Photo No. 44: Tire Dump – Eastern Toe-of-Slope

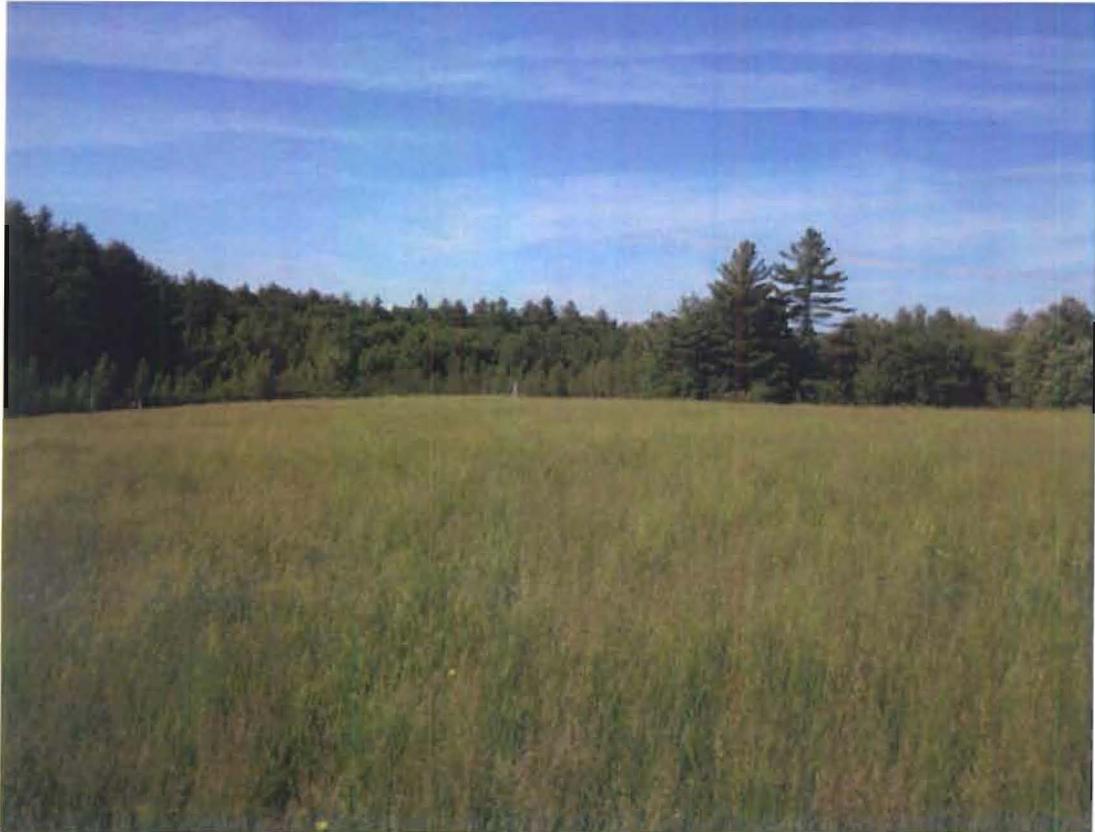
Photo No. 45: Tire Dump – Surface

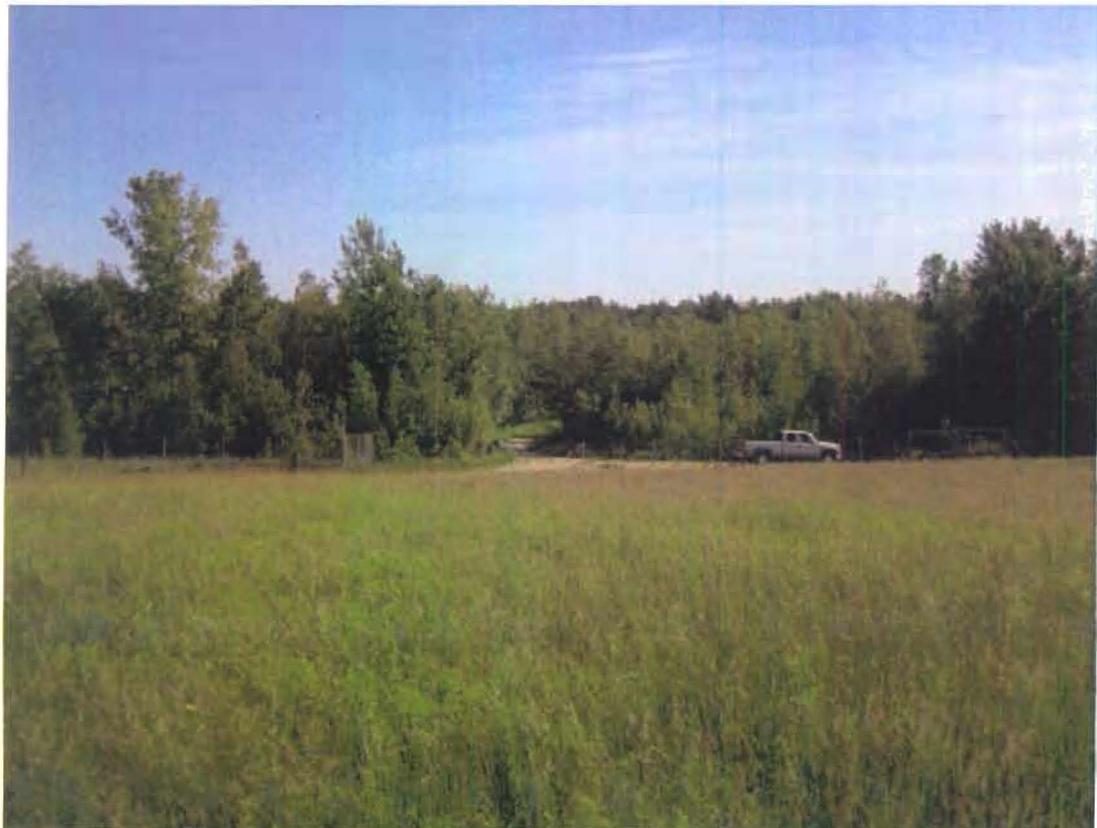
Photo No. 46: Tire Dump – Northern Surface

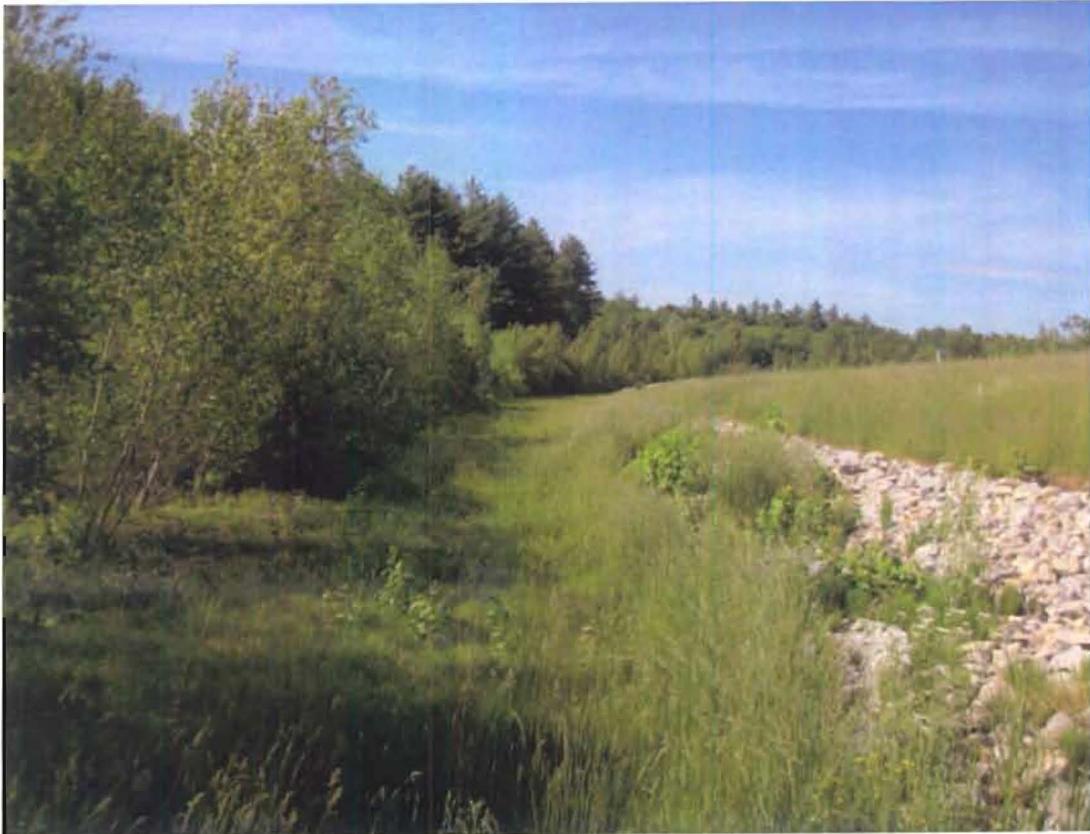
Photo No. 47: Tire Dump – Eastern Toe-of-Slope

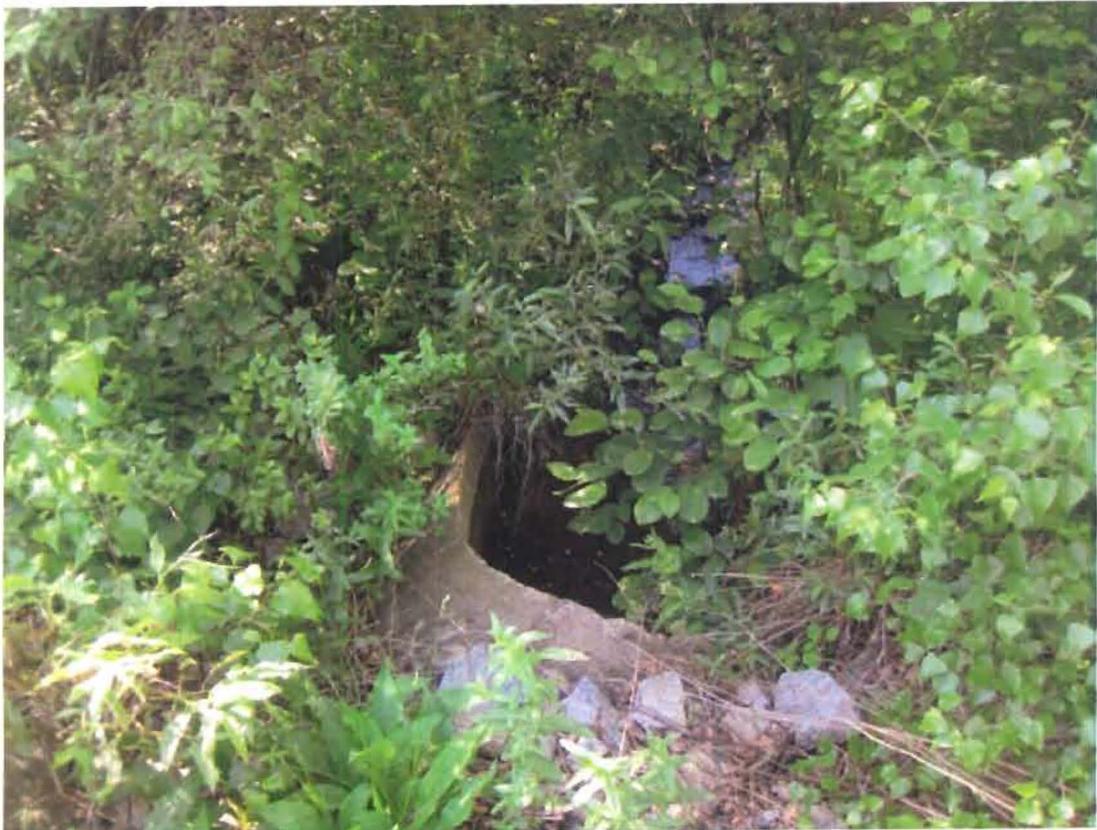
Photo No. 50: Swale D (South) – Culvert Inlet

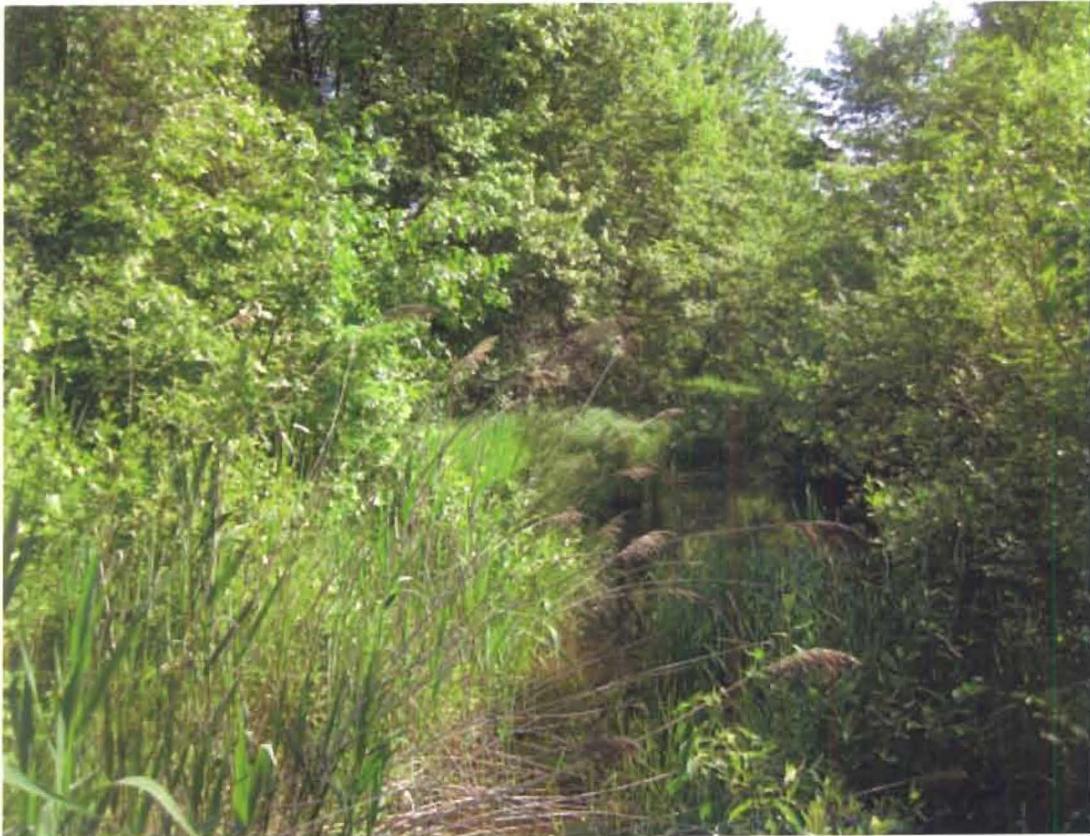
Photo No. 51: Swale D (North)

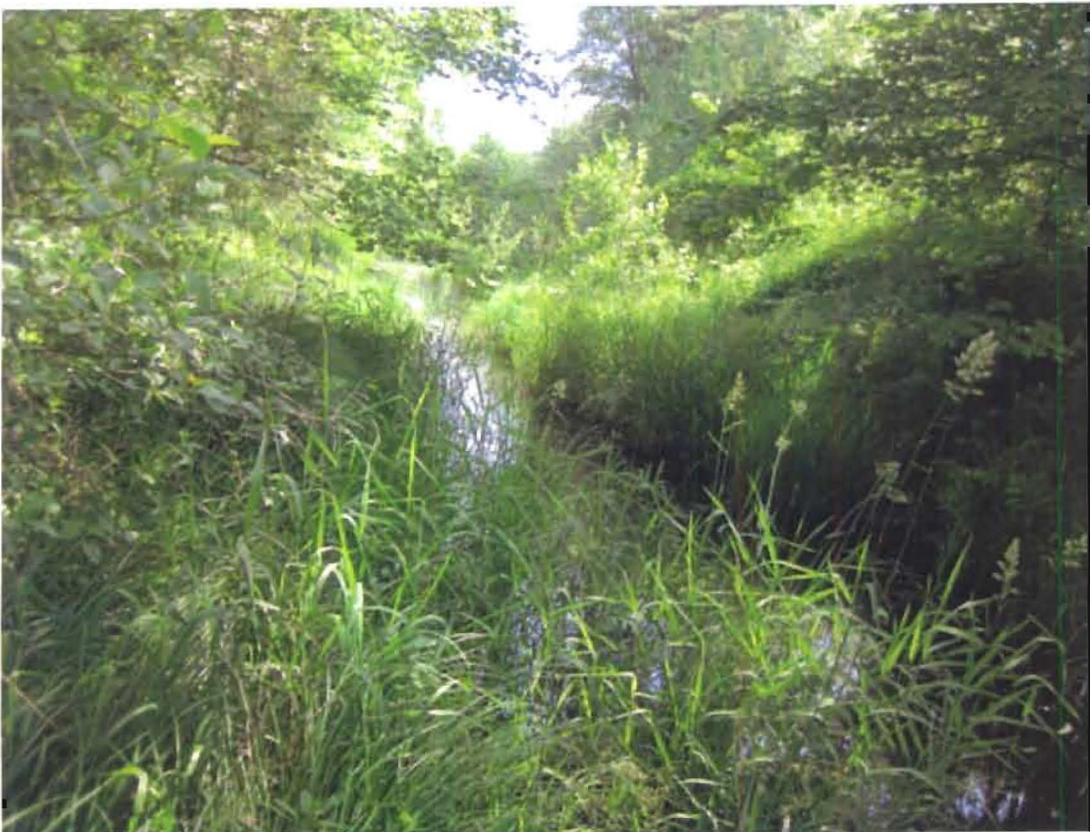
Photo No. 52: Swale D (North)

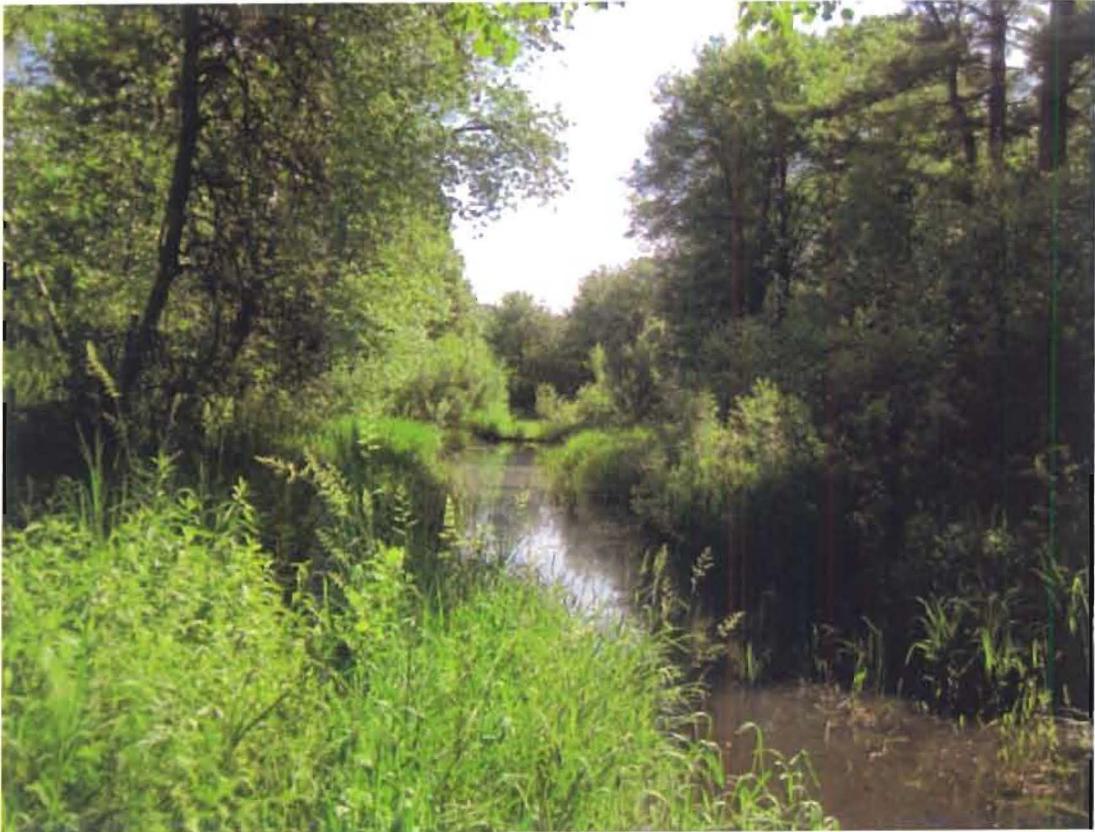
Photo No. 53: Swale D (North)

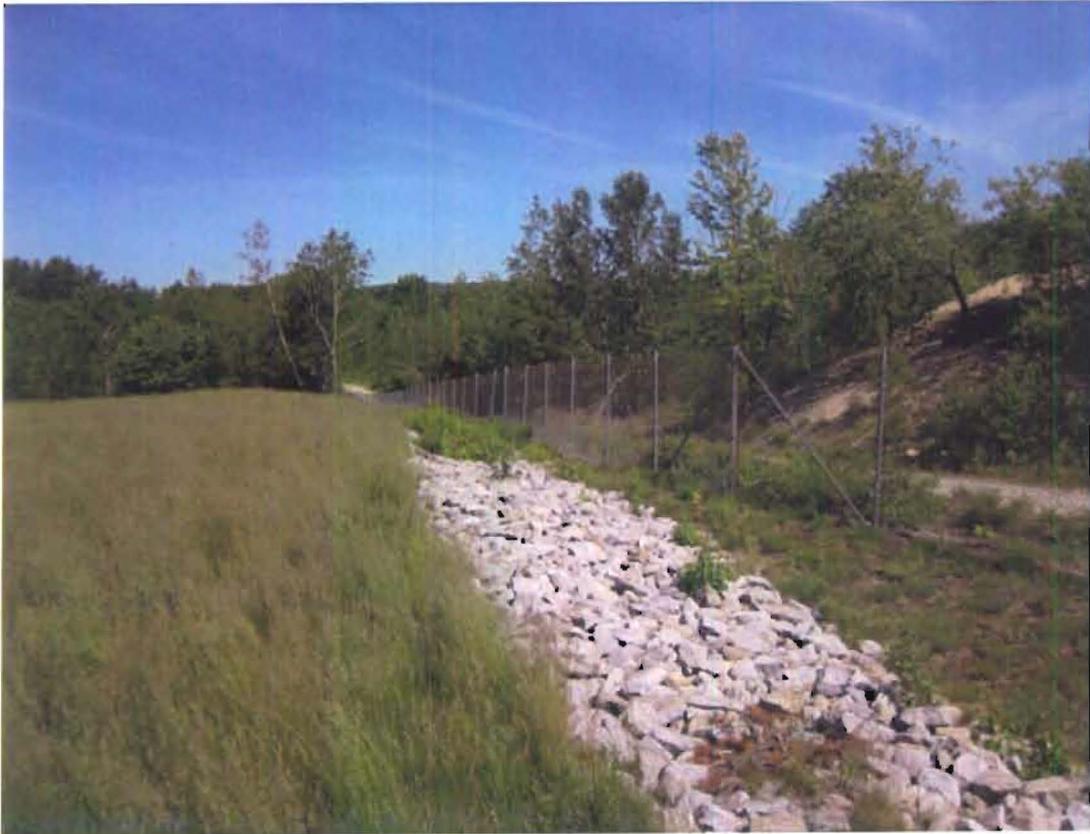
Photo No. 55: SWLF – Northern Toe-of-Slope & Fence Line

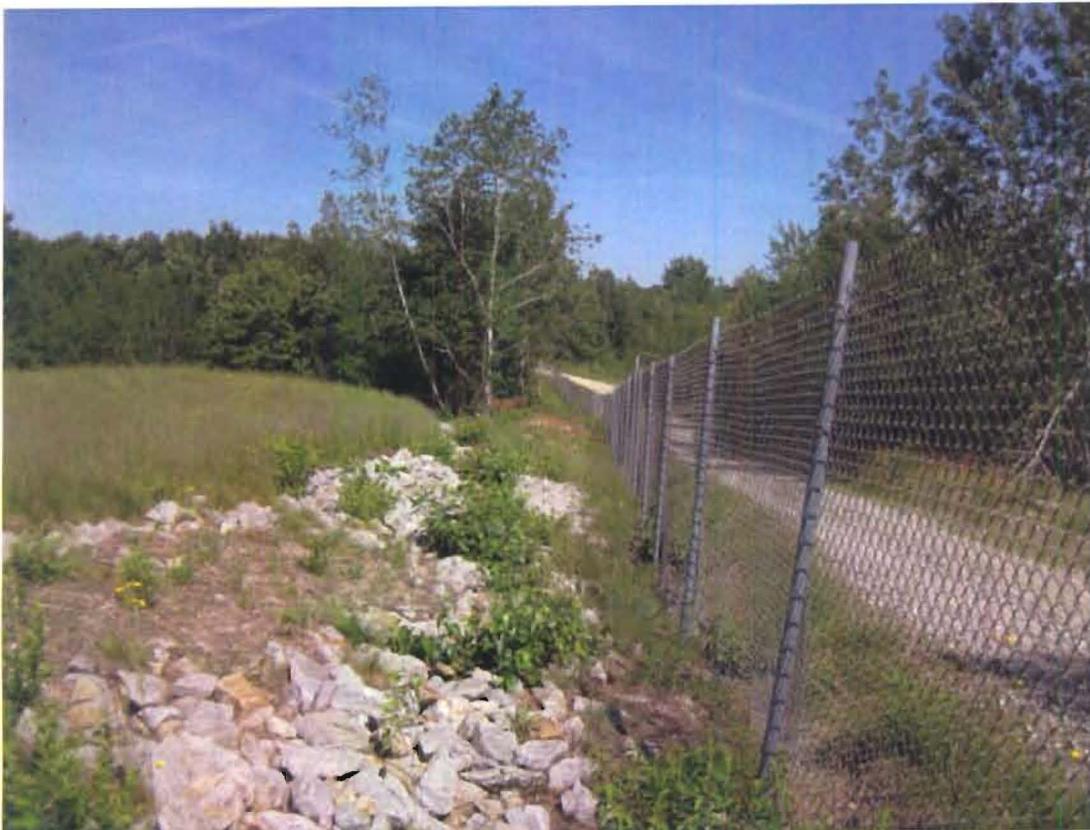
Photo No. 56: SWLF – Northern Toe-of-Slope & Fence Line

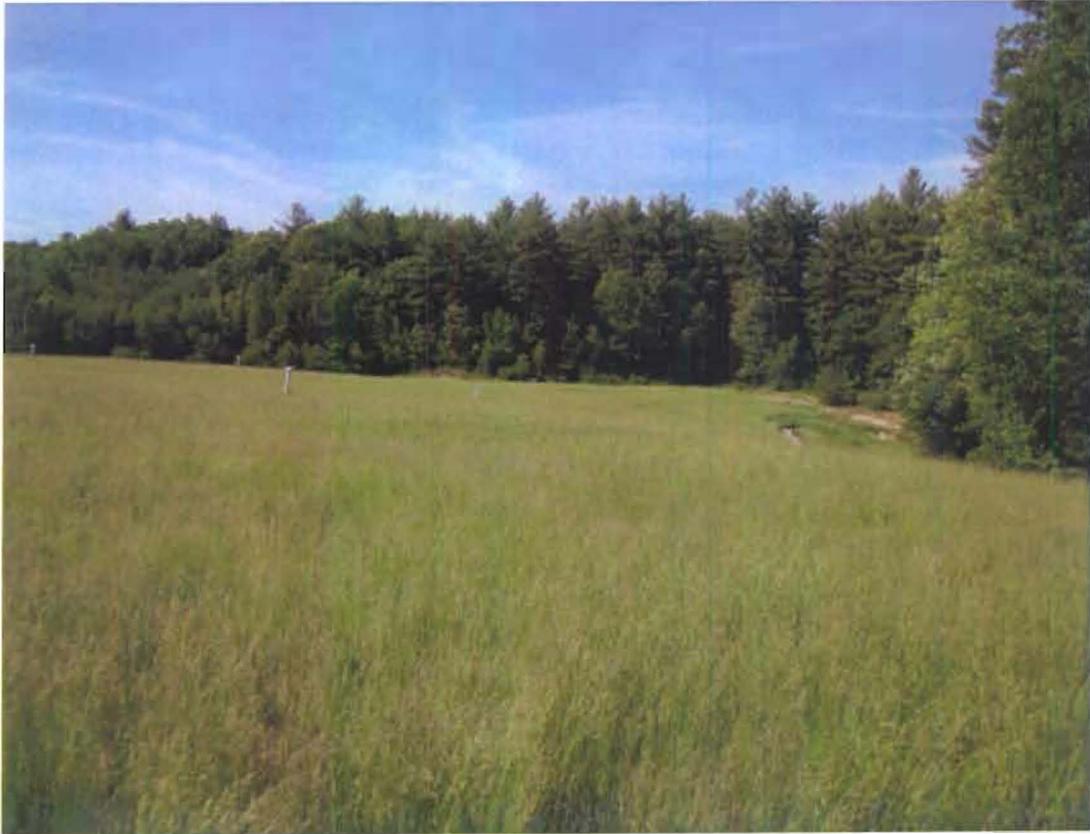
Photo No. 57: SWLF Western Surface

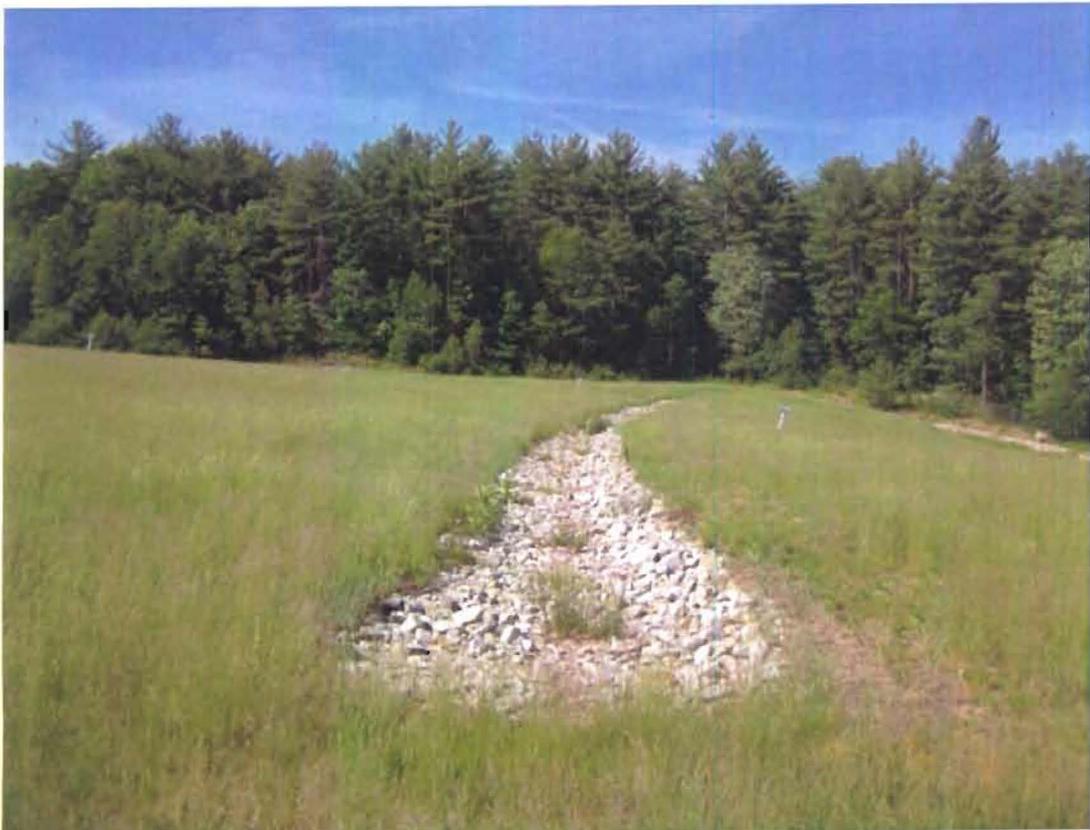
Photo No. 58: SWLF – Mid-Slope Swale

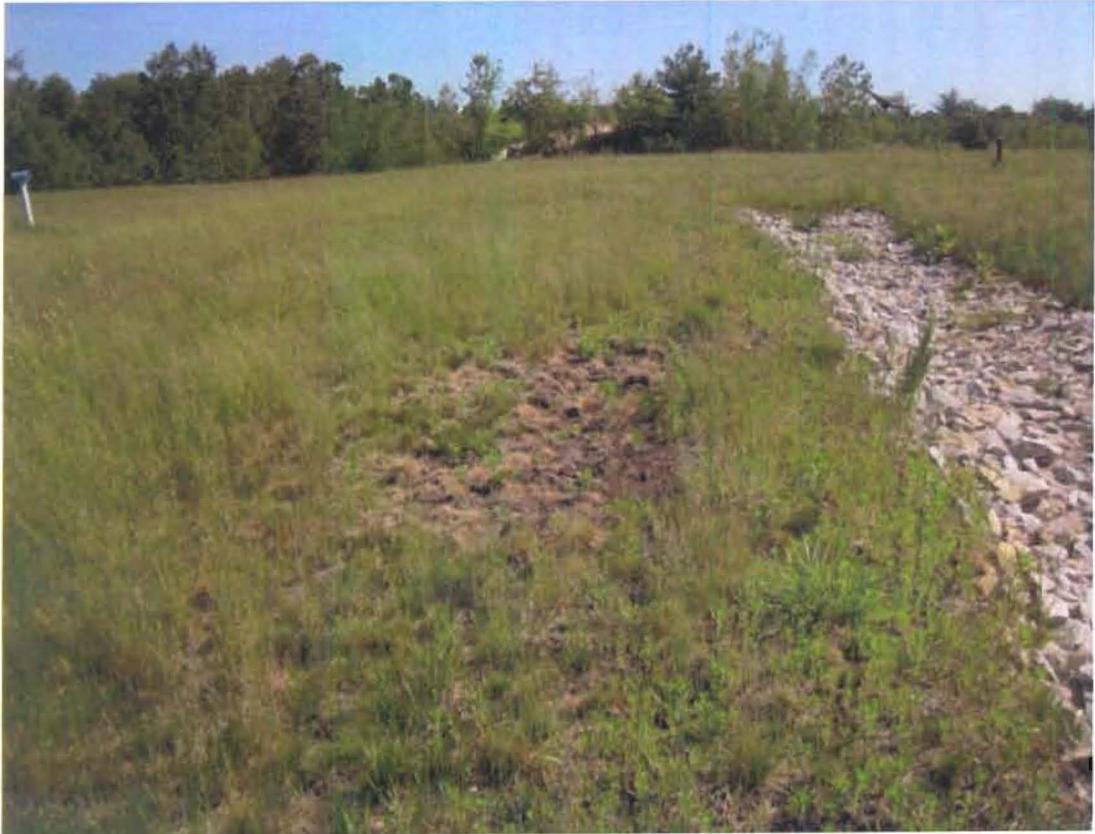
Photo No. 59: SWLF – Mid-Slope Swale

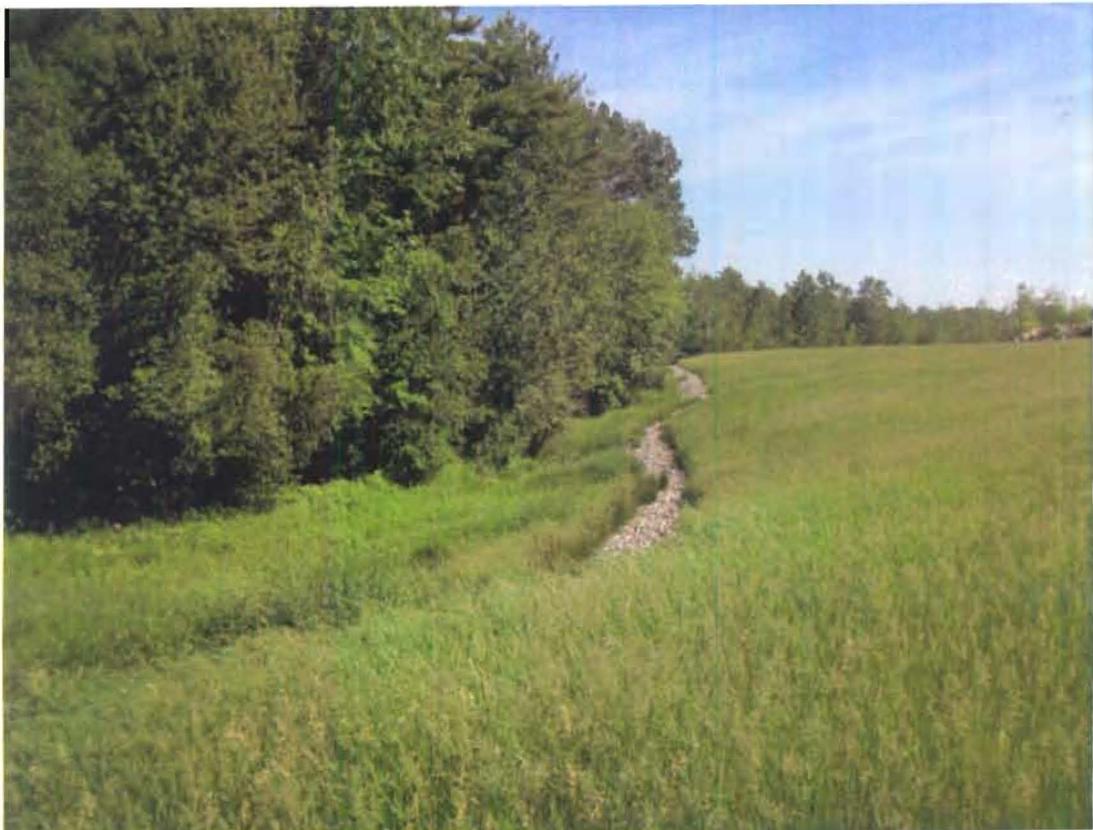
Photo No. 60: SWLF – Western Toe-of-Slope

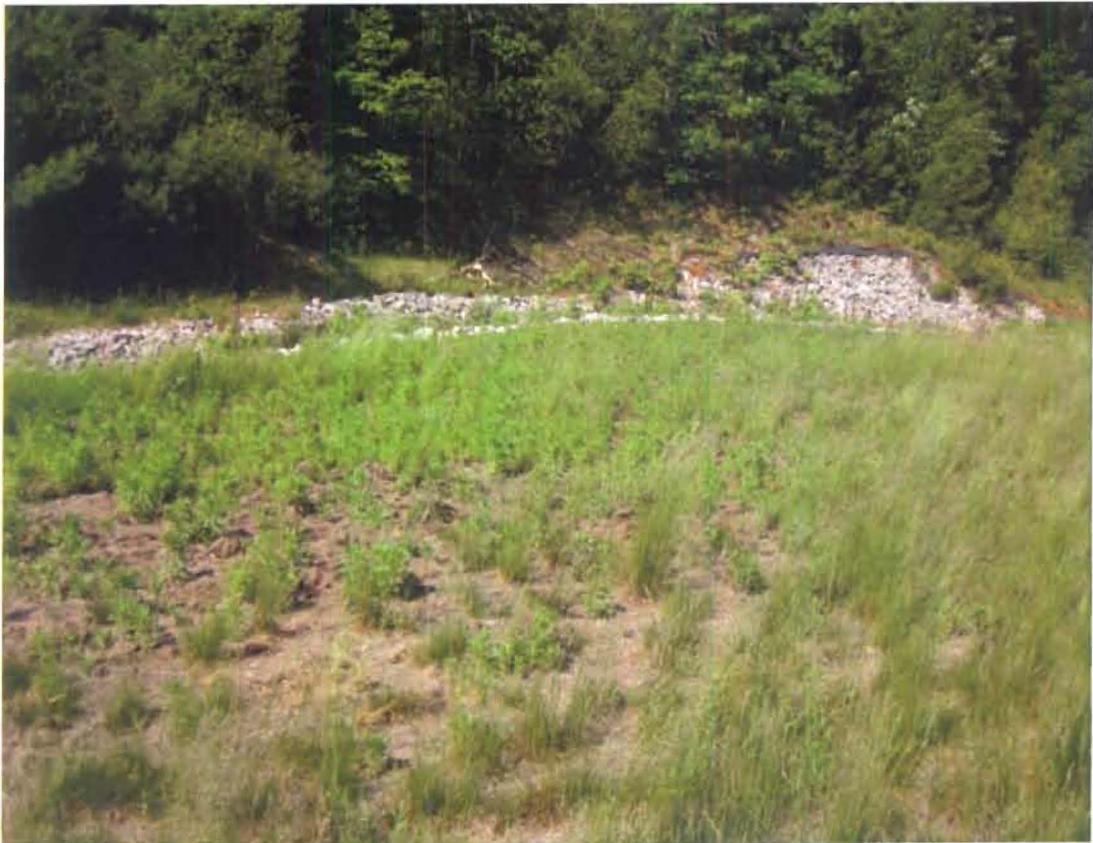
Photo No. 61: SWLF – Southern Surface

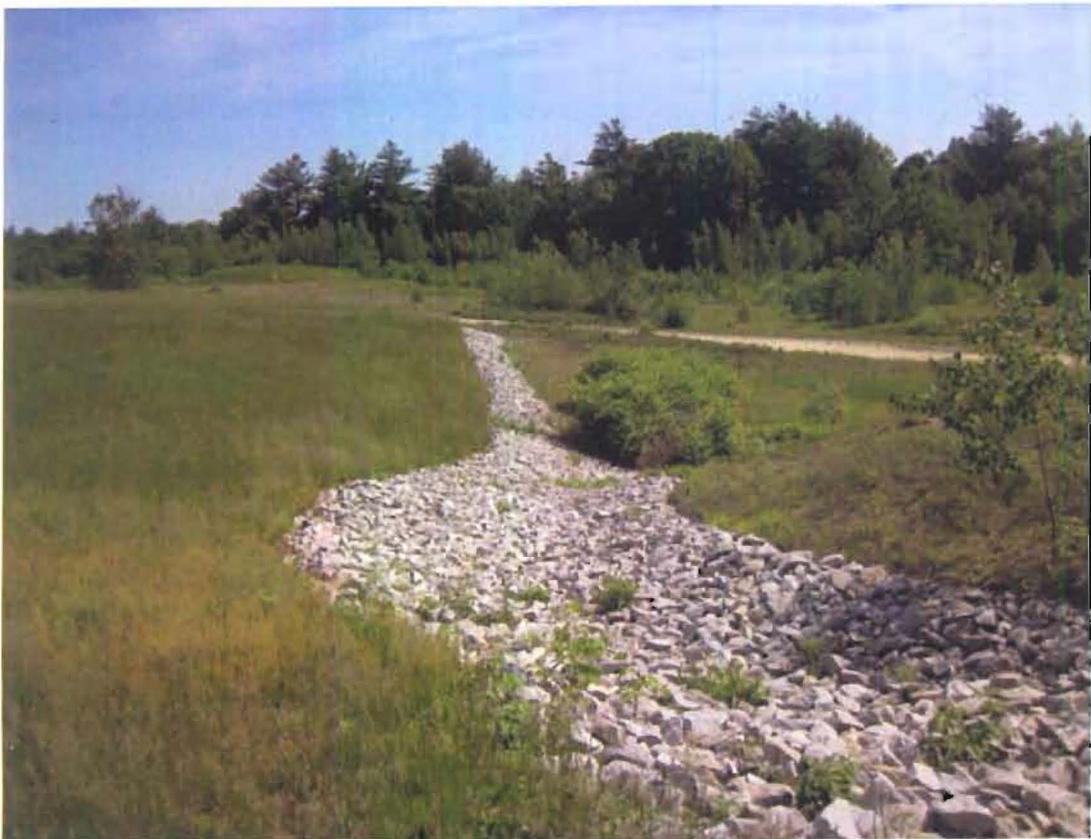
Photo No. 62: SWLF Eastern Toe-of-Slope

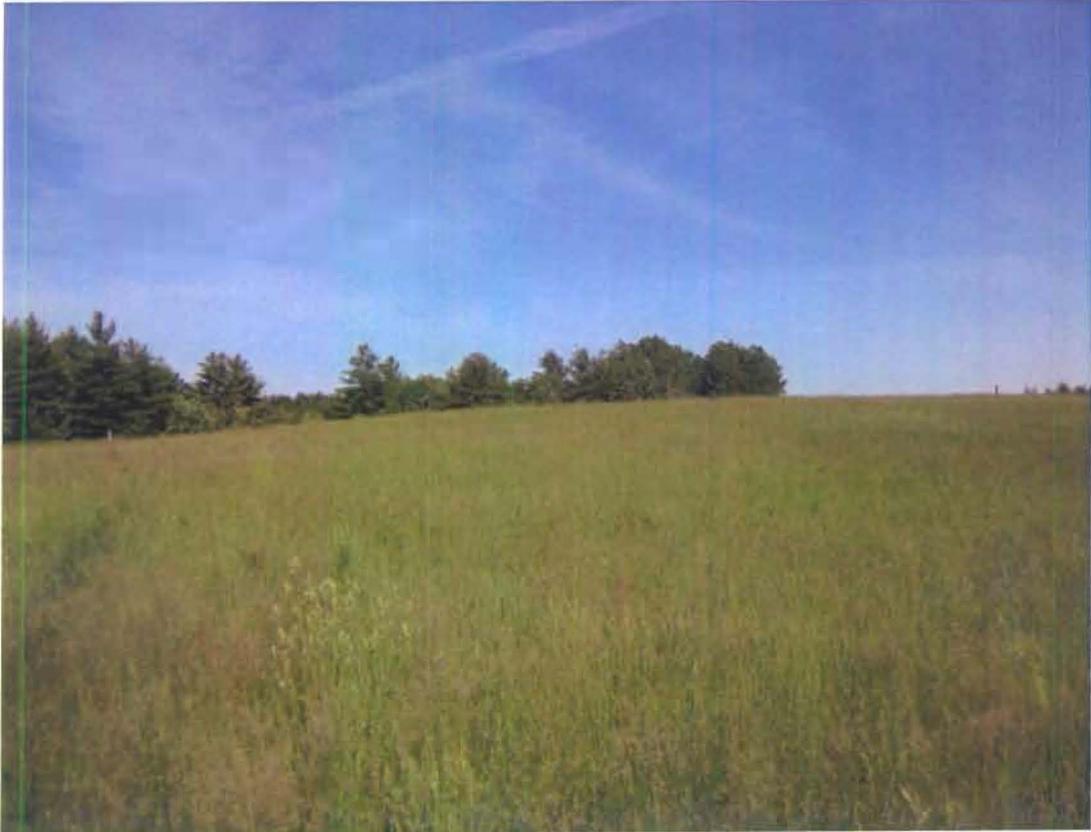
Photo No. 63: SWLF Surface

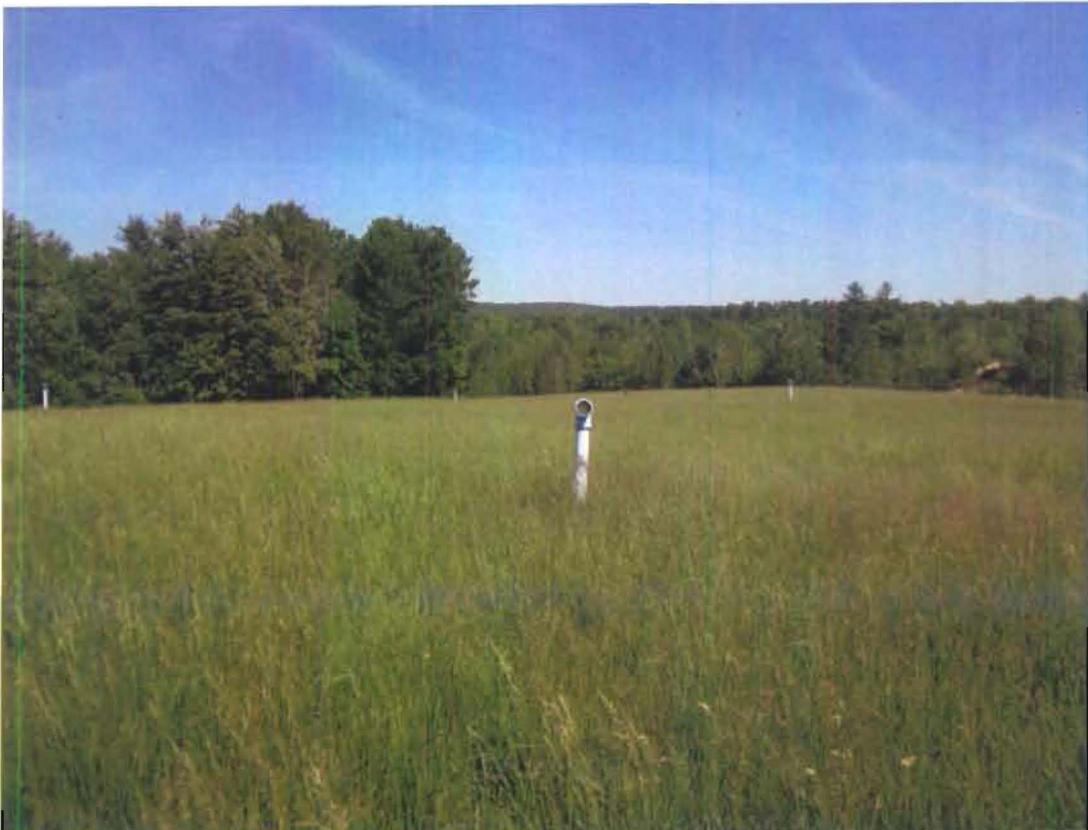
Photo No. 64: SWLF Surface

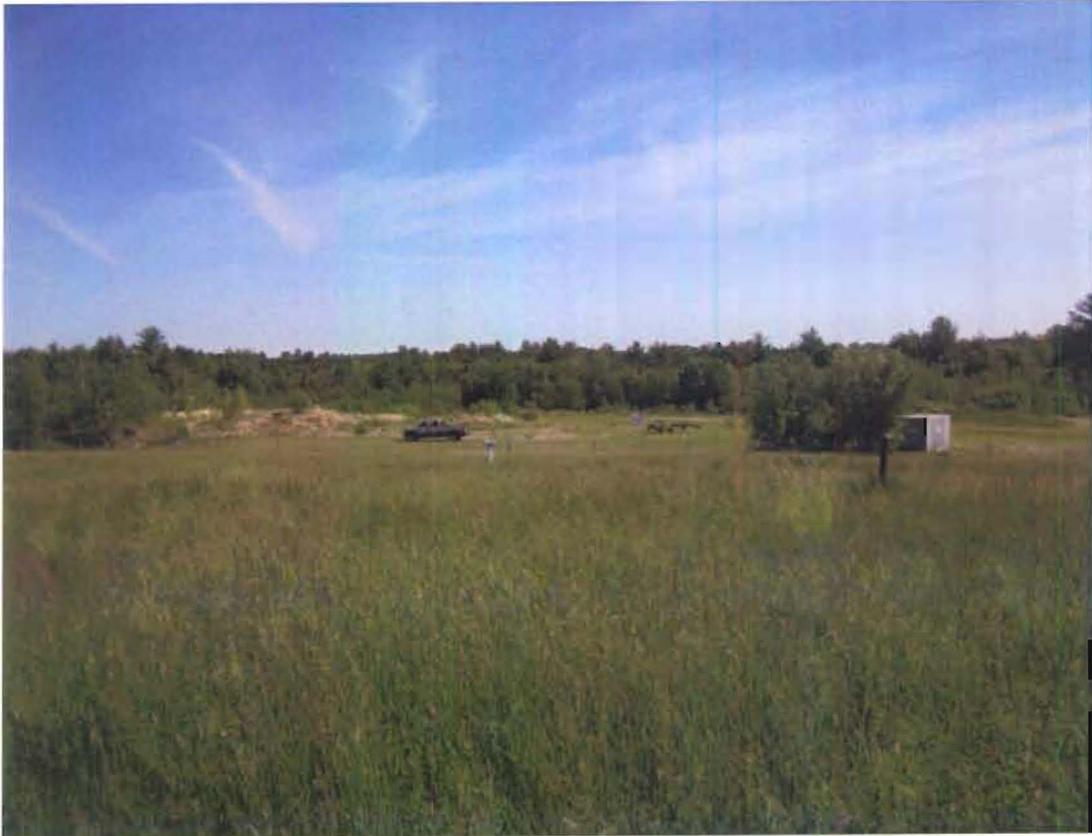
Photo No. 65: SWLF – Surface

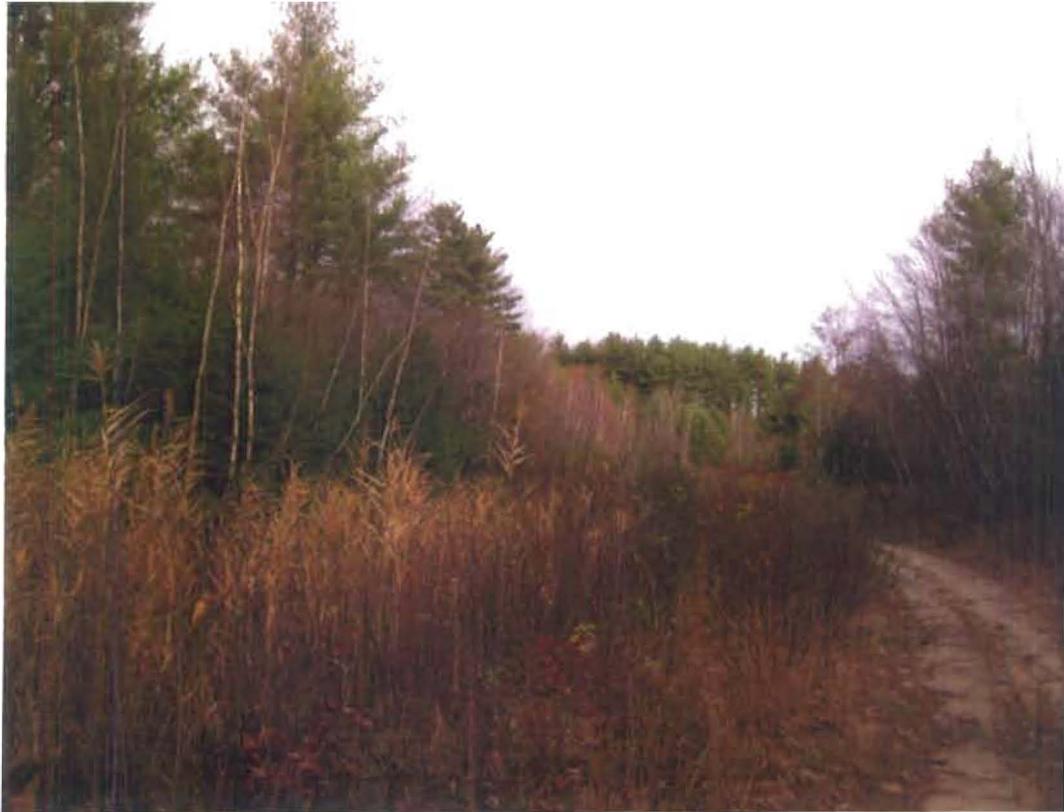
Photo No. 1: Swale E

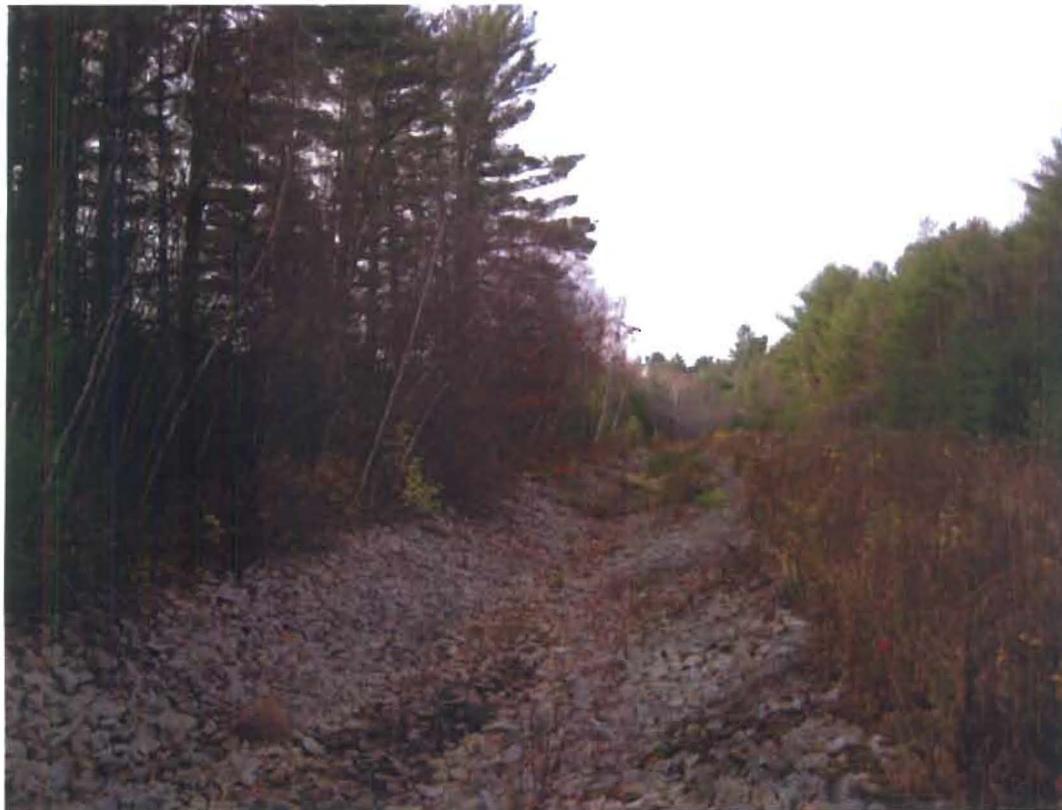
Photo No. 2: Swale H

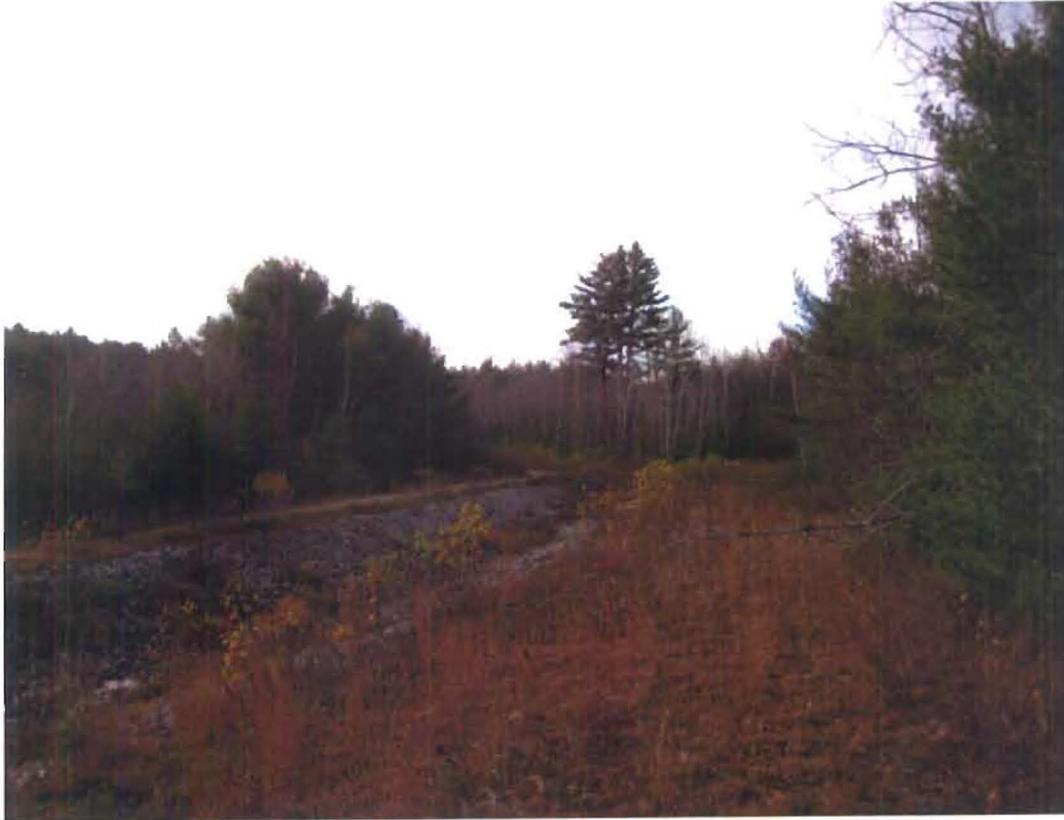
Photo No. 3: Swale F

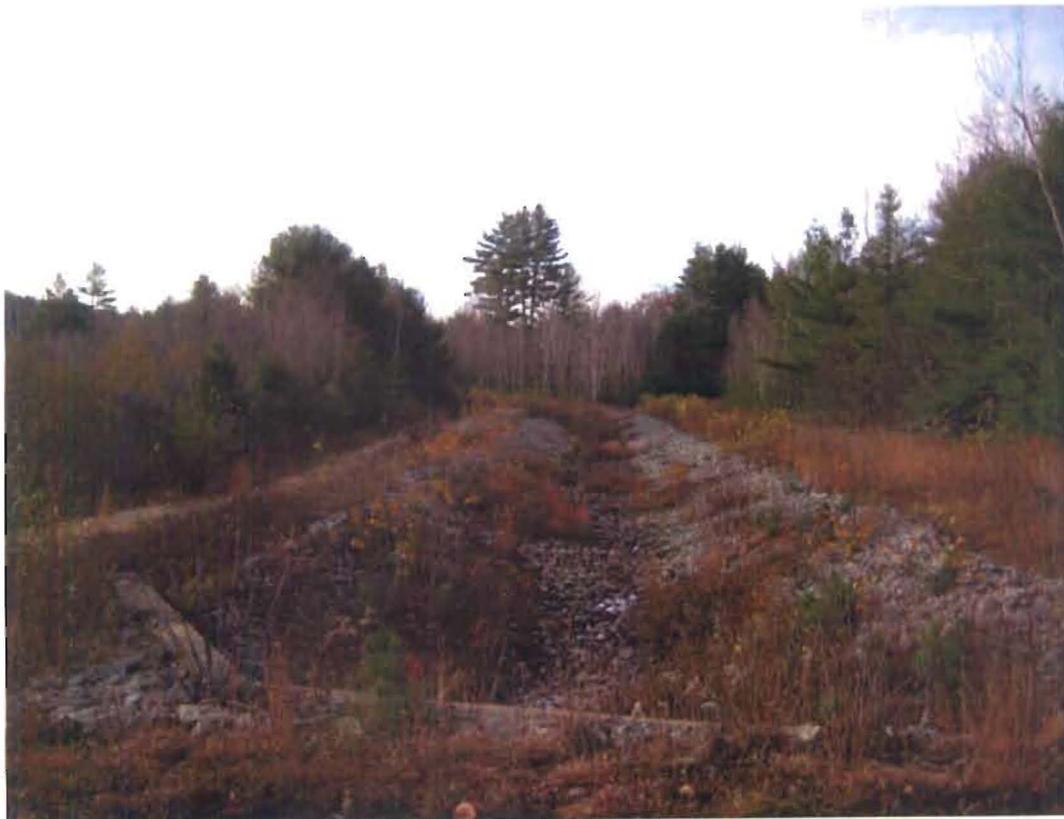
Photo No. 4: Swale F
