**RE: Auburn Road Landfill, Administrative Order,
Docket Number I-90-1092, Londonderry, New Hampshire**

**2012 SOURCE CONTROL
OPERATION & MAINTENANCE REPORT
AUBURN ROAD LANDFILL**

**FOR
TOWN OF LONDONDERRY, NEW HAMPSHIRE**

FEBRUARY 2013

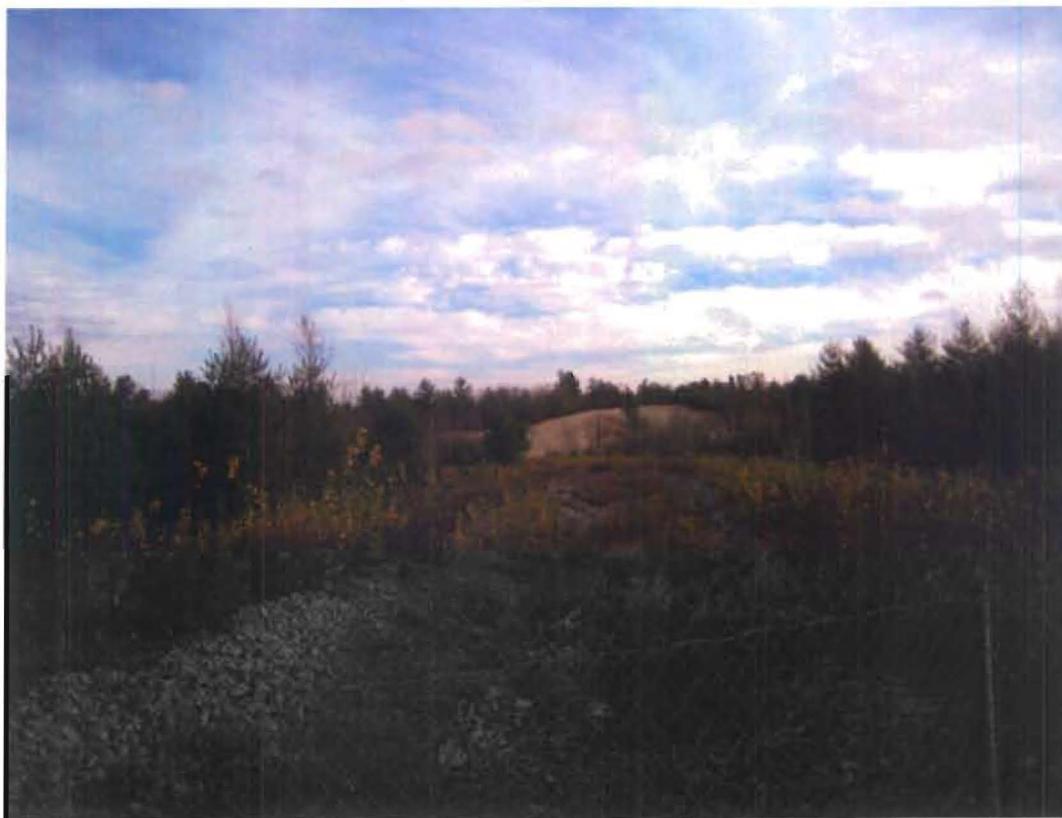
Photo No. 5: Swale B

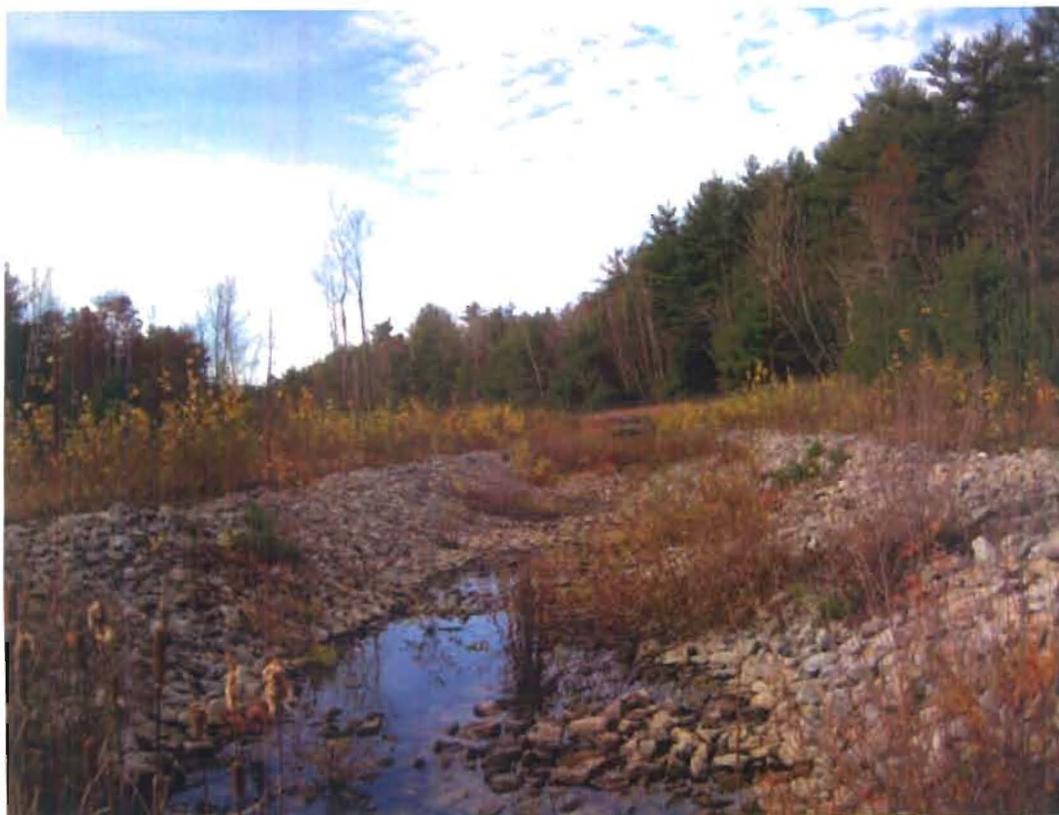
Photo No. 6: Swale B

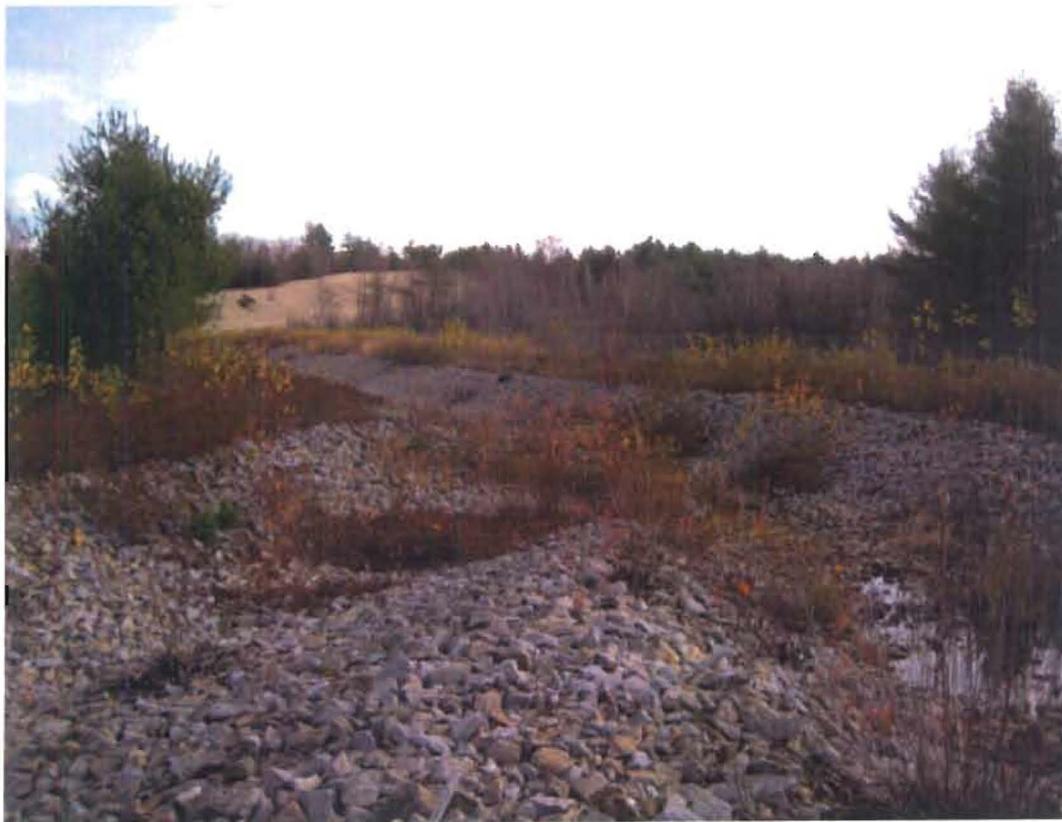
Photo No. 7: Swale C

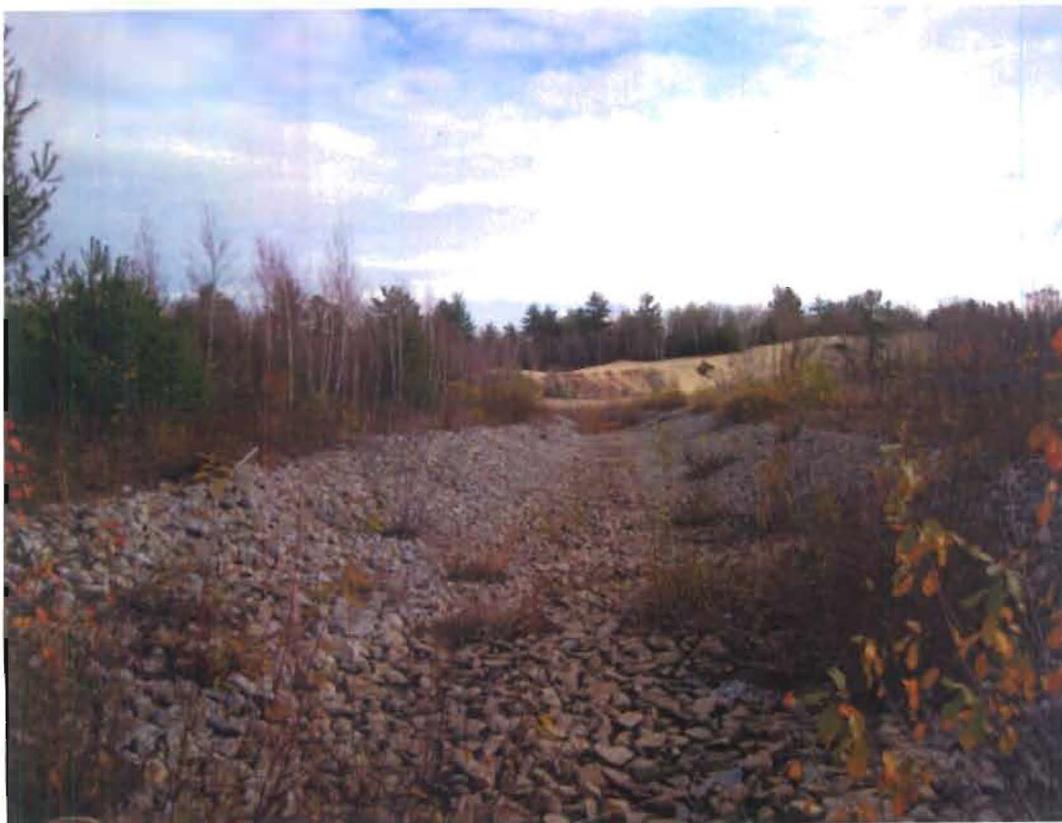
Photo No. 8: Swale C

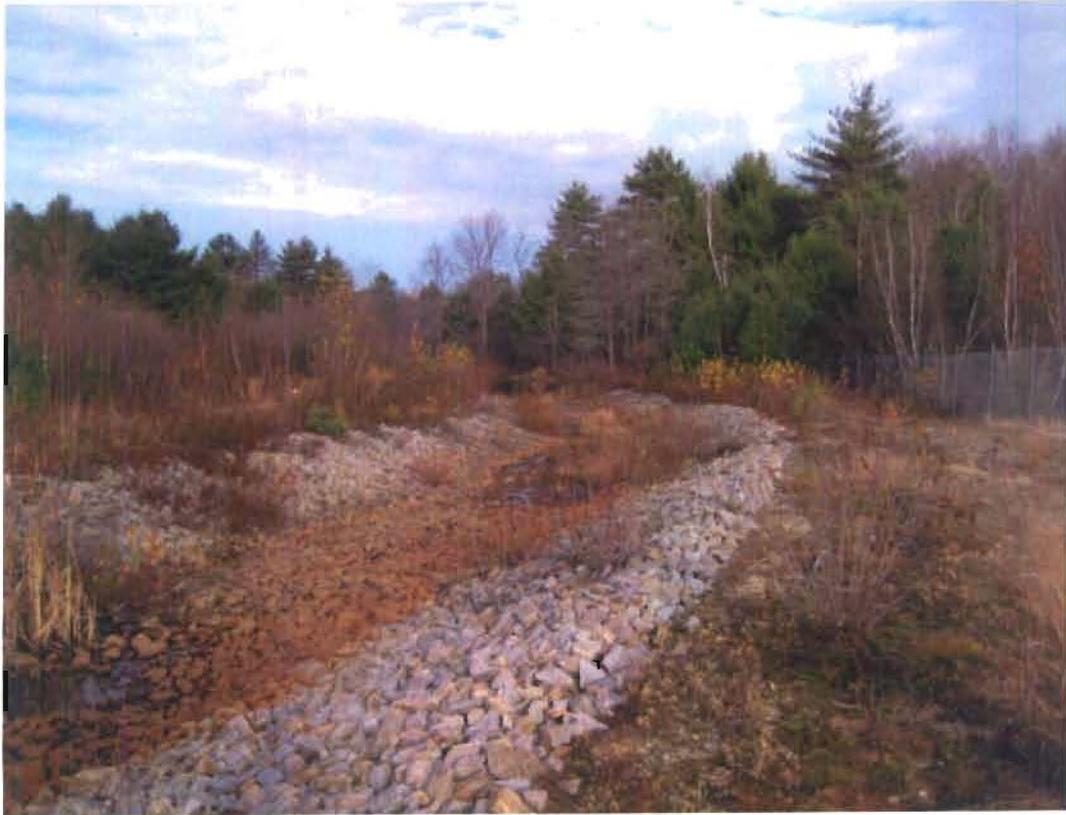
Photo No. 9: Swale C

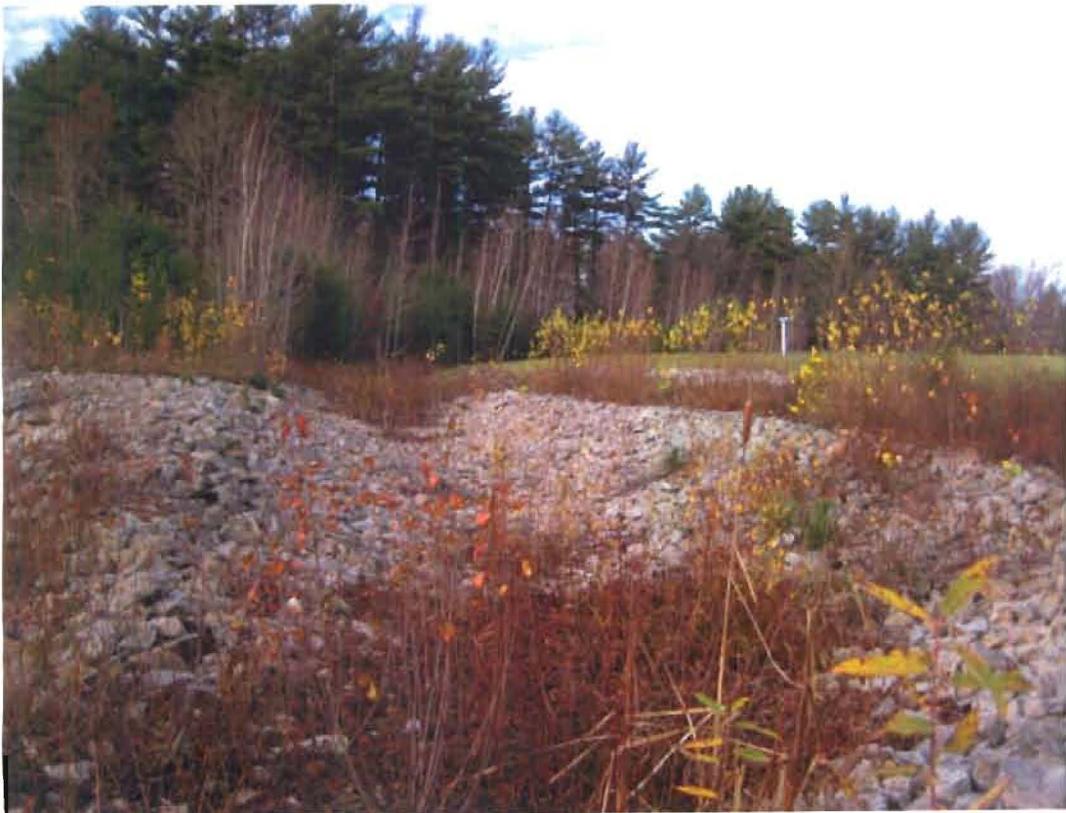
Photo No. 10: Swale A

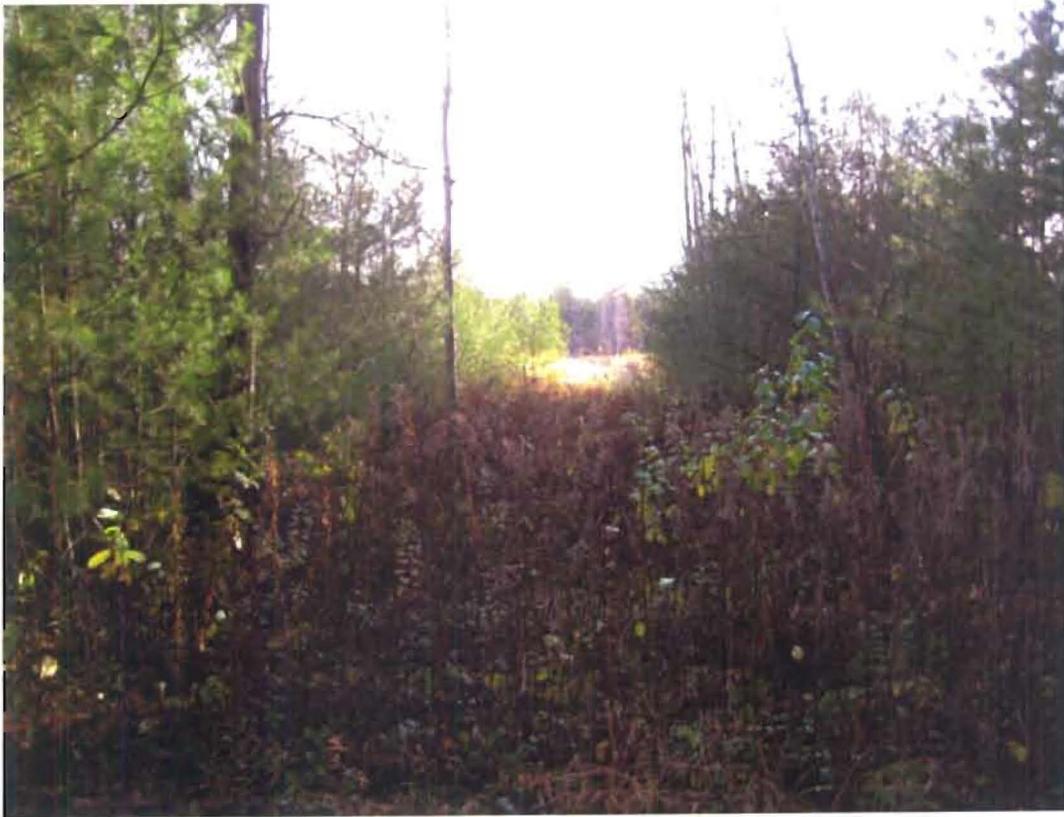
Photo No. 11: Swale A

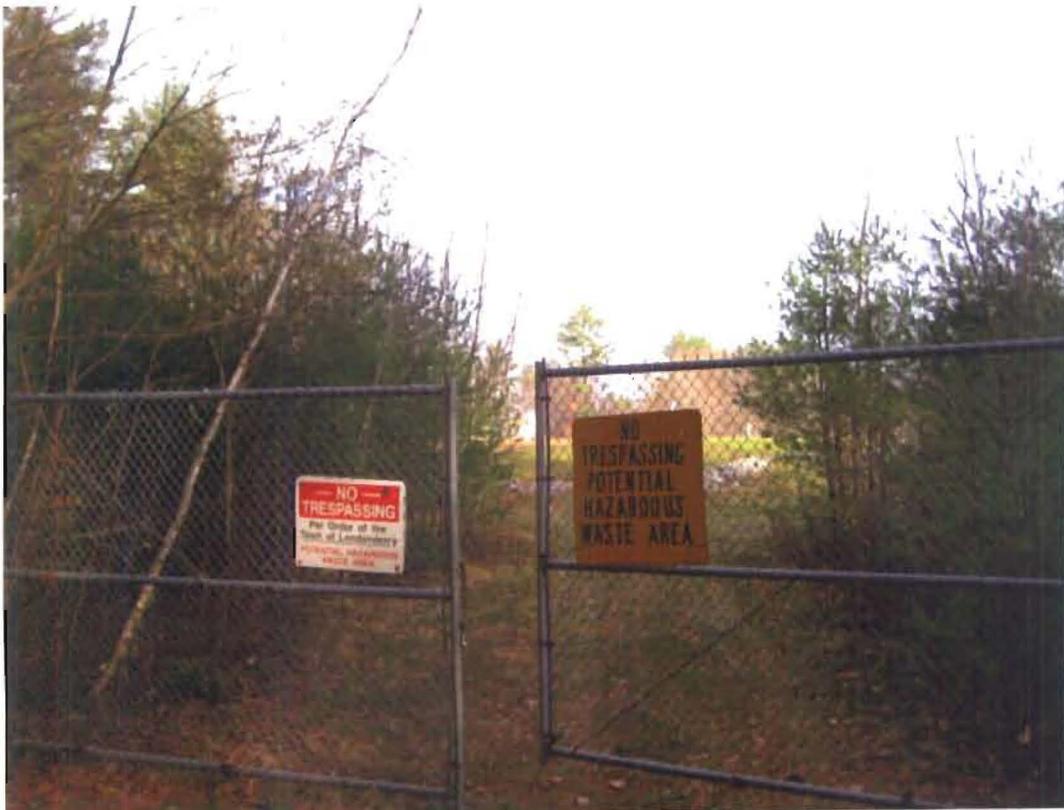
Photo No. 12: Town Dump Entrance Gate

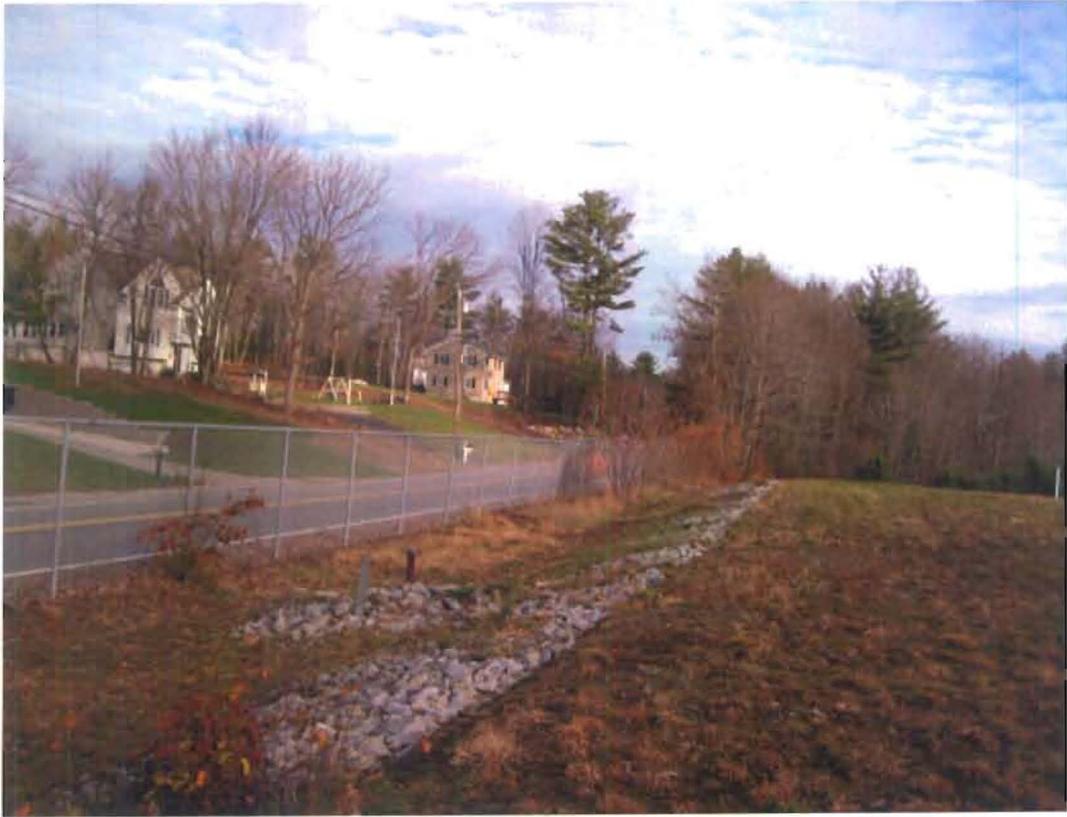
Photo No. 13: Town Dump – Western Toe-of-Slope & Fence

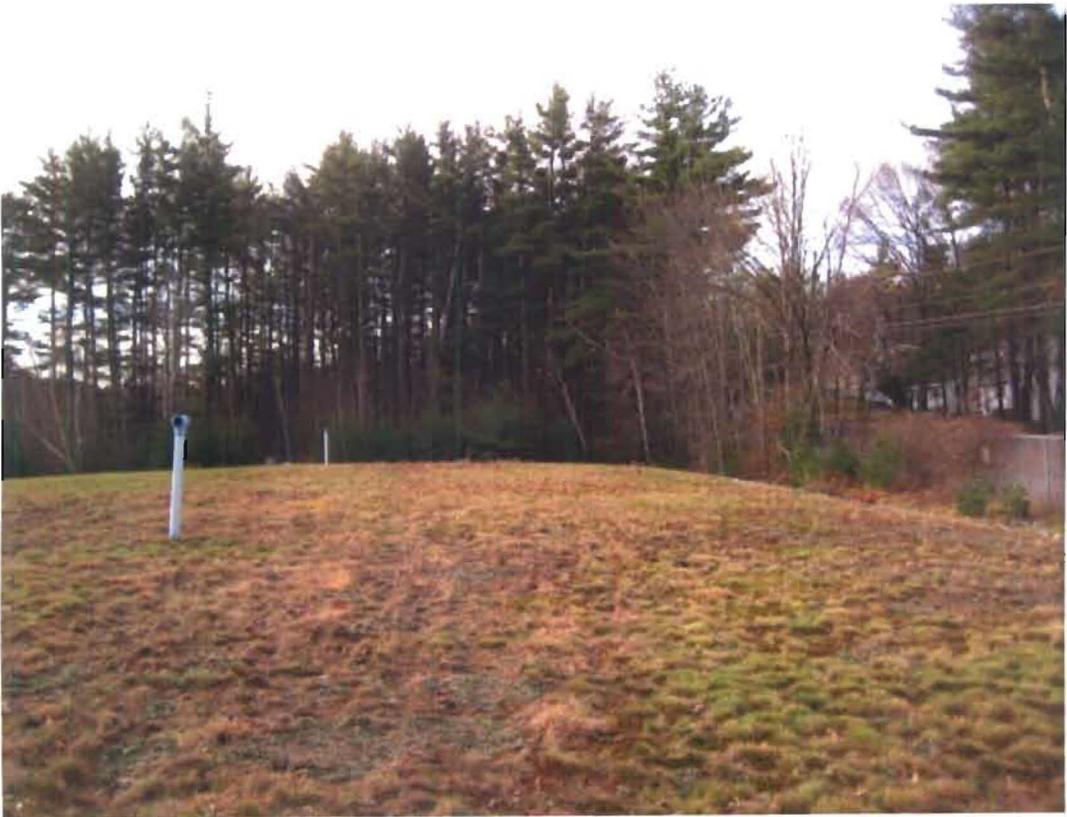
Photo No. 14: Town Dump – Southwestern Surface

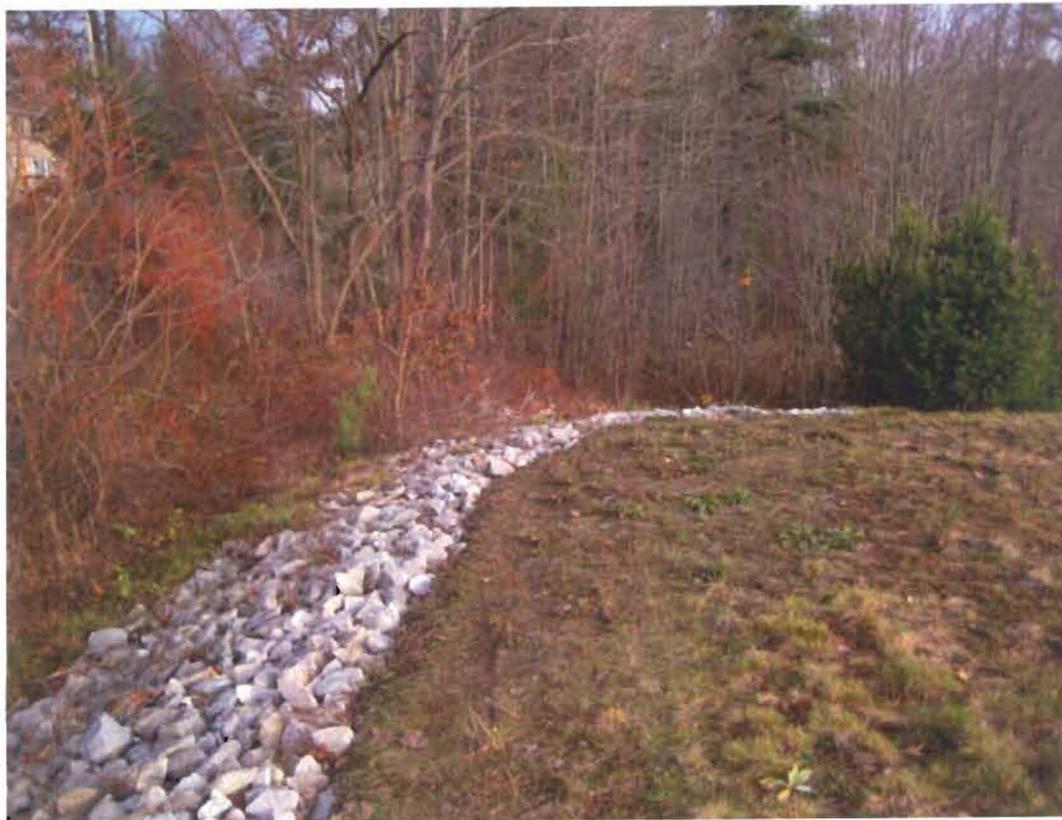
Photo No. 15: Town Dump – Northwest Corner Surface

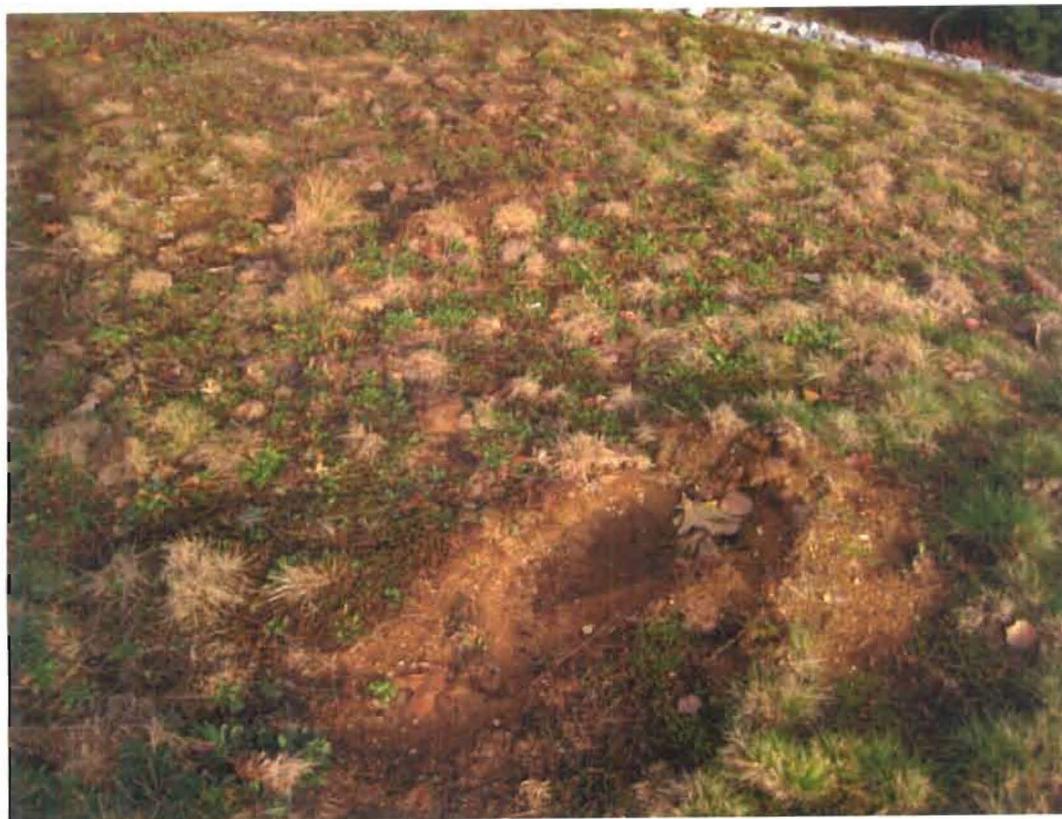
Photo No. 16: Town Dump – Northwestern Surface

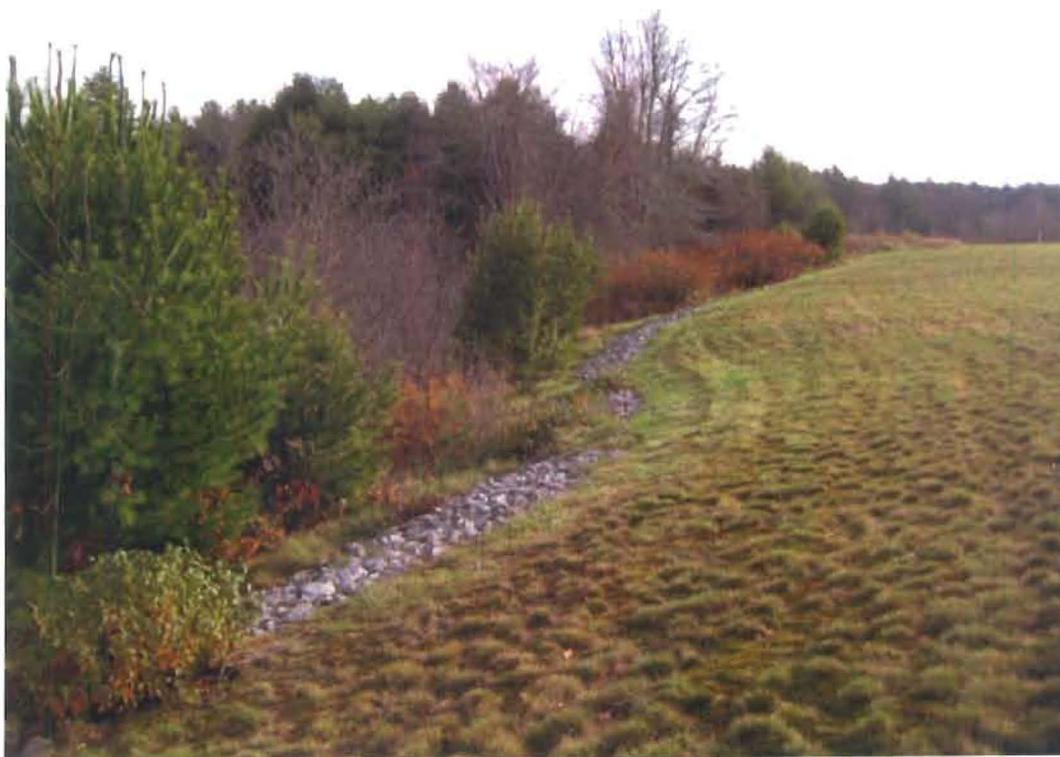
Photo No. 17: Town Dump Northern Toe-of-Slope

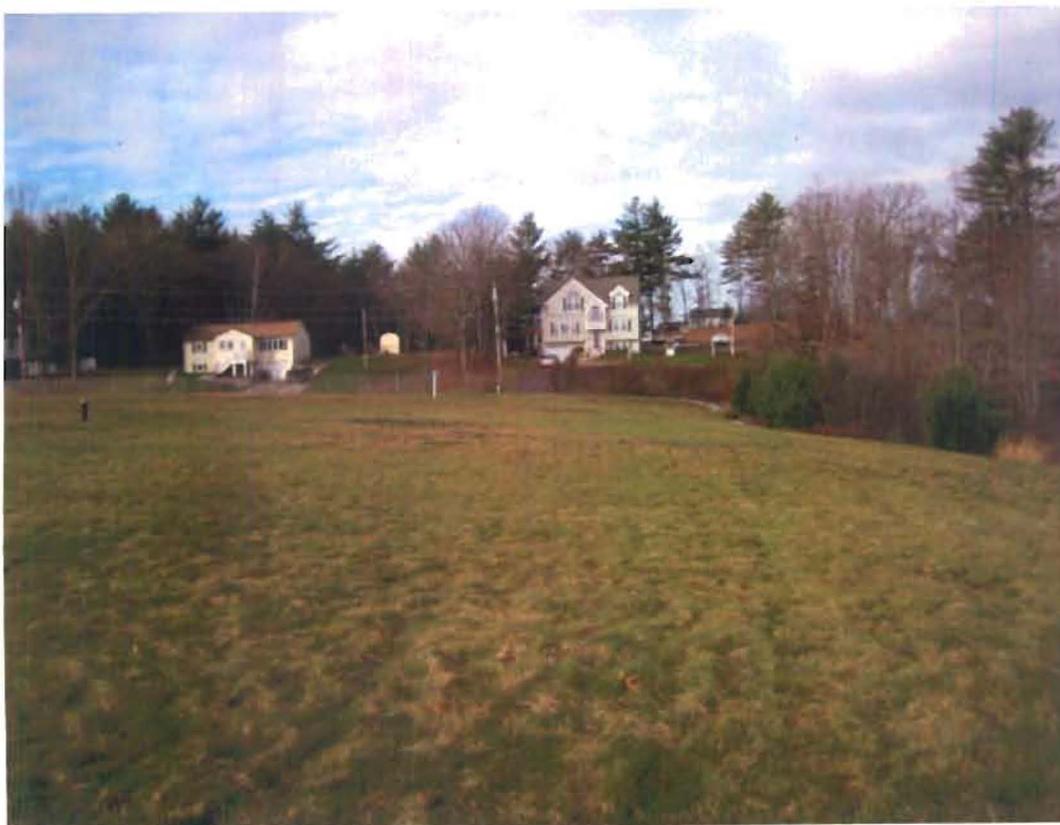
Photo No. 18: Town Dump – Northern Surface

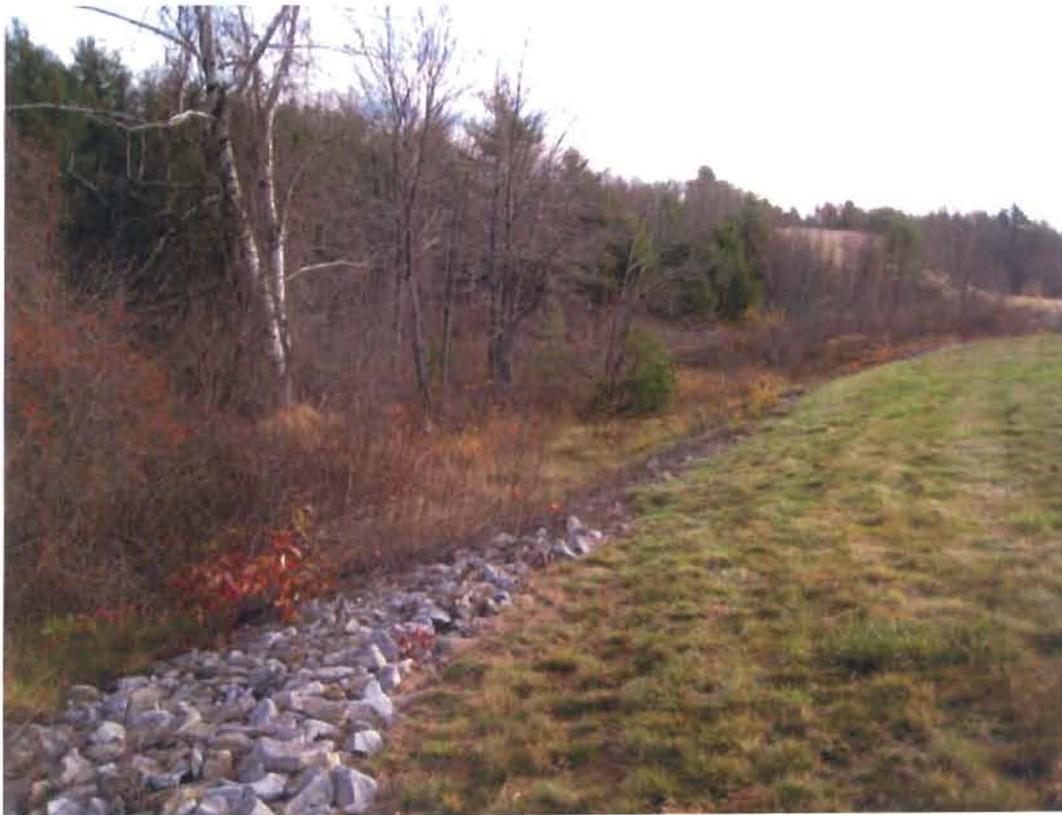
Photo No. 19: Town Dump – Northern Toe-of-Slope
