**RE: Auburn Road Landfill, Administrative Order,  
Docket Number I-90-1092, Londonderry, New Hampshire**

**2013 SOURCE CONTROL  
OPERATION & MAINTENANCE REPORT  
AUBURN ROAD LANDFILL**

**FOR  
TOWN OF LONDONDERRY, NEW HAMPSHIRE**

**FEBRUARY 2014**

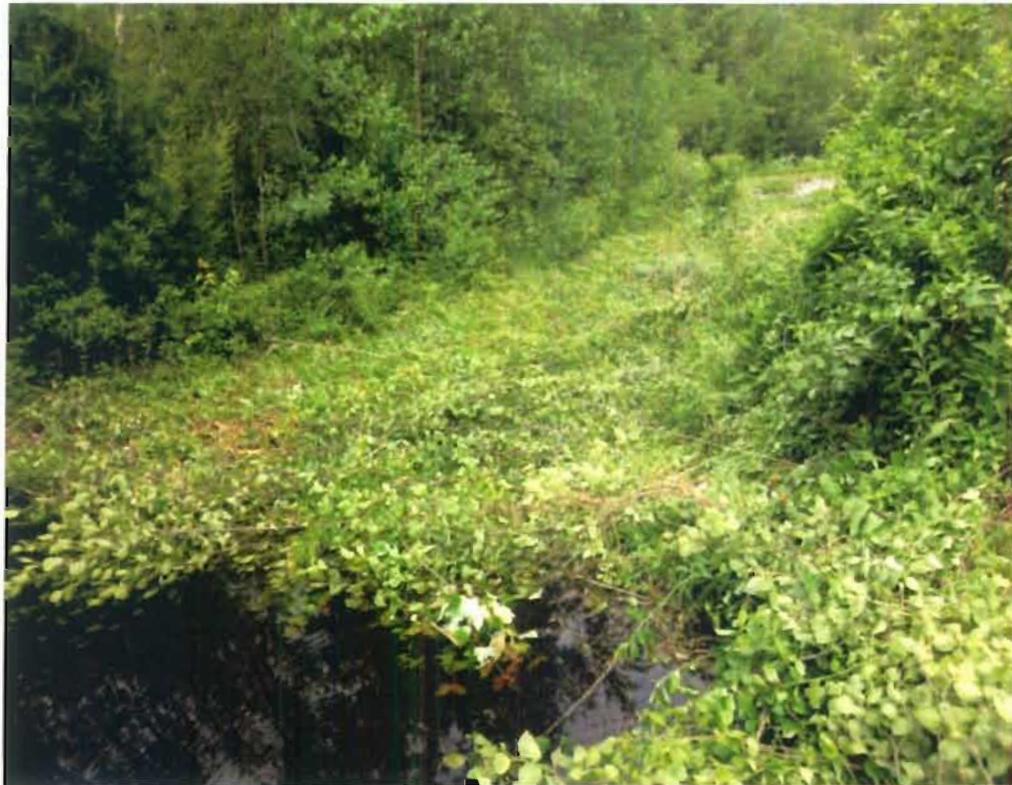
**Photo No. 2: Swale E – Beaver Dam**

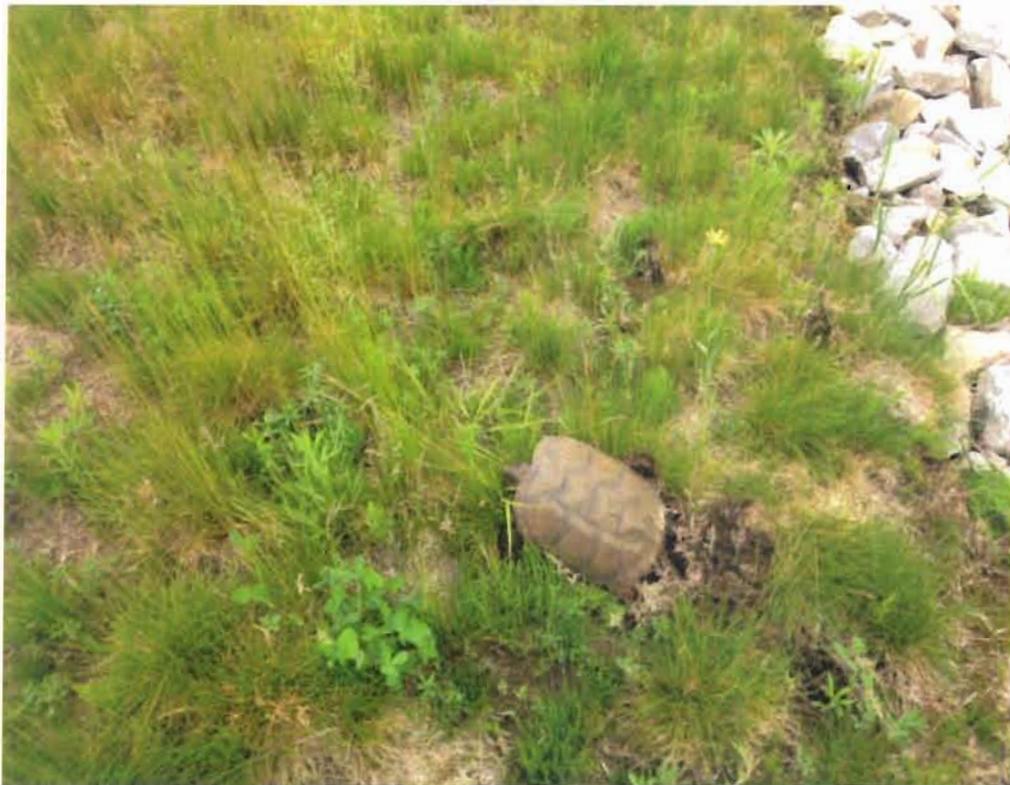
**Photo No. 40: Tire Dump – Eastern Toe-of-Slope & Snapping Turtle**

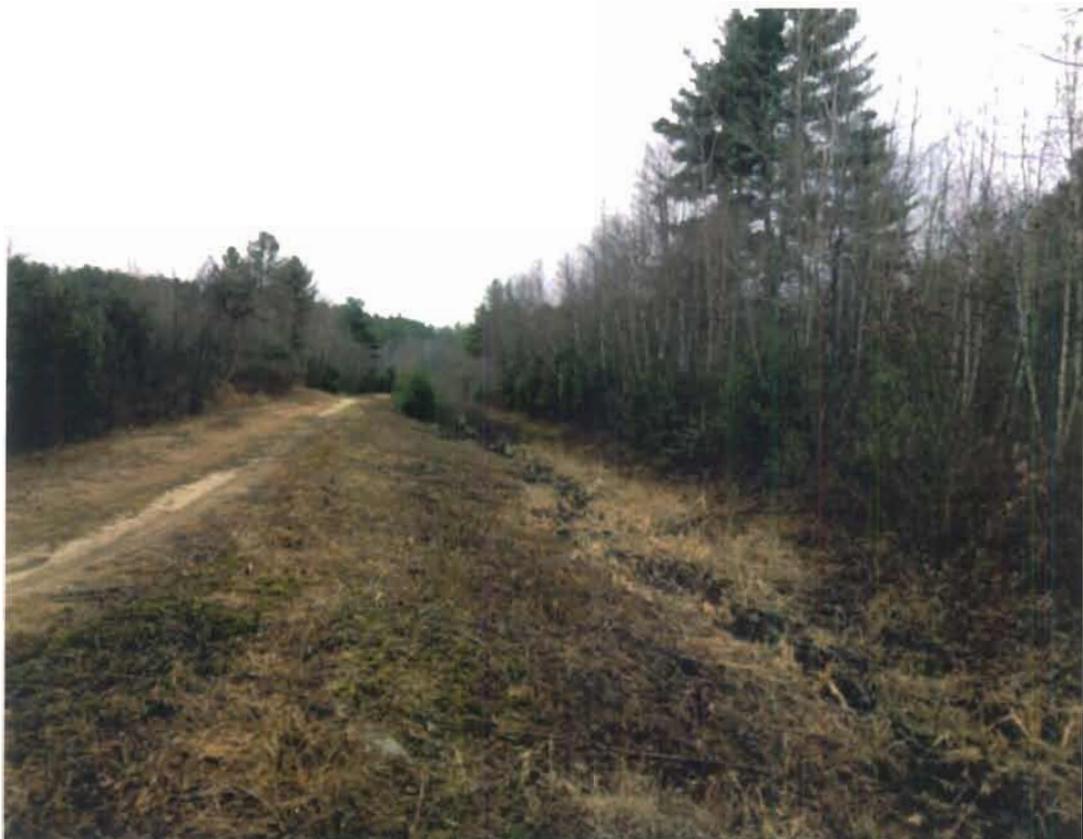
**Photo No. 2: Swale E**

(e.) Swale E (Tire Dump)	The Town has removed the beaver dam. The swale appears to be operating as designed. No standing water was observed during this site visit.		√
(f.) Swale F	In general the swale appears to be operating as designed. In the invert of Swale F near the confluence of Swale E and H, a pocket of sediment and grass build up was found. No standing water was observed, however this area could pose as a restriction to flow from swale H. Sediment build up in this area should be monitored and removed if ponded water is observed in Swale H. The fallen tree reported in the previous report has been removed.		√
(g.) Swale H	The swale is functioning as designed. Sediment build up in the swale should be monitored and removed if ponded water is observed.		√
(h.) Concrete Culverts	The concrete culverts were observed to be in good condition.		√

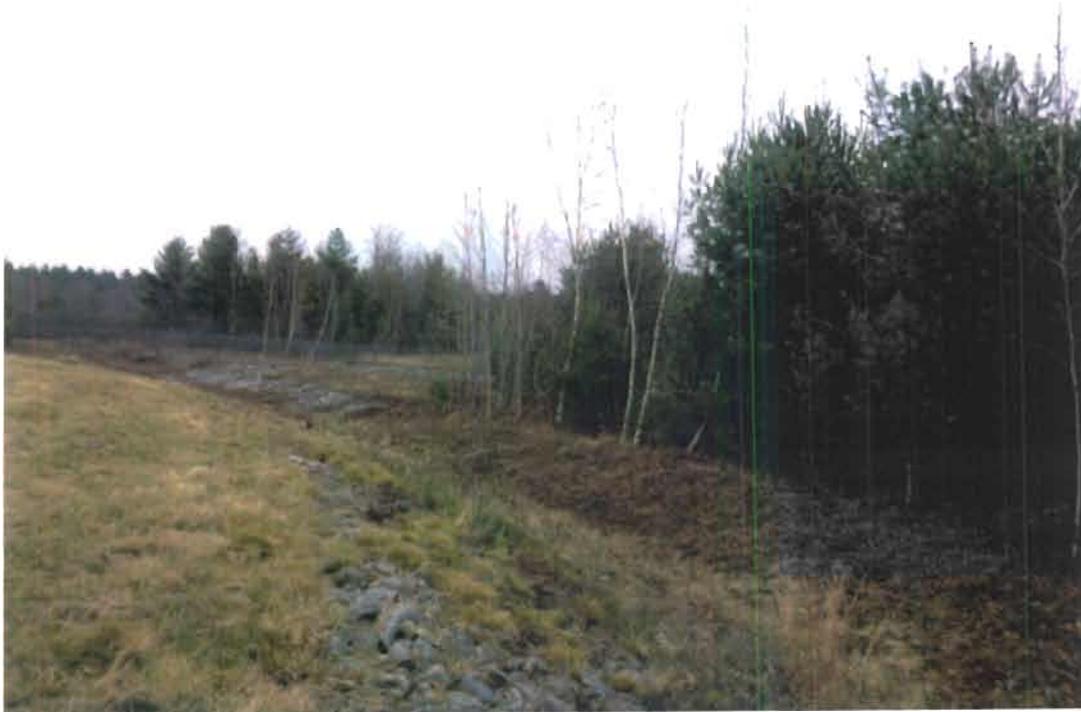
**Photo No. 8: Swale A**

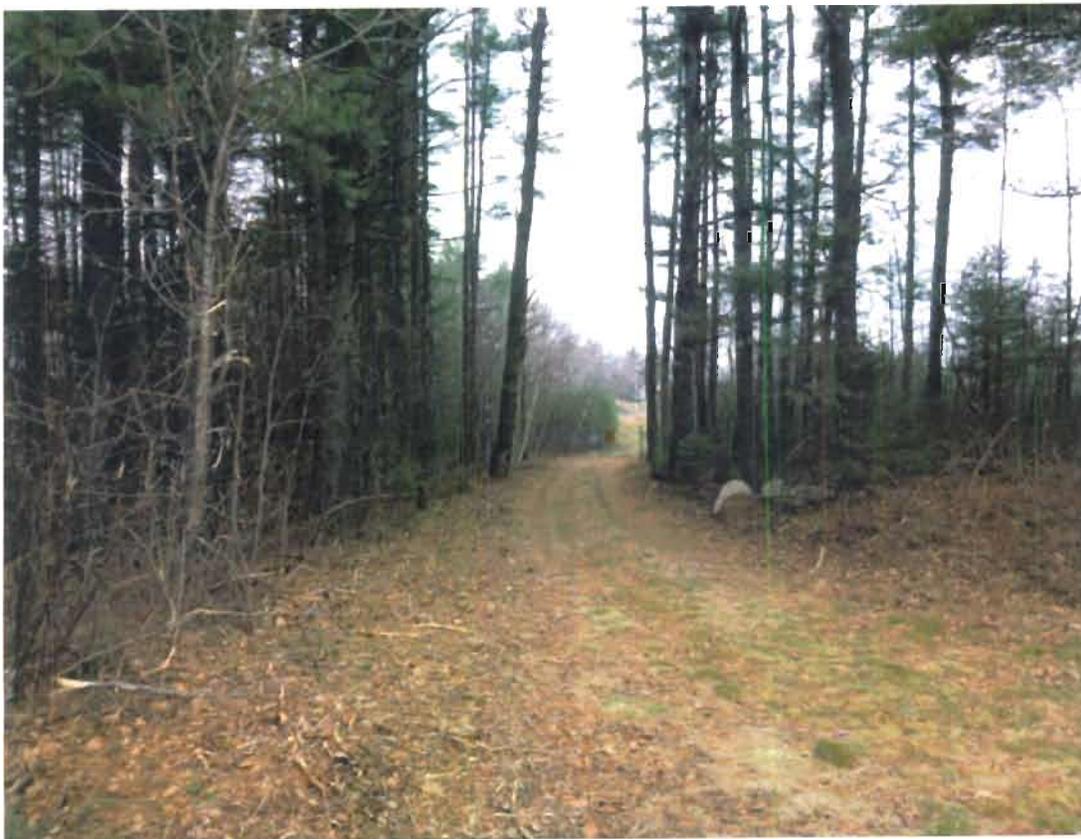
**Photo No. 9: Swale A**

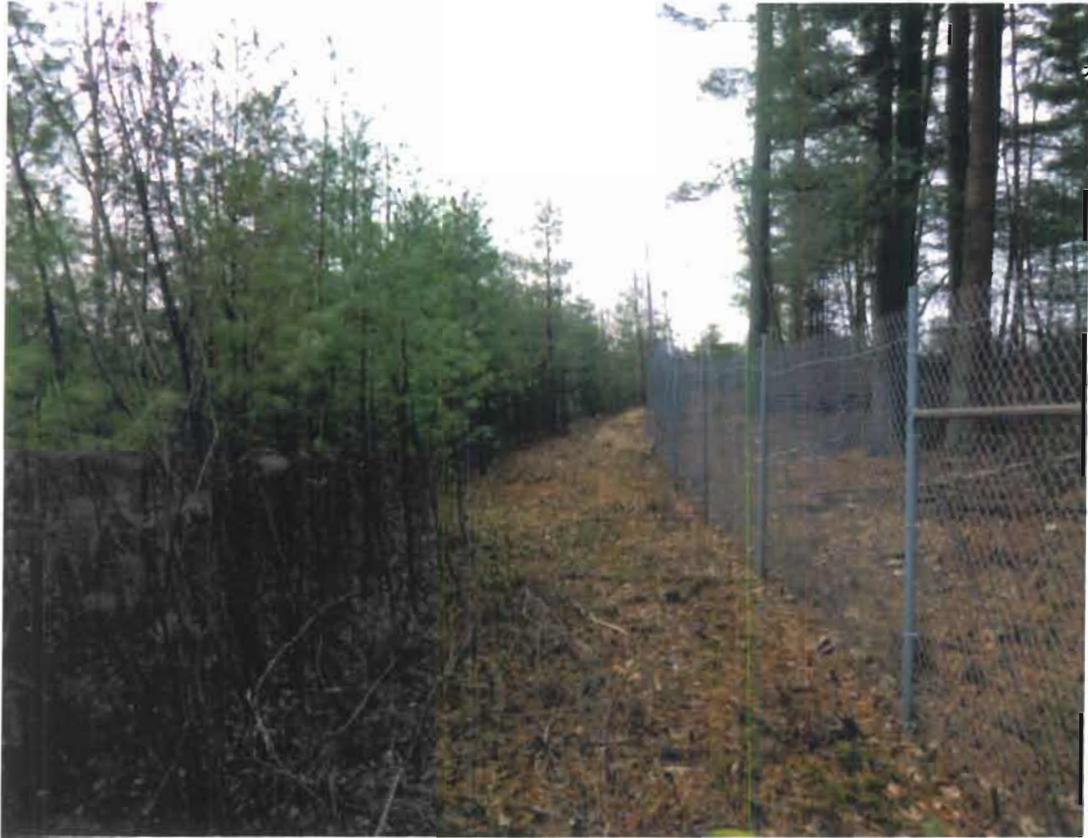
**Photo No. 10: Town Dump Entrance**

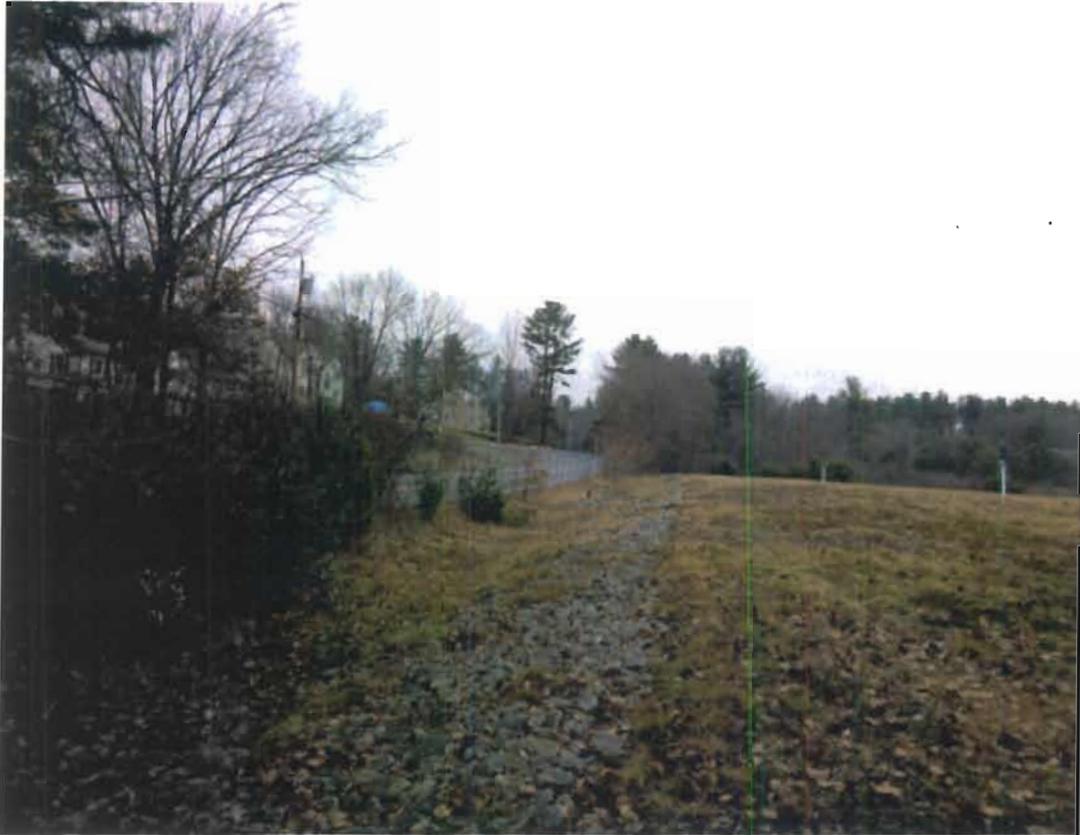
**Photo No. 12: Town Dump Western Surface**

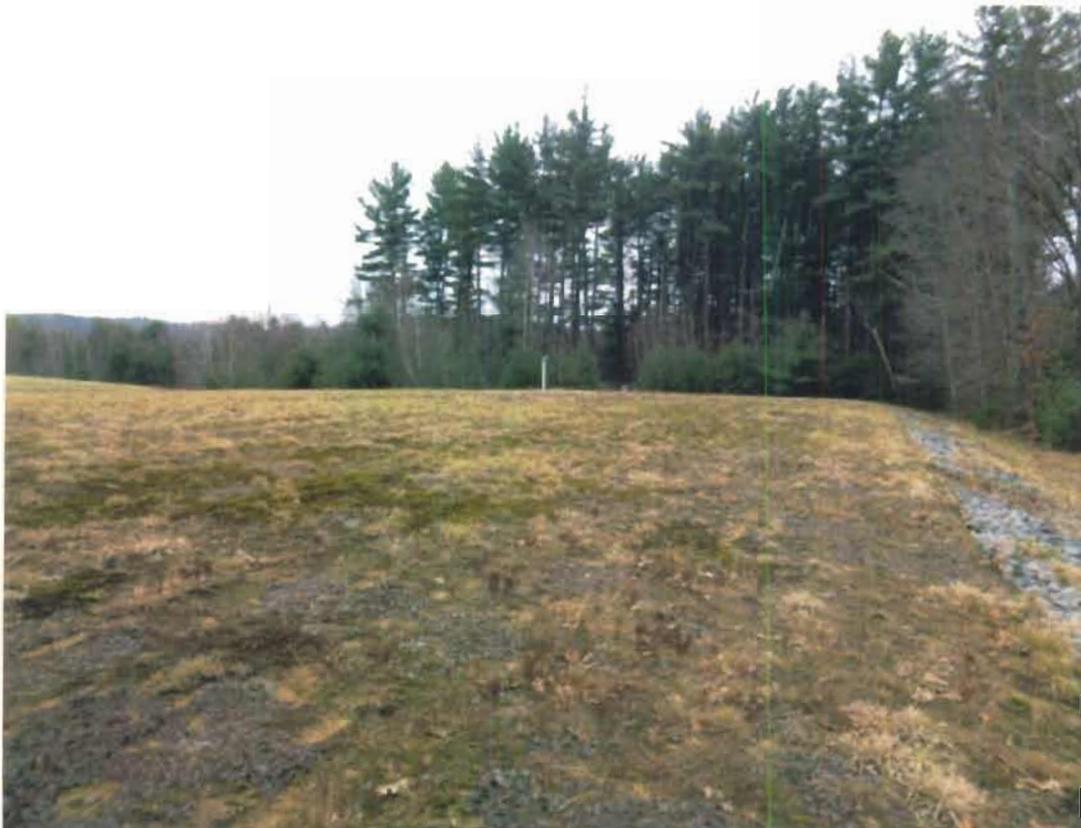
**Photo No. 13: Town Dump – Town Dump Western Surface & Toe-of-Slope**

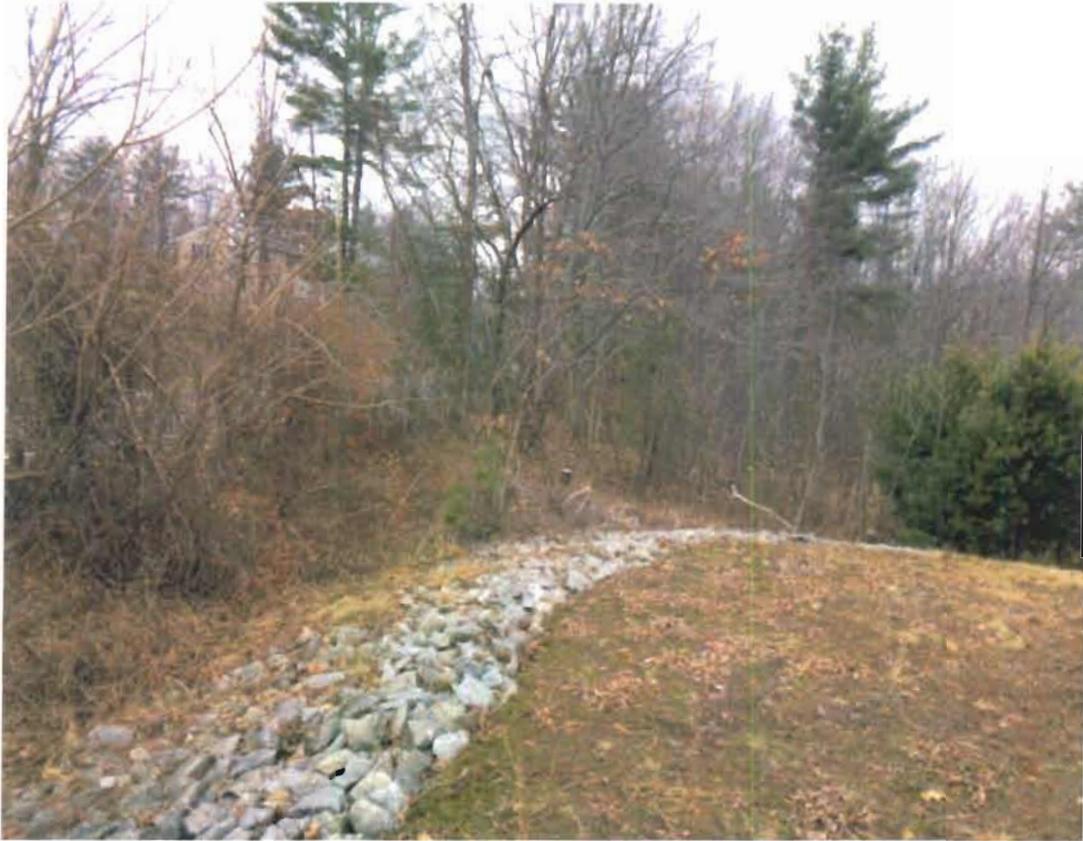
**Photo No. 14: Town Dump – Western Surface**

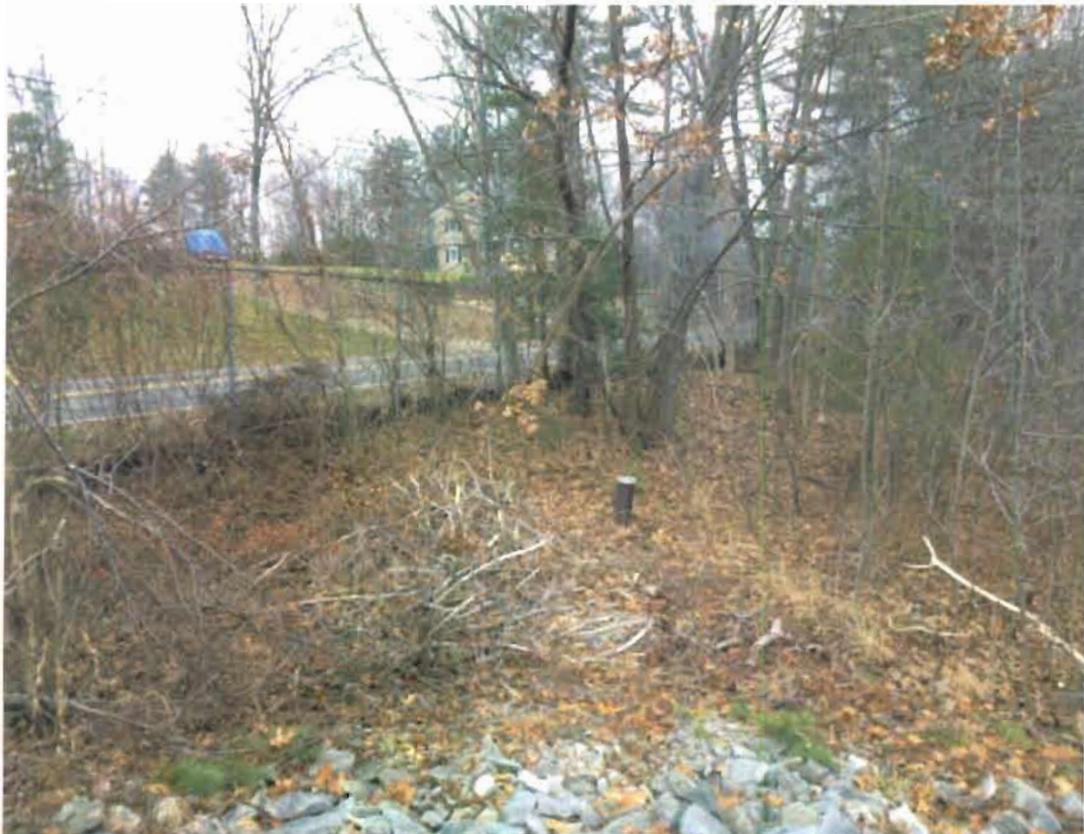
**Photo No. 15: Town Dump – Northwestern Corner**

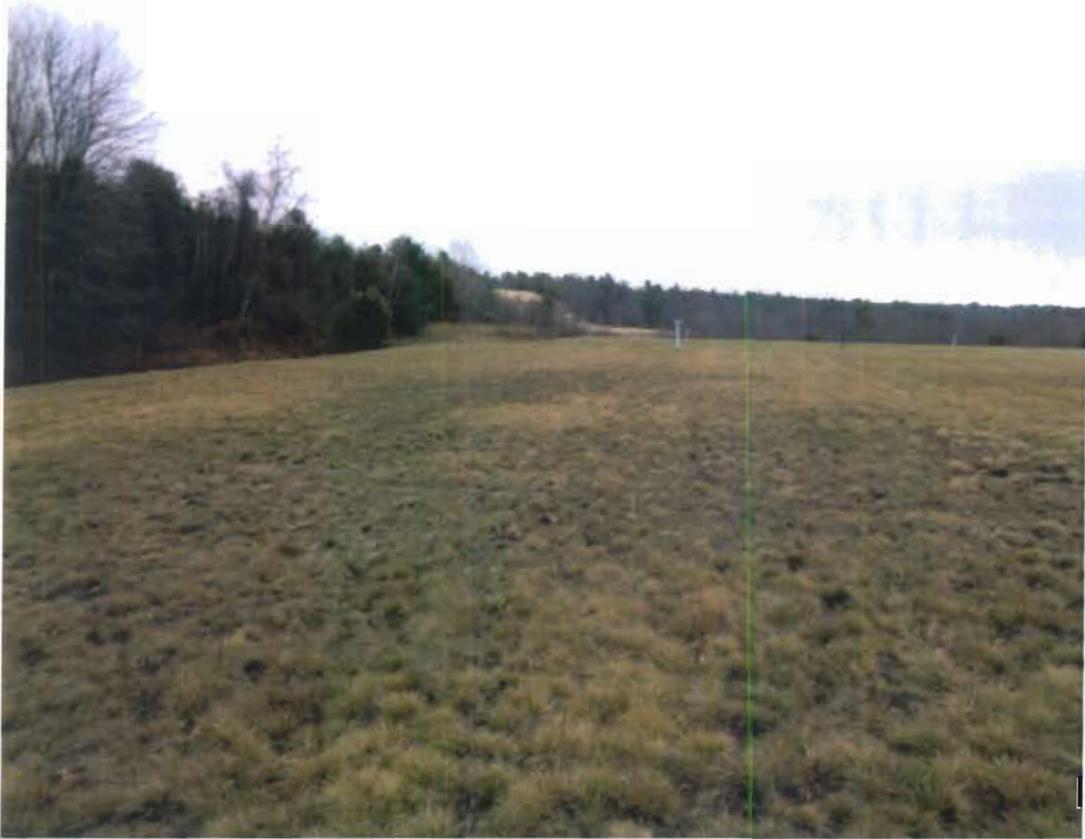
**Photo No. 16: Town Dump – Gas Vent GV-4**

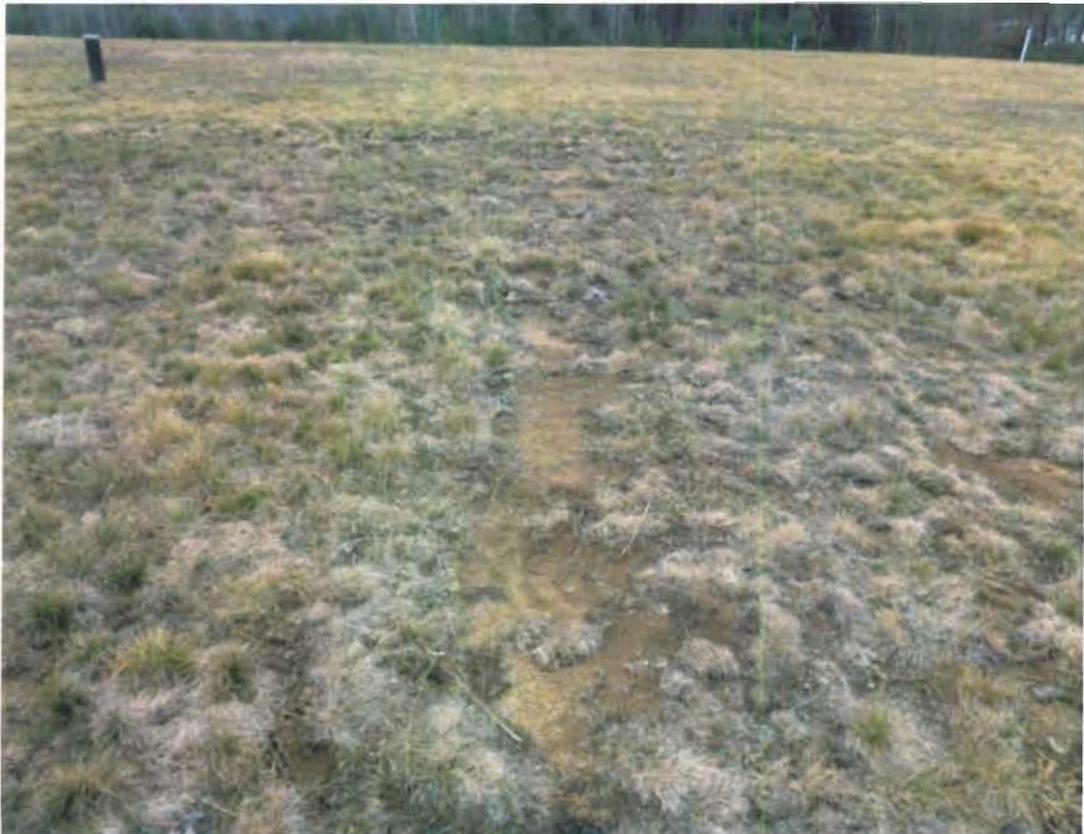
**Photo No. 17: Town Dump Northern Surface**

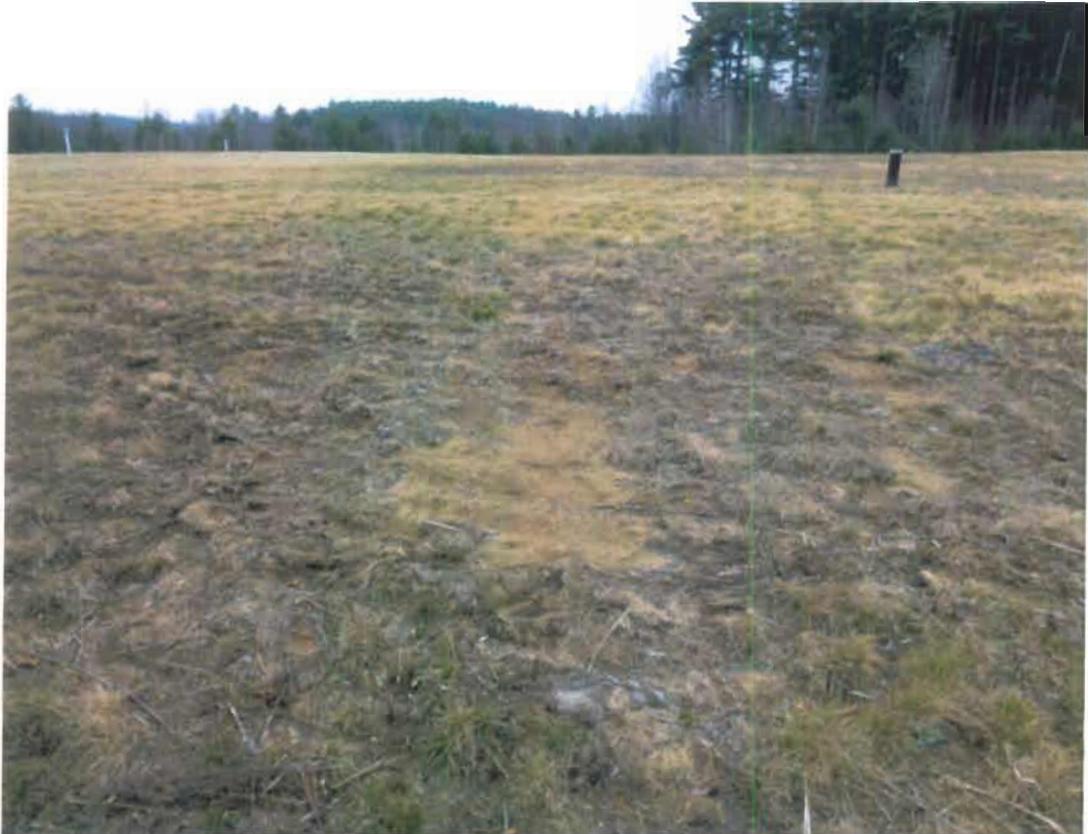
**Photo No. 18: Town Dump – Northern Surface**

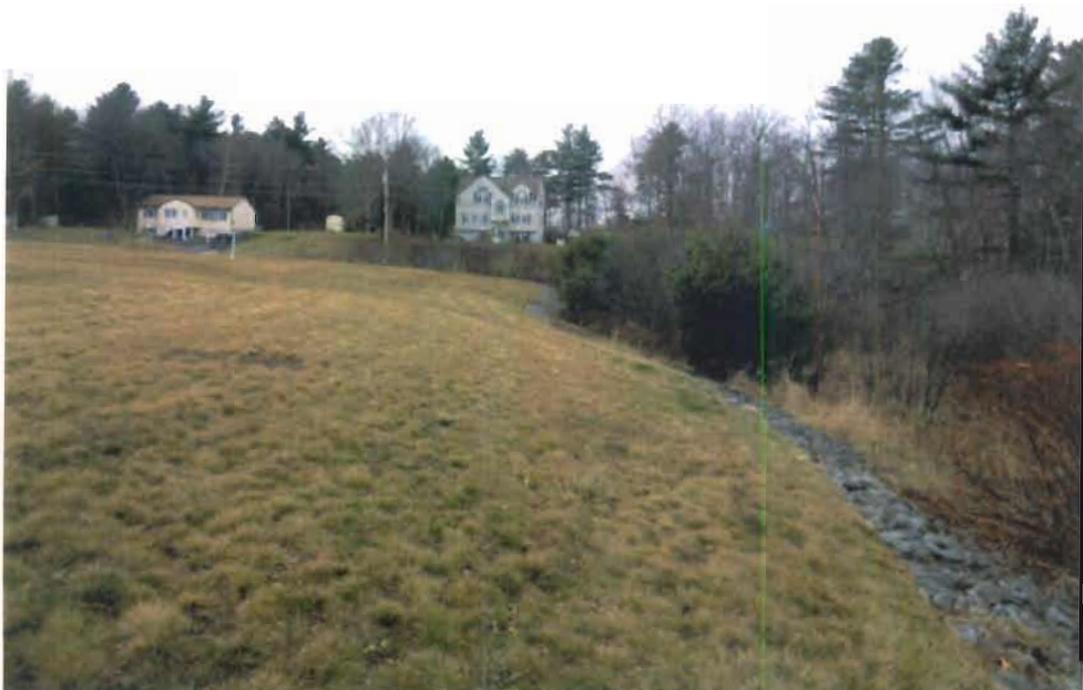
**Photo No. 19: Town Dump – Northern Surface**

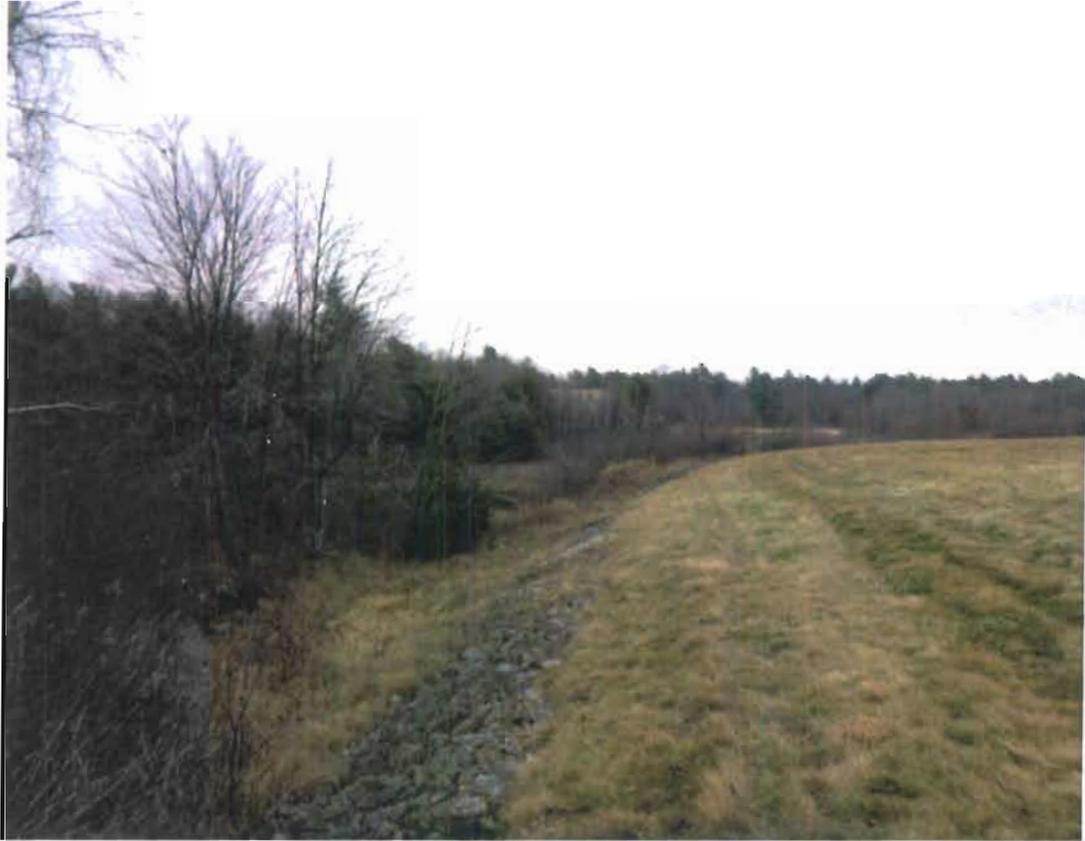
**Photo No. 20: Town Dump – Northern Toe-of-Slope**

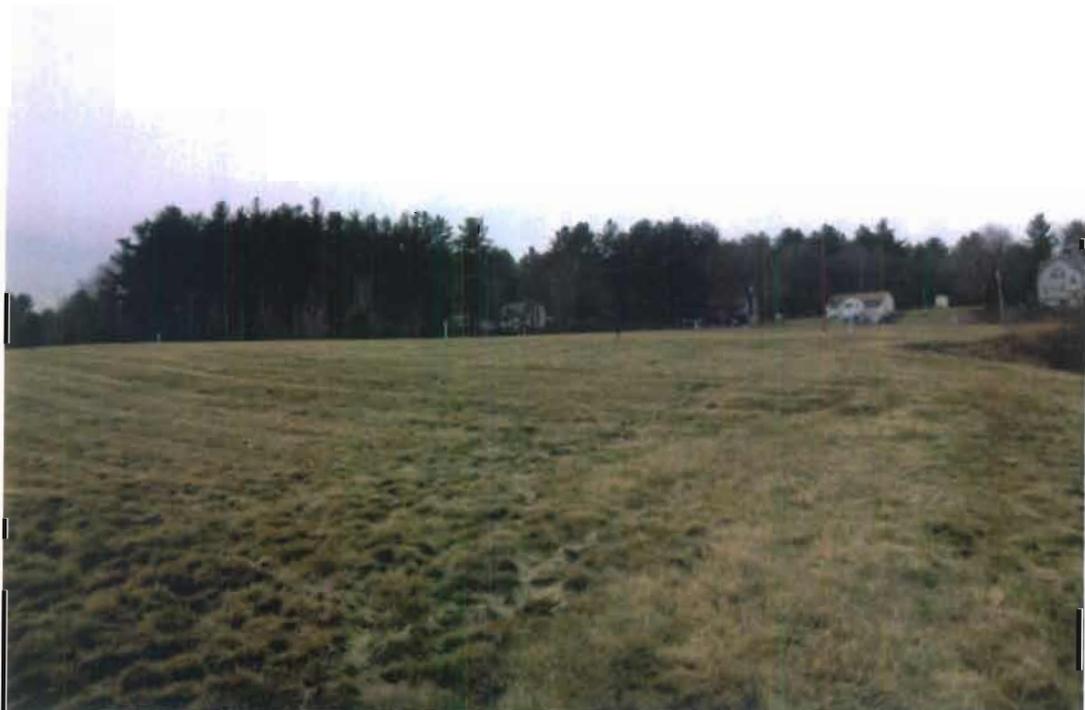
**Photo No. 21: Town Dump – Northern Toe-of-Slope**

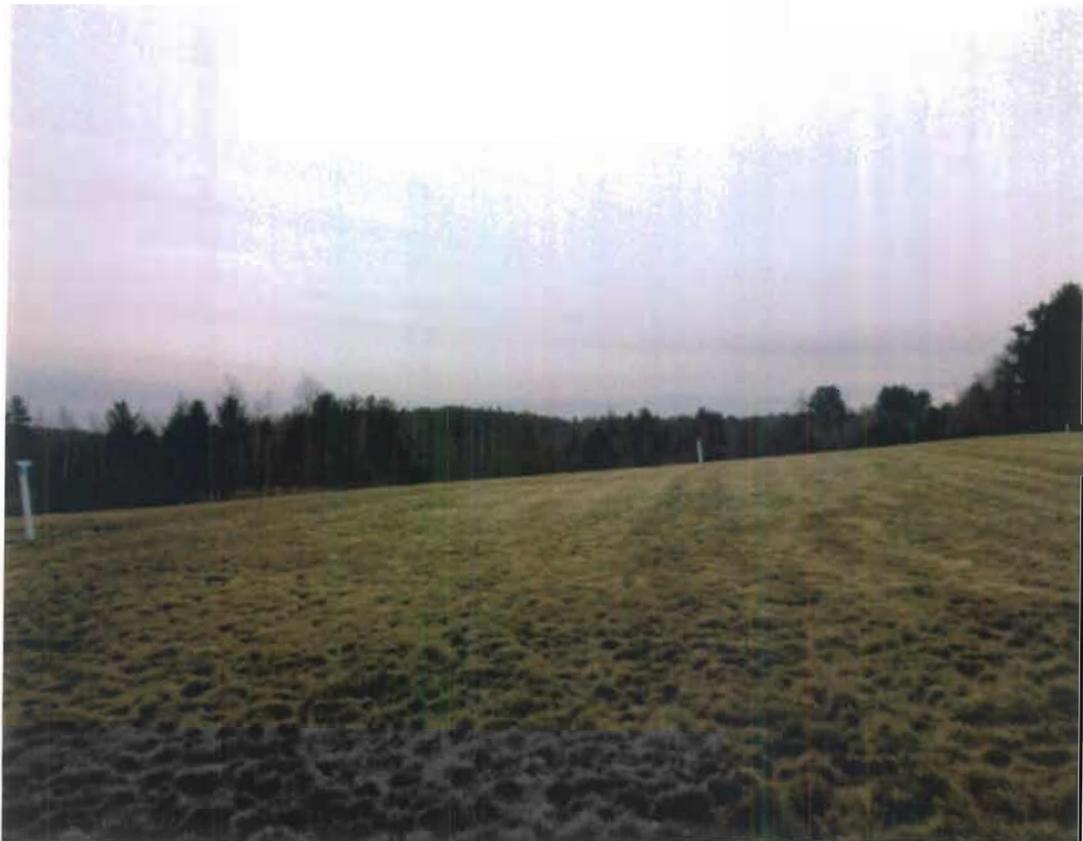
**Photo No. 22: Town Dump – Northern Surface**

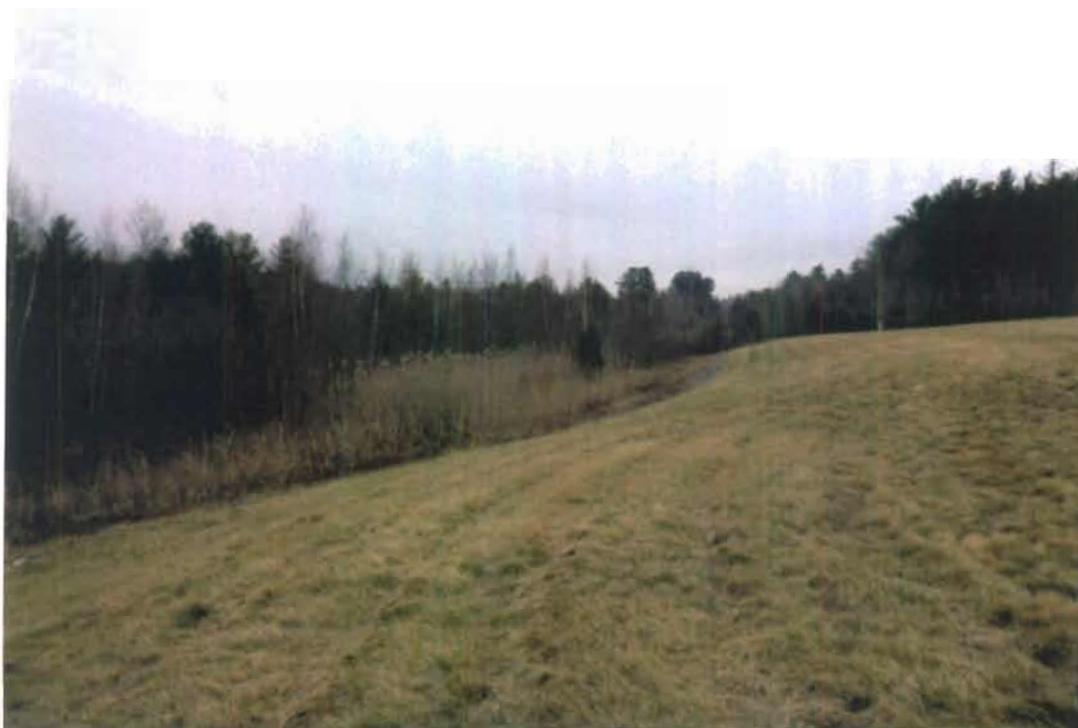
**Photo No. 23: Town Dump – Eastern Surface**

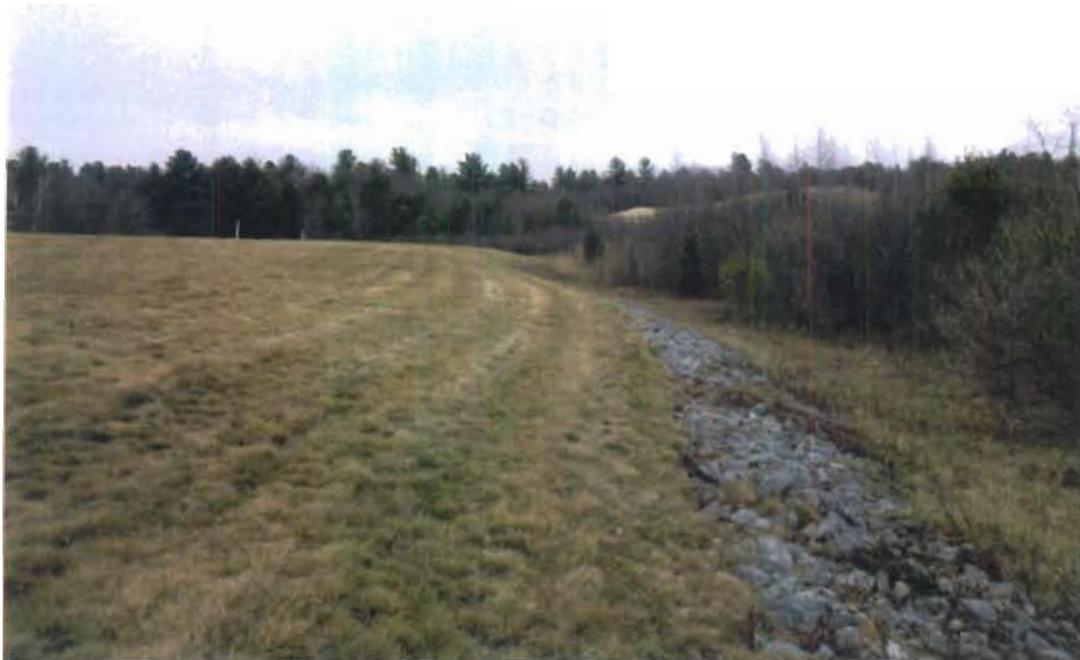
**Photo No. 24: Town Dump – Eastern Surface and Toe-of-Slope**

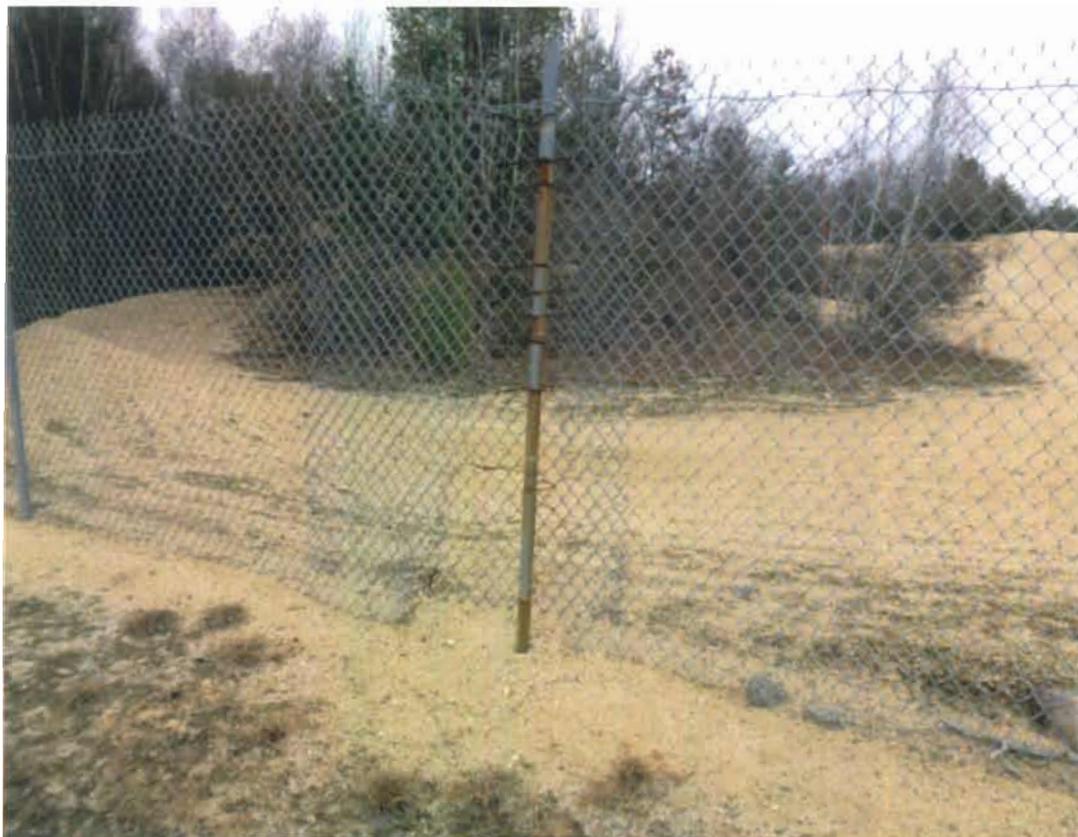
**Photo No. 25: Town Dump – Eastern Toe-of-Slope**

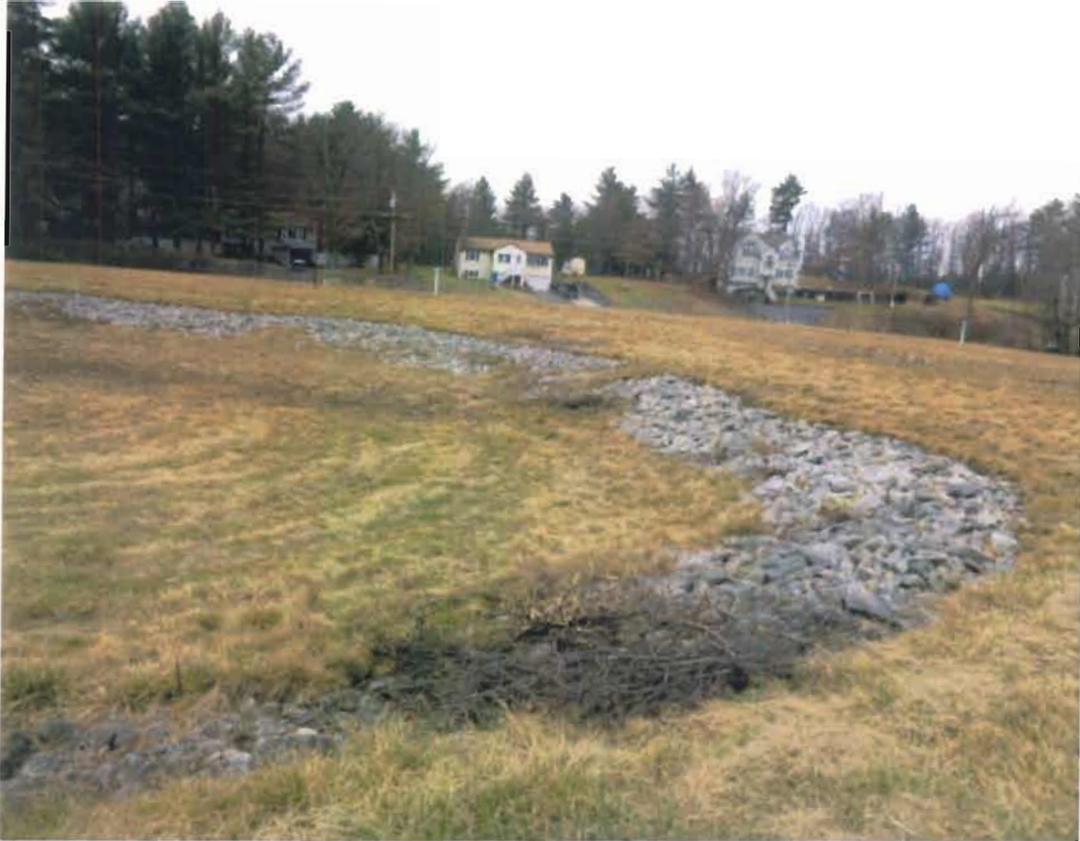
**Photo No. 28: Town Dump – Central Surface & Toe-of-Slope**

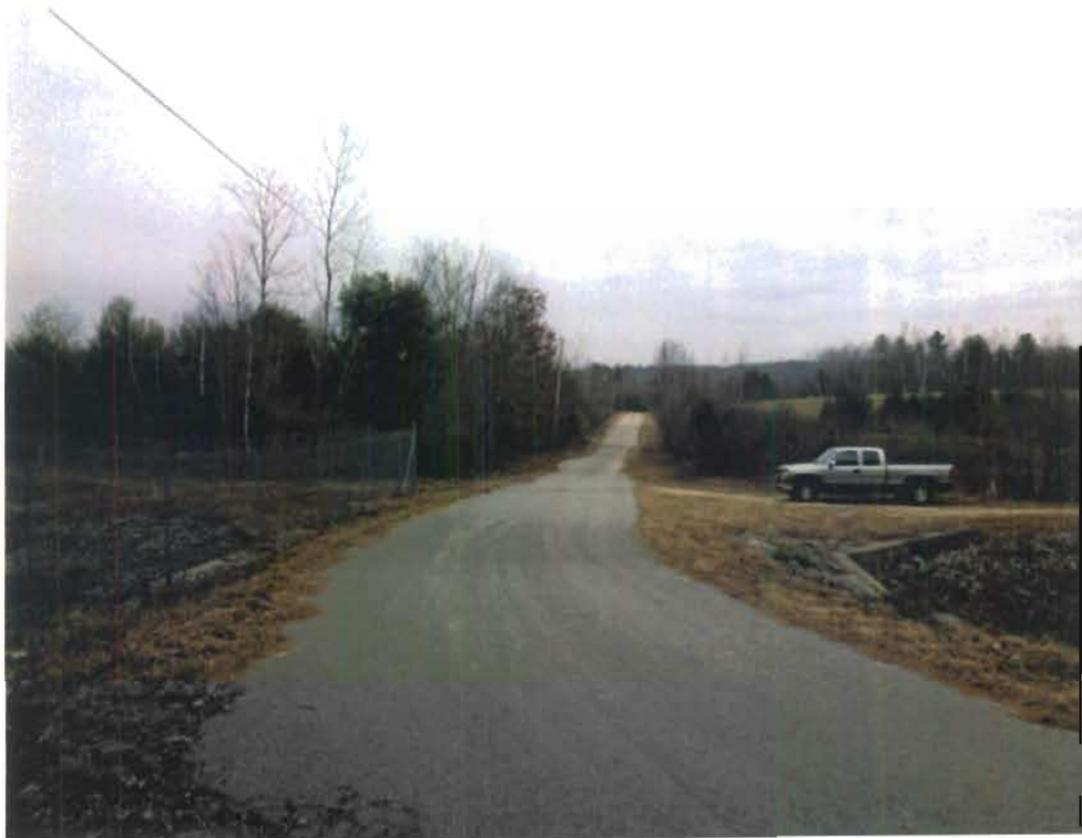
**Photo No. 31: Access Road**

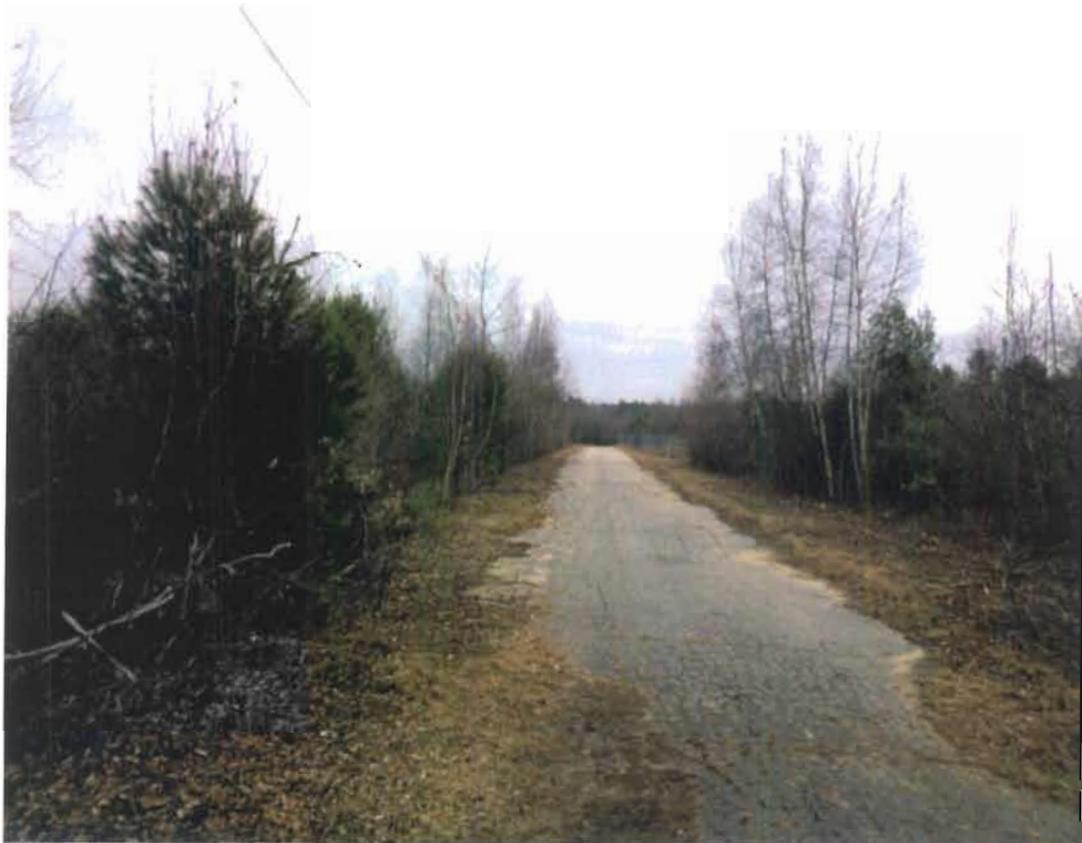
**Photo No. 32: Access Road**

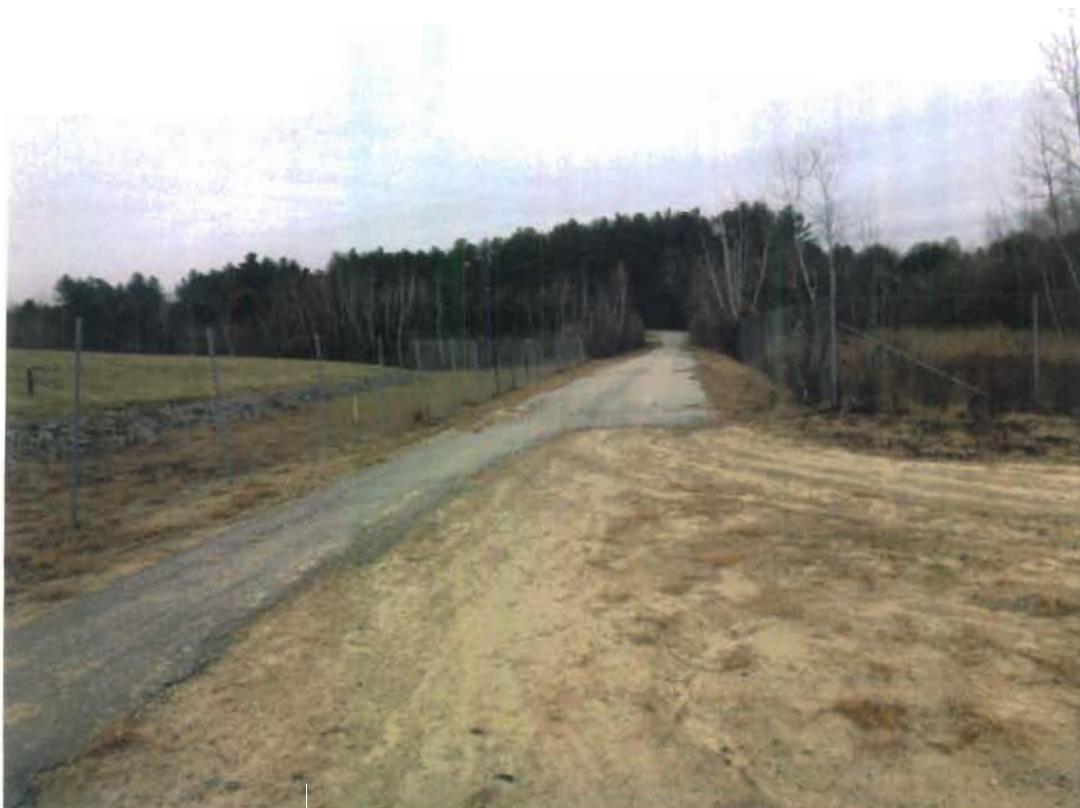
**Photo No. 33: Access Road**

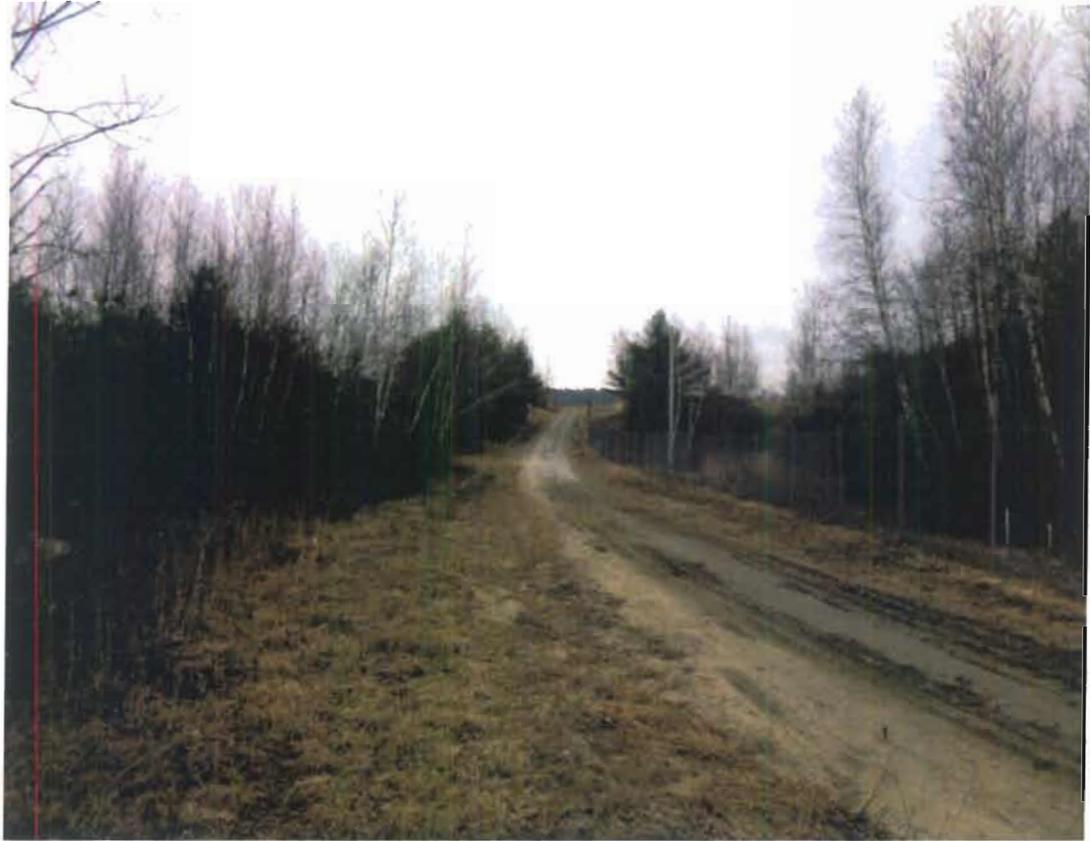
**Photo No. 34: Access Road**

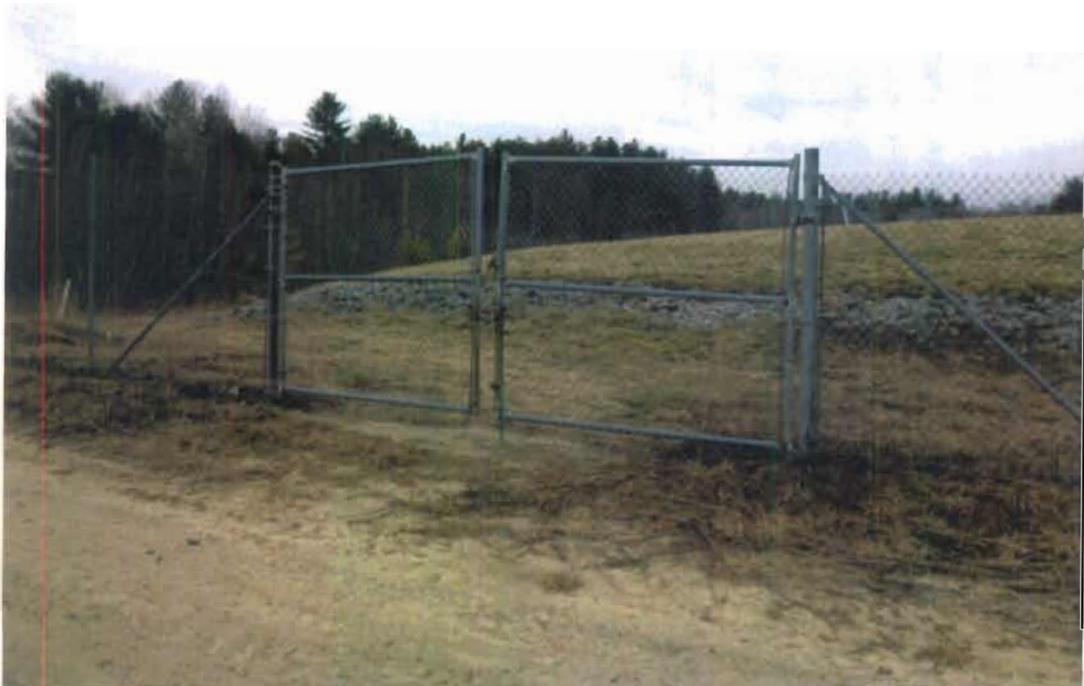
**Photo No. 35: Access Road**
