**RE: Auburn Road Landfill, Administrative Order,  
Docket Number I-90-1092, Londonderry, New Hampshire**

**2013 SOURCE CONTROL  
OPERATION & MAINTENANCE REPORT  
AUBURN ROAD LANDFILL**

**FOR  
TOWN OF LONDONDERRY, NEW HAMPSHIRE**

**FEBRUARY 2014**

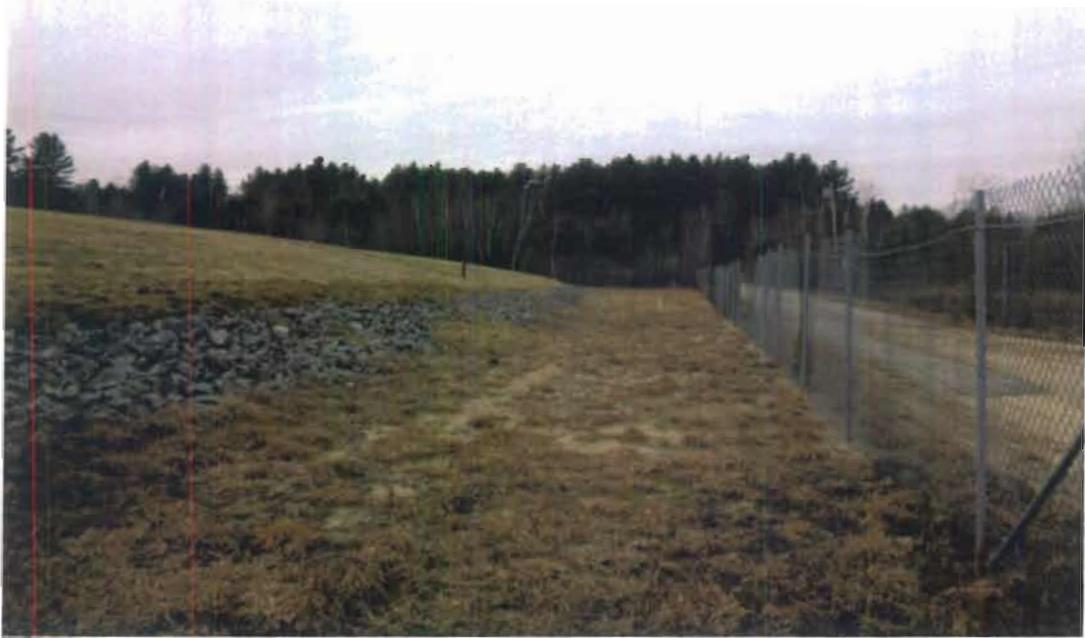
**Photo No. 36: Tire Dump – Entrance Gate**

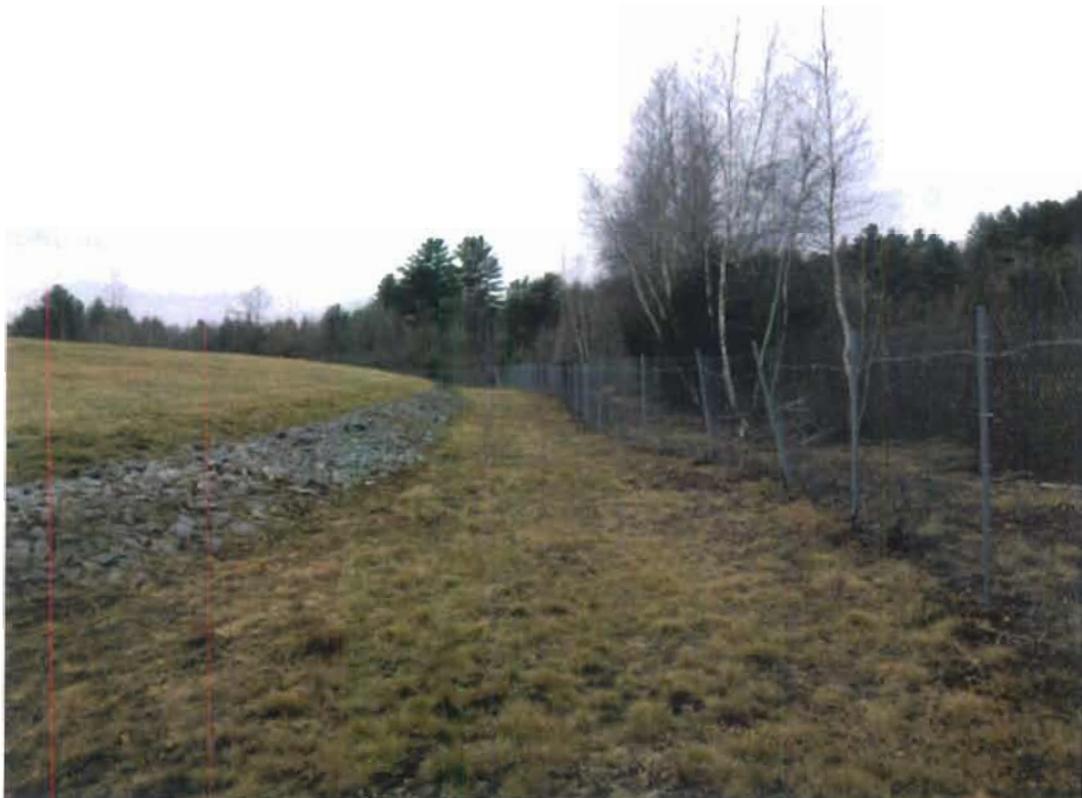
**Photo No. 37: Tire Dump – Northern Toe-of-Slope & Fence**

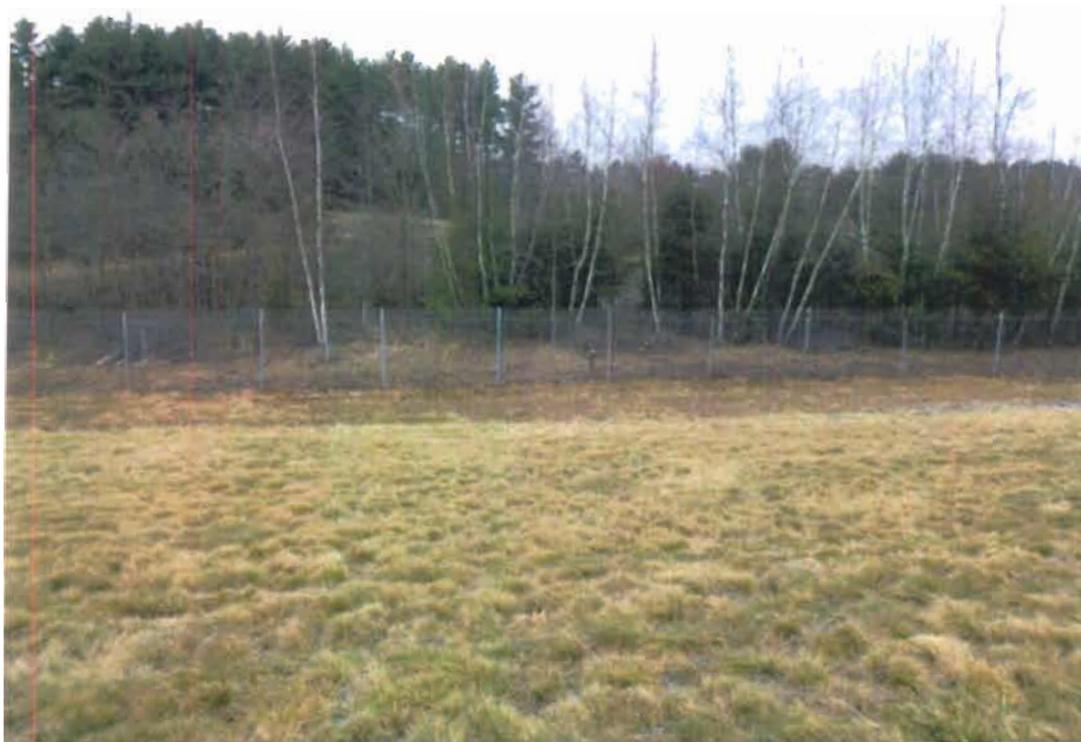
**Photo No. 38: Tire Dump - Western Toe-of-Slope & Fence**

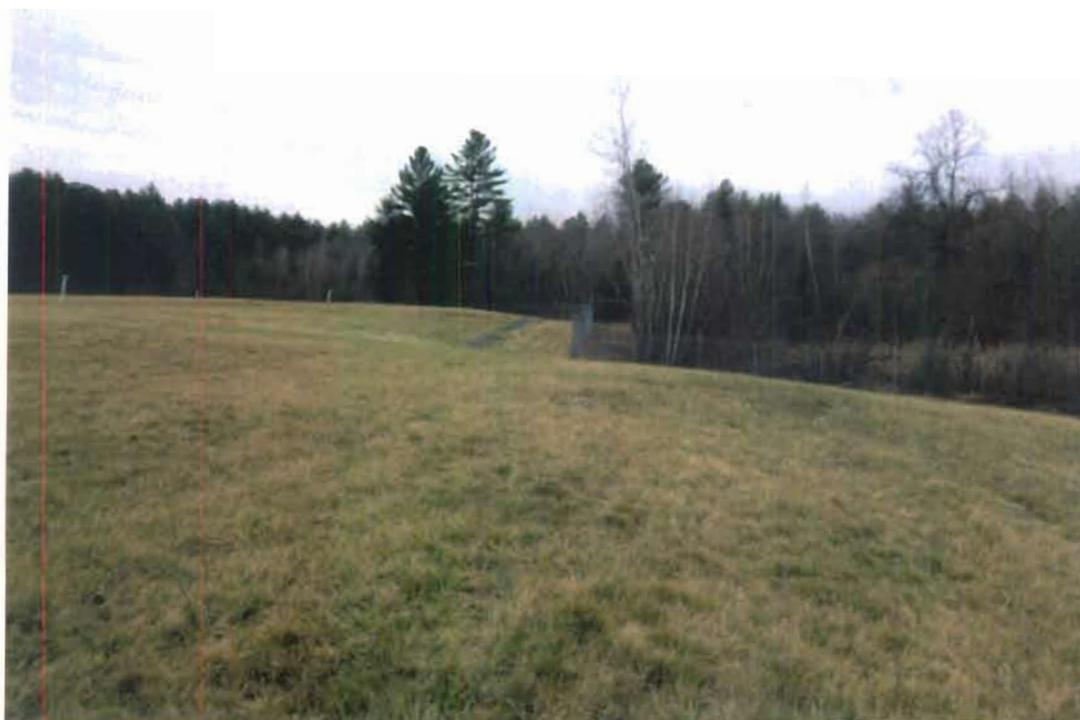
**Photo No. 39: Tire Dump - Western Fence**

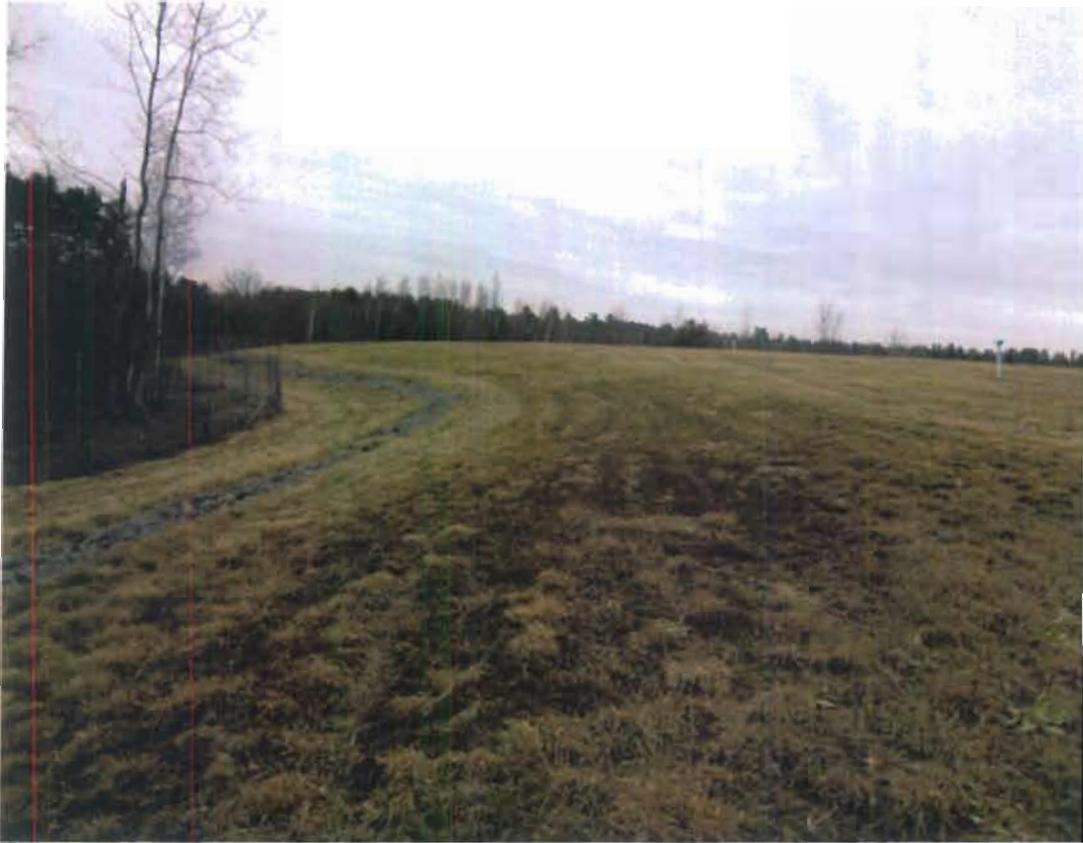
**Photo No. 40: Tire Dump – Western Surface & Fence Line**

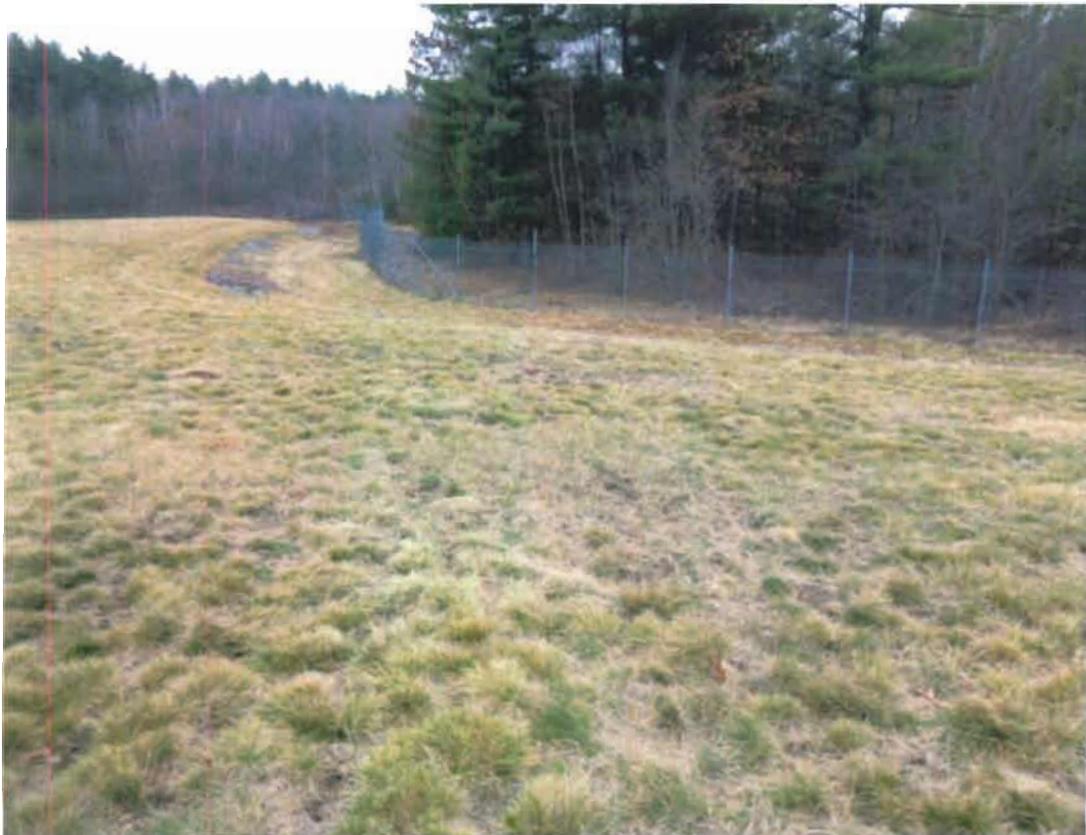
**Photo No. 41: Tire Dump – Western Surface & Toe-of-Slope**

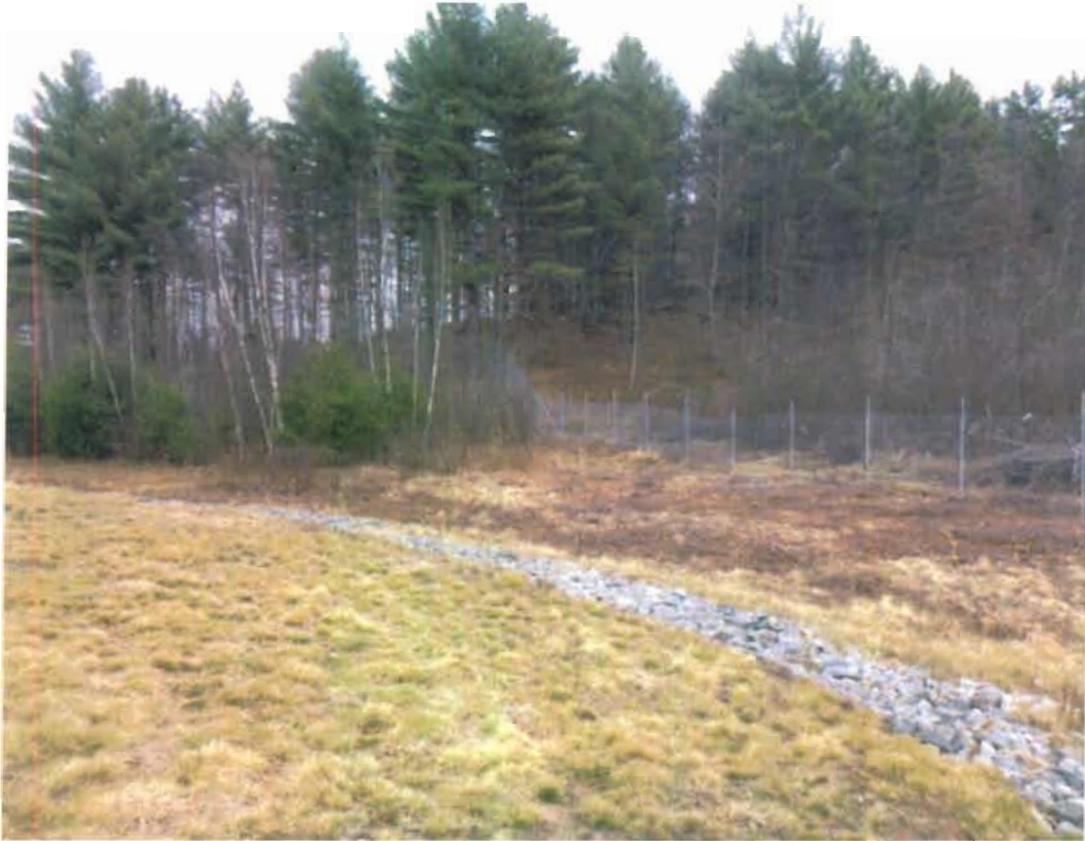
**Photo No. 42: Tire Dump – Western Surface, Toe-of-Slope & Fence**

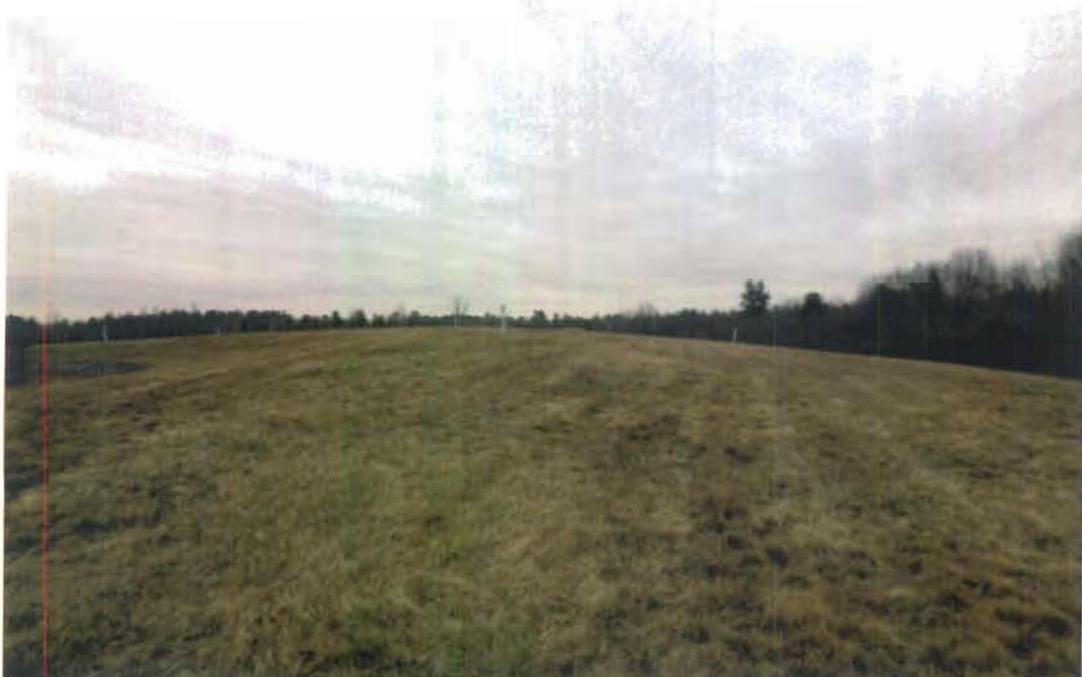
**Photo No. 43: Tire Dump – Southern Toe-of-Slope & Fence**

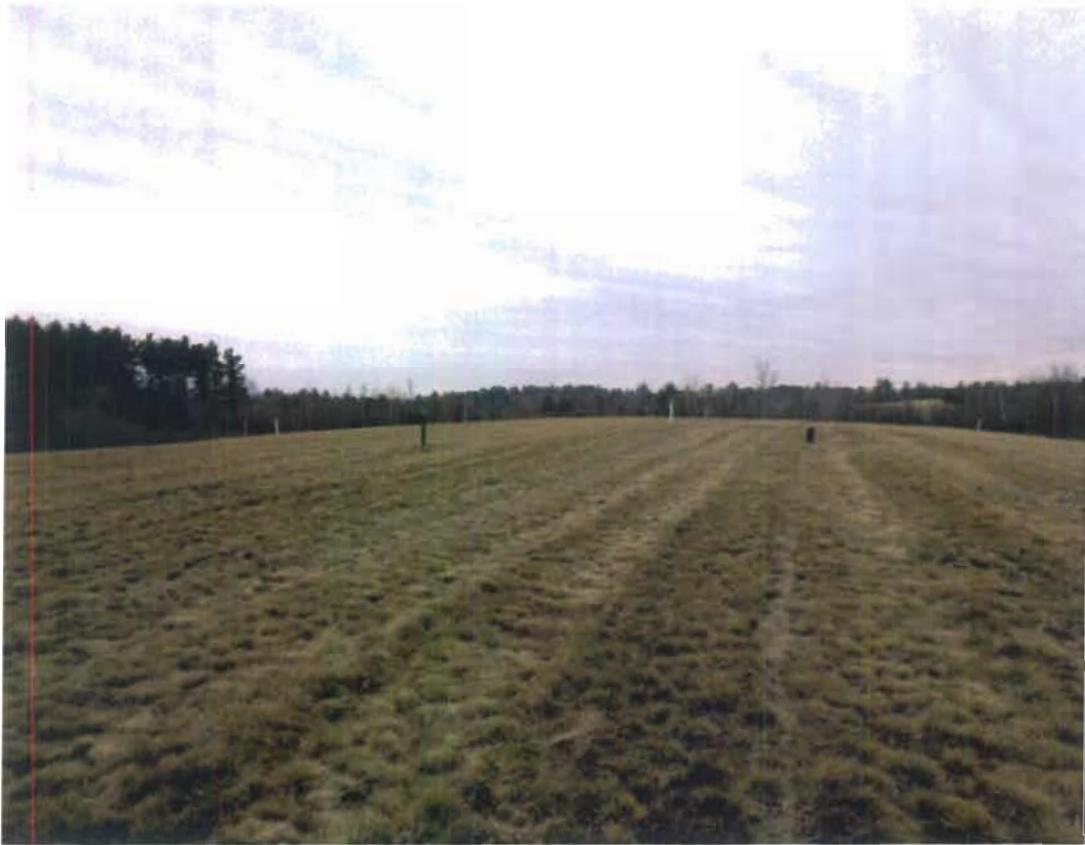
**Photo No. 44: Tire Dump – Southern Surface**

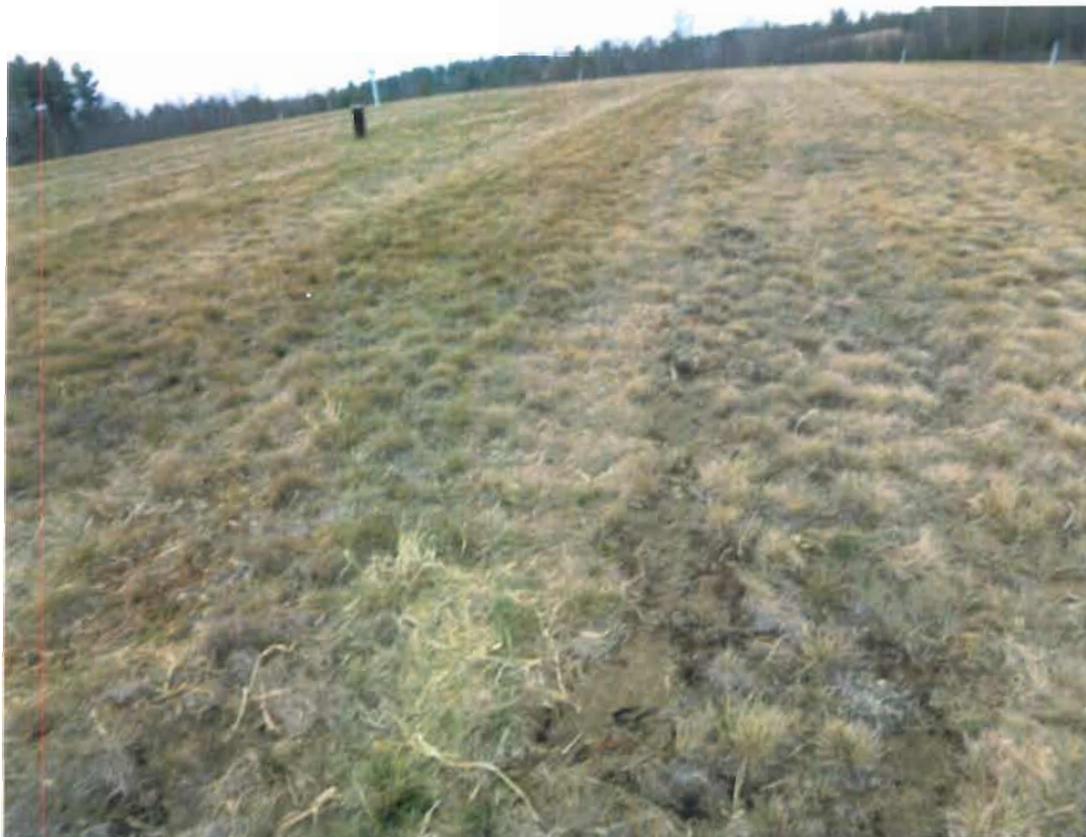
**Photo No. 45: Tire Dump – Top Surface**

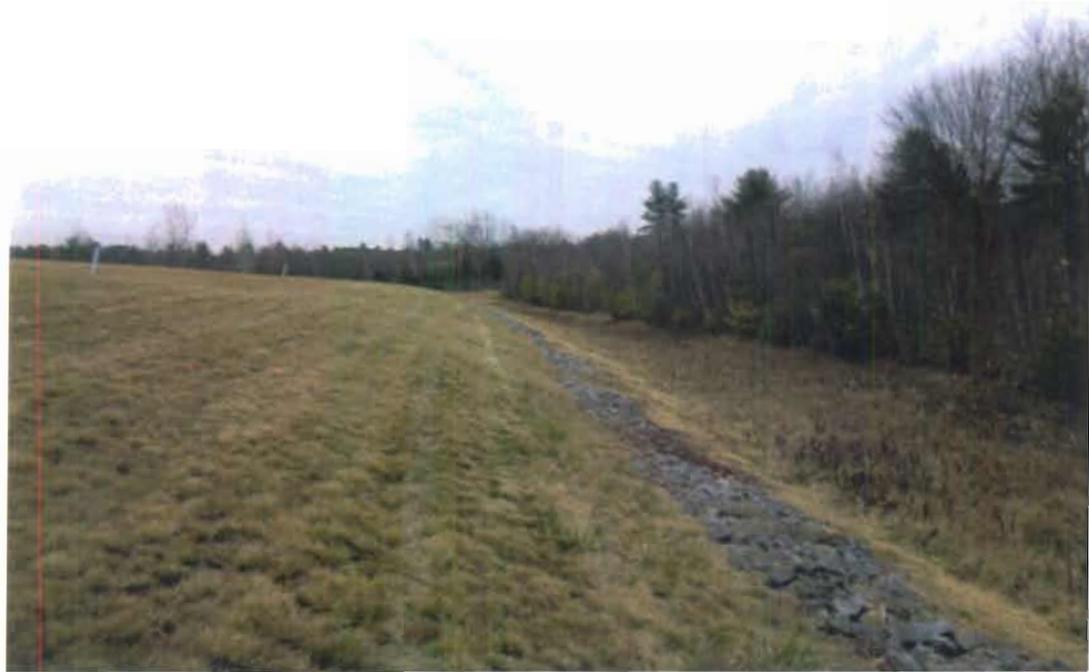
**Photo No. 46: Tire Dump – Top Surface**

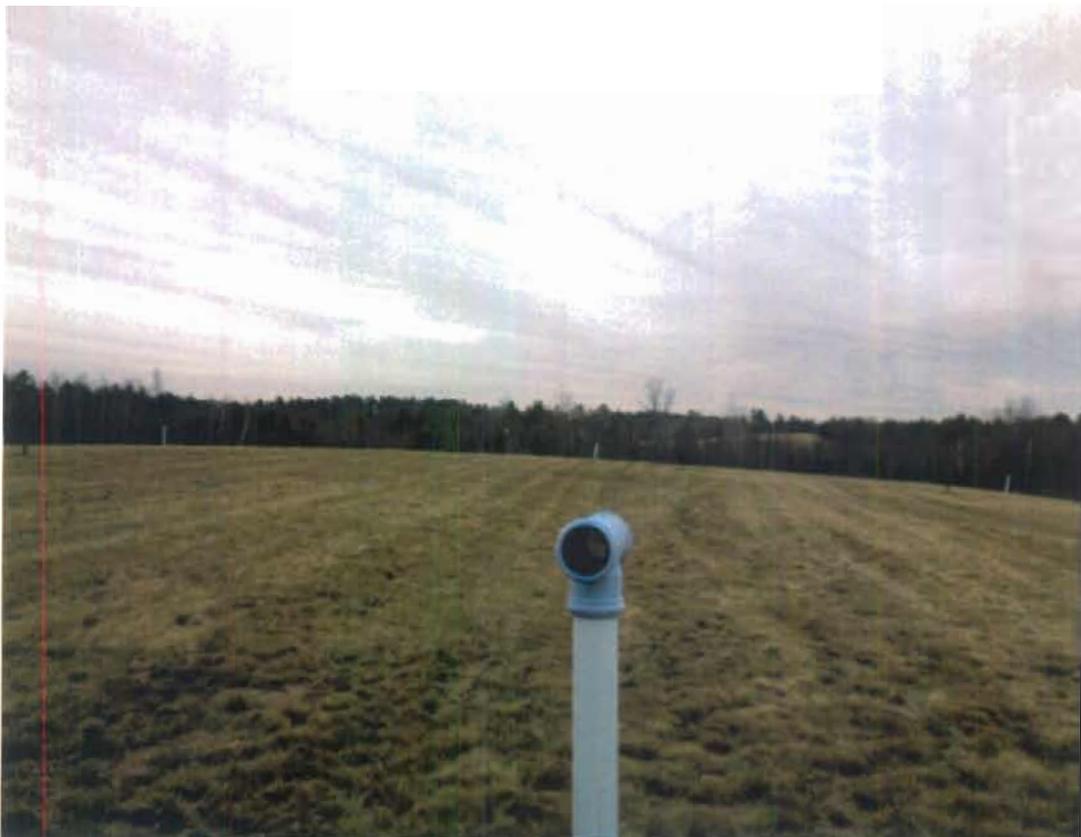
**Photo No. 47: Tire Dump – Eastern Toe-of-Slope**

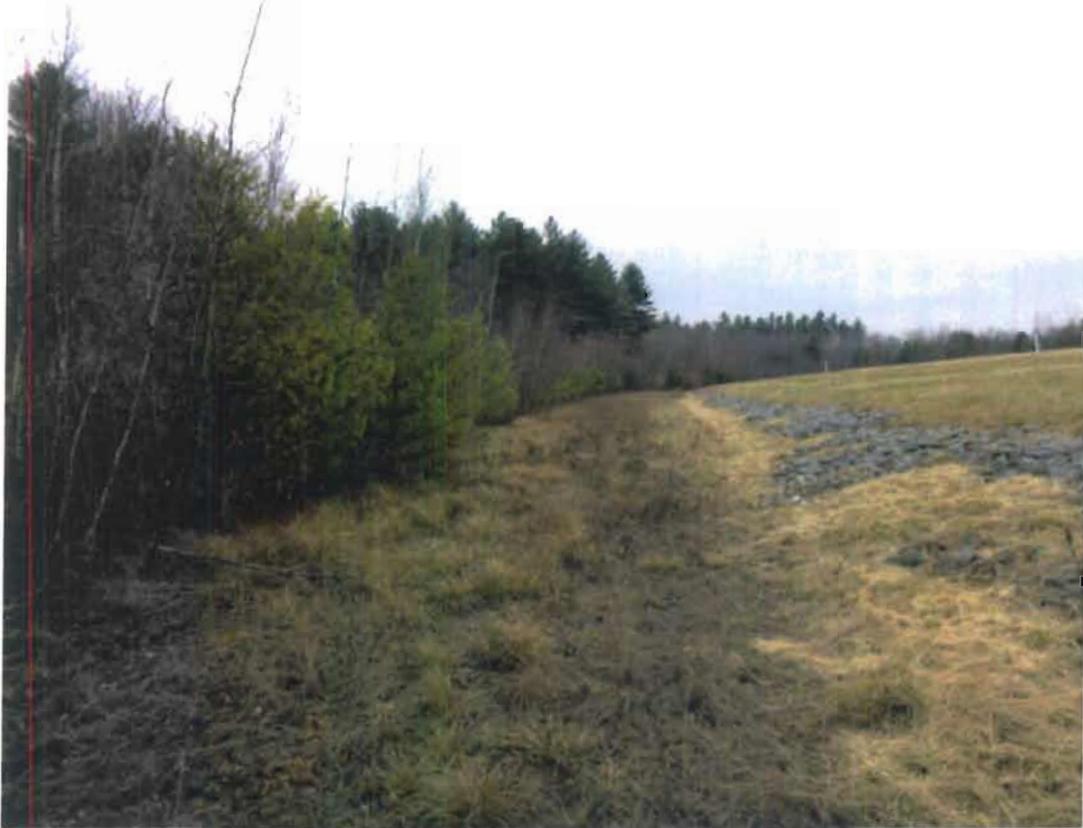
**Photo No. 48: Tire Dump – Top Surface**
