FINAL
YEAR 3 INTERIM MONITORING REPORT –
TERMINAL 4 PHASE I REMOVAL ACTION
PORT OF PORTLAND, PORTLAND, OREGON

Port of Portland
Portland, Oregon

Anchor QEA, LLC
6650 SW Redwood Lane, Suite 333
Portland, Oregon 97224

May 2012

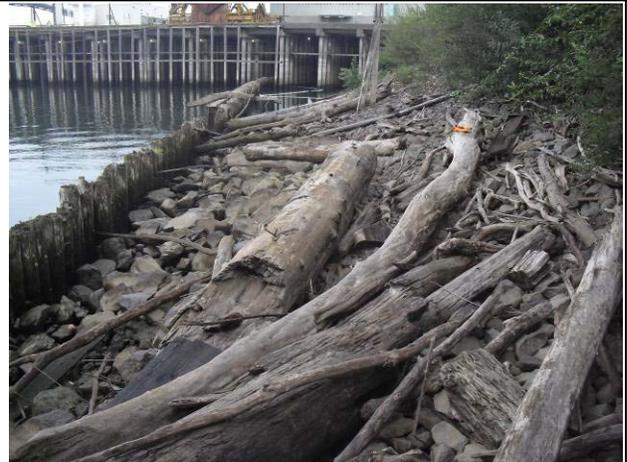
Slip 3 slope looking South

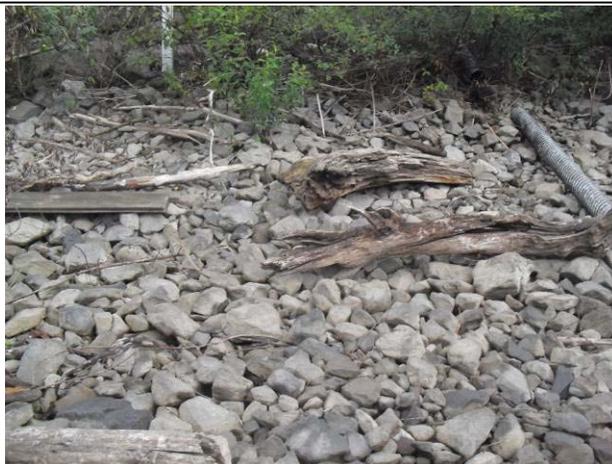
North Transect, looking down-slope

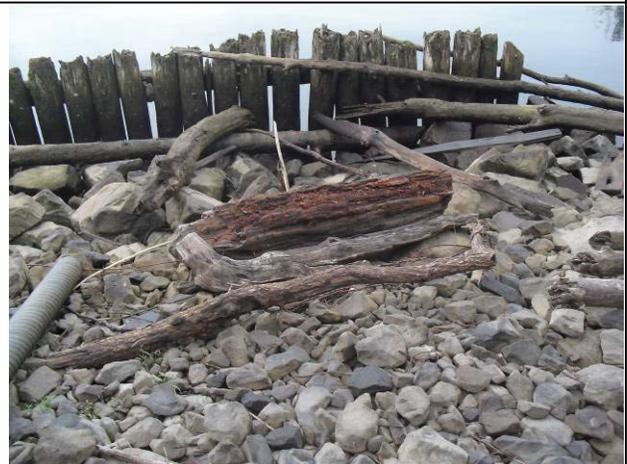
North Transect, looking up-slope

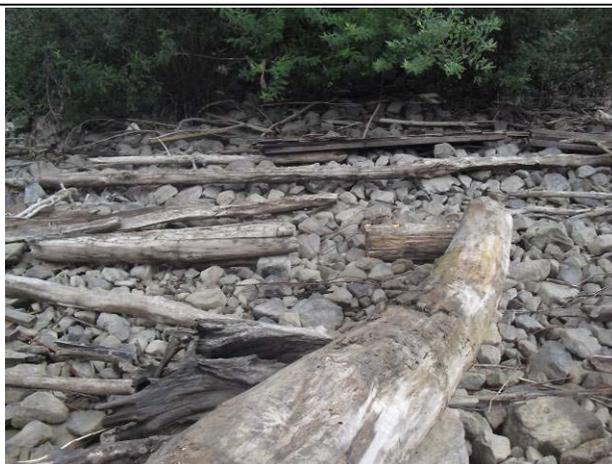
Middle Transect, looking down-slope

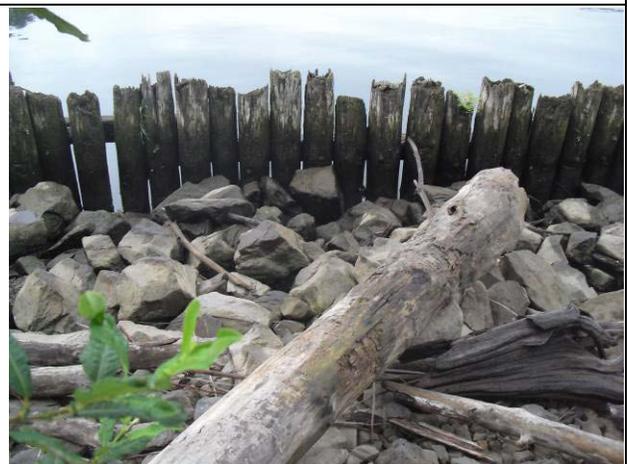
Middle Transect, looking up-slope

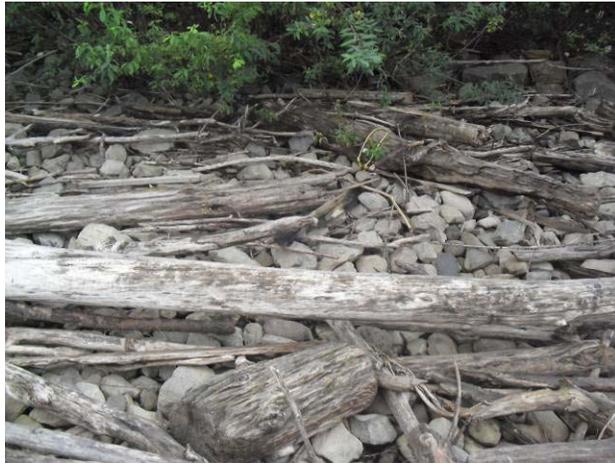
South Transect, looking down-slope

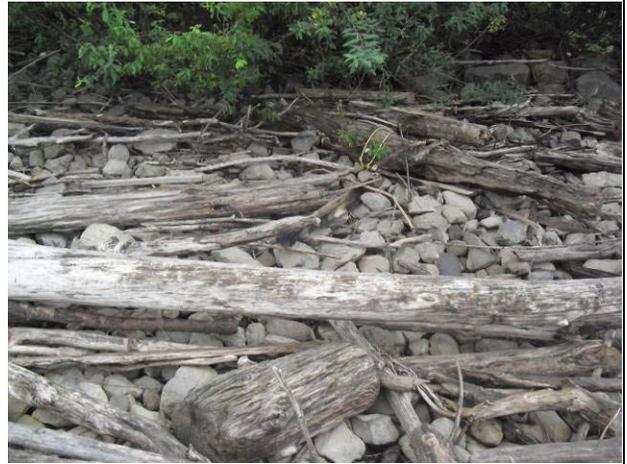
South Transect, looking up-slope

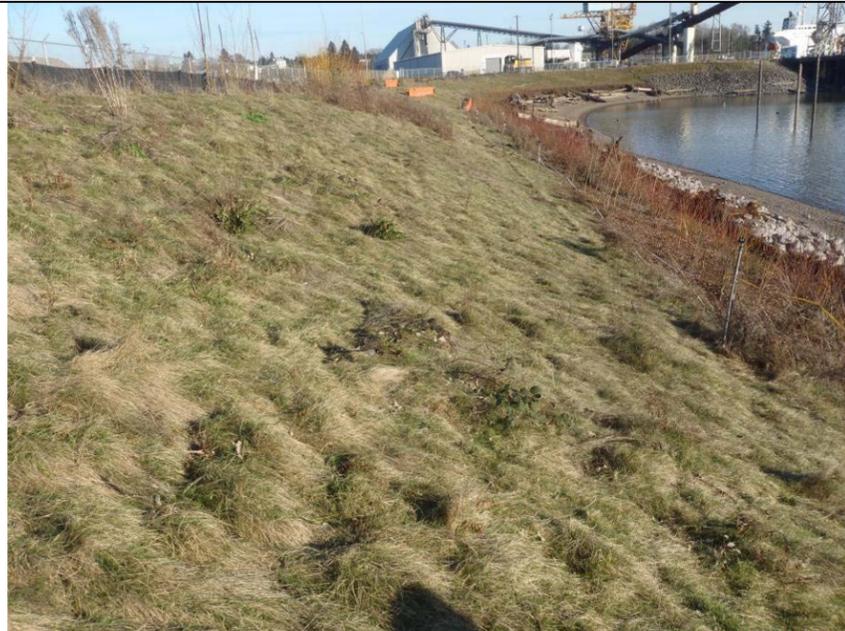
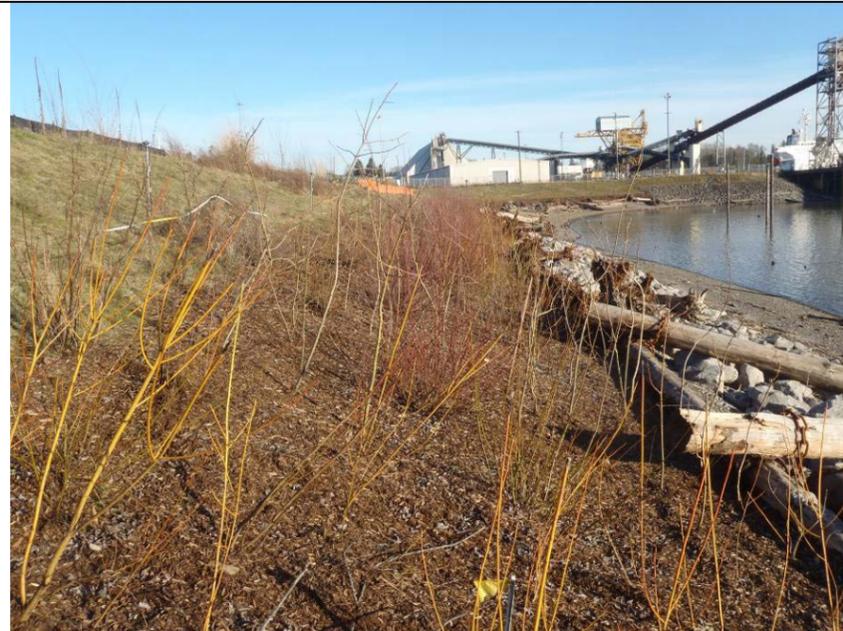
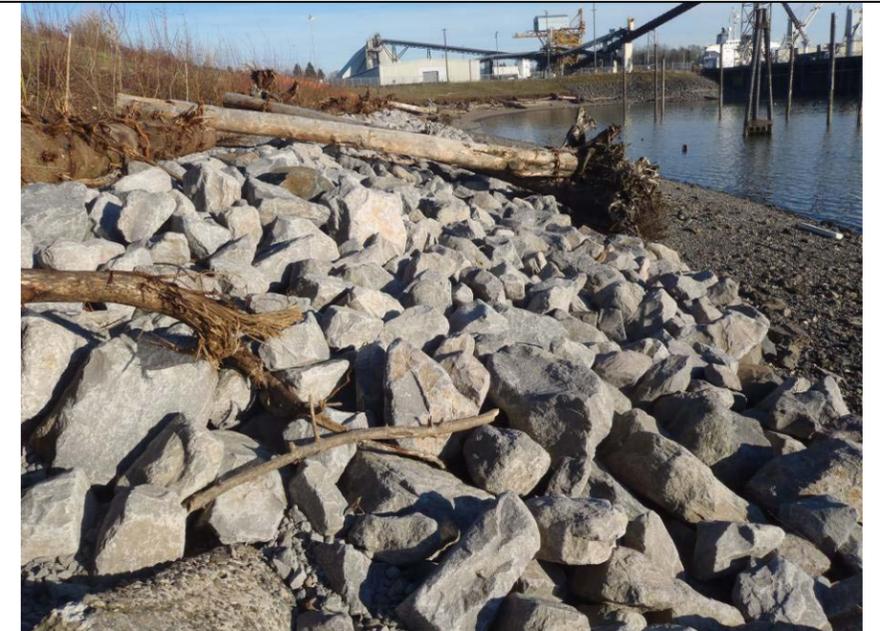
Transect 00+04 @ 140 degrees (G, W, R)

Grass height was approximately 5 centimeters (cm) with greater than 95 percent coverage. Willow height ranged from 0.3 to 2 meters tall. No significant mortality was observed. No areas of erosion, sloughing, or instability were noted in the grass, willow, or armor rock areas. Some blackberry and dormant thistle were present in the grass planting area. Notes and photographs are provided in Attachments B-1 and B-2, respectively.

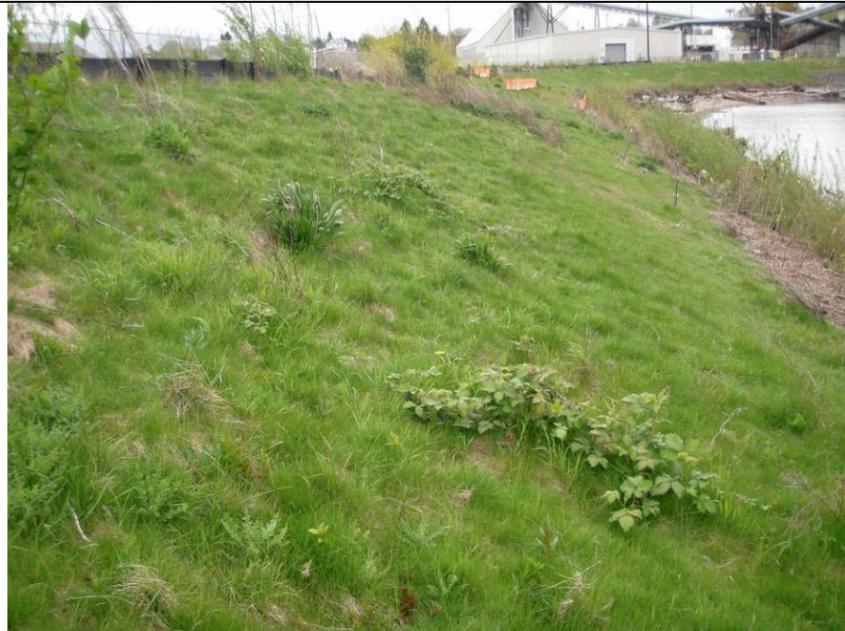
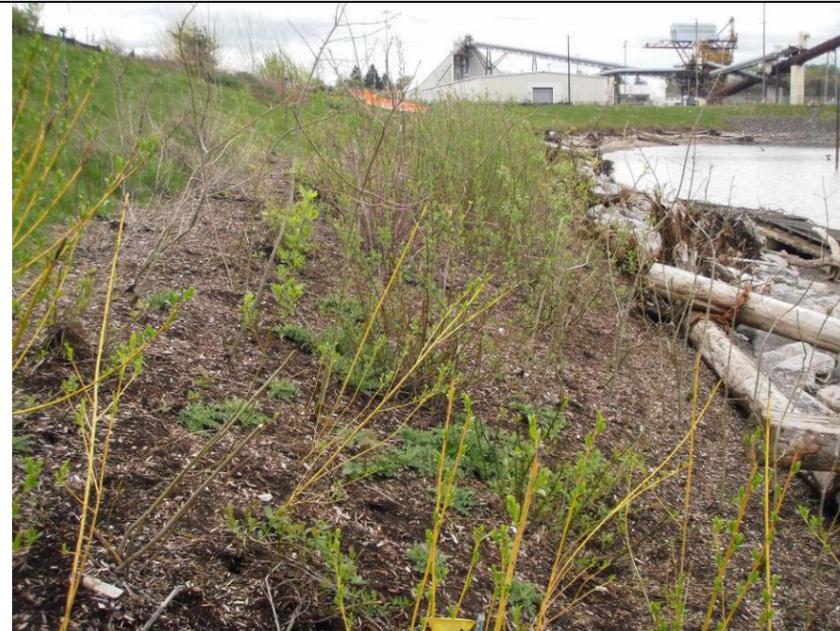
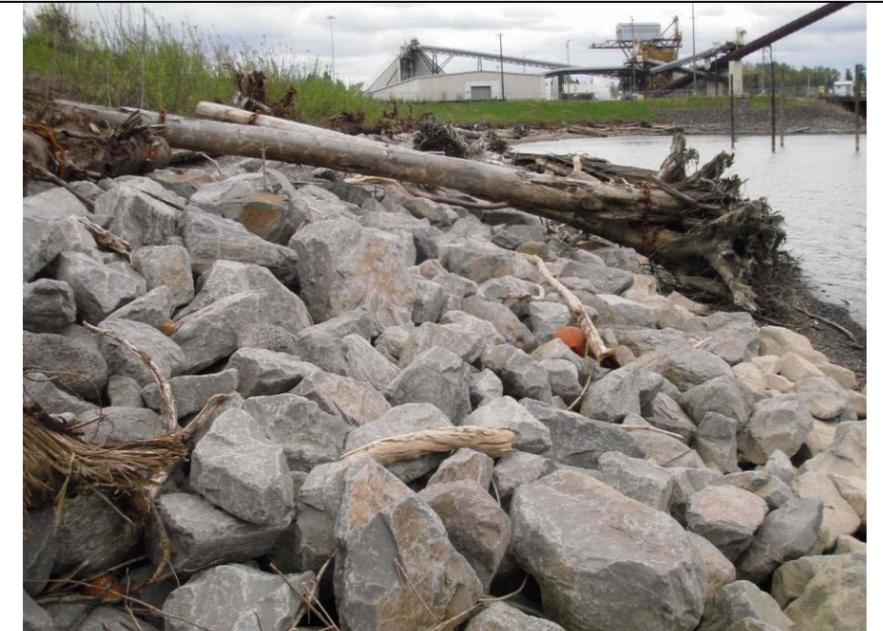
Transect 00+04 @ 140 degrees (G, W, R)

Grass height was between 5 and 20 cm with greater than 95 percent coverage. Willow height ranged from 2 to 3 meters tall. No significant mortality was observed. One small area of bark mulch fill upslope of the large woody debris at Station 00+05 was observed to have settled. No other areas of erosion, sloughing, or instability were noted in the grass, willow, or armor rock areas. Some blackberry and thistle were present in the grass planting area. Notes and photographs are provided in Attachments B-3 and B-4, respectively.

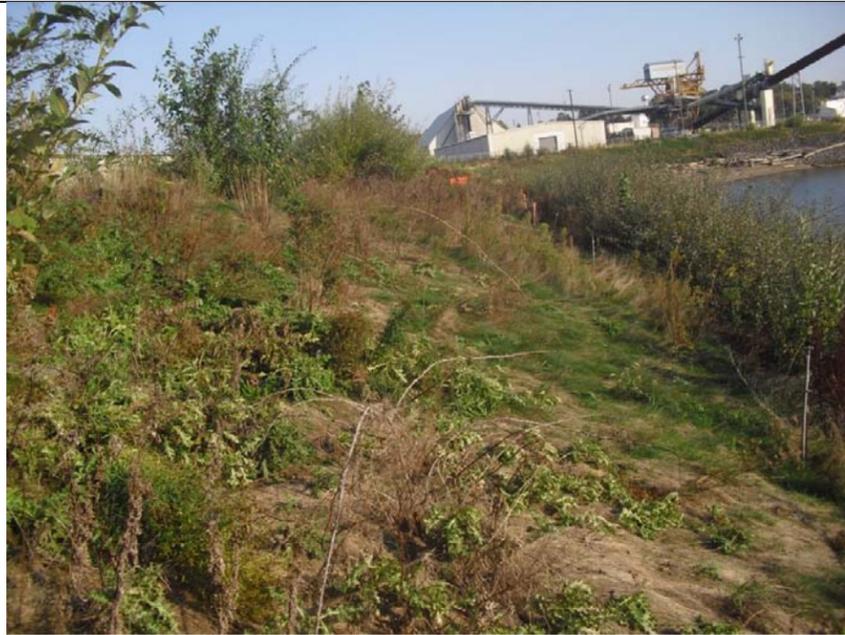
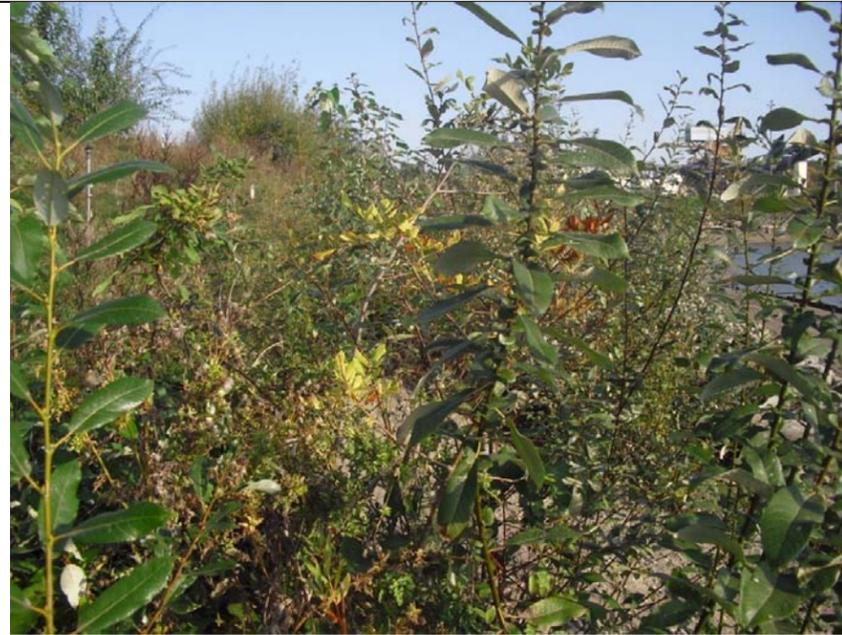
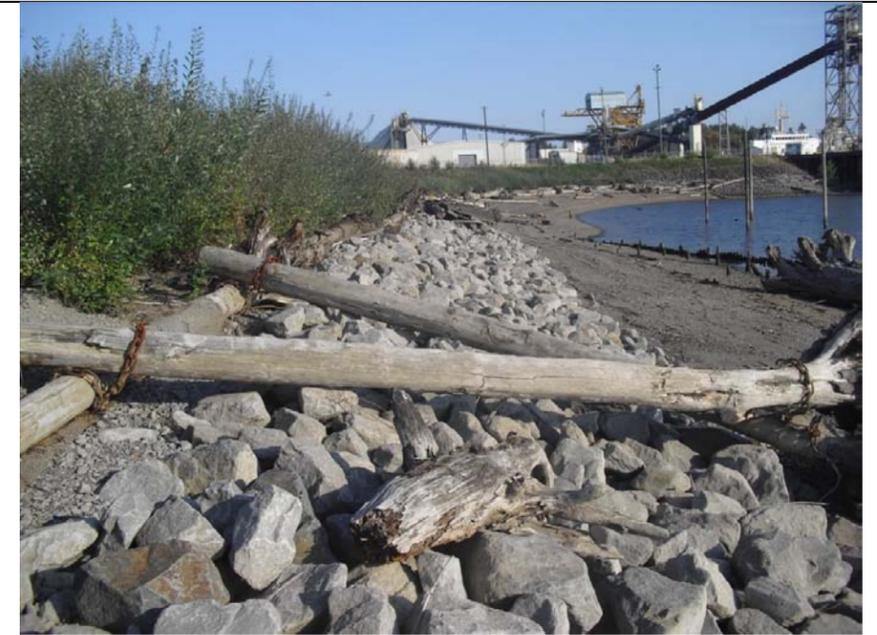
Transect 00+04 @ 140 degrees (G, W, R)

Fourth quarter monitoring was conducted after the completion of the 2011 repairs to the WB shoreline. Grass height was approximately 15 cm with greater than 95 percent coverage. Willow height ranged from 1.5 to 3 meters tall. No significant mortality was observed. No areas of erosion, sloughing, or instability were noted in the grass, willow, or armor rock areas. Some residual thistle and blackberry were observed after the Port of Portland weeding event. Notes and photographs are provided in Attachments B-7 and B-8, respectively.
