YEAR 1 INTERIM MONITORING REPORT – PHASE I REMOVAL ACTION  
TERMINAL 4 EARLY ACTION  
PORT OF PORTLAND, PORTLAND, OREGON

Port of Portland  
Portland, Oregon

Anchor QEA, LLC  
6650 SW Redwood Lane, Suite 333  
Portland, Oregon 97224

**February 2010**

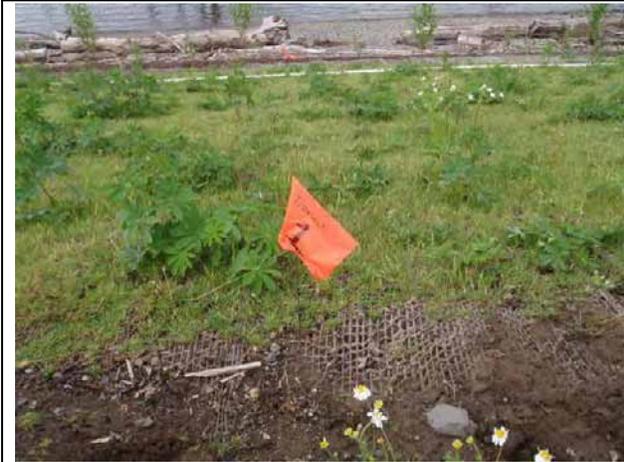
Transect 1, looking down-slope 6/19/2009

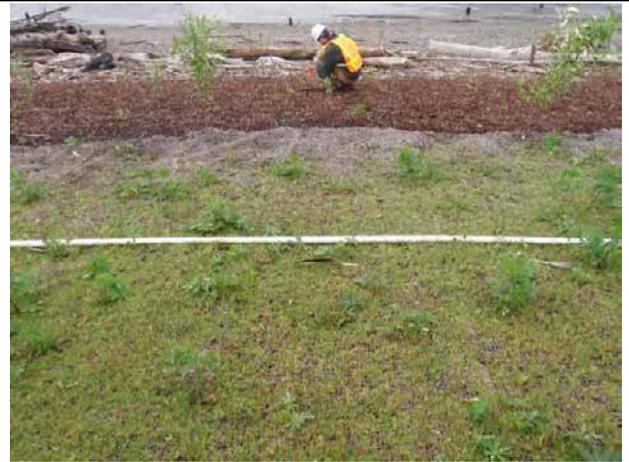
Transect 2, looking down-slope 6/19/2009

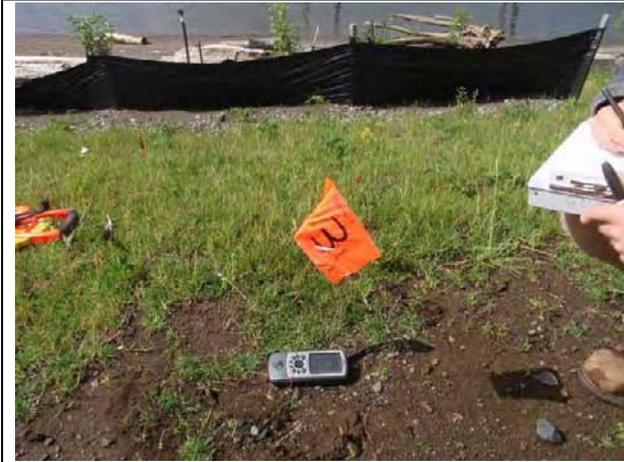
Transect 3, looking down-slope 6/19/2009

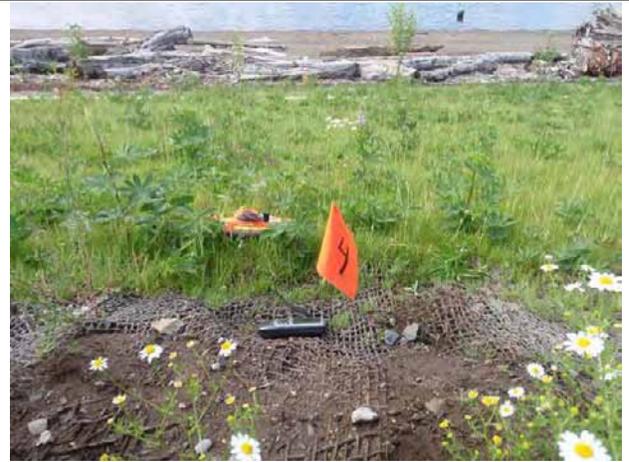
Transect 4, looking down-slope 6/19/2009

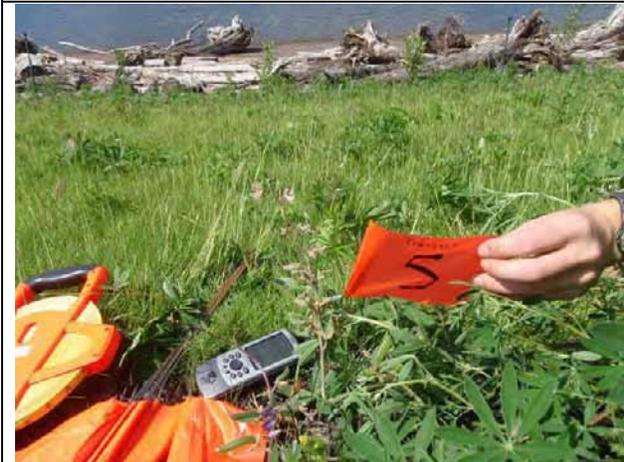
Transect 5, looking down-slope 6/19/2009

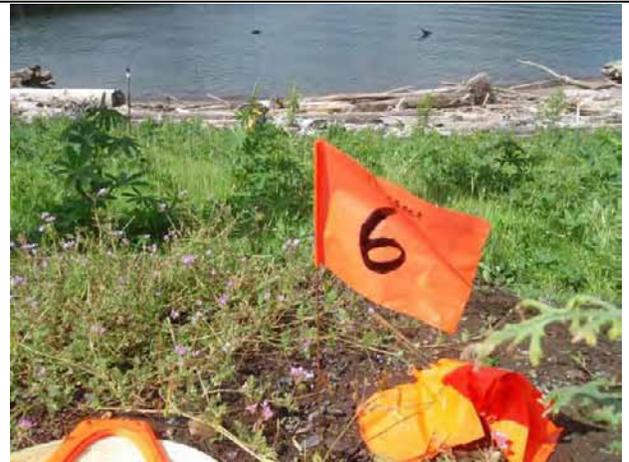
Transect 6, looking down-slope 6/19/2009

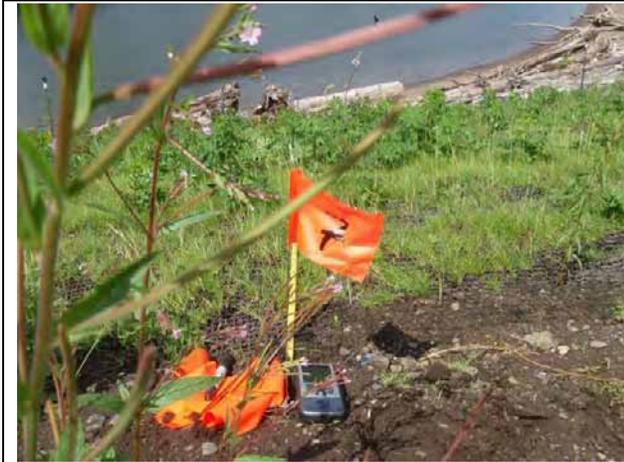
Transect 7, looking down-slope 6/19/2009

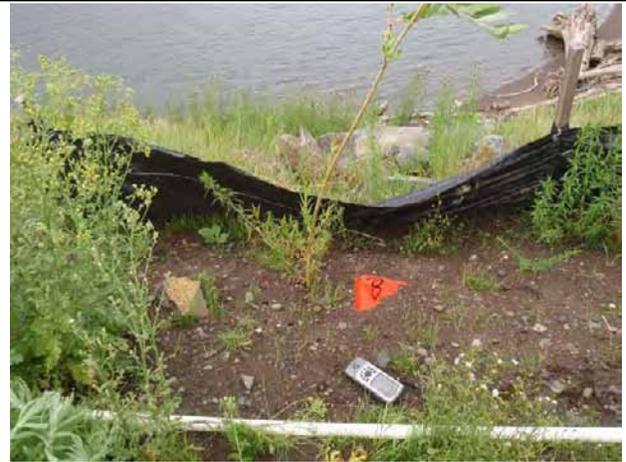
Transect 8, looking down-slope 6/19/2009

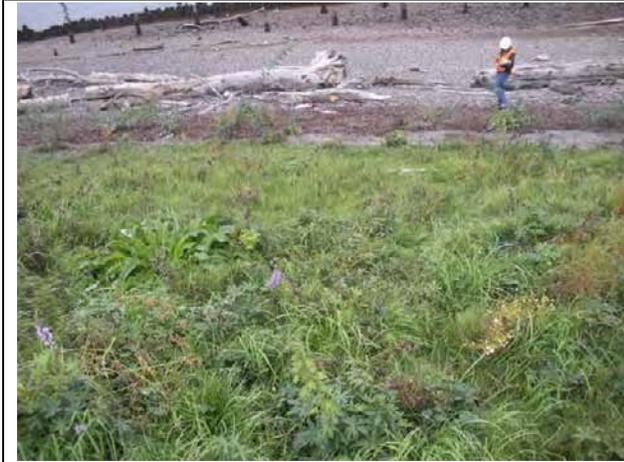
Transect 1, looking down-slope 10/22/2009

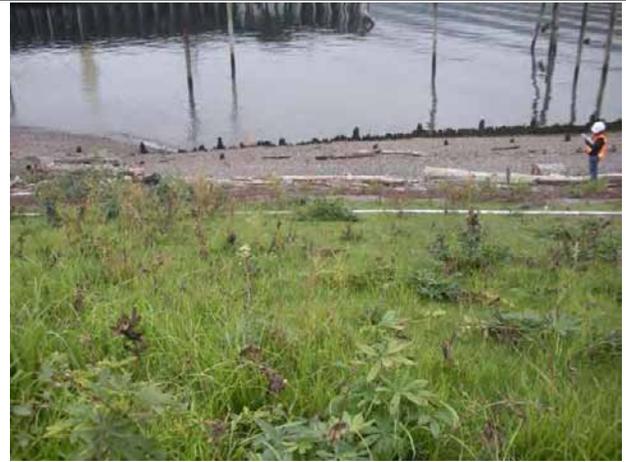
Transect 2, looking down-slope 10/22/2009

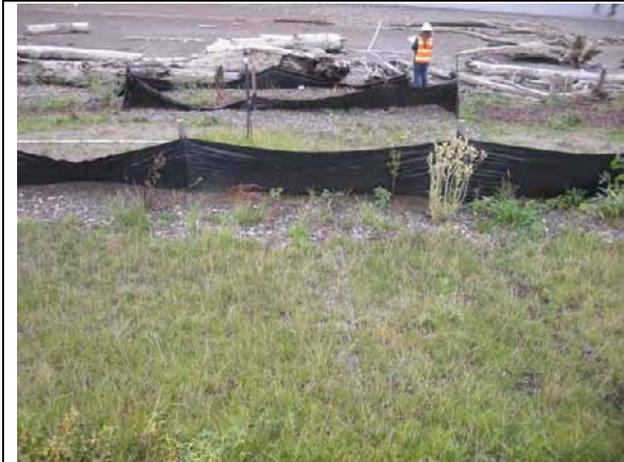
Transect 3, looking down-slope 10/22/2009

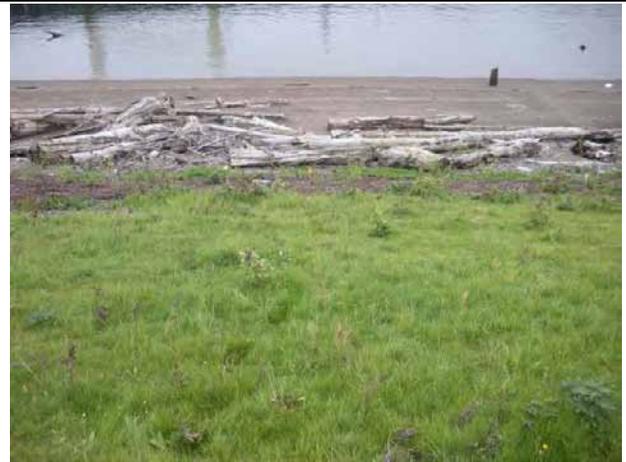
Transect 4, looking down-slope 10/22/2009

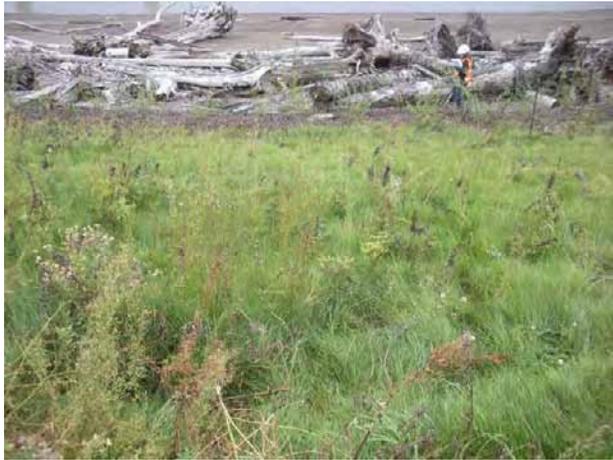
Transect 5, looking down-slope 10/22/2009

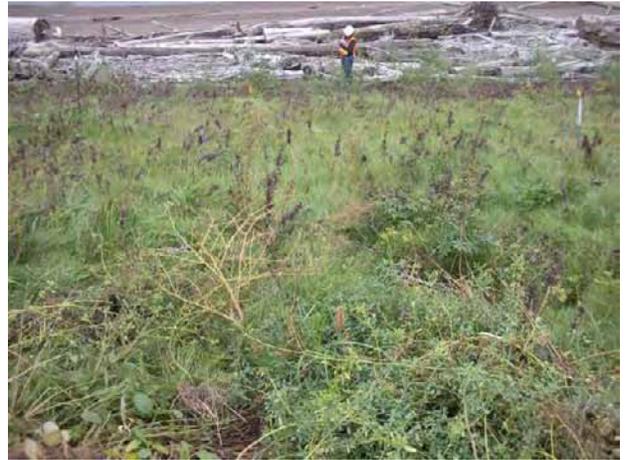
Transect 6, looking down-slope 10/22/2009

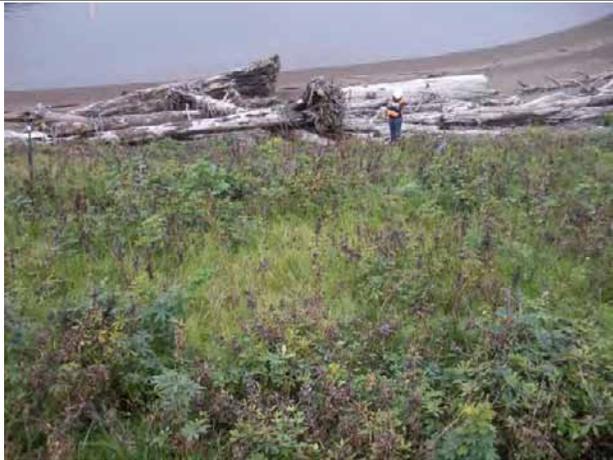
Transect 7, looking down-slope 10/22/2009

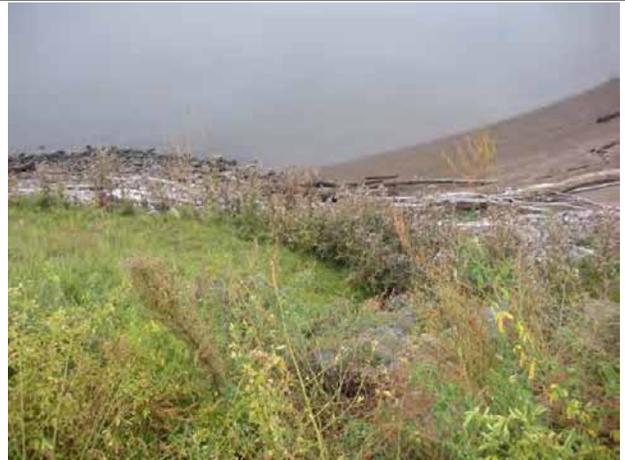
Transect 8, looking down-slope 10/22/2009

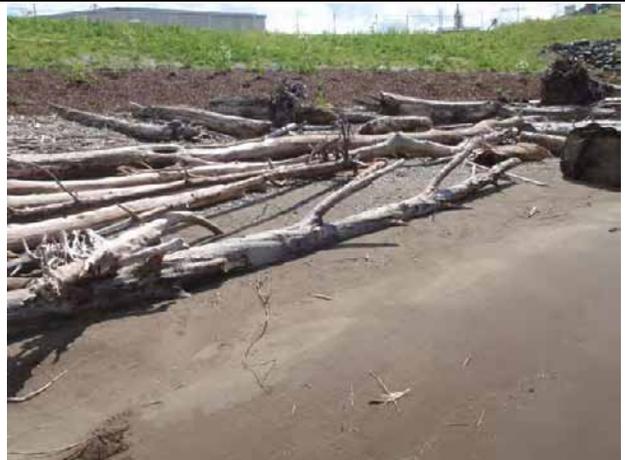
Woody debris along shoreline 6/16/2009

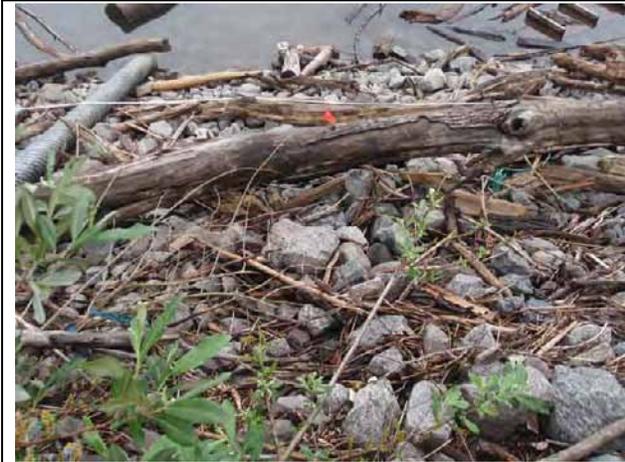
On June 19, 2009, three transects were established on 40-foot spacings perpendicular to the shoreline. A GPS point was taken at the downslope end of each transect. Transects were marked with flags and monitoring staff walked from the upslope edge of the stabilization area to the water. Notes and photographs (provided as attachments to Appendix A) were taken to document visual slope stability along each transect. In summary, no areas of instability were noted.

North Transect, looking down-slope 6/19/2009

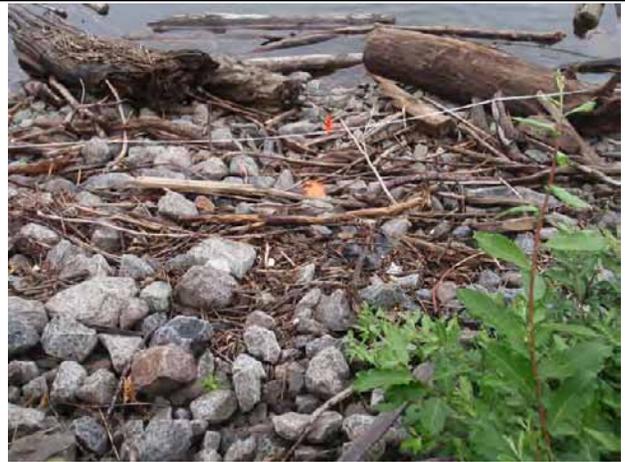
Middle Transect, looking down-slope 6/19/2009

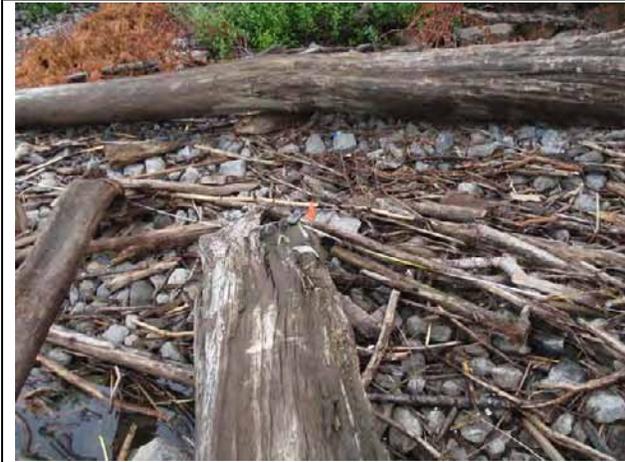
South Transect, looking up-slope 6/19/2009

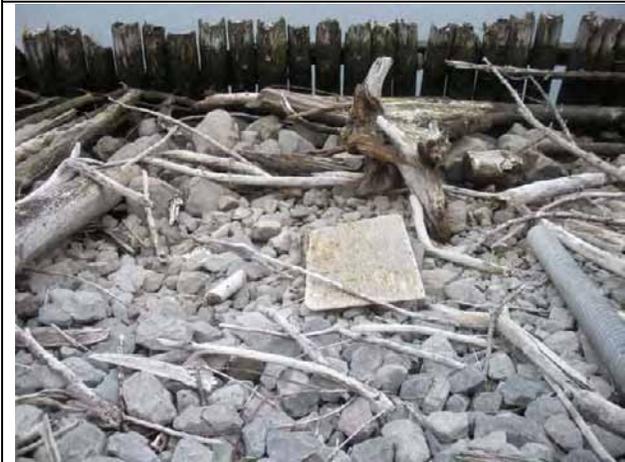
On October 22, 2009, monitoring staff walked from upslope to downslope along the three transects established during the first visual survey event. Notes and photographs (provided as attachments to Appendix A) were taken to document slope stability along each transect. In summary, no areas of instability were noted.

North Transect, looking down-slope 10/22/2009

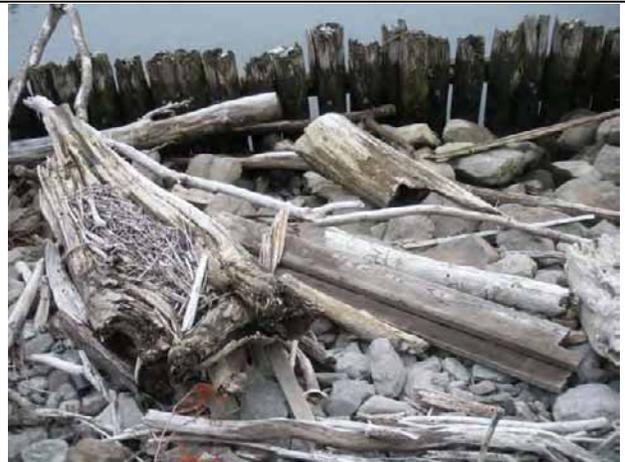
Middle Transect, looking down-slope 10/22/2009

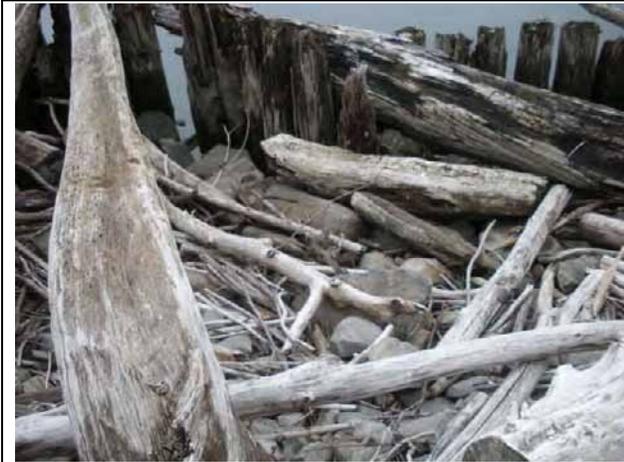
South Transect, looking down-slope 10/22/2009

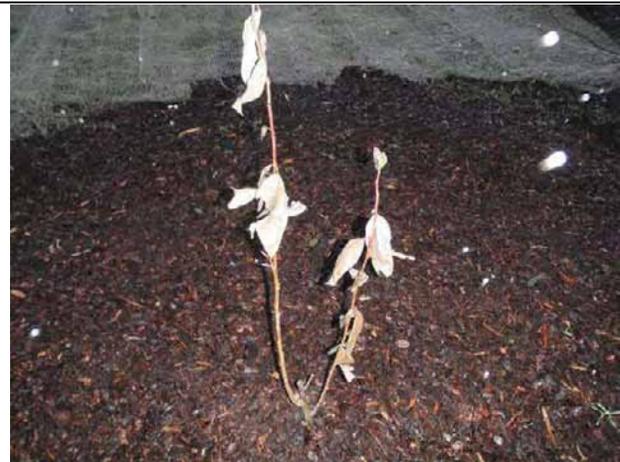
Dormant willow

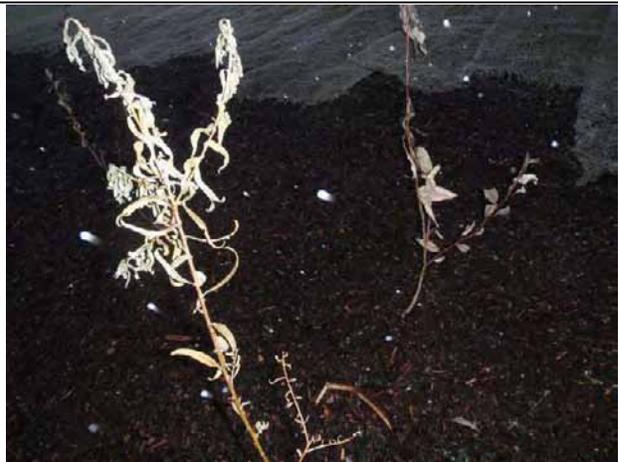
Dormant willows

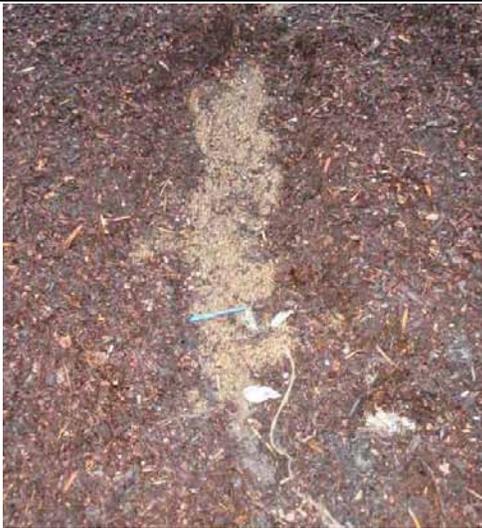
Three small patches of superficial bark mulch erosion at lower elevations were observed (see photographs). The erosion was similar to that observed in the Month 1 Vegetation Observation. There was no indication of any sloughing, slope instability, or significant erosion from elevation +15 to +30 feet NGVD. The bank is free from invasive species.

Bark mulch erosion A

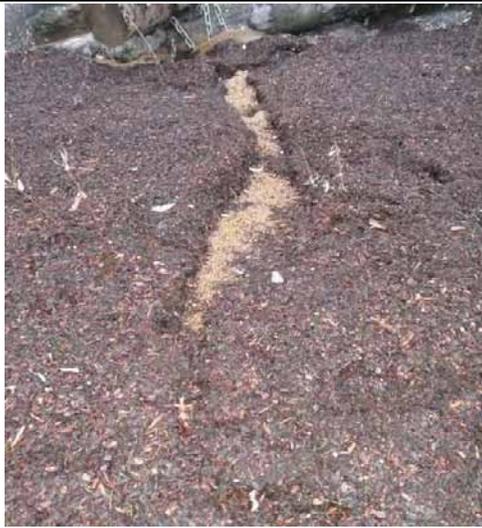
Bark mulch erosion B

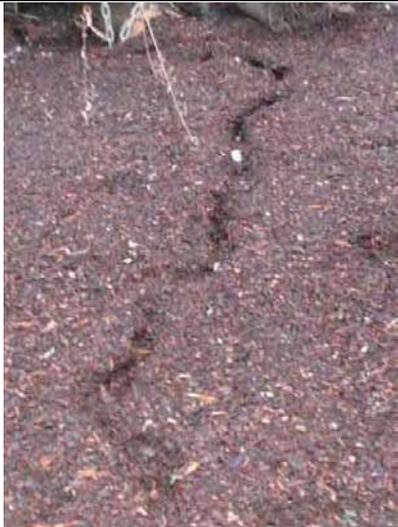
Bark mulch erosion C

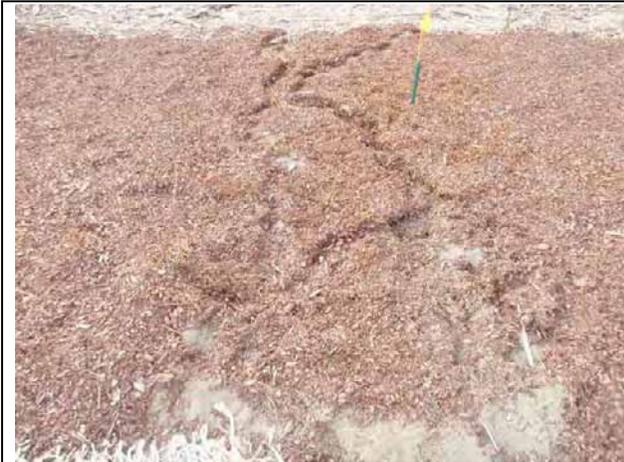
Five small patches of bark mulch erosion at lower elevations were observed (see photographs). Erosion was observed in two additional locations apart from the three observed in the Months 1 and 2 Vegetation Observations (see photographs). Erosion of bark mulch remains superficial and does not penetrate below the jute mat material. There was no indication of any sloughing, slope instability, or significant erosion from elevation +15 to +30 feet NGVD. The bank is free from invasive species.

Bark mulch erosion A

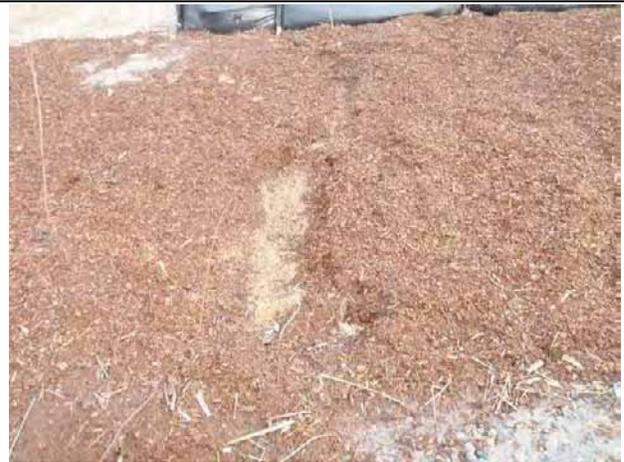
Bark mulch erosion B

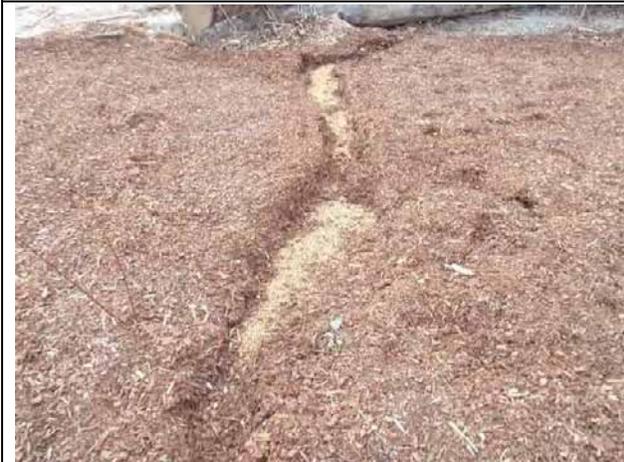
Bark mulch erosion C

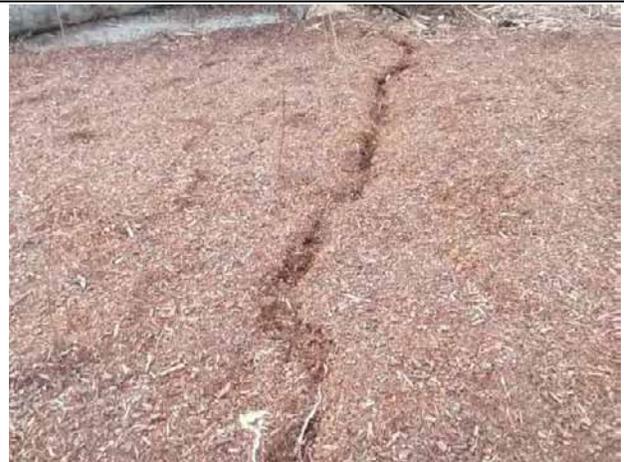
Bark mulch erosion D

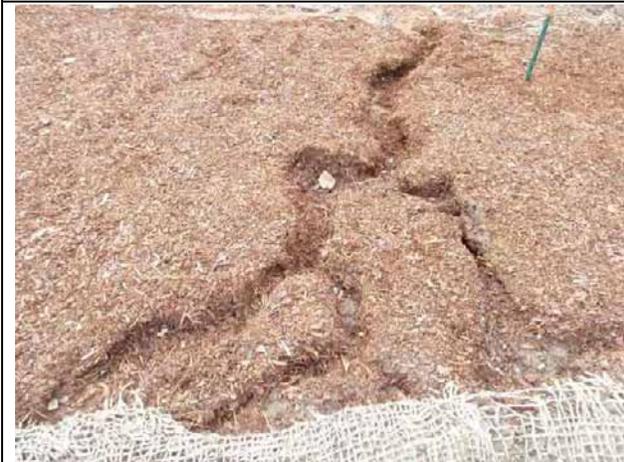
Bark mulch erosion E

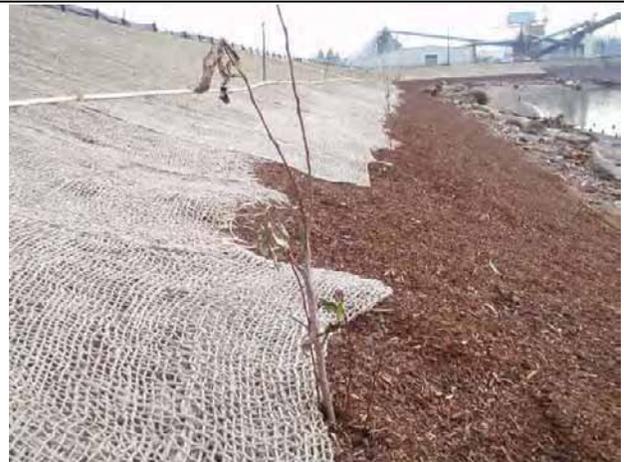
Dormant willow

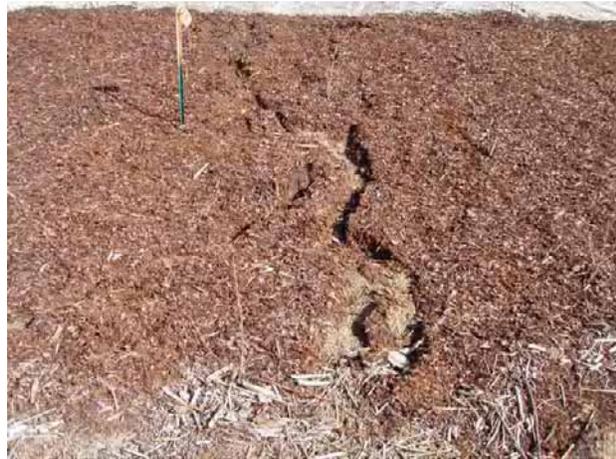
Grass height was low and unchanged from Month 3 (2 to 3 centimeters). Geese were observed on the grass, with some active grazing. Grass was slightly grazed throughout, although more heavily grazed at the lower elevations. Higher elevation willows were approximately 1 meter tall. Lower elevation willows ranged from 0.5 to 1 meter in height. Approximately 50 to 60% of willows showed budding (see attached photographs).

Budding willow

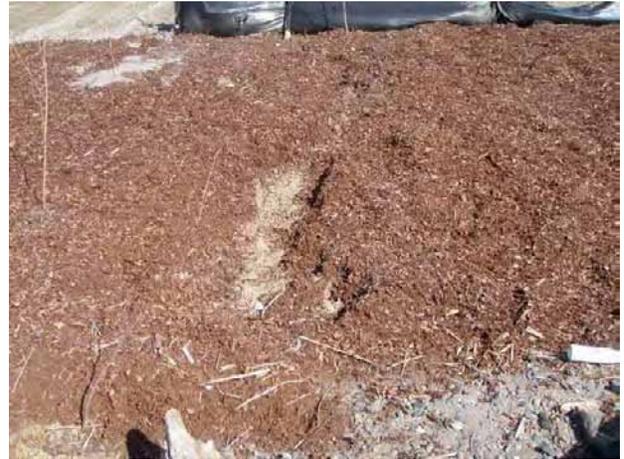
Five small patches of bark mulch erosion at lower elevations were observed (see photographs). Erosion was similar to Month 3 observations and did not penetrate jute mat material. Some erosion was also present in lower elevation bark mulch due to the water reaching higher elevations. No indication of any sloughing, slope instability, or significant erosion from elevation +15 to +30 feet NGVD was observed. The bank is free from invasive species.

Bark mulch erosion A

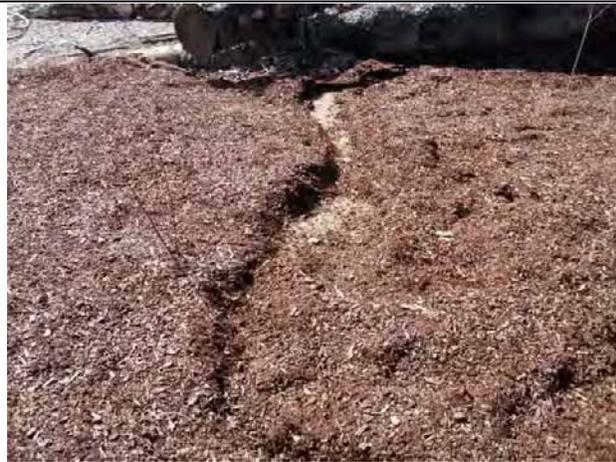
Bark mulch erosion B

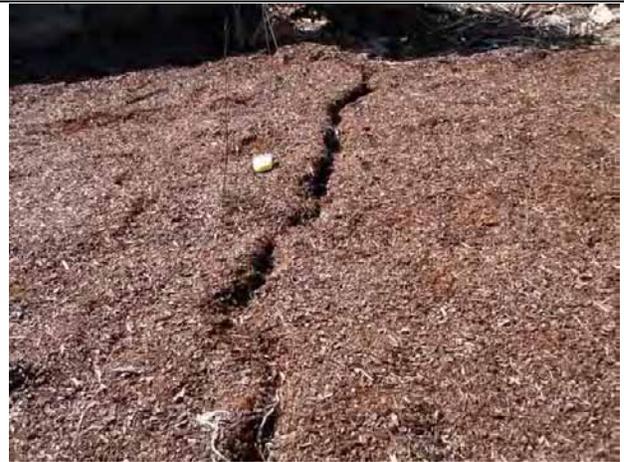
Bark mulch erosion C

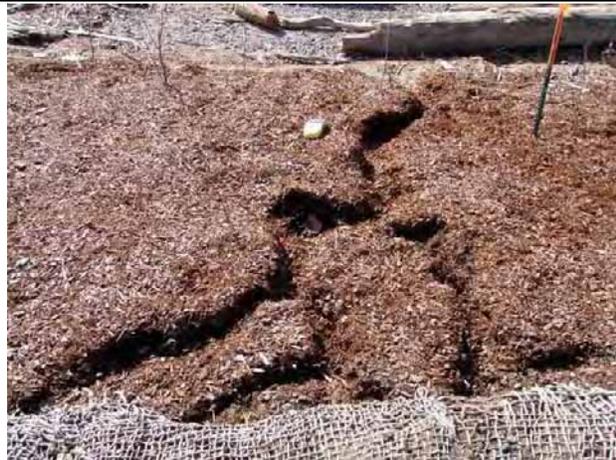
Bark mulch erosion D

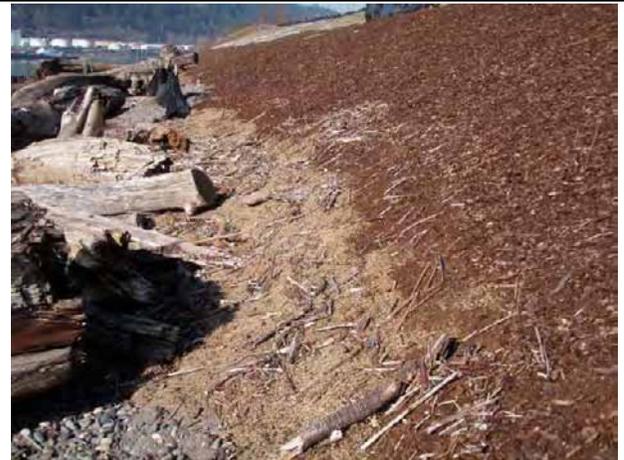
Bark mulch erosion E

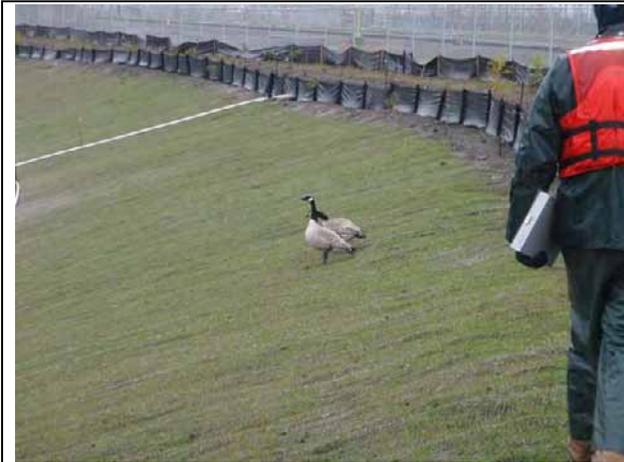
Geese grazing near Station 03G

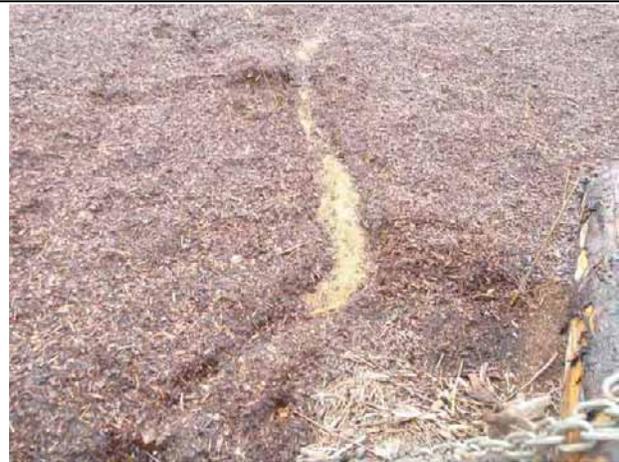
The five small patches of bark mulch erosion that run perpendicular to the shoreline were observed to be unchanged from previous months, both in size and scope (see photographs). This erosion refers to the bark mulch only and does not penetrate beneath the erosion-control fabric. Similar superficial erosion was also observed along the lower edge of the slope

Bark mulch erosion

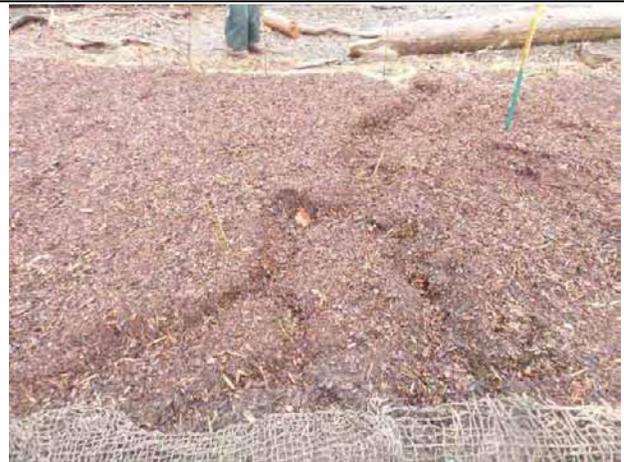
Bark mulch erosion

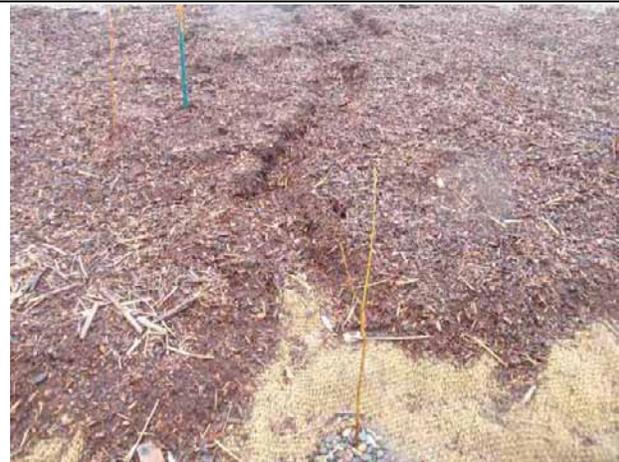
Bark mulch erosion

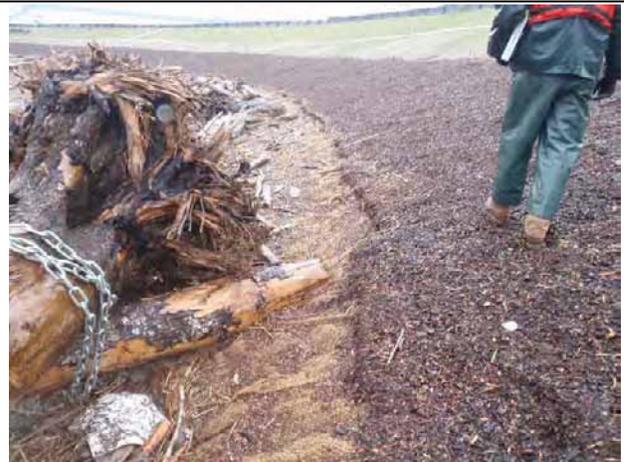
near the higher water elevations. No sloughing of the slope, movement of the armor stones, or erosion of other placed material was observed. In general, the bank appears to be stable and free from invasive species and noxious weeds.

Lower slope bark mulch erosion

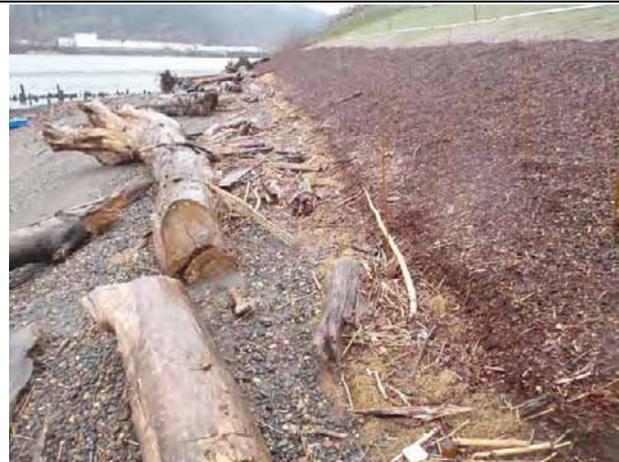
Lower slope bark mulch erosion

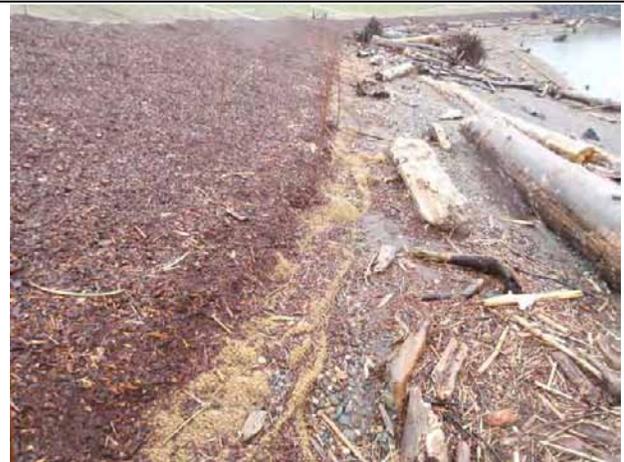
Lower slope bark mulch erosion

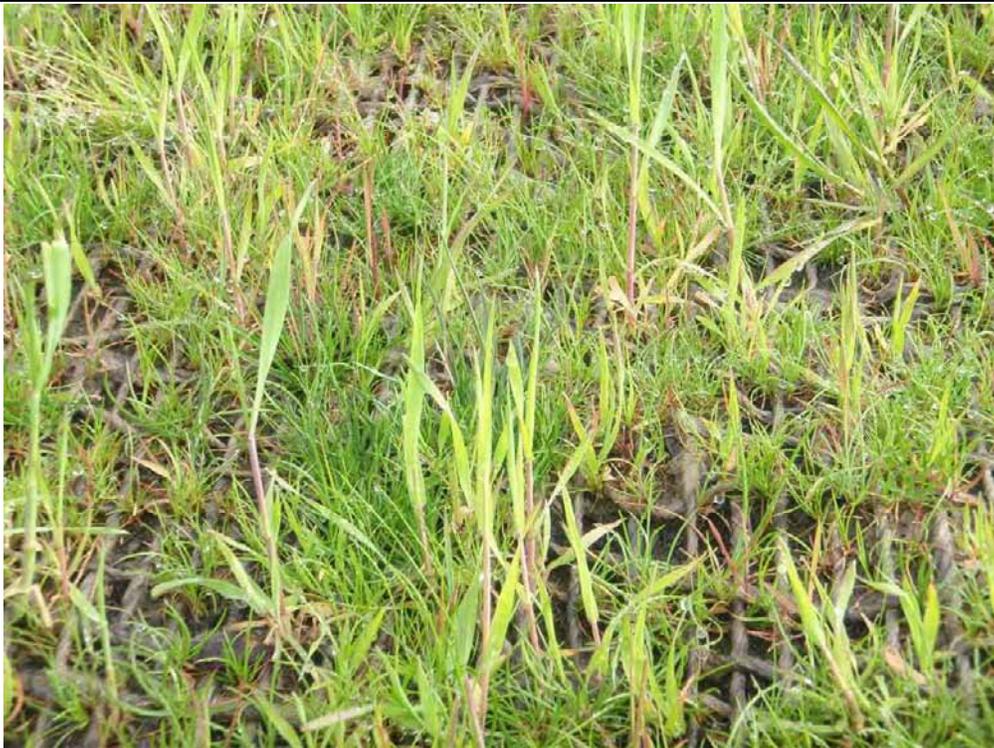
Two grass species found throughout

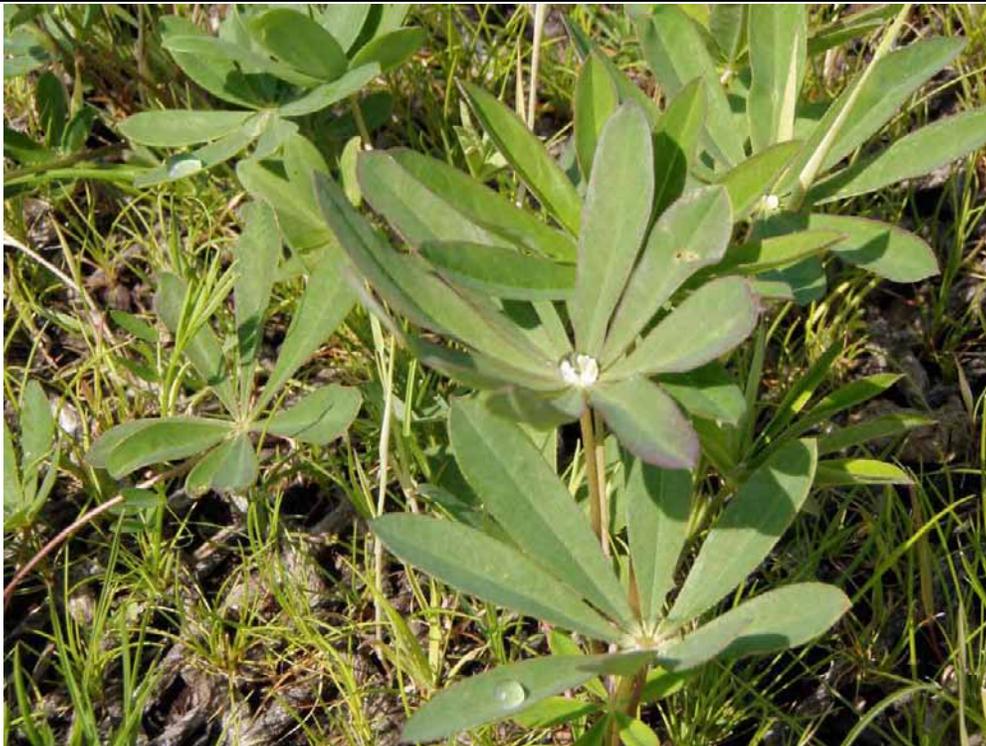
Lupine found throughout grass planting

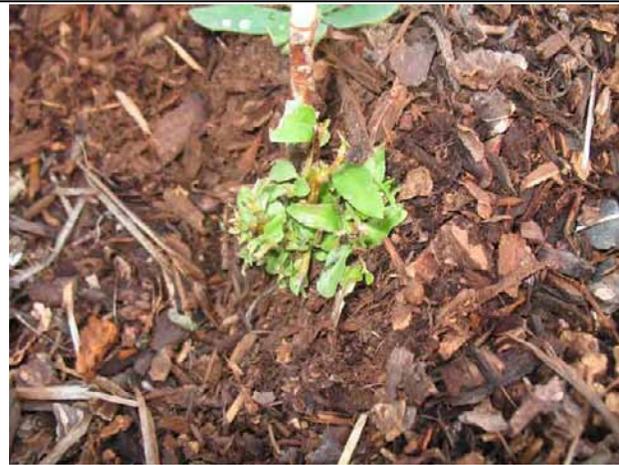
Live willow (presumed dead)

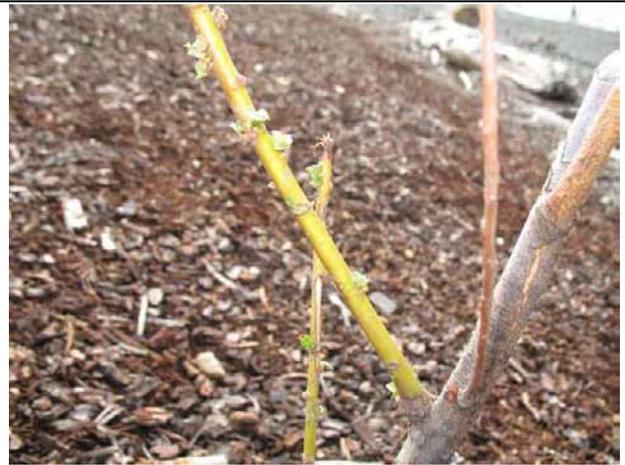
Live willow (presumed dead)

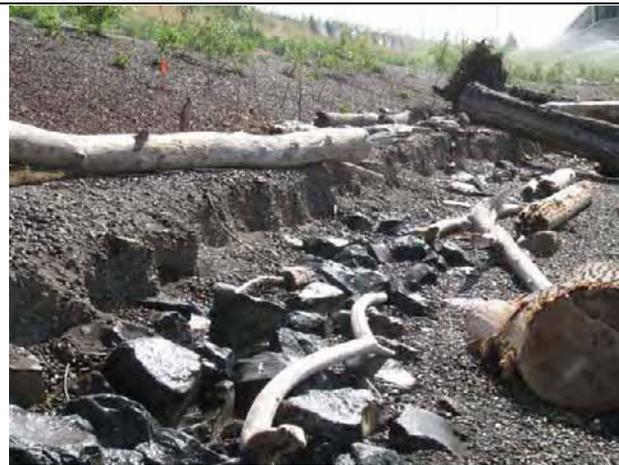
Exposed but stable rock armor layer

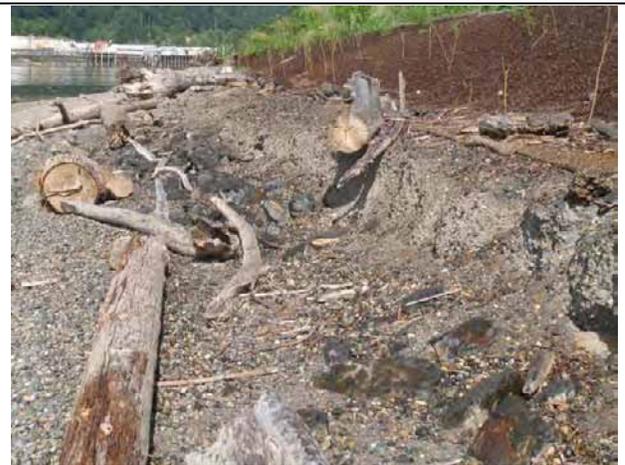
Exposed but stable rock armor layer

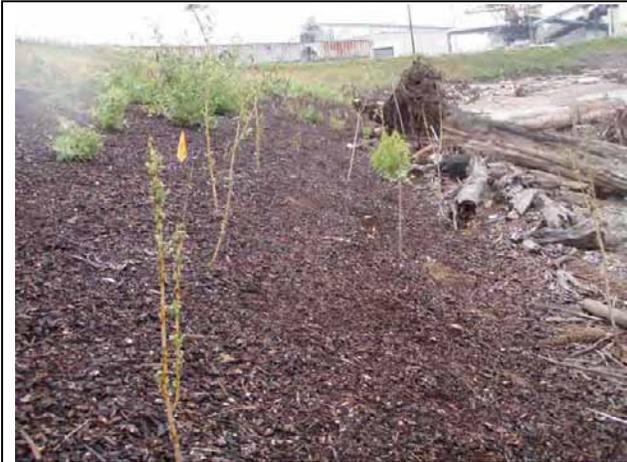
Live willows (presumed dead)

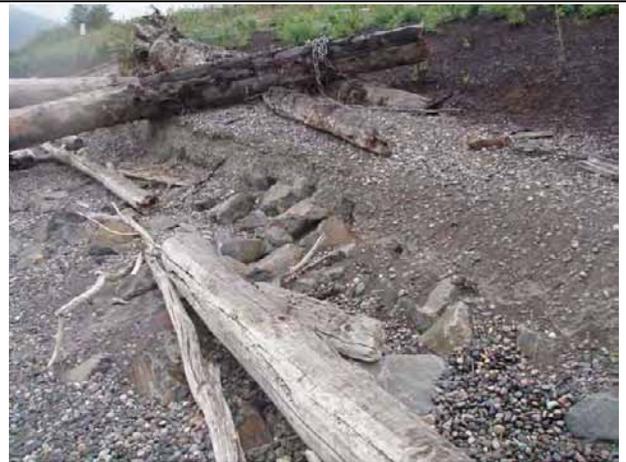
Exposed but stable rock armor layer

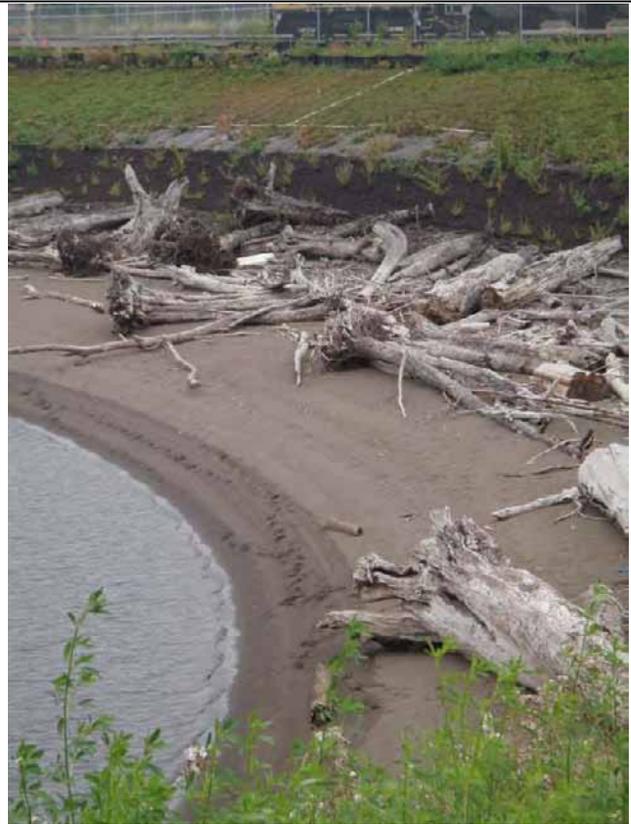
Woody debris

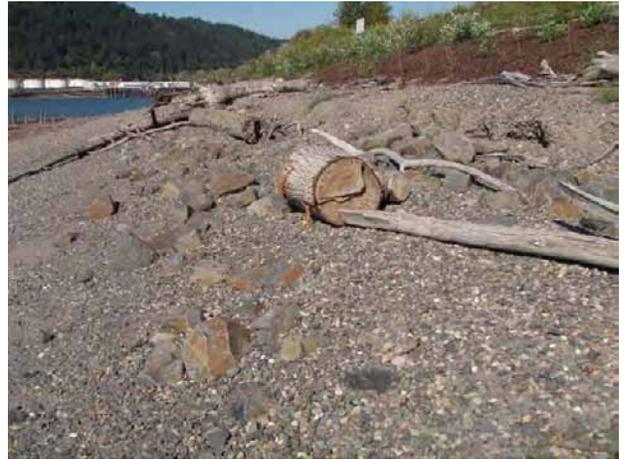
Exposed but stable rock armor layer

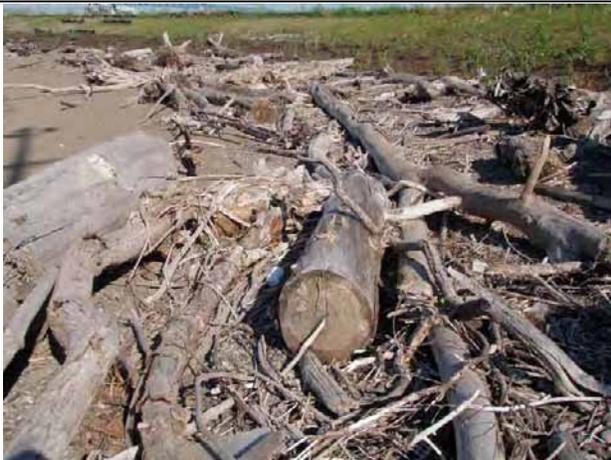
Exposed but stable rock armor layer

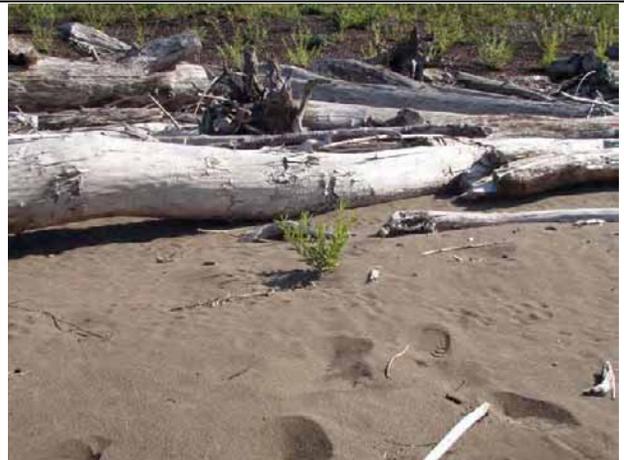
Woody debris

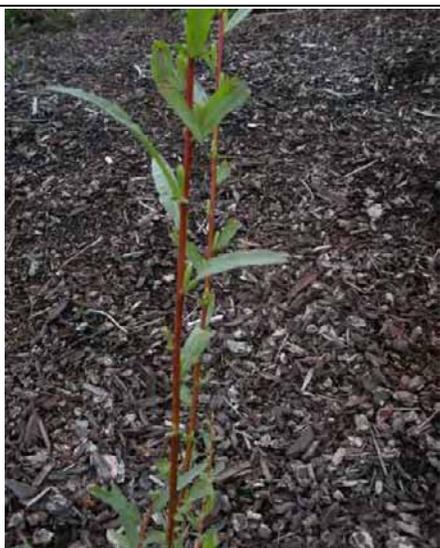
Grazed willow

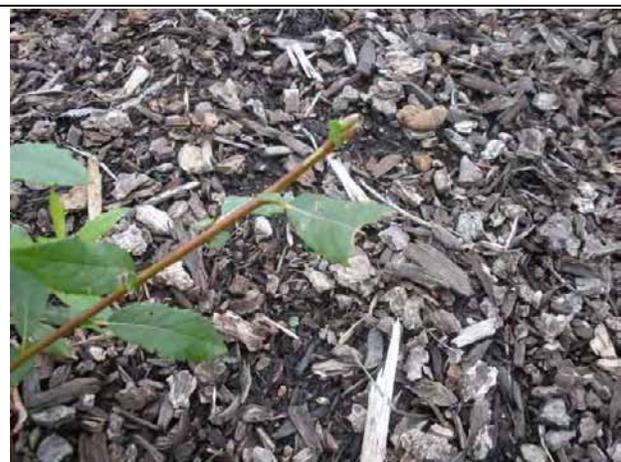
Grazed willow
